Inspection Report

915 W. Annie St.
Austin Texas 78704

PROPERTY INSPECTION REPORT FORM

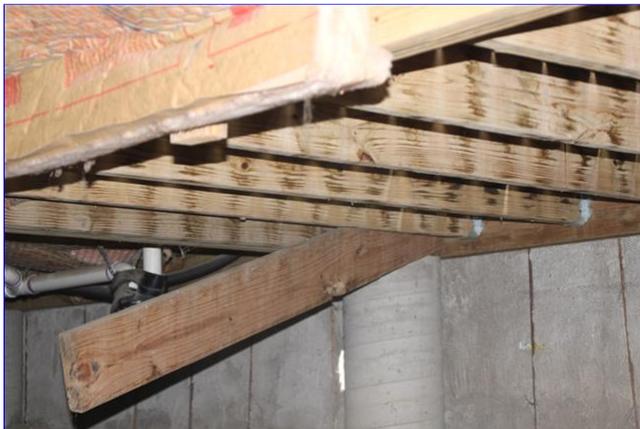
A. Item 1(Picture)

- (1) The foundation appears to be supporting the structure as intended at the time of the inspection.
- (2) **Loose beam observed at the rear of the crawlspace, recommend review for repairs as needed**

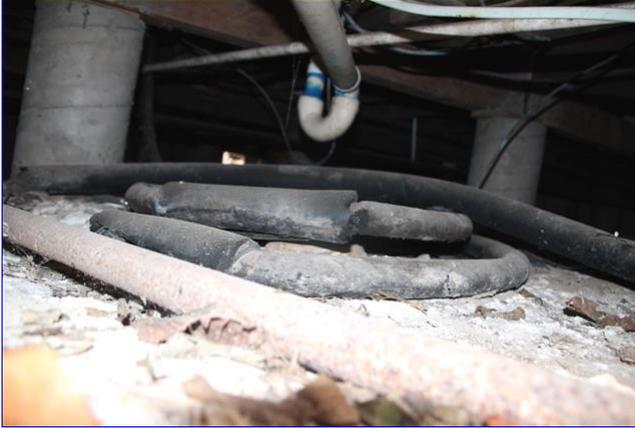
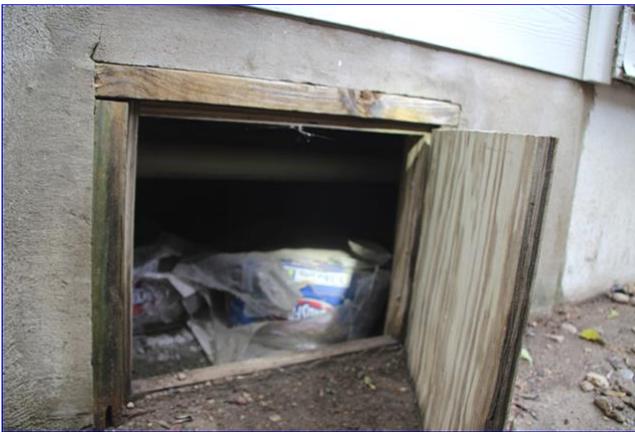
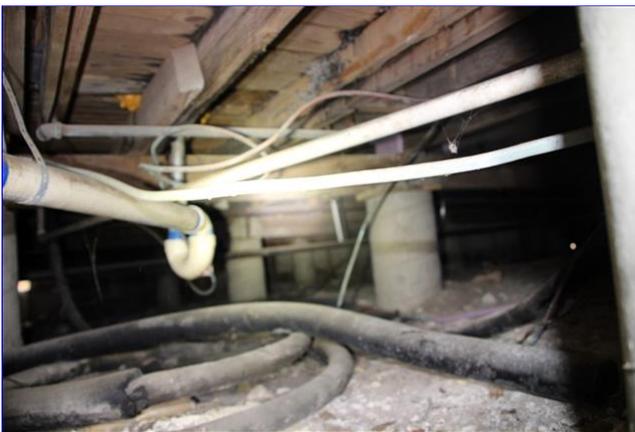
- (3) **Recommend removing trash and debris to help prevent nesting areas for pest**

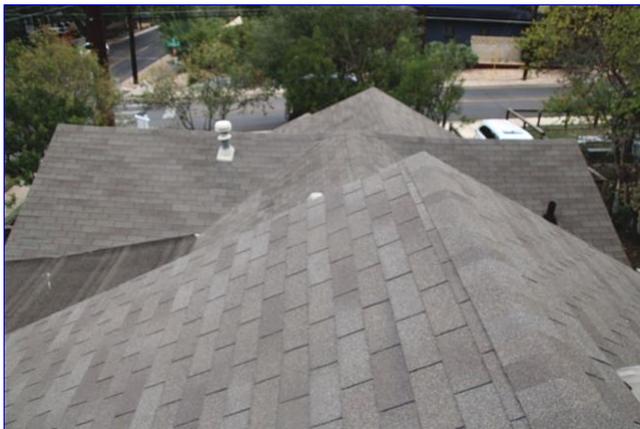
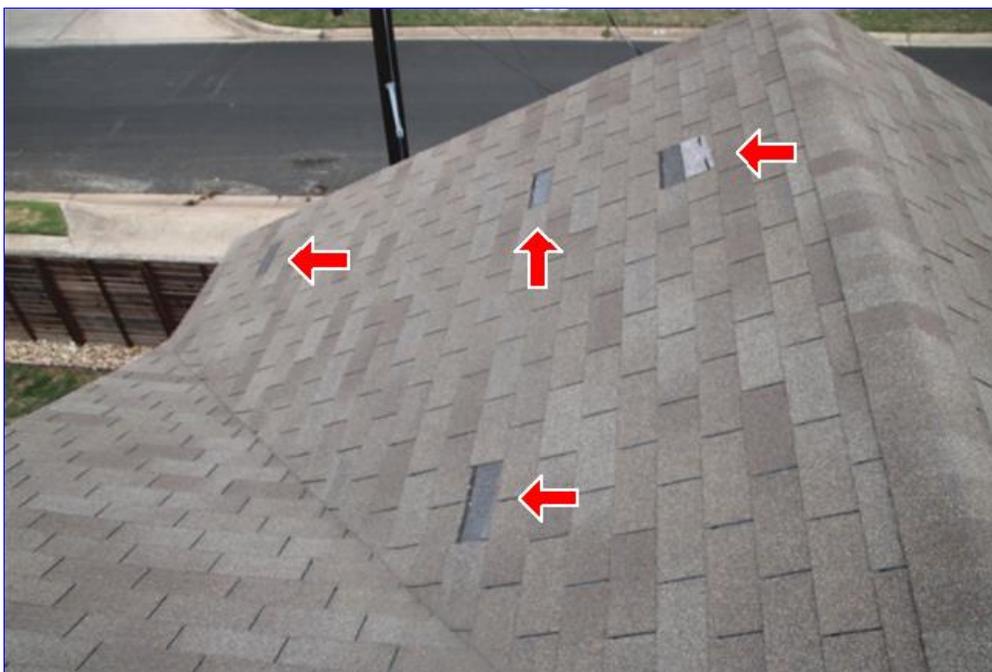
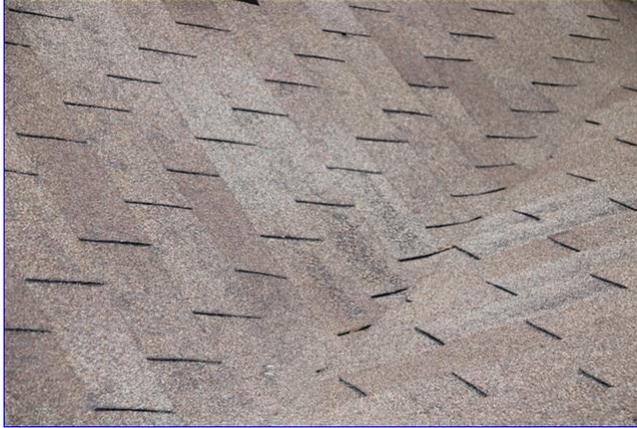
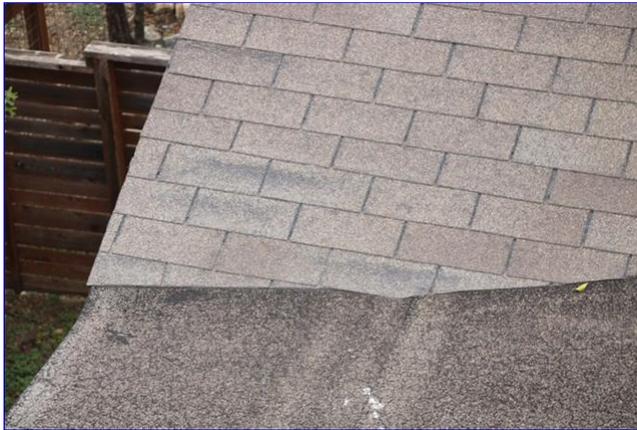
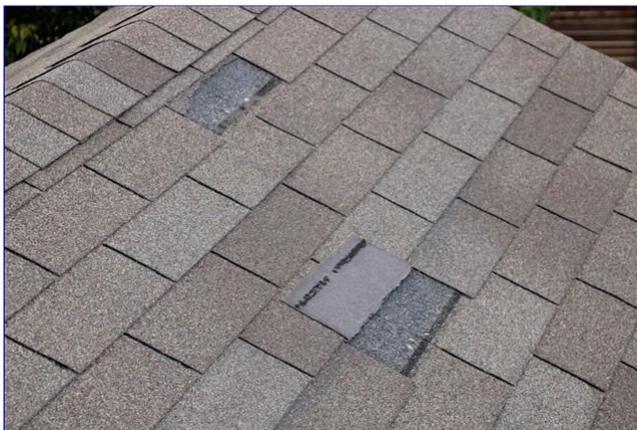
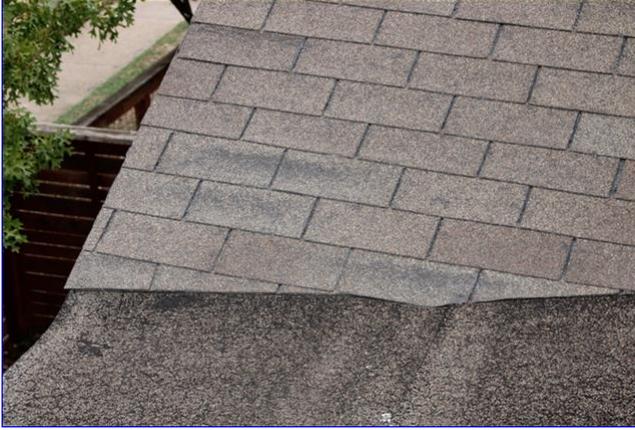
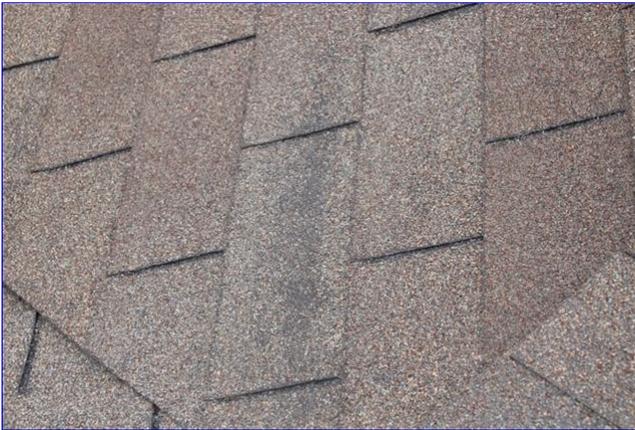
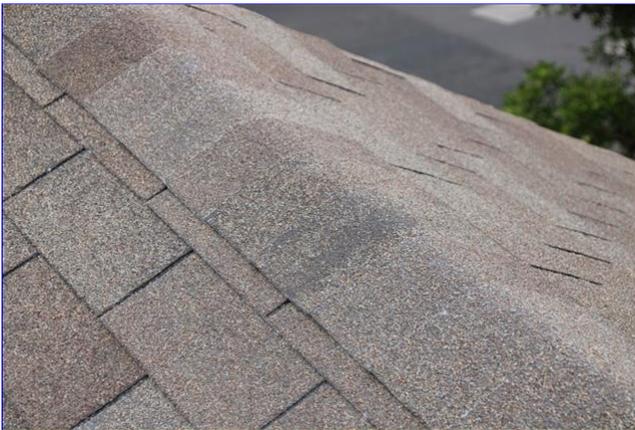
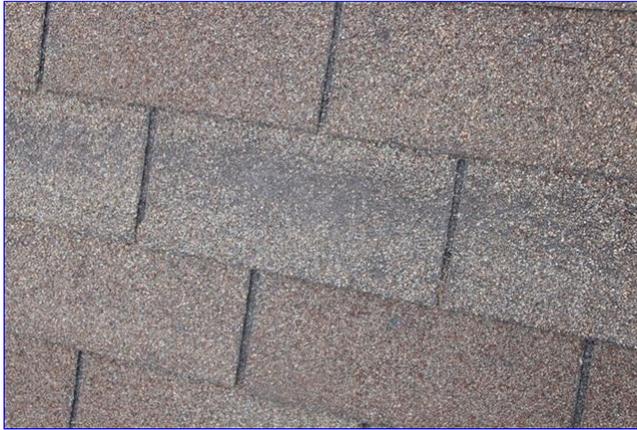
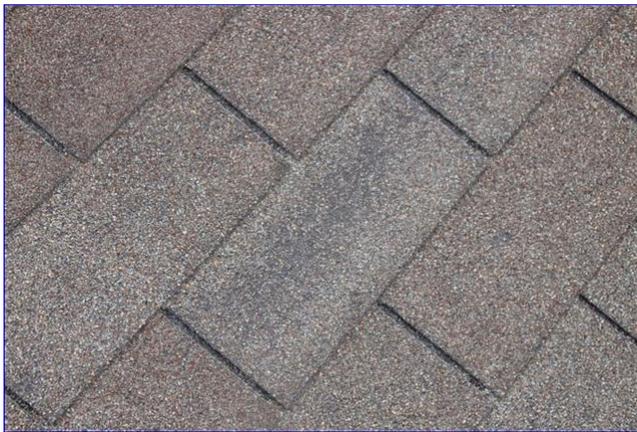
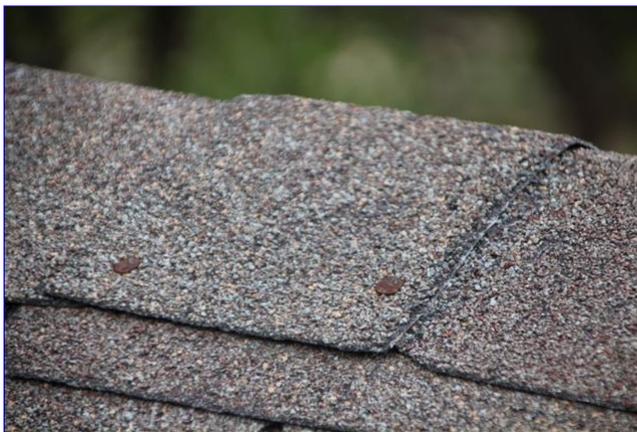
(1) **Missing 4 shingles at the rear roof, multiple areas granules are missing. Recommend review by a qualified roofer for repairs/replacement as needed.**

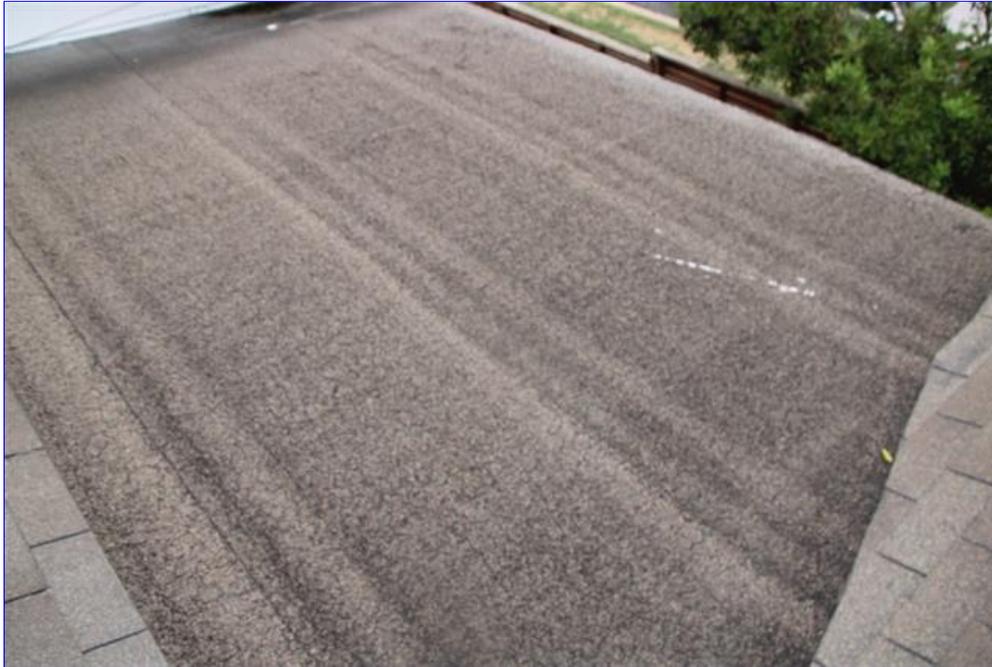
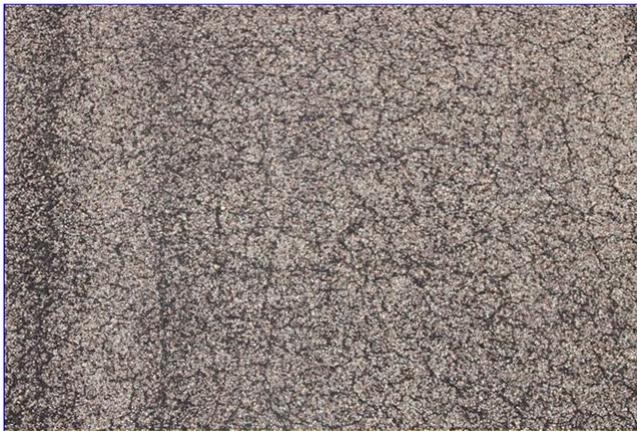
(2) Alligator cracking observed at the rolled roof section. Recommend review by a licensed roofer for replacement, as necessary, prior to close.

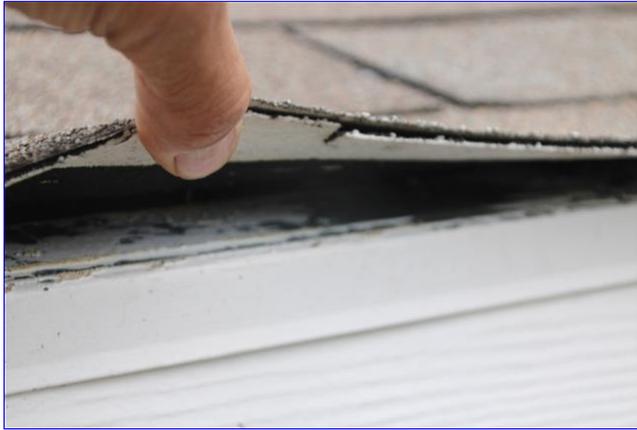
C. Item 14(Picture)

(3) The weather barrier is installed under the drip edge flashing and should be installed over. Recommend review by qualified roofer

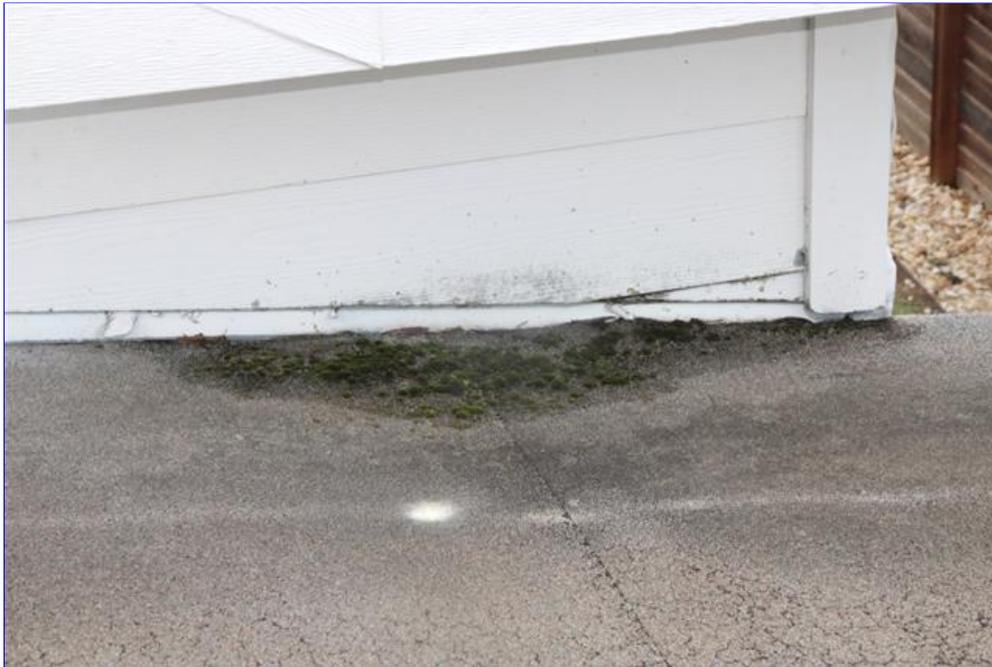
C. Item 15(Picture)

(4) **Ponding and green growth observed at the rolled roof section, recommend review by a roofer for cause and repairs as needed**

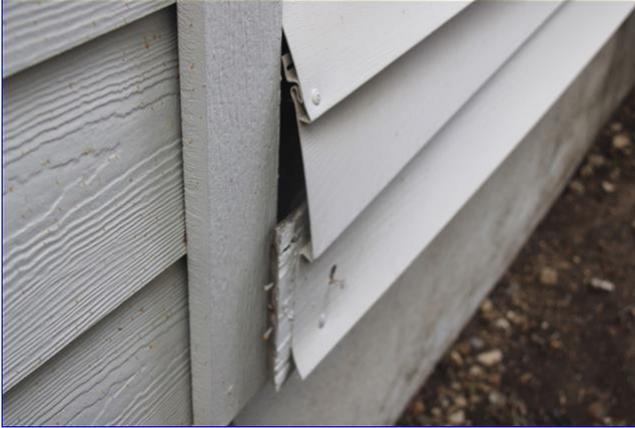
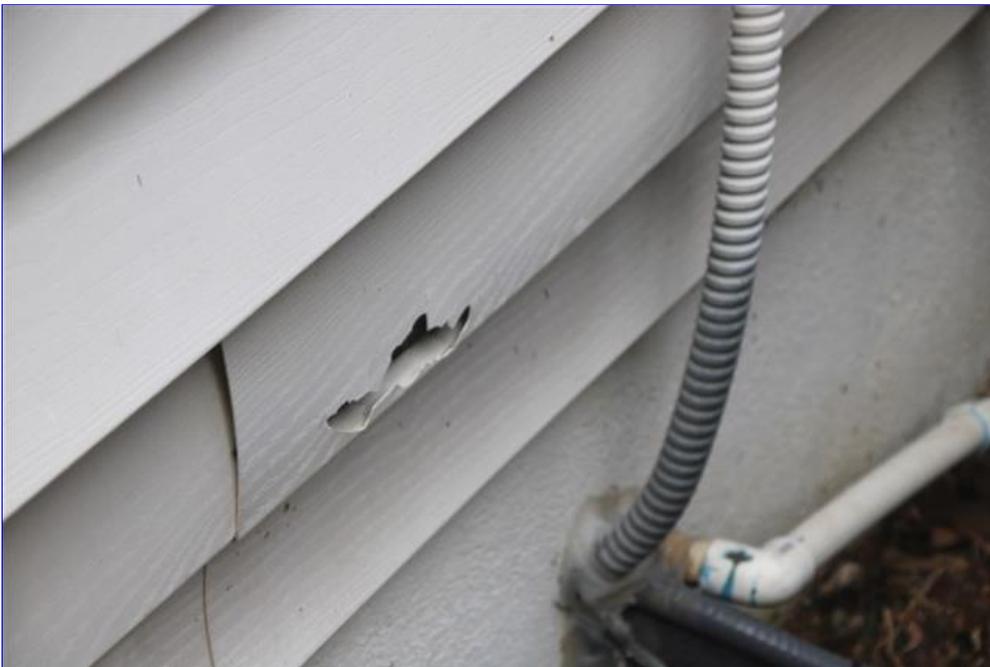
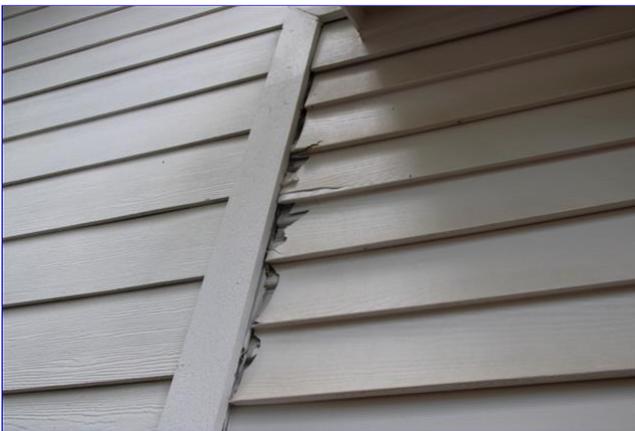
(2) **Several exterior vinyl siding areas have damage, recommend review for repairs as needed**

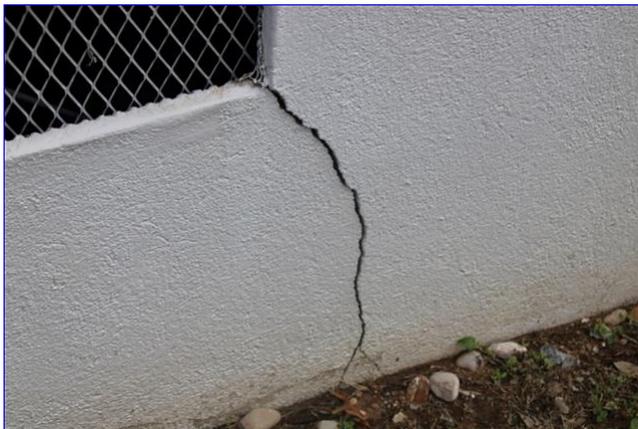
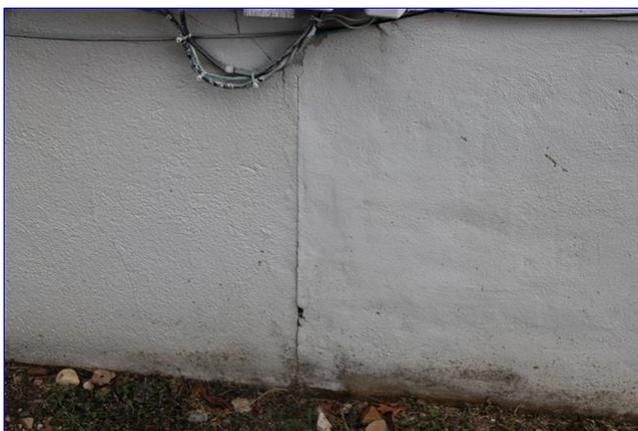
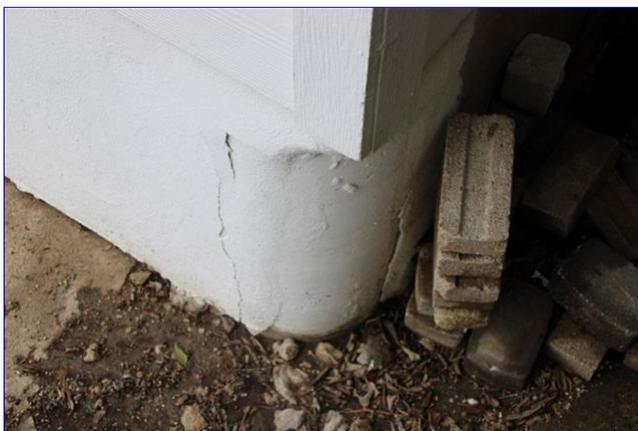
(3) **Crawl space wall has cosmetic damage at several areas, recommend repairs if this is a concern**

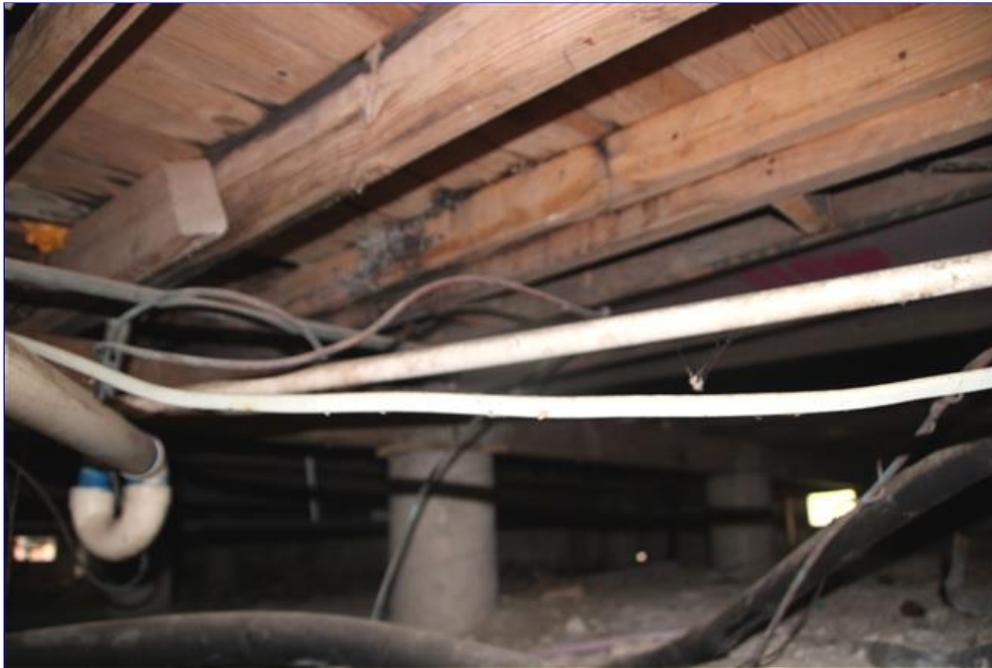
F. Item 1(Picture)

Some staining present at the crawl space ceiling, recommend review by a qualified contractor

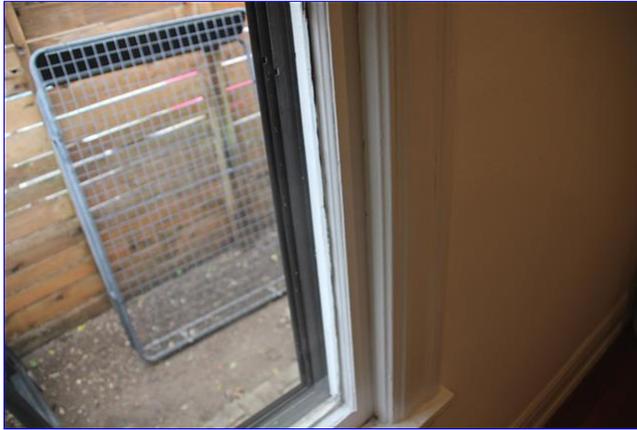
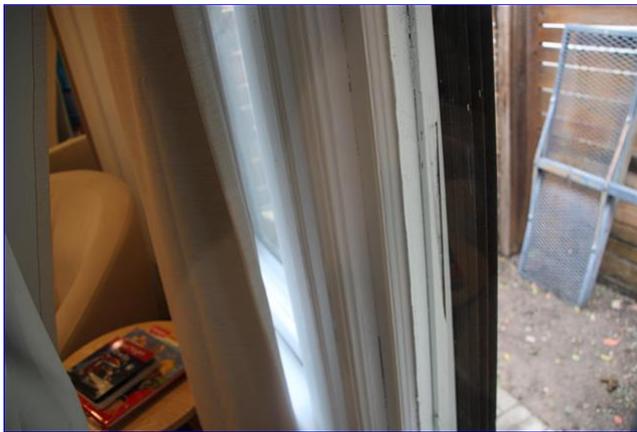
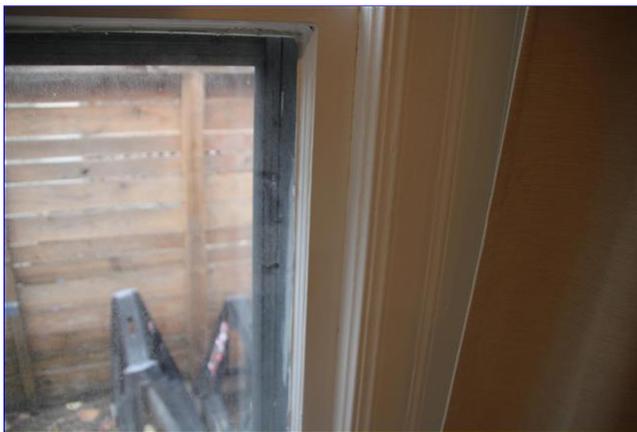
(1) **Multiple windows are painted shut and unable to open. recommend review**

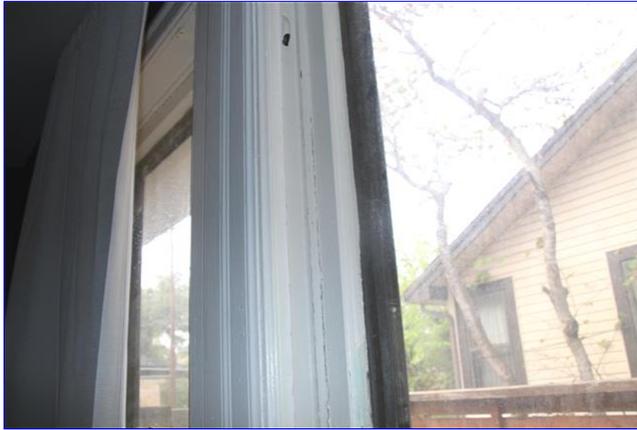
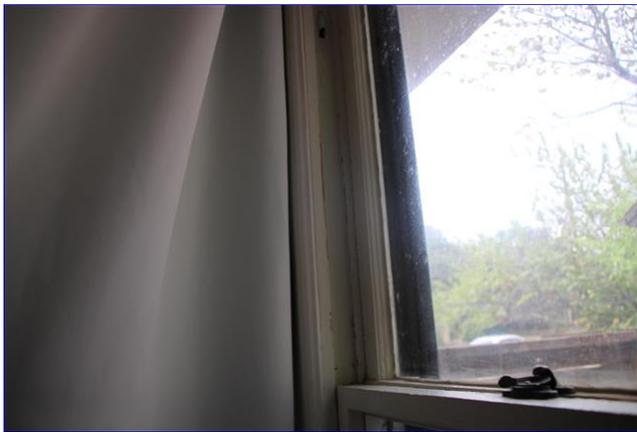
(2) Broken sash wire/cord observed in the bedroom and dining room at the front section . This is a "Safety Concern". Sash wire/cord holds window in open position. Suggest repairs/replacement as needed to ensure safety.

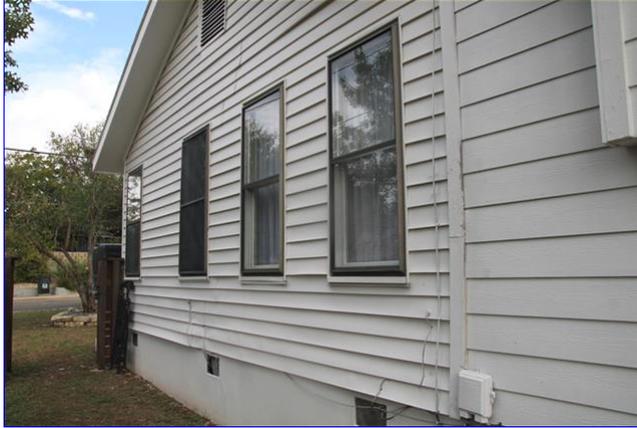
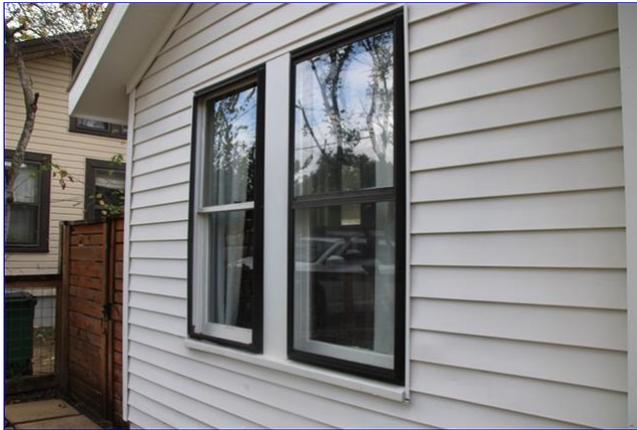
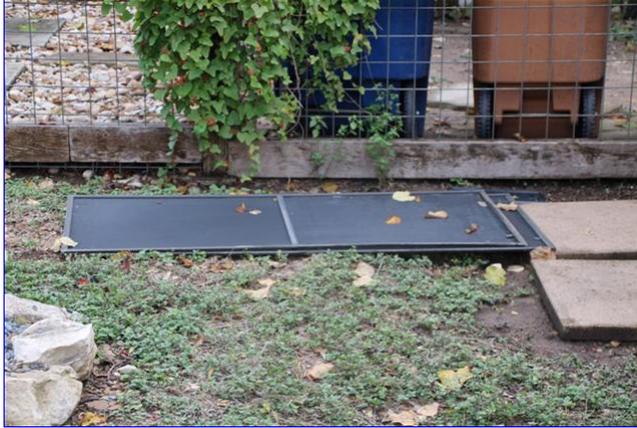
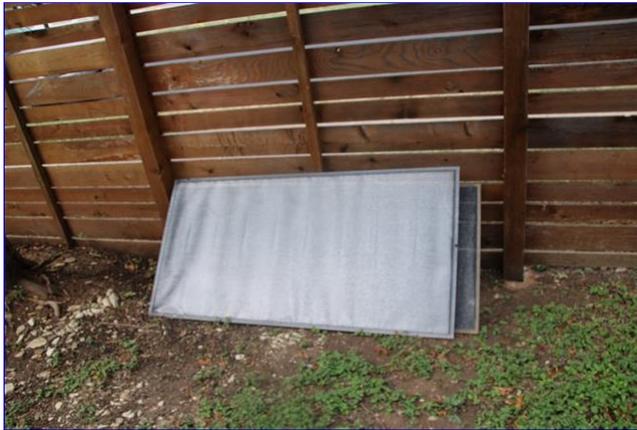
(3) Missing window screens observed, several located on the ground, recommend confirming for proper use

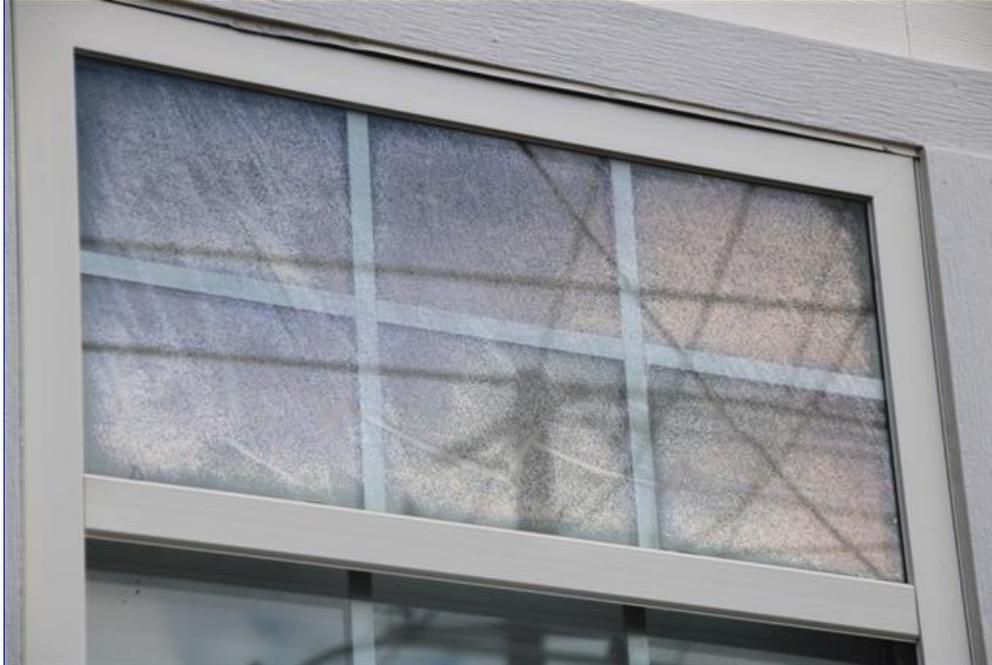
H. Item 10(Picture)

(4) **Purple haze observed at the kitchen window, possible broken seal, recommend review for repair**

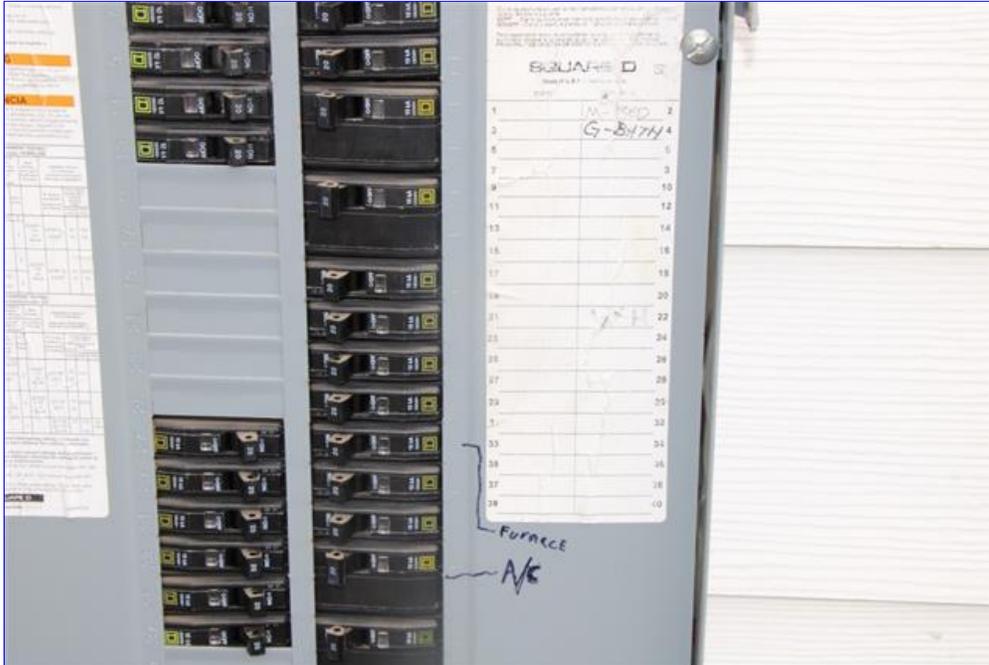
A. Item 2(Picture)

(3) **The electrical panel is missing labels, recommend correction by a qualified contractor**

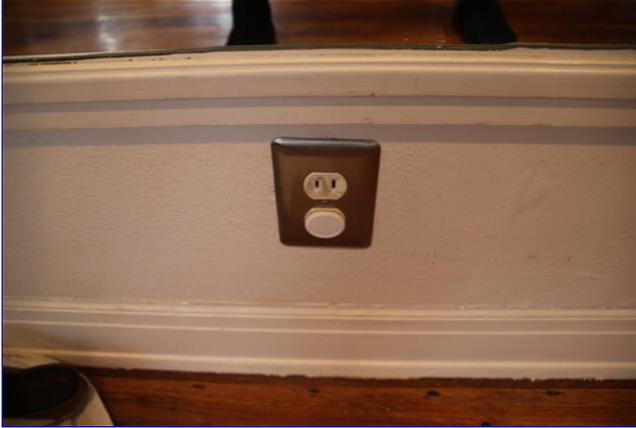
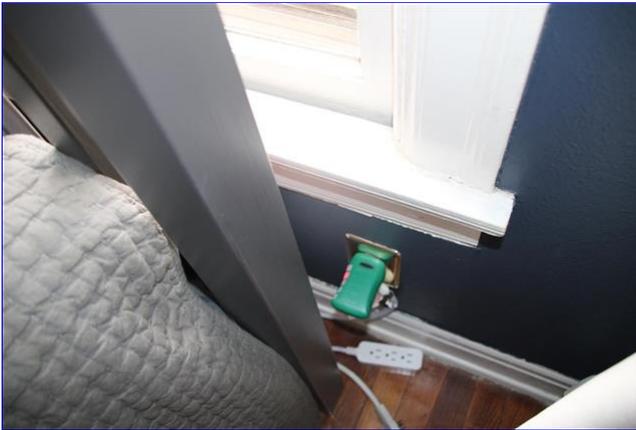
- (1) **Missing smoke alarm in the front bedroom, recommend installing combo with CO2.**
- (2) **Ungrounded three prong receptacle observed in the dining room. It is recommended that these types of receptacles be grounded, replaced with two prong receptacles, or protected on a GFCI circuits as applicable. Suggest review by licensed electrical contractor for repairs/replacements as needed to ensure safety.**
- (3) **Two prong ungrounded receptacles observed in the front section bedrooms and dining room. Recommend corrections as needed**

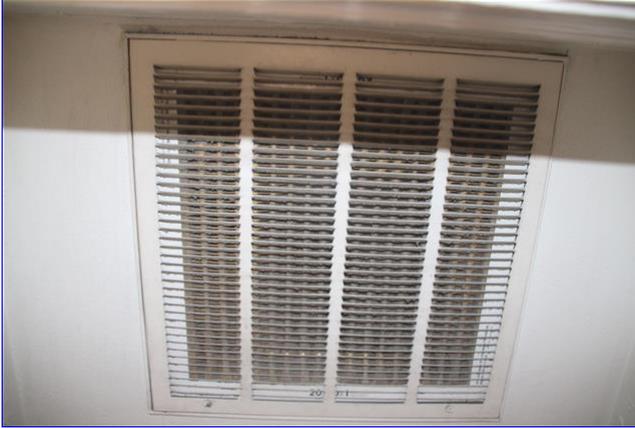
B. Item 3(Picture)

(2) The Filters are dirty and need replacing.

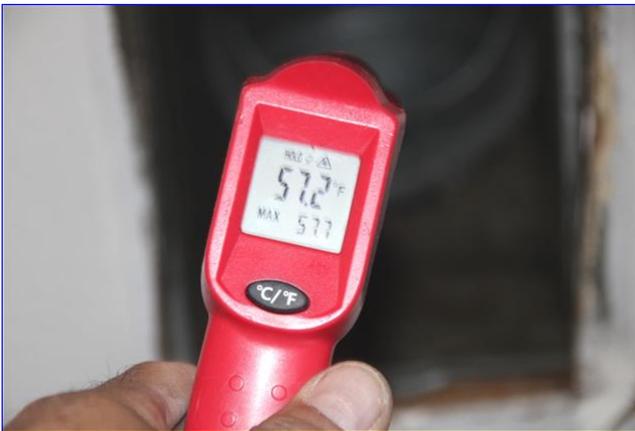
B. Item 4(Picture)

(3) A temperature drop was performed across the evaporator coil of this unit. When tested, a difference of 18 degrees which is in the 14 to 22 degree normal operating range. Unit functioned properly when tested and was serviceable at time of inspection.

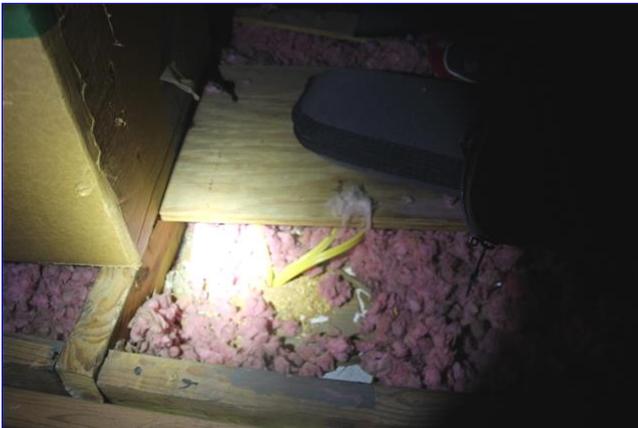
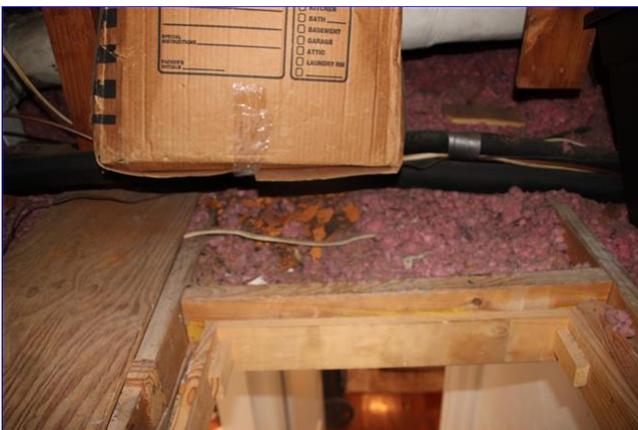
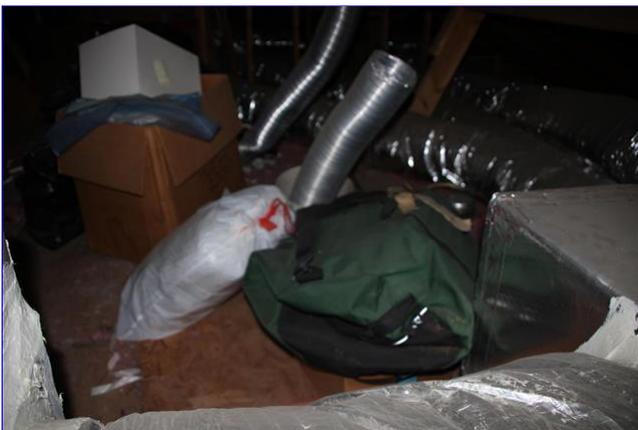
Insulation in the attic varies from 3-4" to 10". consider adding additional coverage for better energy efficiency. This may get discovered on buyer inspection.

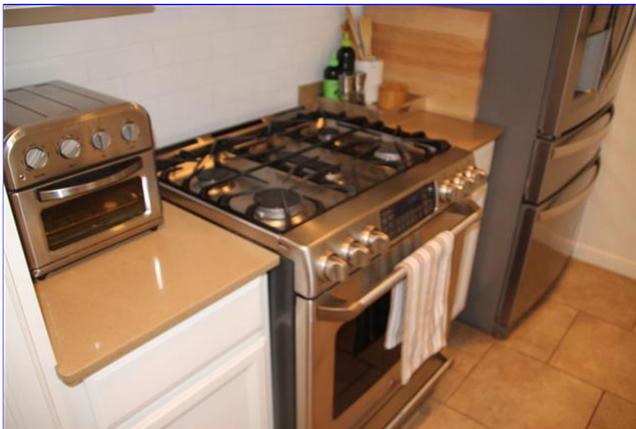
D. Item 1(Picture)

A stove anti tip over device has not been installed on this unit. If a child steps on the open door or if a heavy pot is placed on the door, the door acts like a lever forcing the front of the stove down and then back up. Not only will the stove tip and possibly land on your feet, but anything on the range top, such as a pot of boiling water which could cause serious injury. An anti tip bracket can be attached to the bottom of the wall behind the stove by a licensed general contractor. The stove will still slide in and out but will not tip over.
