# INSPECTION REPORT

For the Property at:  
**3 LARCHWOOD AVENUE**  
PETERBOROUGH, ON K9J 1M5

Prepared for: TEAM VANRAHAN  
Inspection Date: Wednesday, July 17, 2024  
Prepared by: David Sharman

RE: Report No. 4897  
3 Larchwood Avenue  
Peterborough, ON  
K9J 1M5

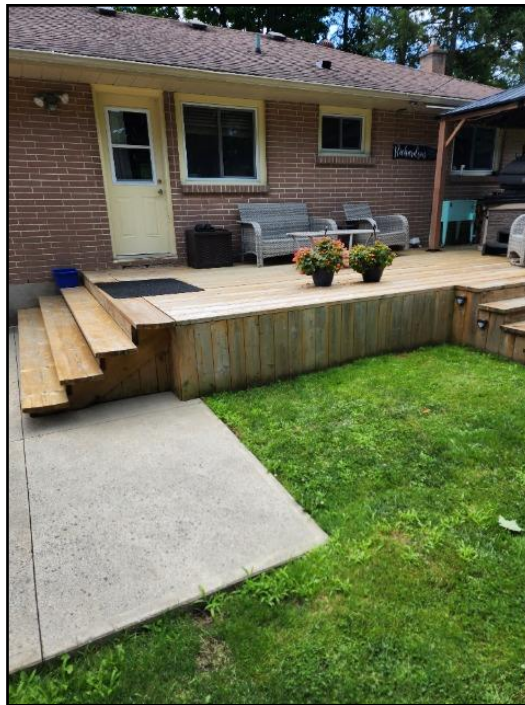
**2. Condition:** • Missing

**Implication(s):** Fall hazard

**Location:** Raised decking

3. Missing

**Task:** Provide

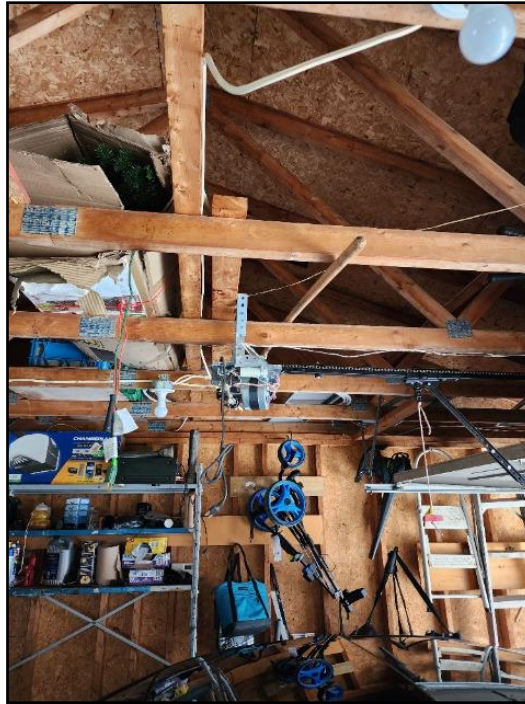
3. Condition: • Inoperative

**Implication(s):** System inoperative

**Location:** Garage

4. Inoperative

**Task:** Repair or replace

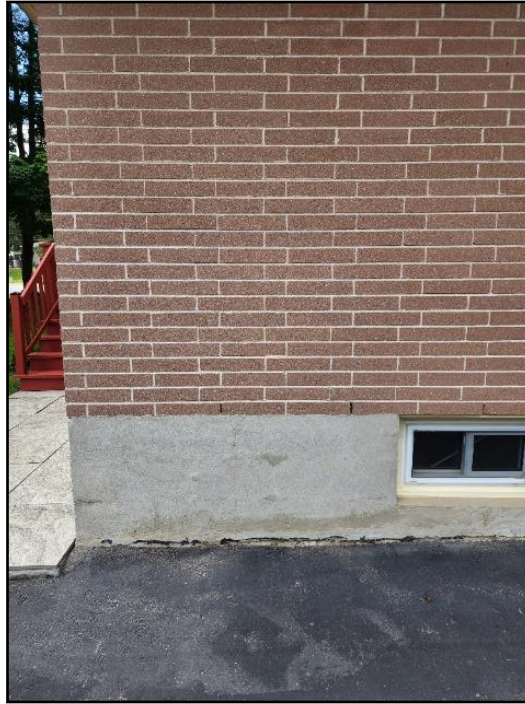
**WALLS \ Masonry veneer walls**  
**6. Condition:** • Typical minor cracks  
**Implication(s):** Chance of frost damage & material deterioration  
**Location:** Right elevation  
**Task:** Repair  
**Time:** Discretionary  
**Cost:** Minor

5. *Typical minor cracks*

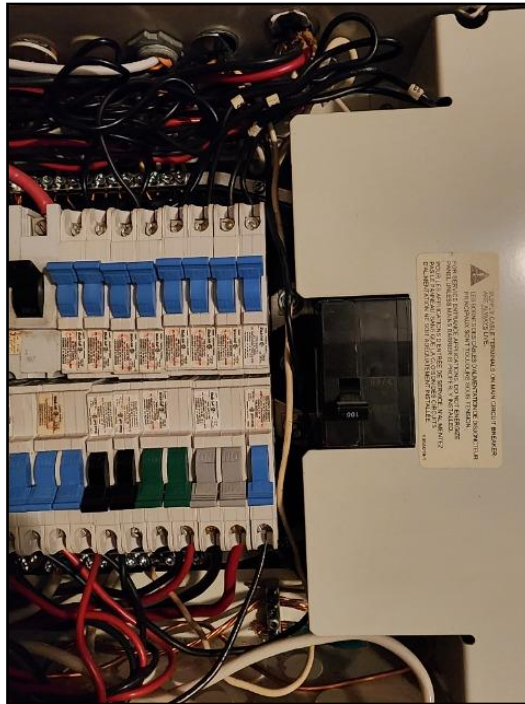
**7. Condition:** • Wire crossing bus connections

**Implication(s):** Electric shock | Fire hazard

**Location:** Distribution panel

9. Wire crossing bus connections

**Task:** Improve

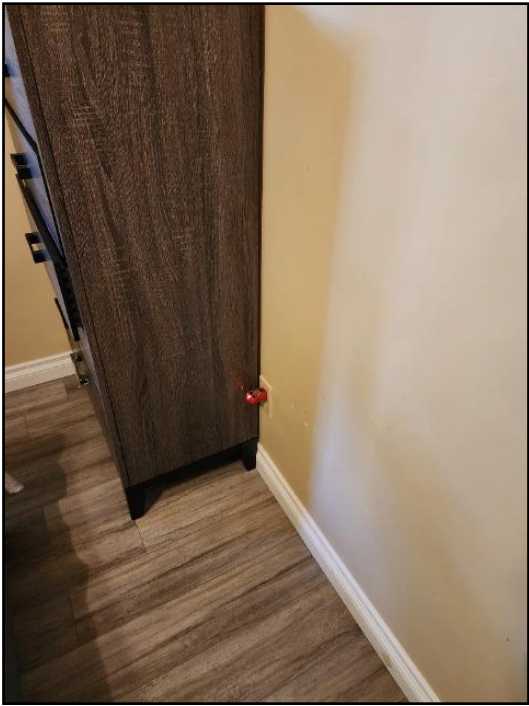
**8. Condition:** • Reversed polarity

**Implication(s):** Electric shock

**Location:** Bedroom

10. Reversed polarity

**Task:** Correct

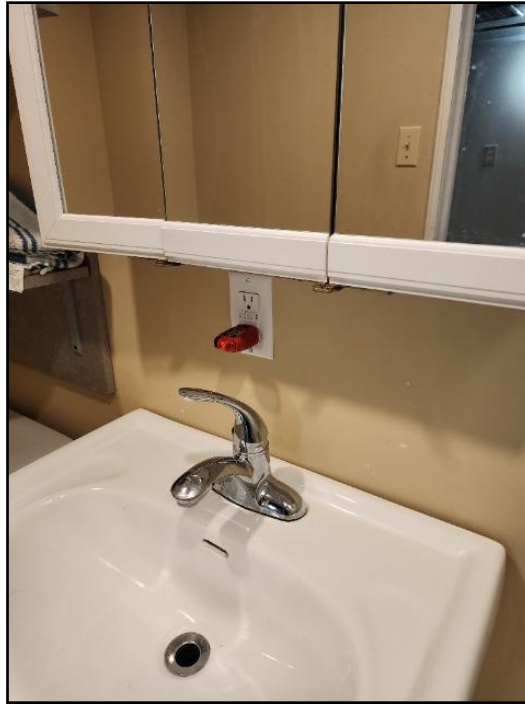
**9. Condition:** • Ungrounded  
**Implication(s):** Electric shock  
**Location:** Basement bathroom  
**Task:** Repair

11. Ungrounded

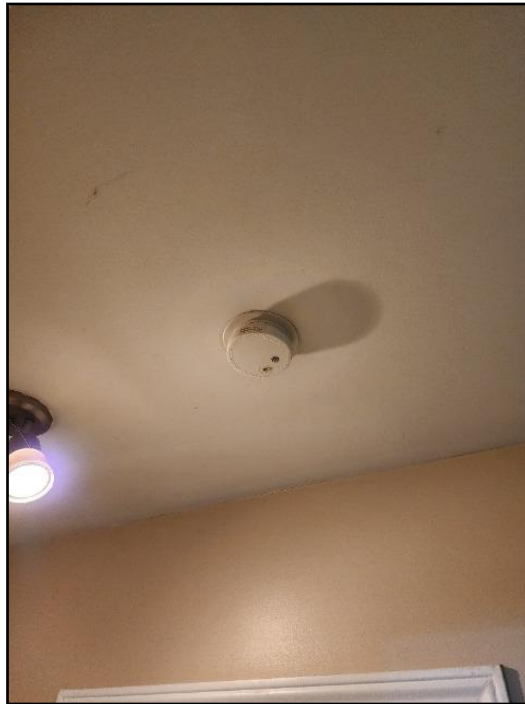
**10. Condition:** • Past life expectancy

**Implication(s):** Life safety hazard

**Location:** First floor

12. Past life expectancy

**Task:** Replace

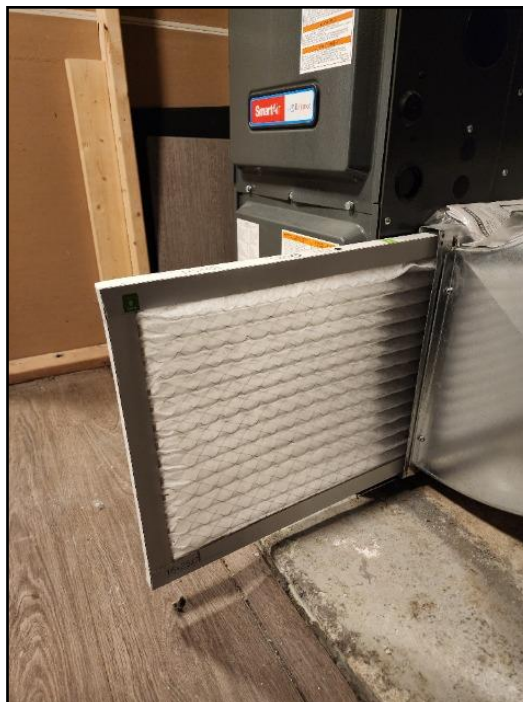
**12. Condition:** • Replace - regular maintenance

18. Replace - regular maintenance

**Task:** Replace - regular maintenance

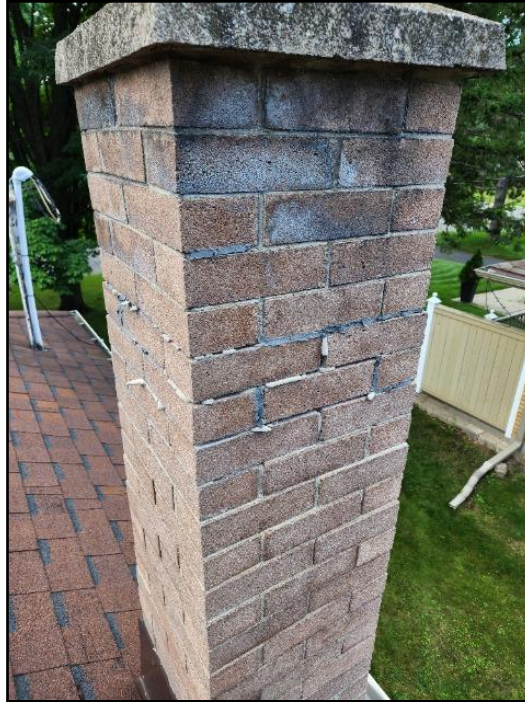
**13. Condition:** • Loose, missing or deteriorated mortar

**Implication(s):** Material deterioration

**19.** *Loose, missing or deteriorated mortar*

**Task:** Repair

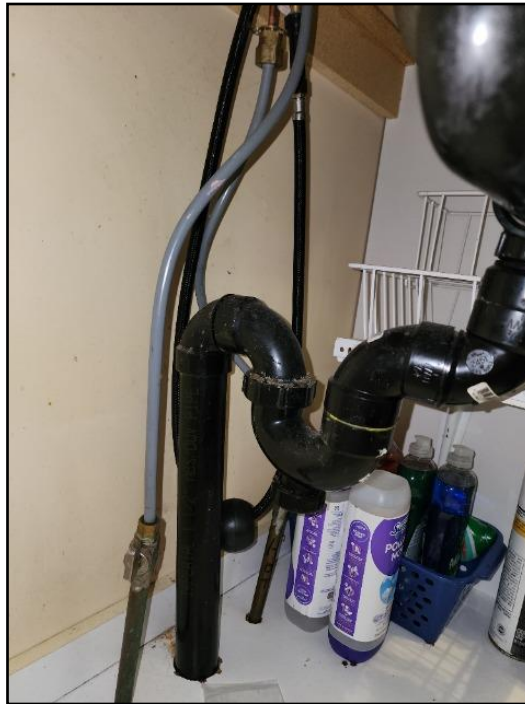
**17. Condition:** • Wrong type

26. Wrong type

**Task:** Monitor

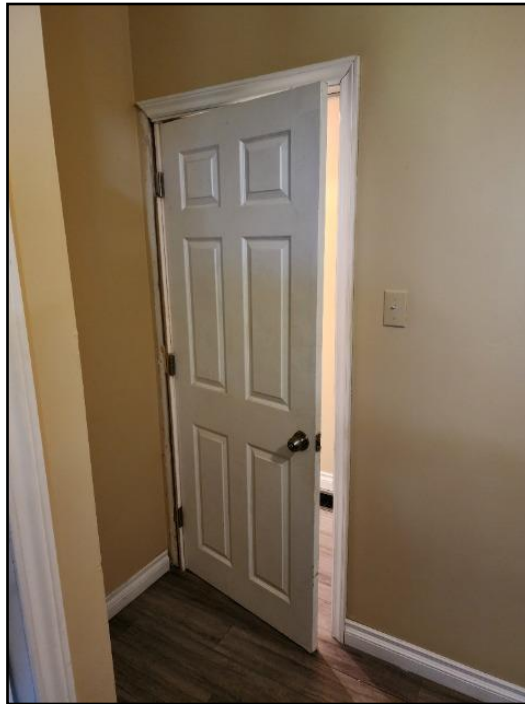
**18. Condition:** • Loose or poor fit

**Implication(s):** Chance of damage to finishes and structure

27. Loose or poor fit

**Task:** Repair

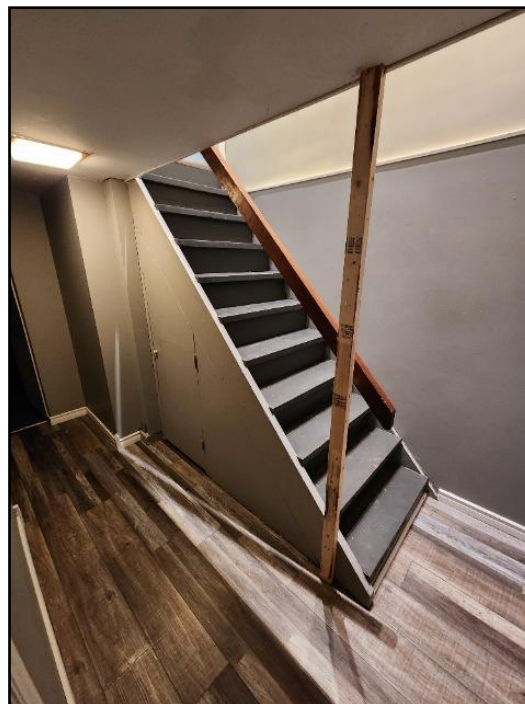
**19. Condition:** • Missing

**Implication(s):** Fall hazard

28. Missing

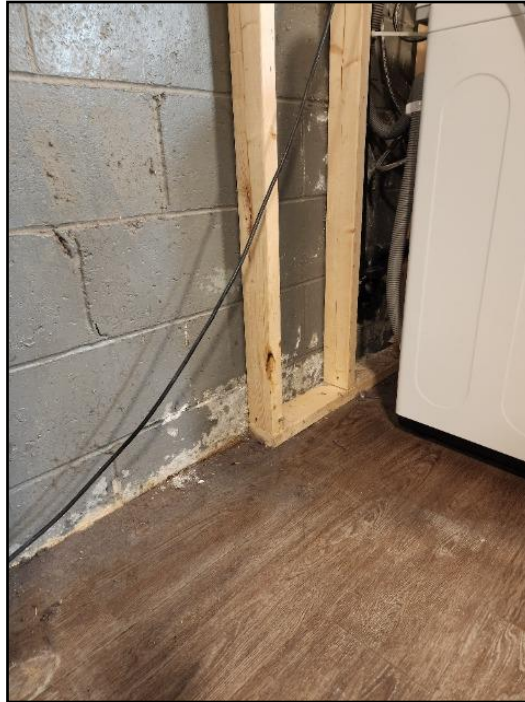
**20. Condition:** • Efflorescence

**Implication(s):** Chance of water damage to structure, finishes and contents

29. Efflorescence

**Task:** Monitor
