Inspection Report

Property Address:

919 Josephine
Windsor ON

Mailloux Home Inspections

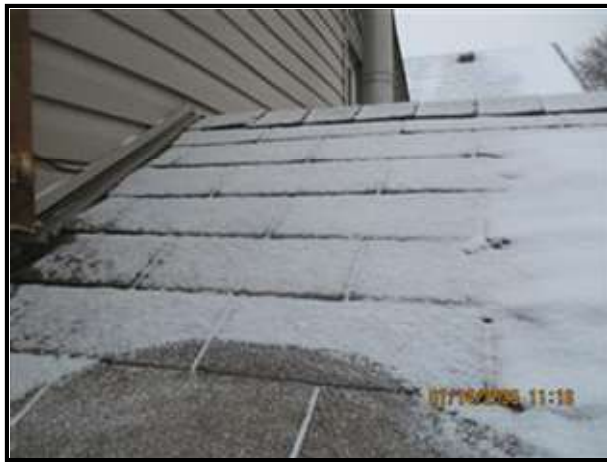
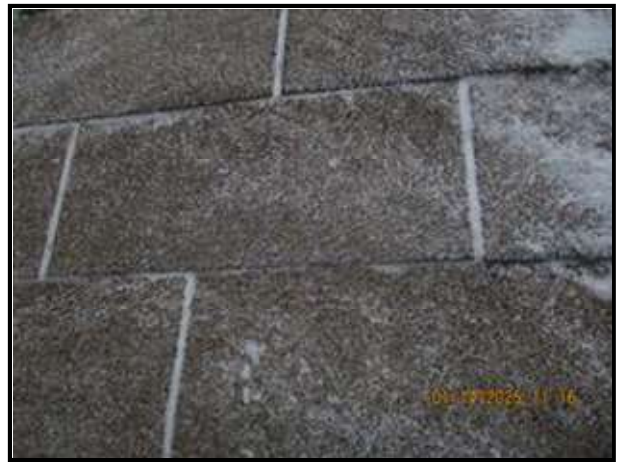
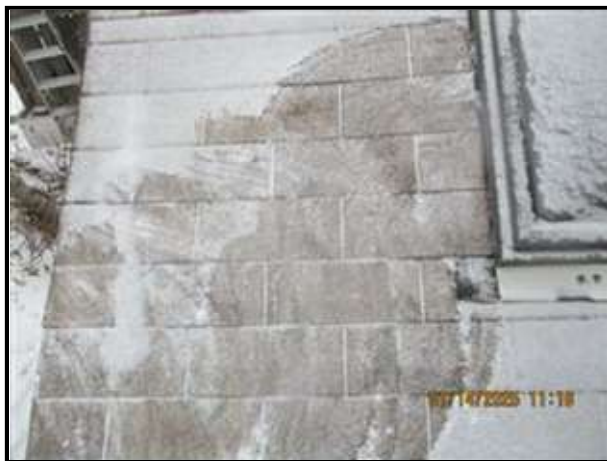
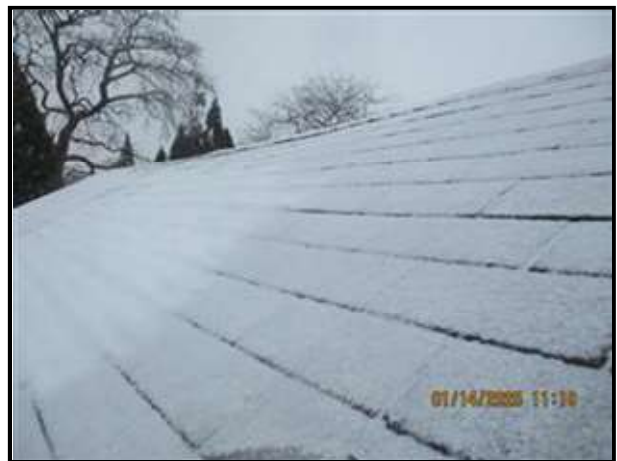
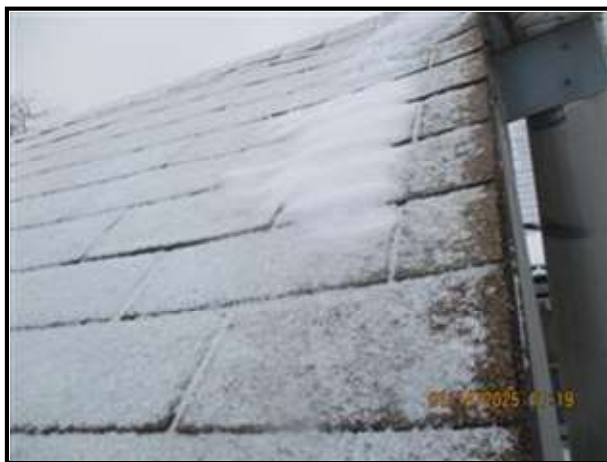
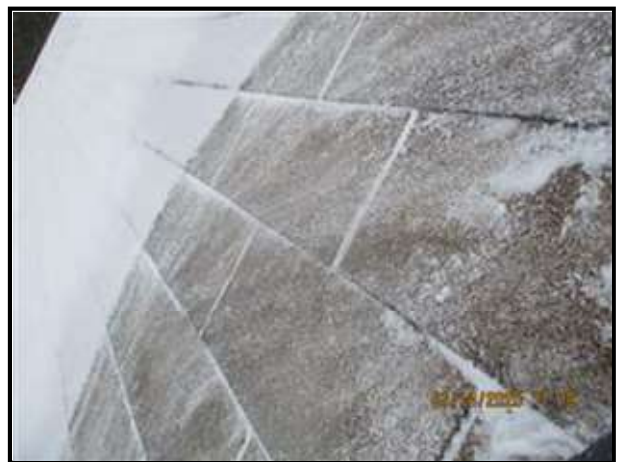
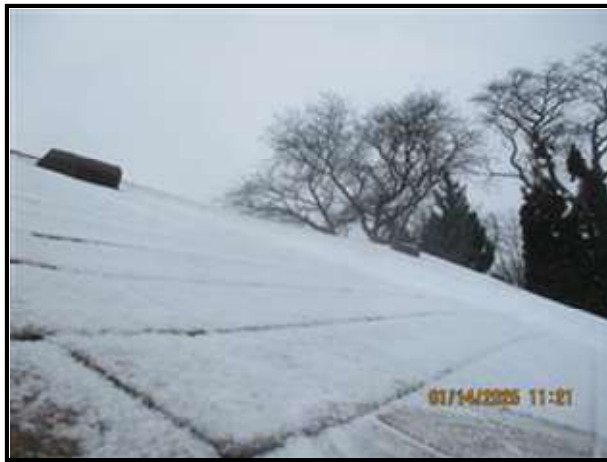
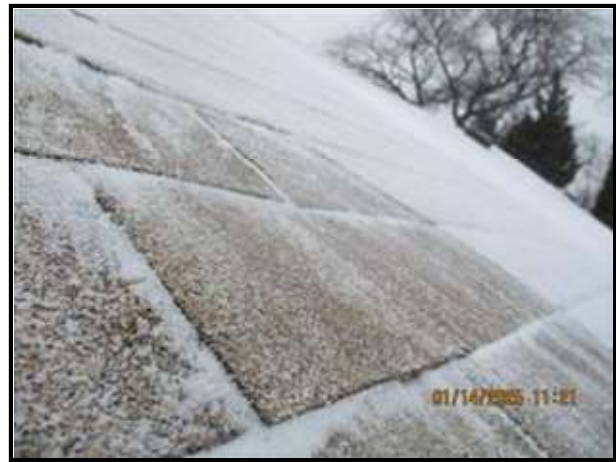
1.0 Snow covered and not visible at time of inspection. Inspection was limited to viewing from various places while on a ladder. Areas that were cleared away, showed no defects and were in the age group indicated above. Entire roof should be inspected when clear of snow.

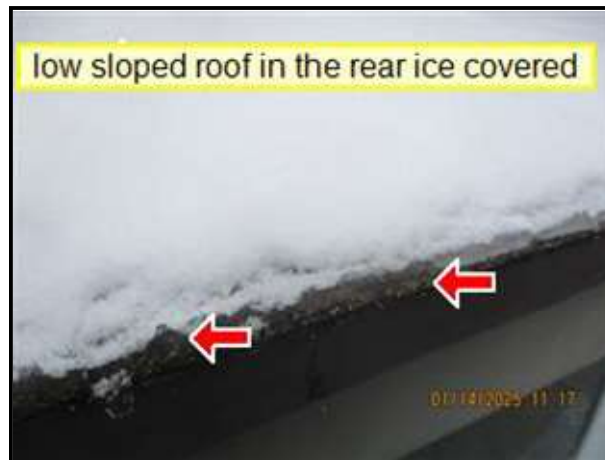
1.1 Picture 1

1.1 (1) Snow covered and not visible at time of inspection. Inspection was limited to viewing from various places while on a ladder. Areas that were cleared away, showed no defects and were in the age group indicated above. Entire roof should be inspected when clear of snow.

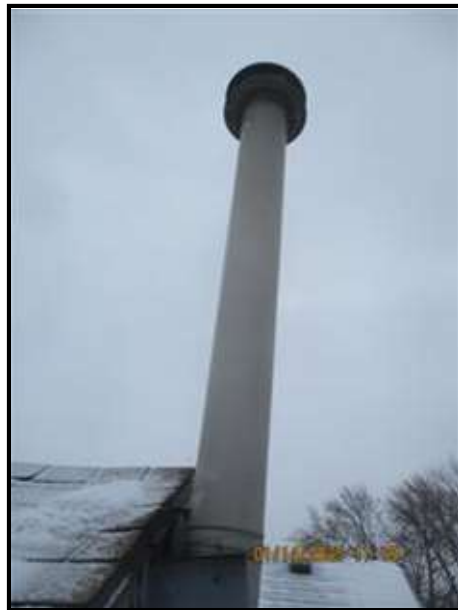
1.3 Picture 1

1.3 Metal vent that is no longer in use and can be removed is desired.

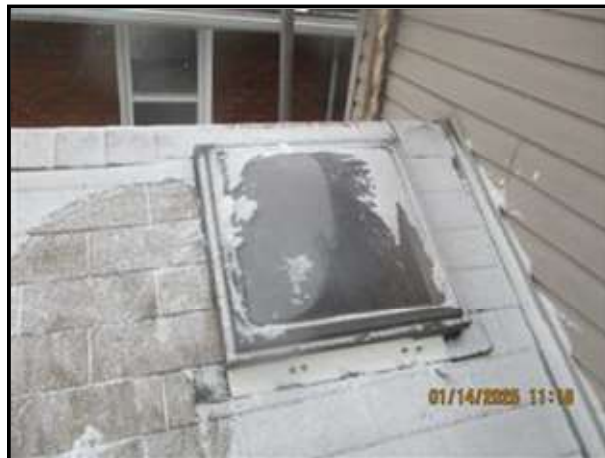
1.5 Picture 1

1.5 Plastic skylights noted. These skylights do not have large curbs incorporated like the newer units today. There is a good deal of sealant around the edges of the skylight. This may be to correct prior leaks or used as preventative maintenance. Consider upgrading to a newer model skylight at the next reroofing. Consult the roofing company for options.

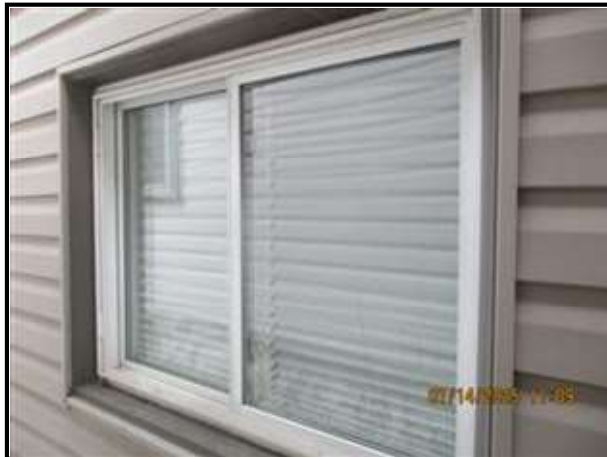
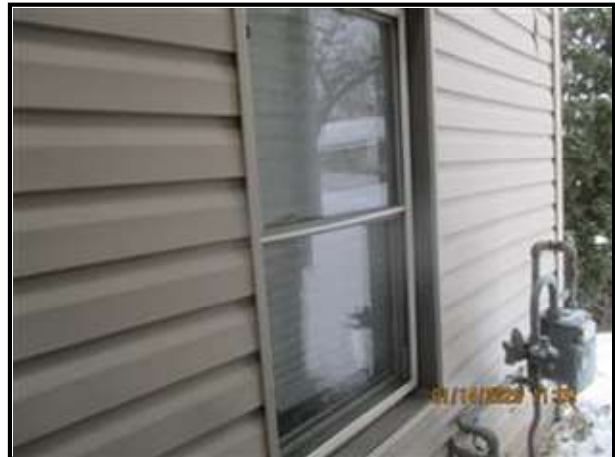
2.1 Although some windows had missing screens.

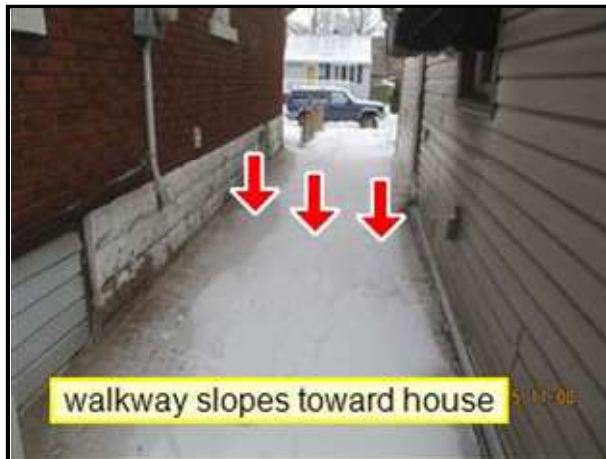
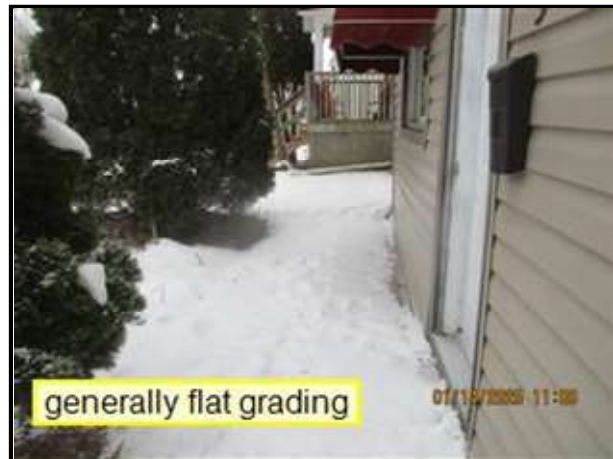
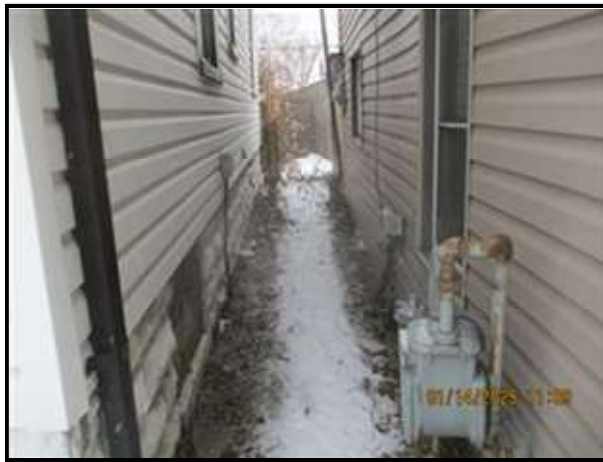
3.0 Walkway sloping toward the house will allow water runoff to drain along the foundation. This increases the risk of interior water seepage. If seepage is or becomes an issue, replacement or remedial work, such as concrete lifting will help drain water away from the foundation and reduce the risk of seepage in the future however, replacement and/or drainage system work may be only feasible measure in some cases.

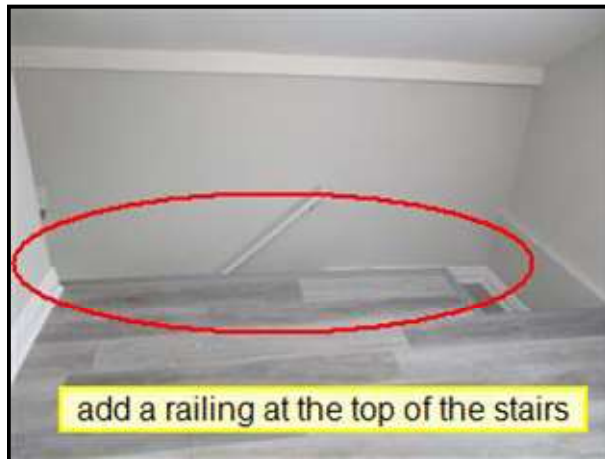
7.4 Picture 1

7.4 There is no railing at the top of the stairs. This is a safety hazard and a railing needs to be added.

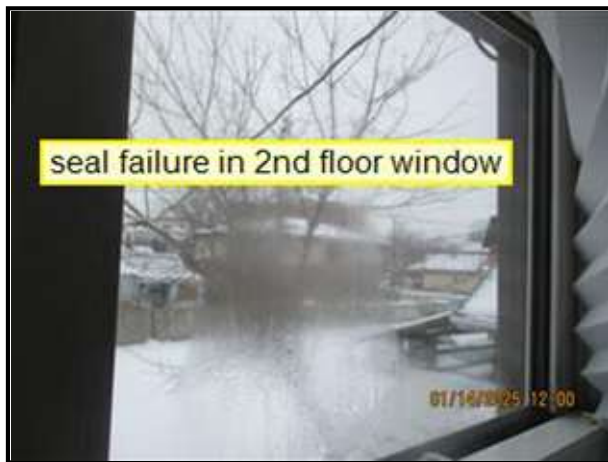
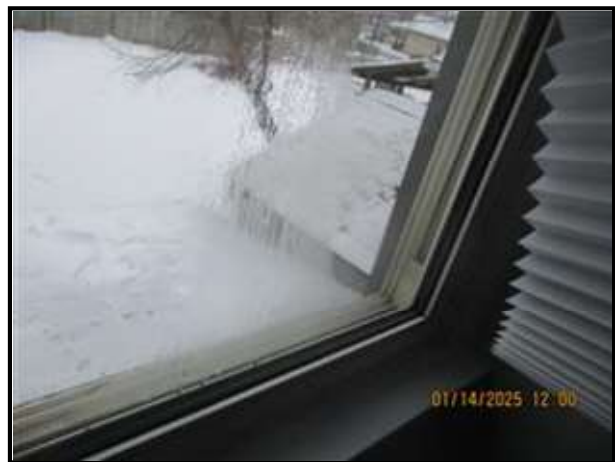
7.5 Some double glaze units have lost their seal; correct as desired/required. Replacement of insulated glass windows or doors is usually required to correct failed or defective vacuum seals. Fortunately, the insulation value is usually not significantly reduced. Replacement time frame may be discretionary; however, conditions will gradually worsen with time.

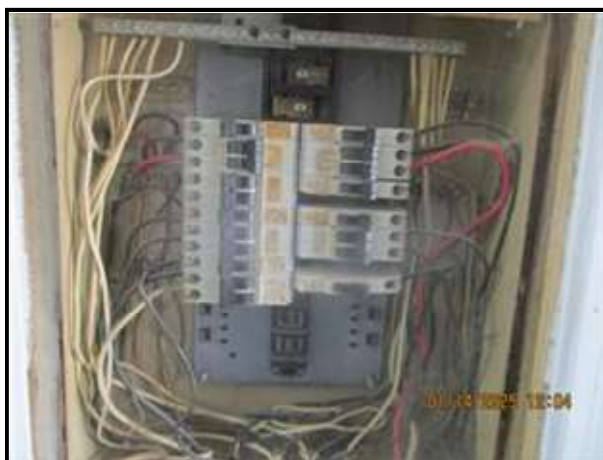
10.3 Picture 1

10.3 Although the stove is on a 30 amp breaker. This wire is designed to accommodate up to 40 amps. If the stove trips the breakers from overload, upgrade to a 40 amp breaker. The 30 amp may be adequate based on individual needs.

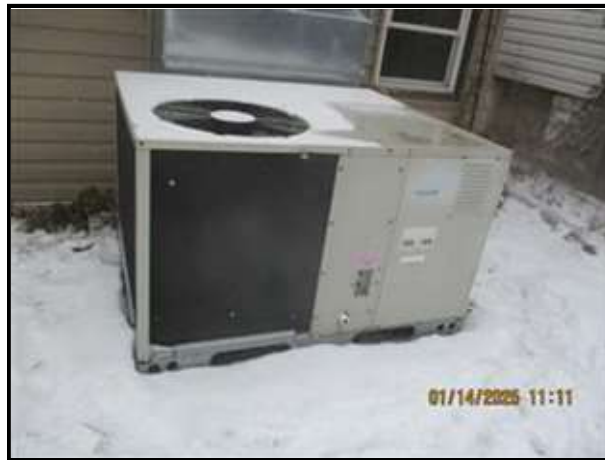
11.1 Picture 1

DO NOT attempt to test the air conditioner until temperatures are above 20 degrees celsius (70 F) and stay at this level for some time. Starting an air conditioner in cold temperatures will damage the compressor. Consult an HVAC contractor if you for complete directions if required.

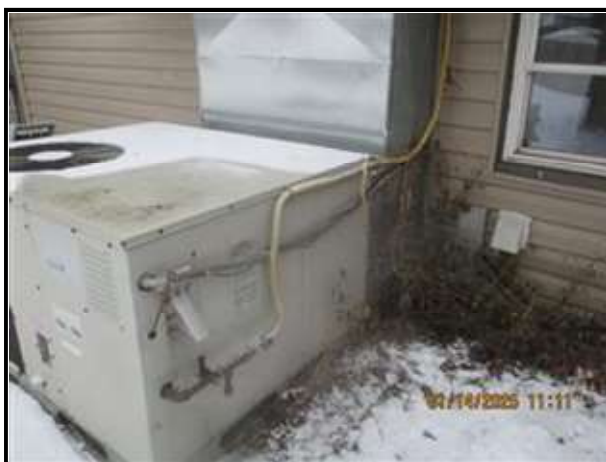
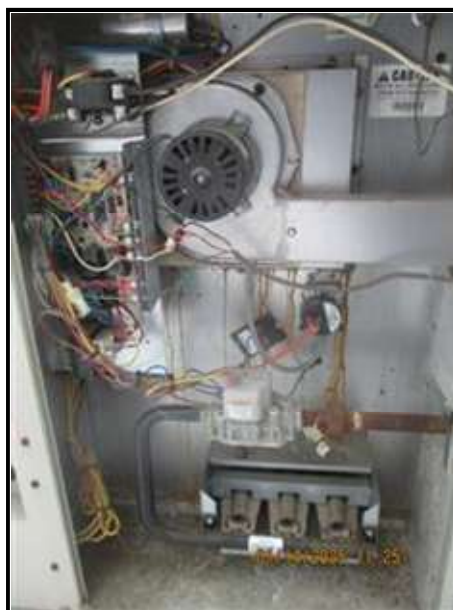
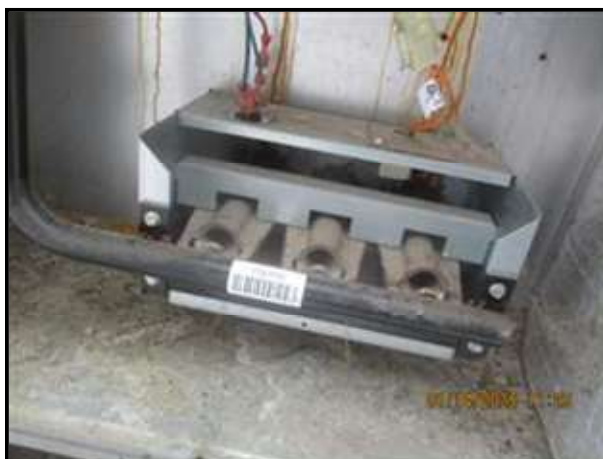
12.0 Older unit, although operated without any difficulty for the inspection. Older units can exceed their design life, although these units are more prone to higher maintenance costs and will eventually require replacement. Annual maintenance by a qualified heating contractor is recommended. Carbon monoxide detectors should be installed on each floor of the house as a precaution.

Many of the larger HVAC companies have maintenance programs that cover routine service and repairs. Often times this can be beneficial with old furnaces and air conditioners. Consider looking into these services as an option.

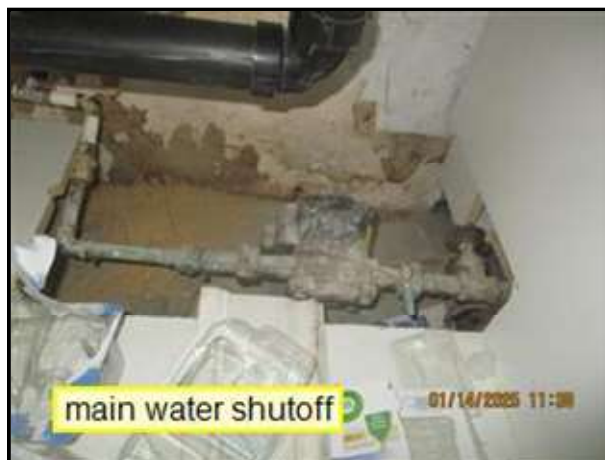
13.0 Picture 1

13.0 All visible piping in the house was updated to copper or IPEX, although the service from the road is still the older piping. This older pipe is more prone to leakage and replacement will be inevitable at some point in the future.
