England Home Inspections LLC
102 Benoir Trail
Madison,, AL 35756

131 Indian Valley Rd
Huntsville, Alabama 35806

Marginal Summary

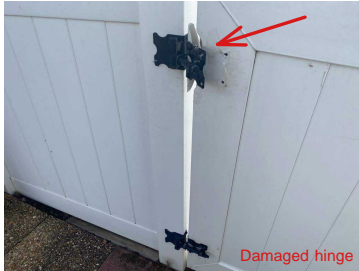
1. Fences Vinyl - The top hinge is damaged on the gate at the backyard. Recommend evaluation and repairs.

TO BE DONE

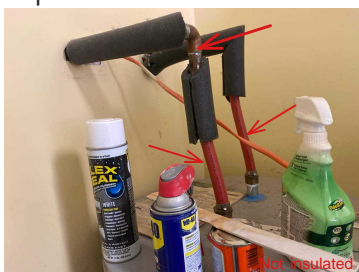
4. Water Supply Pipes PEX and Copper - Some of the plumbing pipes at the top of the water heater were not insulated. The water heater is in the garage and the pipes are subject to freezing. Recommend evaluation and repairs.

TO BE DONE

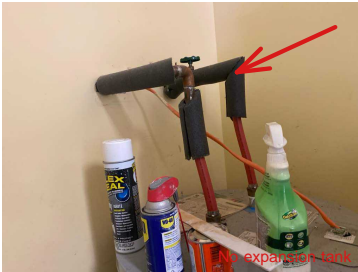
6. Garage Water Heater Water Heater Operation: Needs Repairs - The water heater should have an expansion tank attached to the cold water supply line. This is required by municipal inspectors on new water heater installations. It is likely that a permit was not pulled for the installation of this water heater and therefore an expansion tank was not installed. Recommend evaluation and repair. This is a safety hazard.

TO BE DONE

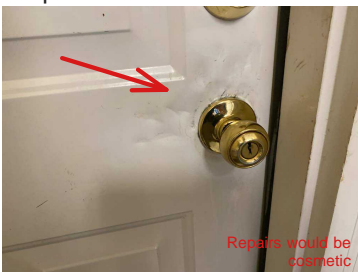
7. Attached Garage Garage Walk-Through Pedestrian Door Metal - Deterioration was noted at the bottom right and left of the door jamb for the garage walk-through pedestrian door. Repairs have been made with spray foam and appear to be functioning however this could be considered a substandard repair. Recommend evaluation and repairs or upgrades.
8. Attached Garage Garage To Interior Door Metal - Significant denting was noted at the garage to interior door near the door knob on the garage side. The door is still functioning correctly including the door knob and deadbolt. Repairs would be cosmetic.

AS IS

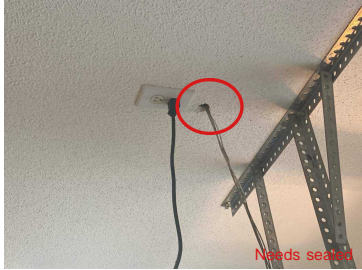
9. Attached Garage Ceiling/Walls/Firewall Drywall and Paint - Recommend sealing the garage ceiling where the wiring for the vehicle door(s) opener passes through. This hole hurts fire integrity for the firewall in the garage.

TO BE DONE

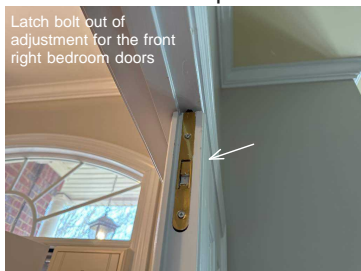
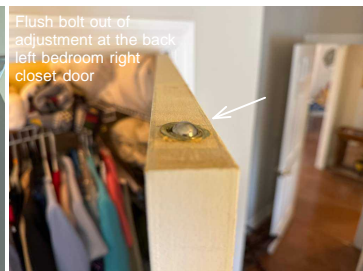
- - The top latch bolt would not insert properly for the front right bedroom interior front doors. Recommend evaluation and repairs.
 - - The front right bedroom door and the front right bedroom closet door would not latch to the strike plate at time of inspection. Recommend evaluation and repairs.

- - The guest bathroom pocket door was out of adjustment and did not appear to latch properly. Recommend evaluation and repairs.
 - - The top flush bolt was out adjustment for the right closet door at the back left bedroom. Recommend evaluation and repairs

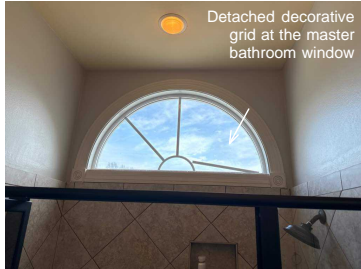
13. Interior Living Space Windows Fiberglass Double Hung and Wood Double Hung - A section of the decorative grid was detached for the master bathroom window above the shower. Recommend evaluation and possible repairs.

AS IS

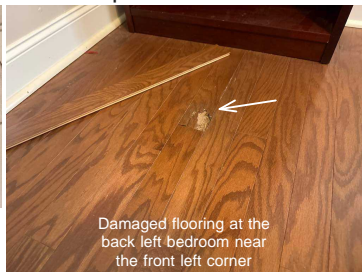
14. Interior Living Space Floors Wood, Carpet, and Tile - A cracked floor tile was noted at the guest bathroom flooring near the tub. No sharp edges were present. Repairs would be cosmetic.

- - A section of damage wood flooring was noted at the back left bedroom near the front left corner. Recommend evaluation and repairs.

TO BE DONE

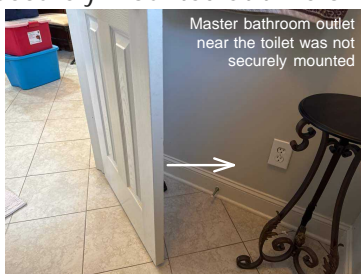
16. Interior Living Space Interior Outlets Recommend Repairs - The master bathroom outlet near the toilet was not securely mounted at time of inspection. Recommend evaluation and repairs.

TO BE DONE

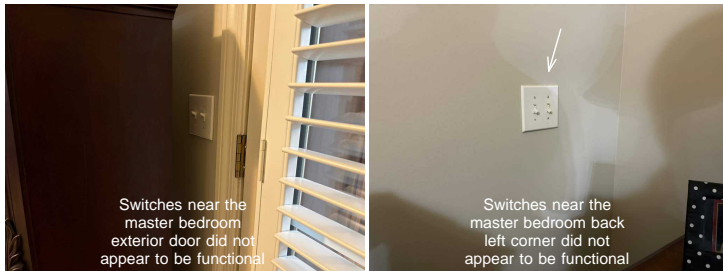
18. Interior Living Space Interior Lighting Recommend Repairs - Note: it could not be verified what the two switches near the master bedroom exterior door were intended for. It cannot be verified what the two switches near the master bedroom back left corner were intended for.

AS IS

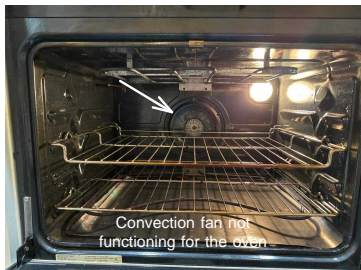
22. Main Floor Kitchen Cooktop/Oven Electric Cooktop/Electric Oven - The convection fan did not function for the oven. Recommend evaluation and repairs.

TO BE DONE

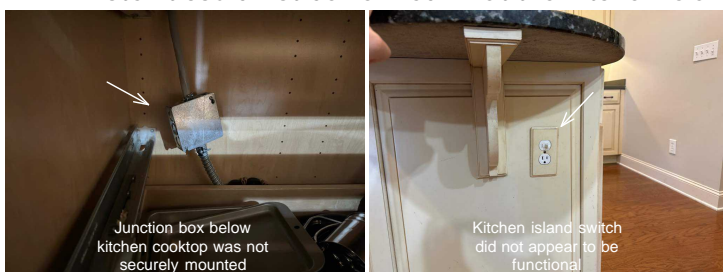
23. Main Floor Kitchen Electrical Recommend Repairs - The electric junction box for the kitchen cooktop below the countertop was not securely mounted at time of inspection. Recommend evaluation and repairs.

- - Note: it could not be verified what the kitchen island switch was intended for.

TO BE DONE
