# INSPECTION REPORT

For the Property at:  
**672 PERCY BOOM ROAD**  
CAMPBELLFORD, ON K0L 1L0

Prepared for: TEAM VANRAHAN  
Inspection Date: Tuesday, May 28, 2024  
Prepared by: David Sharman

RE: Report No. 4823  
672 Percy Boom Road  
Campbellford, ON  
K0L 1L0

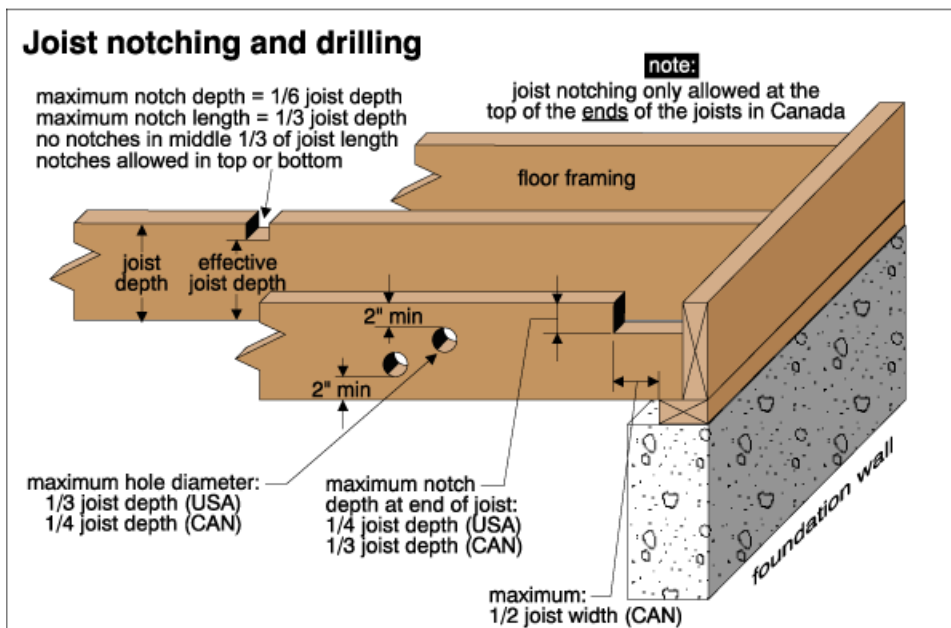
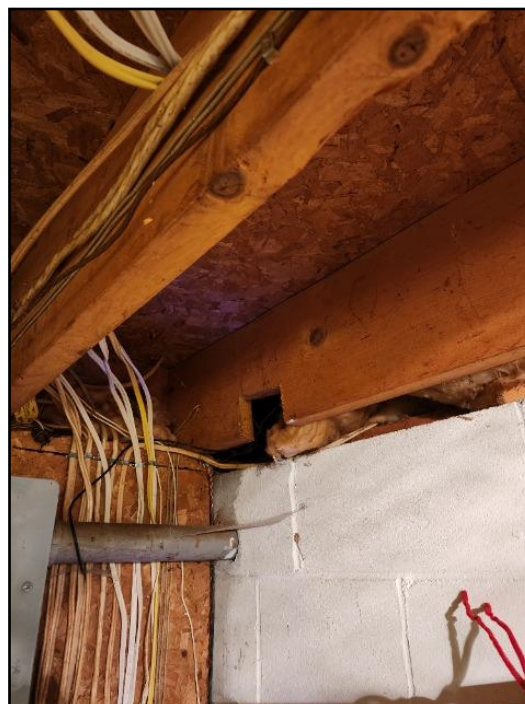
**5. Condition:** • Notches or holes

**Implication(s):** Weakened structure

3. Notches or holes

**Task:** Repair

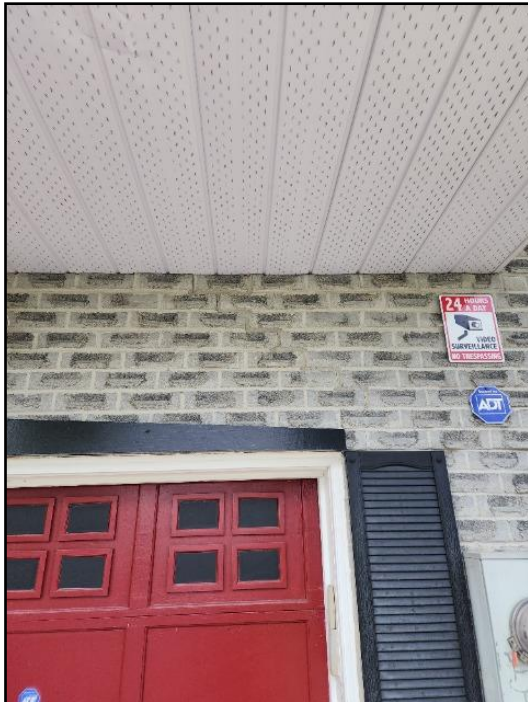
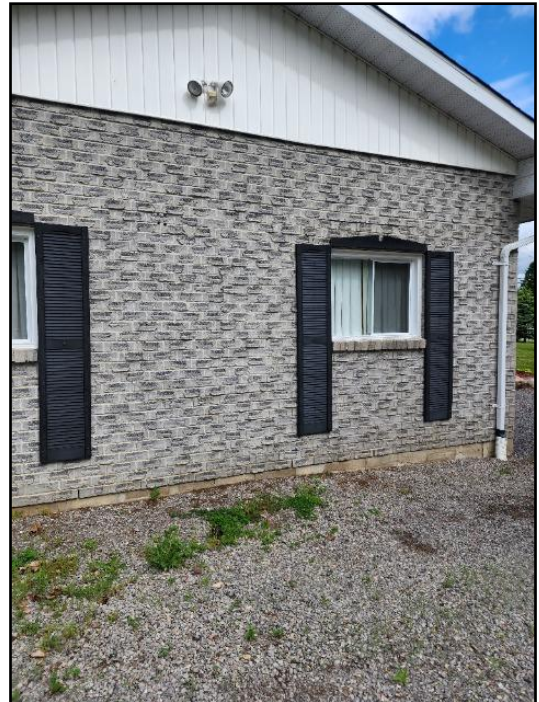
**6. Condition:** • Typical minor cracks

**Implication(s):** Chance of frost damage & material deterioration

**Location:** Garage

4. Typical minor cracks

5. Typical minor cracks

**Task:** Repair

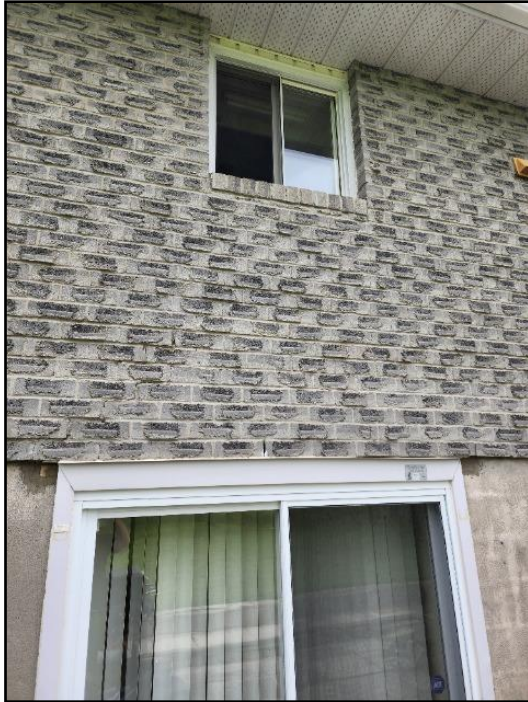
## 7. Condition: • Typical minor cracks

This cracking may be indicative of the exterior door having been changed/upgraded.

**Implication(s):** Chance of frost damage & material deterioration

**Location:** Rear elevation

6. Typical minor cracks

**Task:** Repair

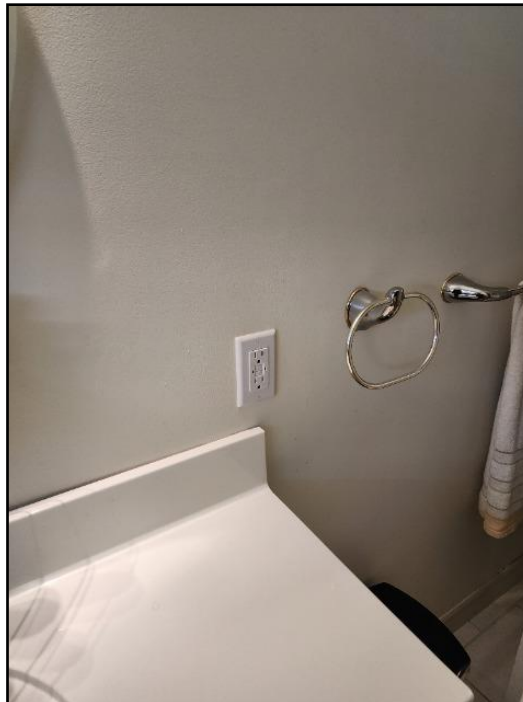
**8. Condition:** • Not on dedicated circuit

Bathroom GFCI shares a branch circuit with a bedroom

**Implication(s):** Nuisance, safety hazard

**Location:** First floor Bathroom

10. Not on dedicated circuit

**Task:** Correct

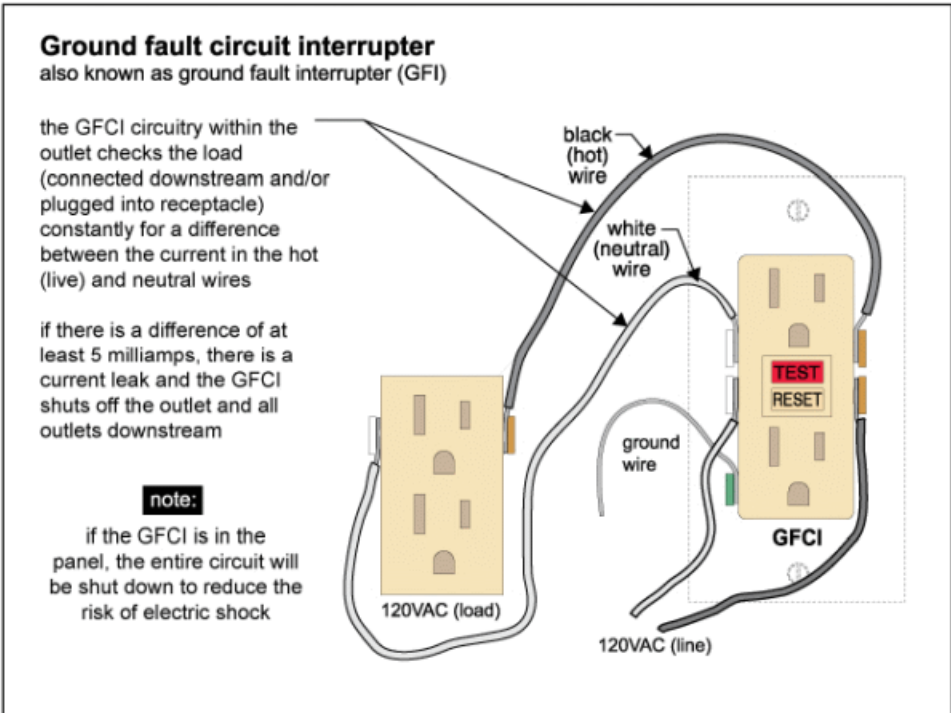
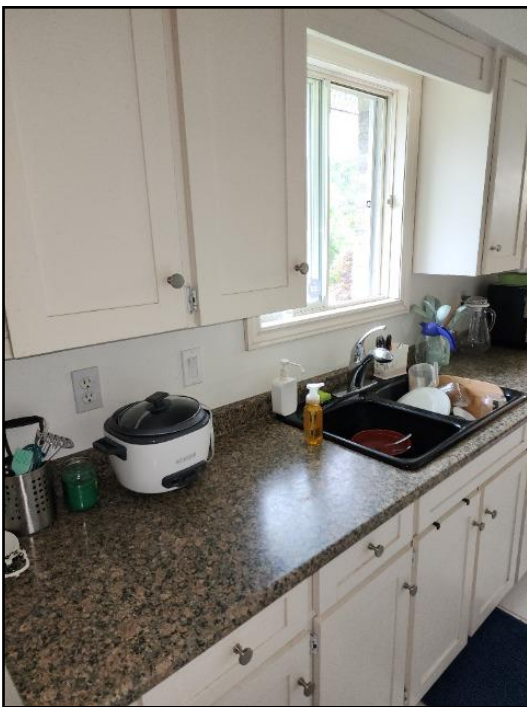
**9. Condition:** • No GFCI/GFI (Ground Fault Circuit Interrupter)

Although not a deficiency in a building of this age, safety may be improved by upgrading these receptacles

**Implication(s):** Electric shock

**Location:** Kitchen

11. No GFCI/GFI (Ground Fault Circuit...

**Task:** Upgrade

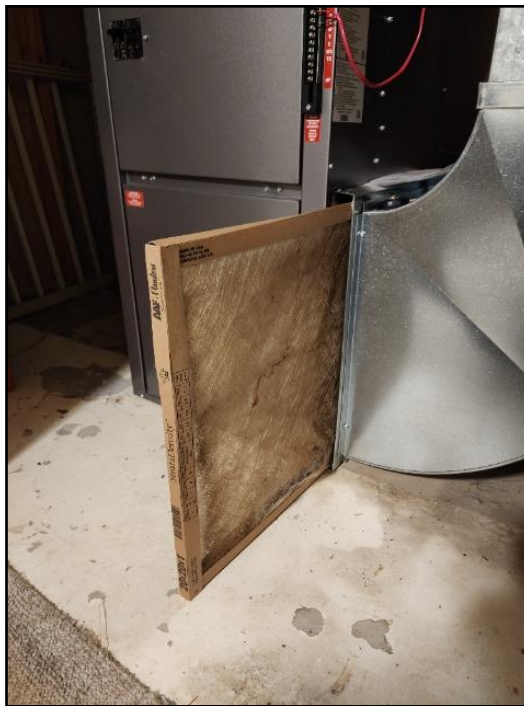
**11. Condition:** • Replace - regular maintenance

**Implication(s):** Increased heating & maintenance costs, Reduced comfort

15. Replace - regular maintenance

**Task:** Replace - regular maintenance

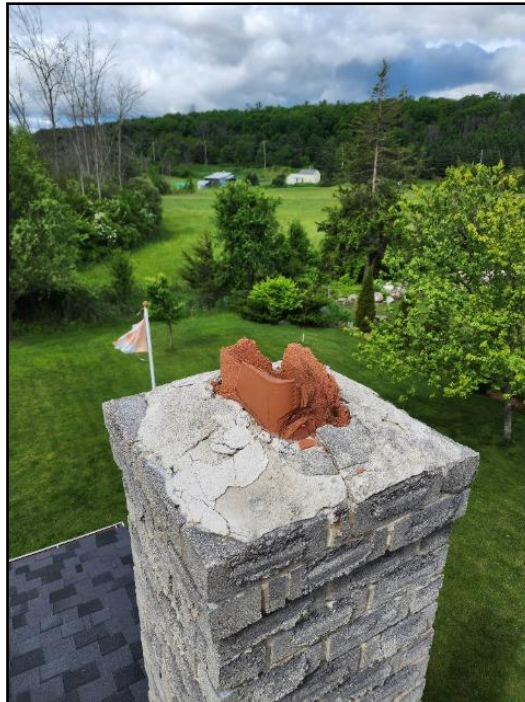
**12. Condition:** • Cracked or damaged

**Location:** Exterior

16. Cracked or damaged

**Task:** Repair or replace

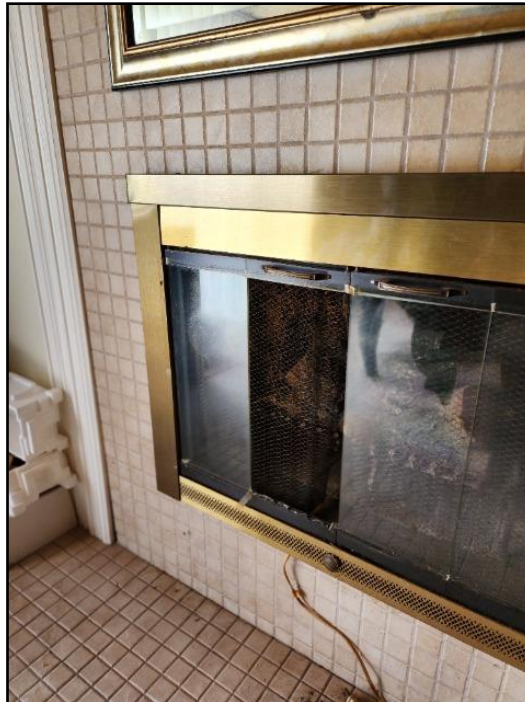
**13. Condition:** • Cracked or broken glass

**Implication(s):** Hazardous combustion products entering home

**Location:** Basement

17. *Cracked or broken glass*

**Task:** Replace

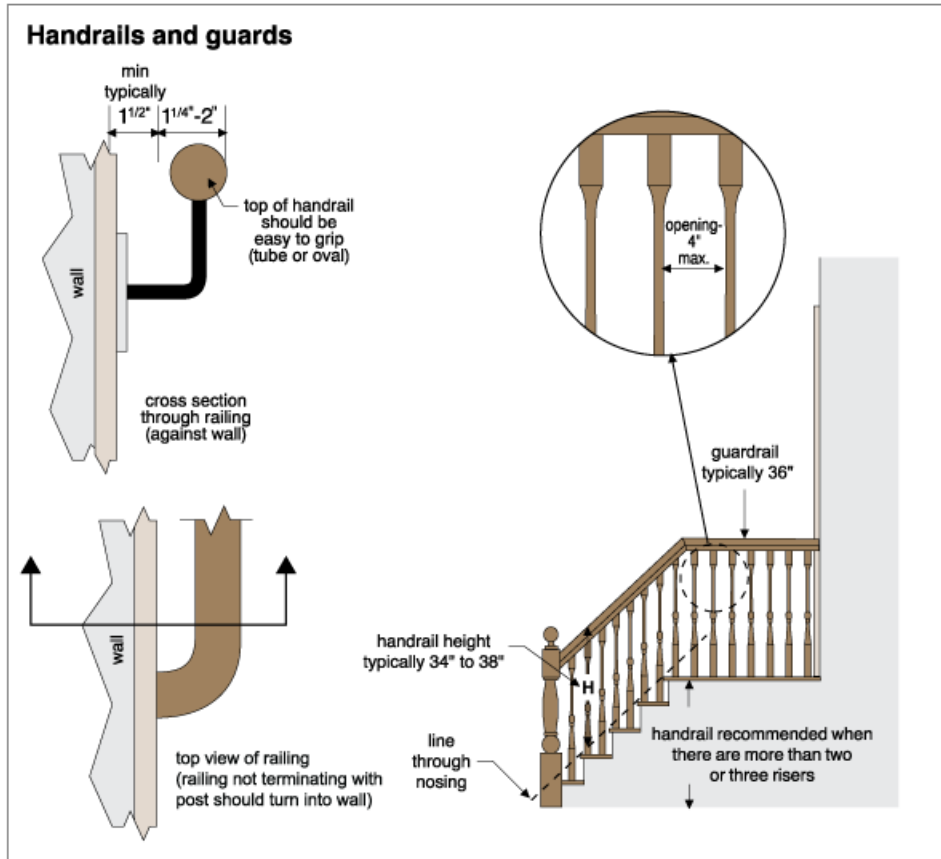
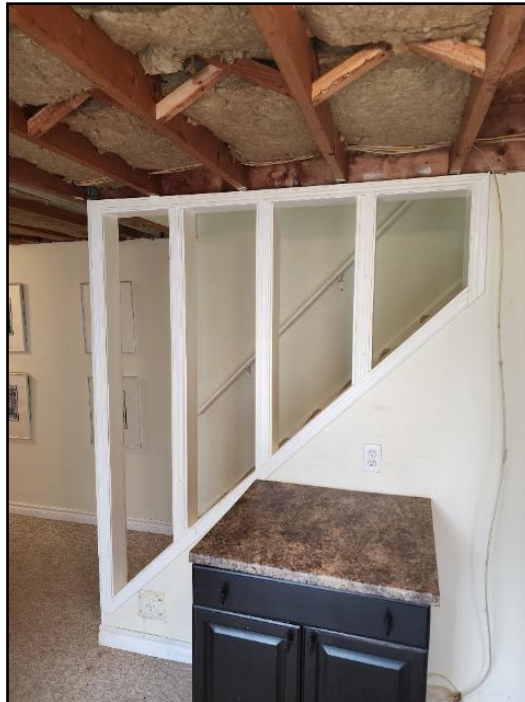
**17. Condition:** • Too far apart

Implication(s): Fall hazard

23. Too far apart

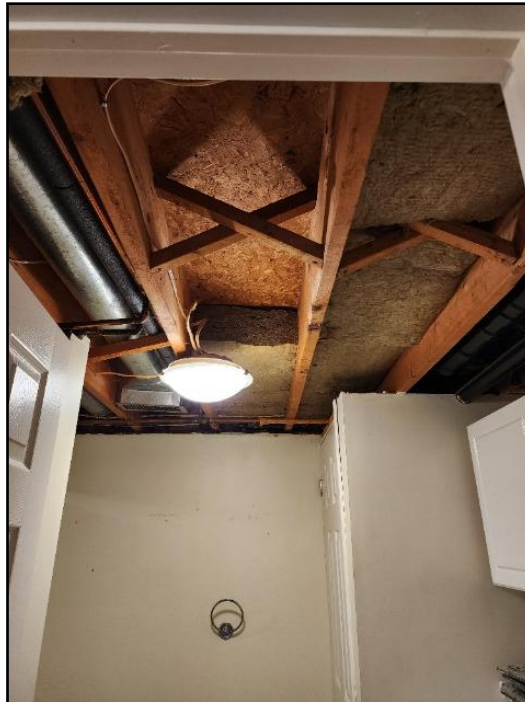
**18. Condition:** • Missing

**Implication(s):** Chance of condensation damage to finishes and/or structure

24. Missing

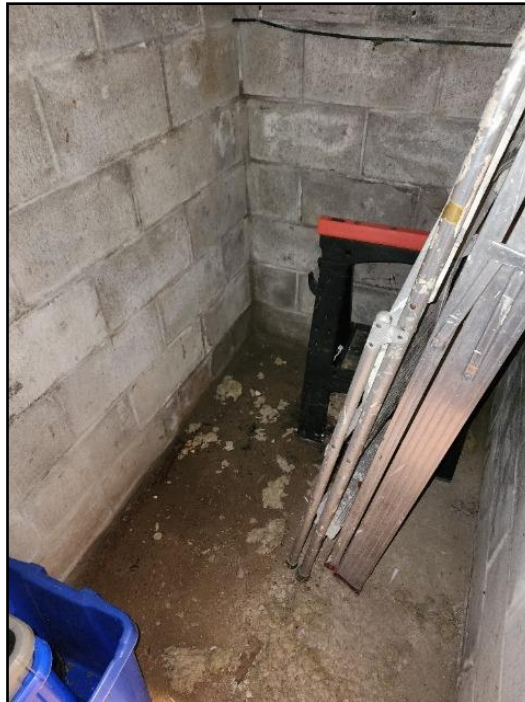
**19. Condition:** • Dampness on floors or walls

**Implication(s):** Chance of water damage to structure, finishes and contents | Material deterioration

25. Dampness on floors or walls

**Task:** Monitor

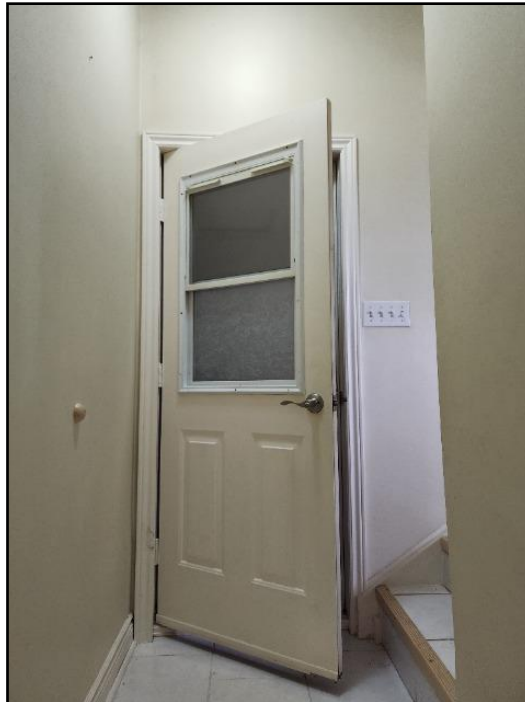
**20. Condition:** • Self closer missing, damaged or disconnected

**Implication(s):** Hazardous combustion products entering home

26. Self closer missing, damaged or disconnected

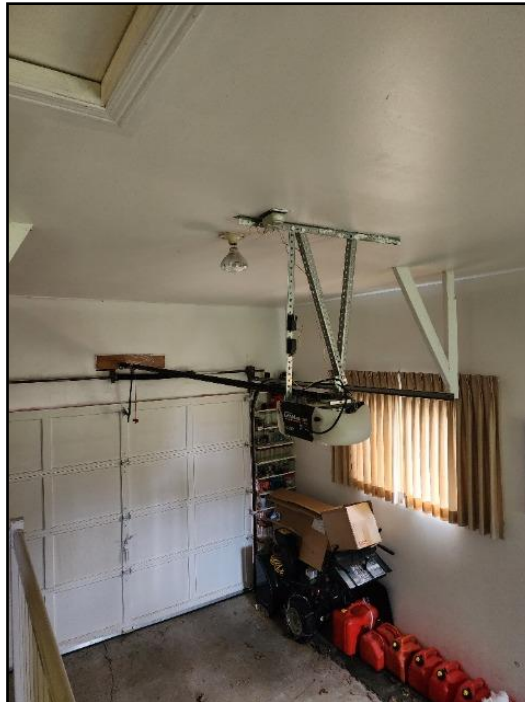
**21. Condition:** • Inoperative

27. Inoperative

**Task:** Repair or replace
