INSPECTION REPORT

For the Property at:
2594 FARMCREST AVENUE
PETERBOROUGH, ON K9L 1H7

Prepared for: TEAM VANRAHAN
Inspection Date: Thursday, August 28, 2025
Prepared by: David Sharman

RE: Report No. 5422
2594 Farmcrest Avenue
Peterborough, ON
K9L 1H7

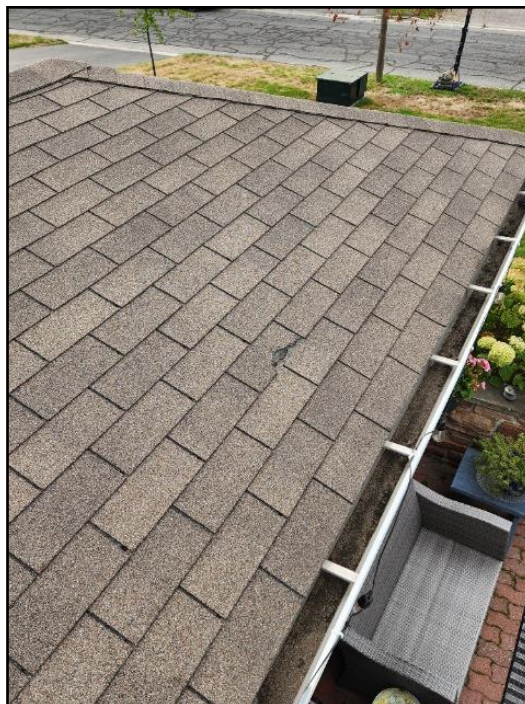
1. Condition: • Damage

Implication(s): Chance of water damage to structure, finishes and contents

Location: Front elevation

5. Damage

Task: Replace

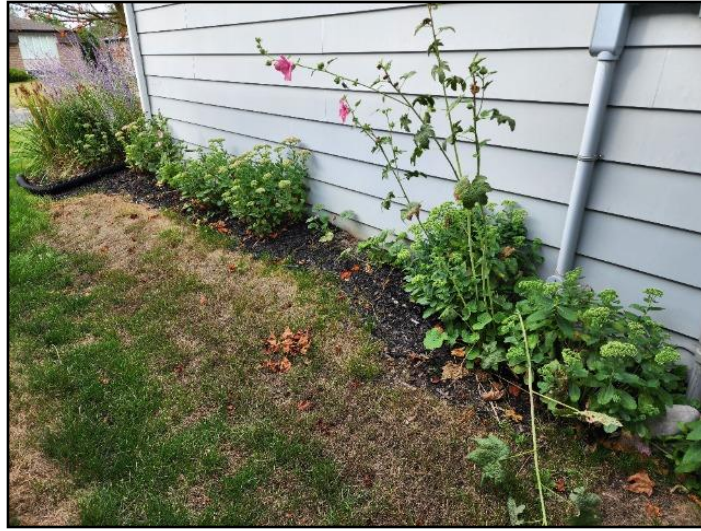
2. Condition: • Too close to or below grade

Implication(s): Chance of water damage to structure, finishes and contents | Material deterioration

Location: Various locations

6. Too close to or below grade

Task: Improve

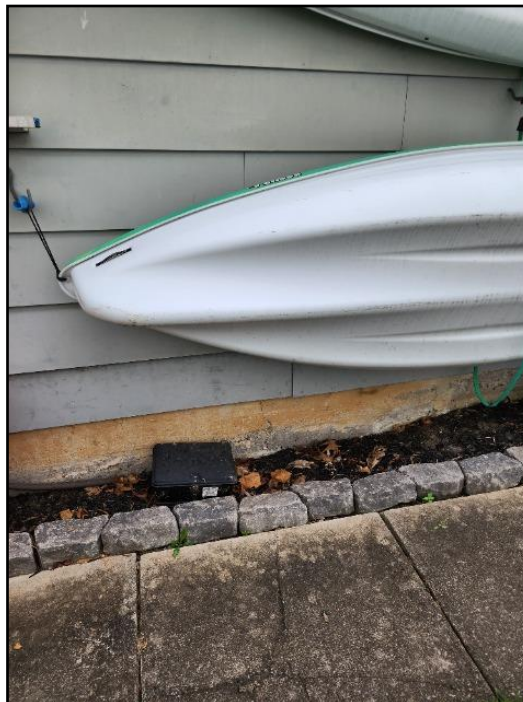
3. Condition: • Typical minor cracks

Implication(s): Material deterioration

Location: Garage

7. Typical minor cracks

Task: Repair

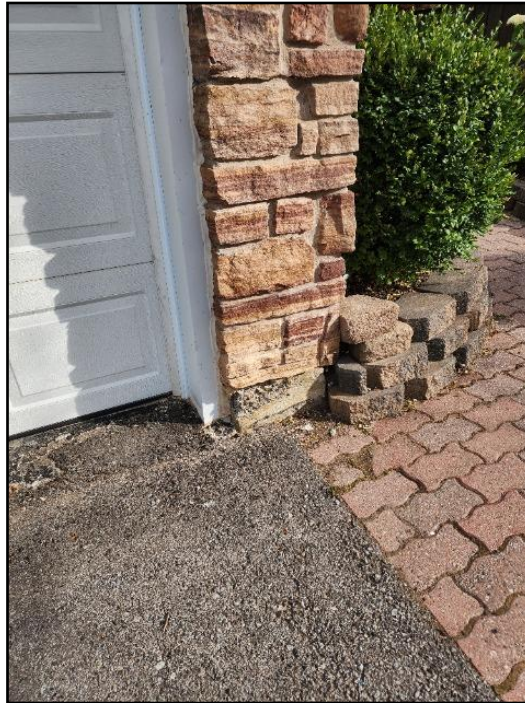
4. Condition: • Spalling, crumbling or broken material

Implication(s): Continued material deterioration.

Location: Garage

8. *Spalling, crumbling or broken material*

Task: Repair

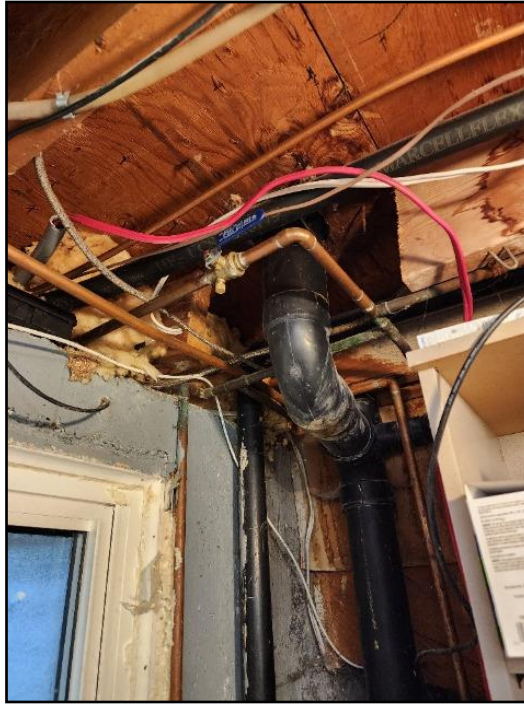
6. Condition: • Cut through

Implication(s): Weakened structure

Location: Utility room

9. Cut through

Task: Monitor

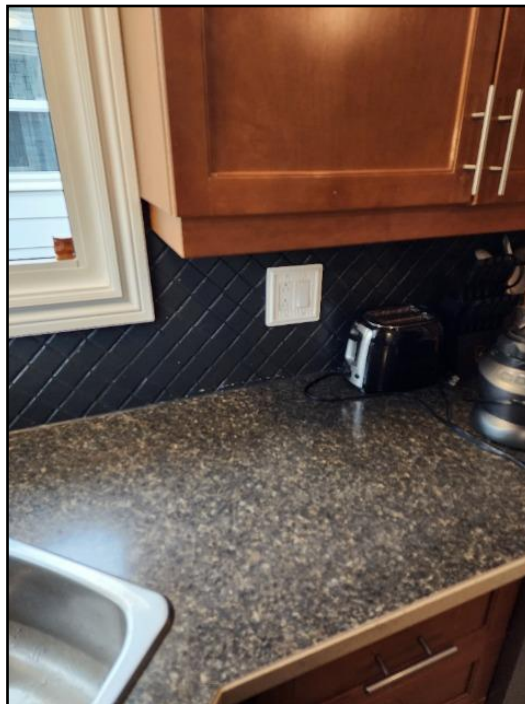
**13.** No GFCI/GFI (Ground Fault Circuit...**DISTRIBUTION SYSTEM \ Smoke alarms (detectors)****8. Condition:** • None observed

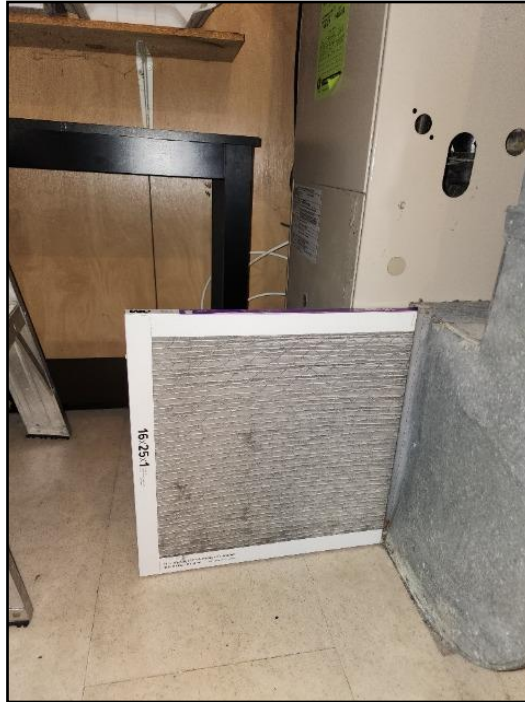
11. Condition: • Replace - regular maintenance

Implication(s): Increased heating & maintenance costs, Reduced comfort

Location: Cold air return

19. Replace - regular maintenance

Task: Replace - regular maintenance

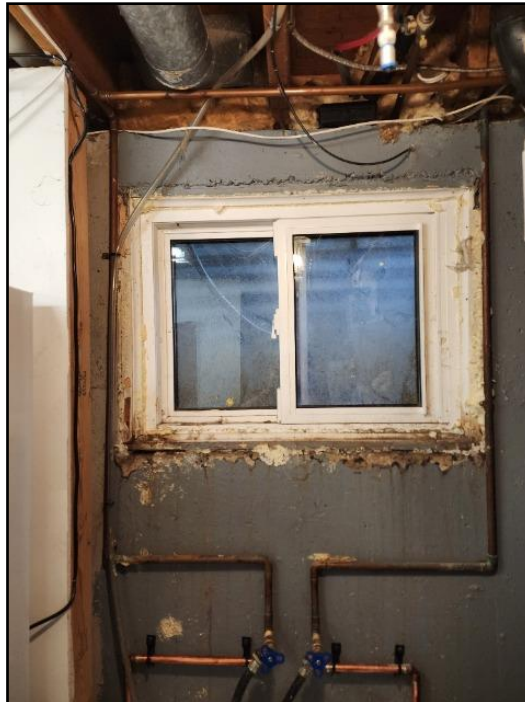
15. Condition: • Water leaks

Implication(s): Chance of damage to finishes and structure | Chance of damage to structure

26. Water leaks

Task: Repair or replace

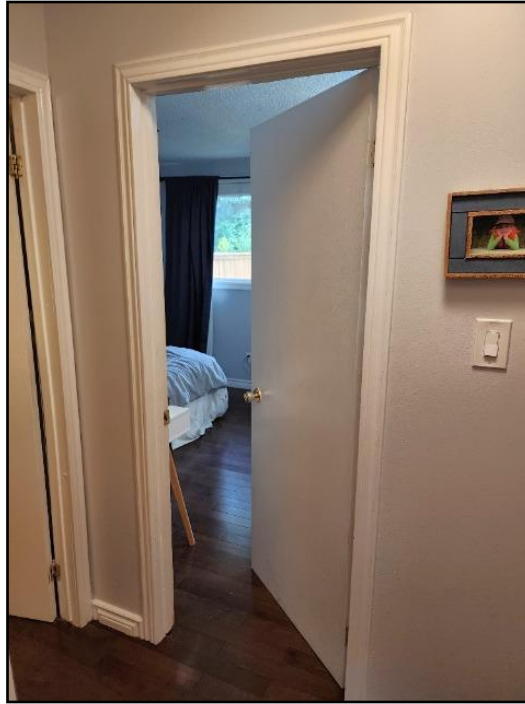
16. Condition: • Loose or poor fit

Implication(s): Chance of damage to finishes and structure

27. Loose or poor fit

Task: Repair

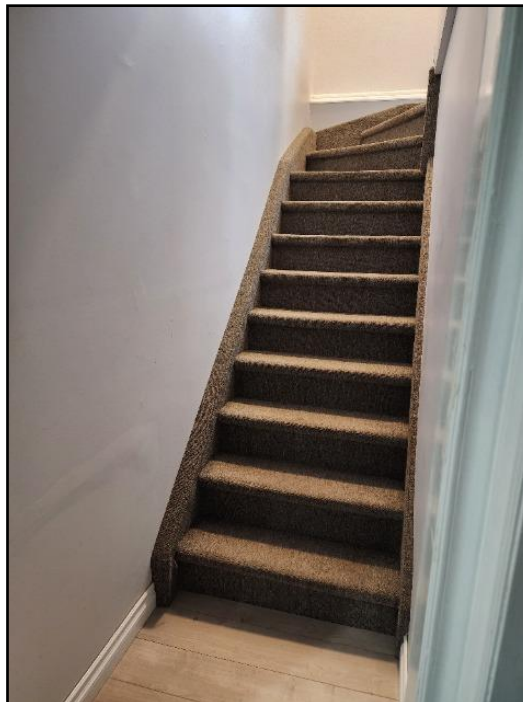
17. Condition: • Missing

Implication(s): Fall hazard

28. Missing
