# INSPECTION REPORT

**54 EMERALD COURT**  
BELLEVILLE, ON K8R 1G8

Inspection Date: Tuesday, March 21, 2023

RE: Report No. 4232  
54 Emerald Court  
Belleville, ON  
K8R 1G8

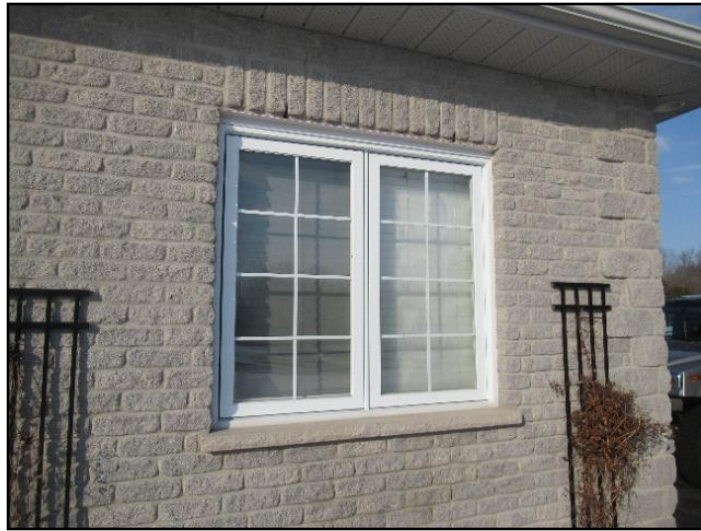
**2. Condition:** • Lost seal on double glazing

**Implication(s):** Shortened life expectancy of material | Nuisance

**Location:** Garage

4. Lost seal on double glazing

**Task:** Repair or replace

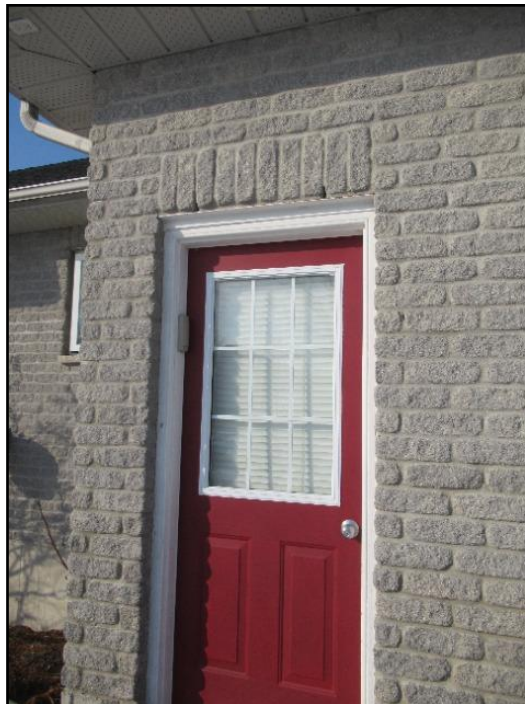
**3. Condition:** • Lost seal on double glazing

**Implication(s):** Shortened life expectancy of material | Nuisance

**Location:** Garage

5. Lost seal on double glazing

**Task:** Repair or replace

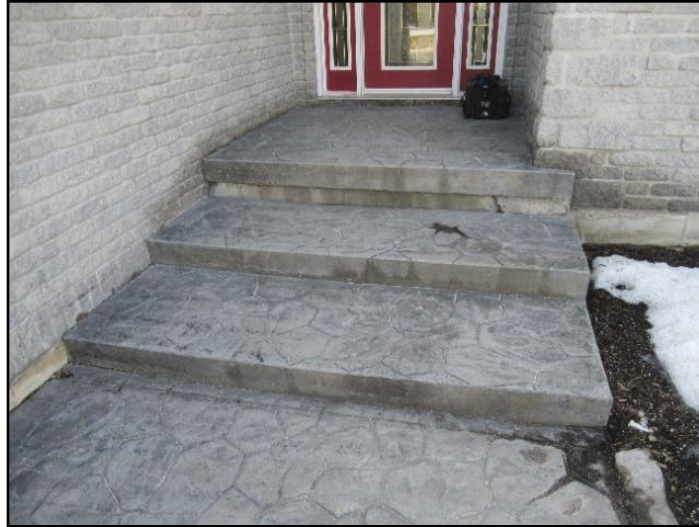
**4. Condition:** • Steps or landings settling

**Implication(s):** Trip or fall hazard

**Location:** Front elevation

**6.** *Steps or landings settling*

**Task:** Repair

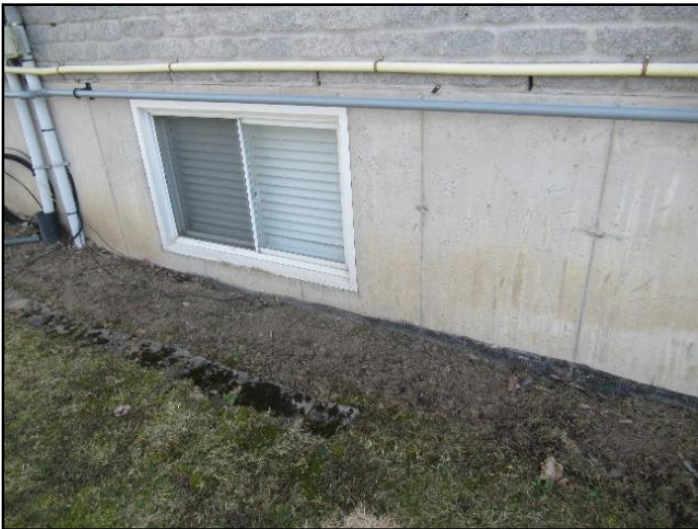
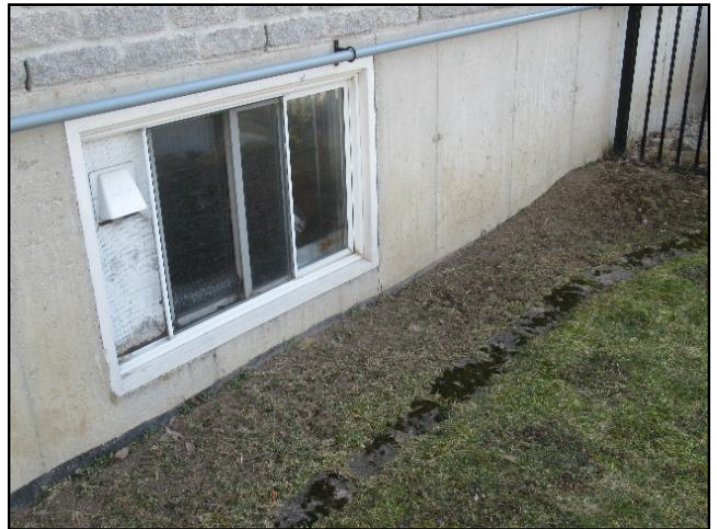
**5. Condition:** • Typical minor cracks

**Implication(s):** Material deterioration

**Location:** Right elevation

7. Typical minor cracks

**Task:** Monitor

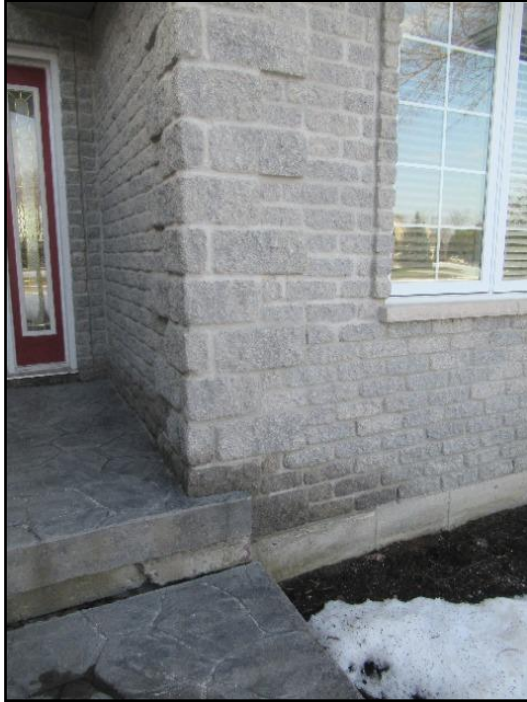
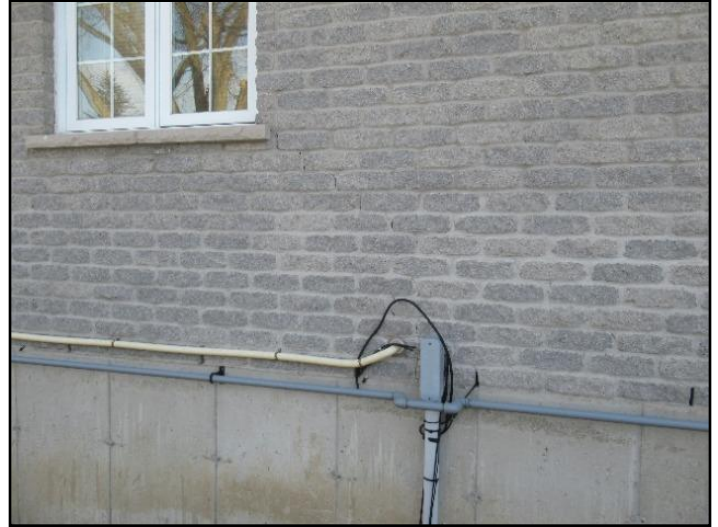
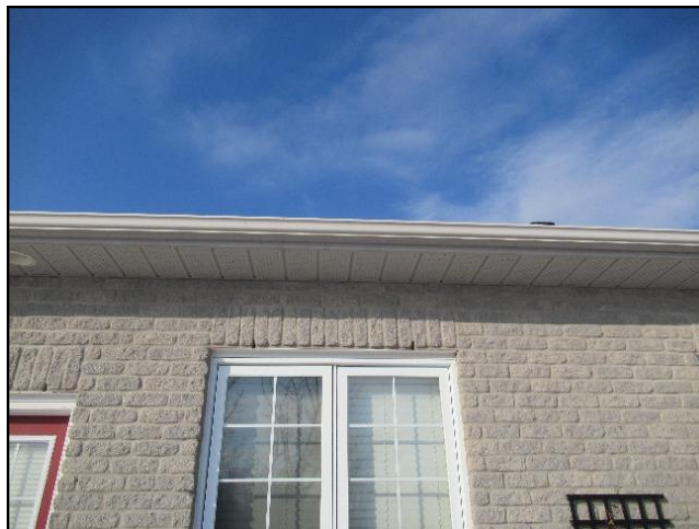
**7. Condition:** • Typical minor cracks

**Implication(s):** Chance of frost damage & material deterioration

**Location:** Various locations

9. Typical minor cracks

**Task:** Repair

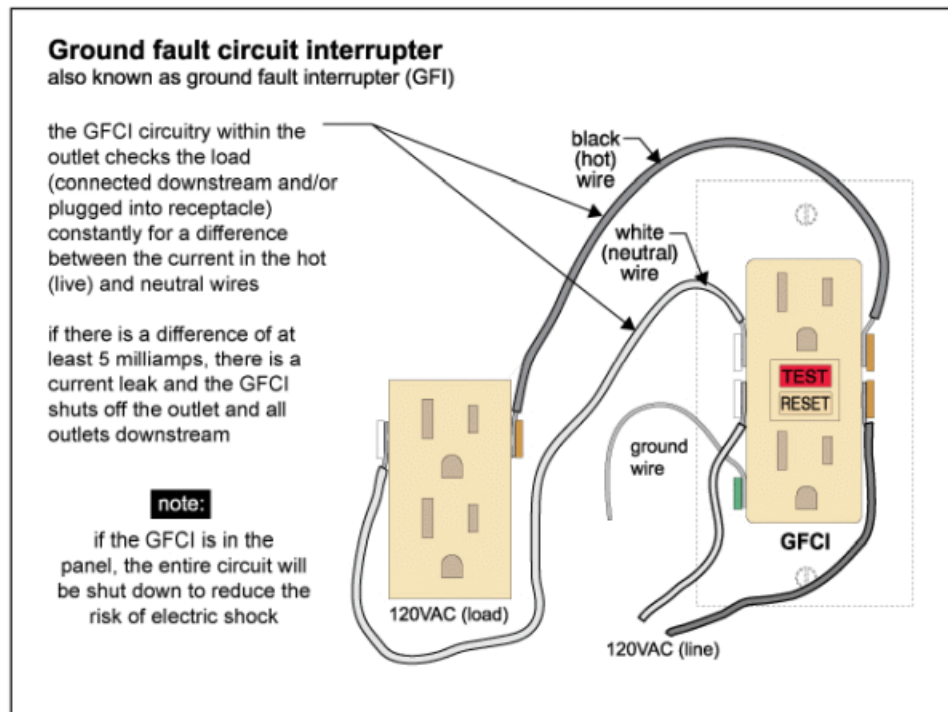
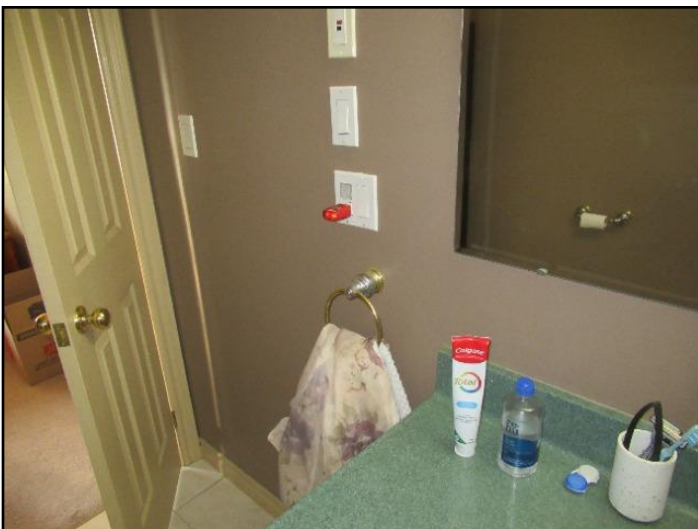
**8. Condition:** • No GFCI/GFI (Ground Fault Circuit Interrupter)

**Implication(s):** Electric shock

**Location:** Bathroom & washroom

14. No GFCI/GFI (Ground Fault Circuit...

**Task:** Replace

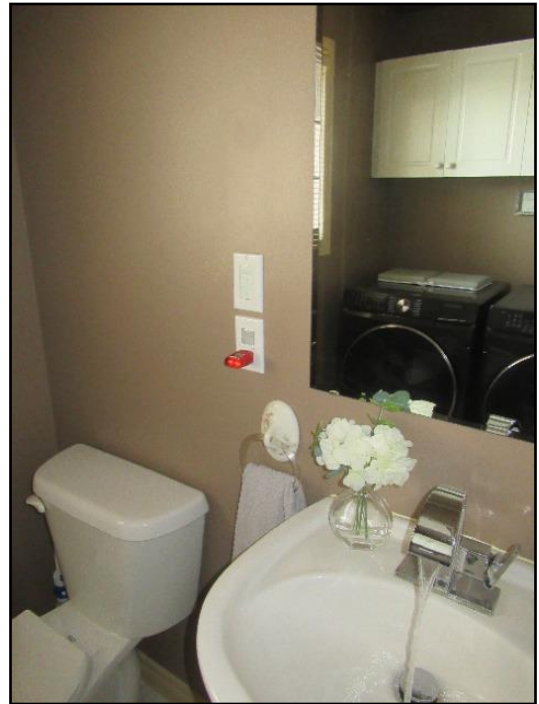
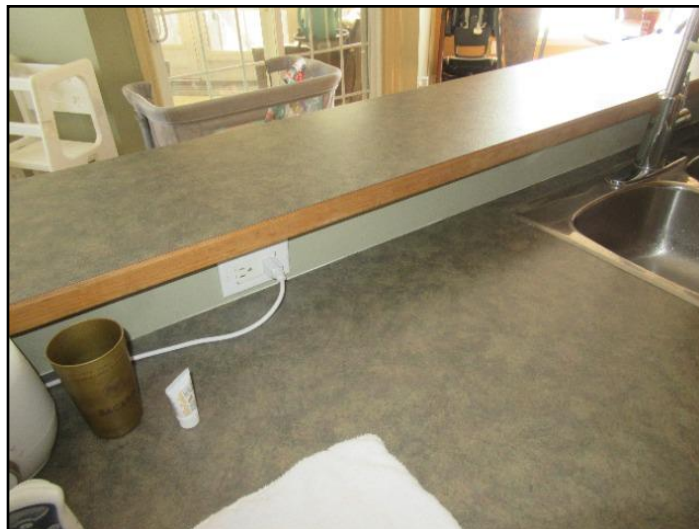
**9. Condition:** • No GFCI/GFI (Ground Fault Circuit Interrupter)

Although not a deficiency in a home of this age, safety may be improved by upgrading this receptacle

16. No GFCI/GFI (Ground Fault Circuit...

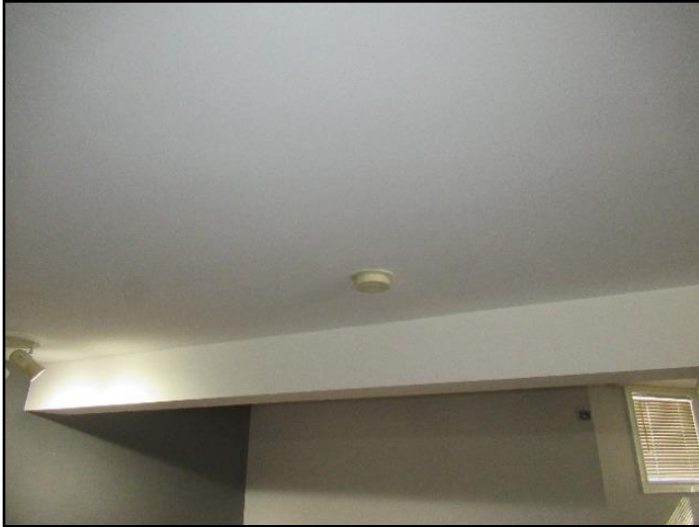
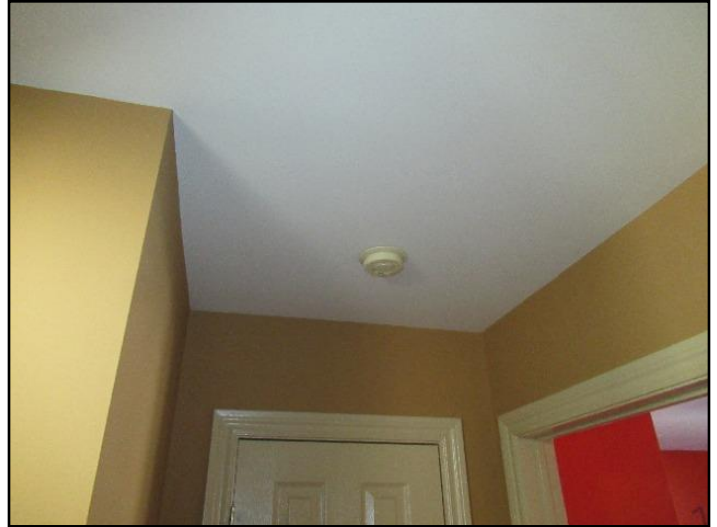
**10. Condition:** • More than 10 years old

**Implication(s):** Life safety hazard

17. More than 10 years old

**Task:** Replace

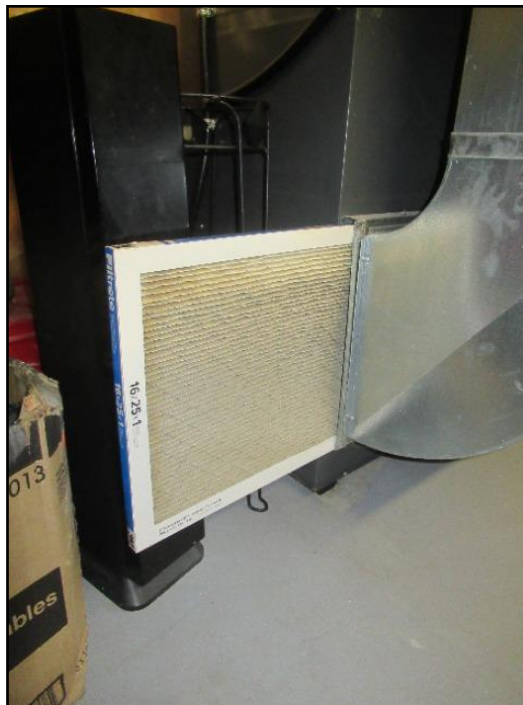
**11. Condition:** • Replace - regular maintenance

**28. Replace - regular maintenance**

**Task:** Replace

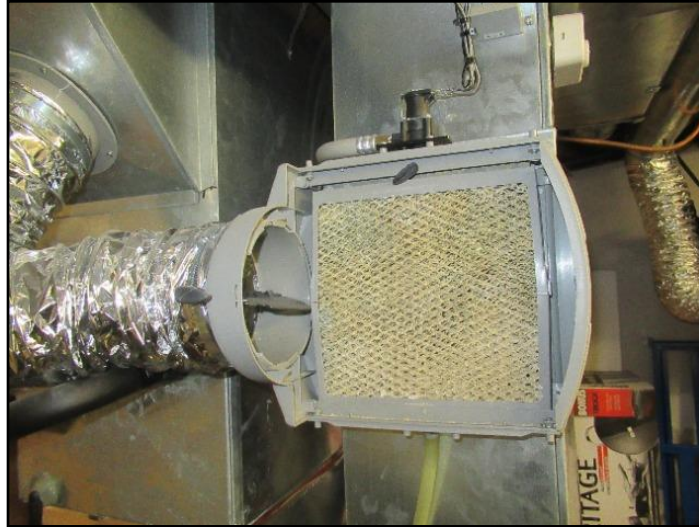
**12. Condition:** • Clean pad/mesh - regular maintenance

*29. Clean pad/mesh - regular maintenance*

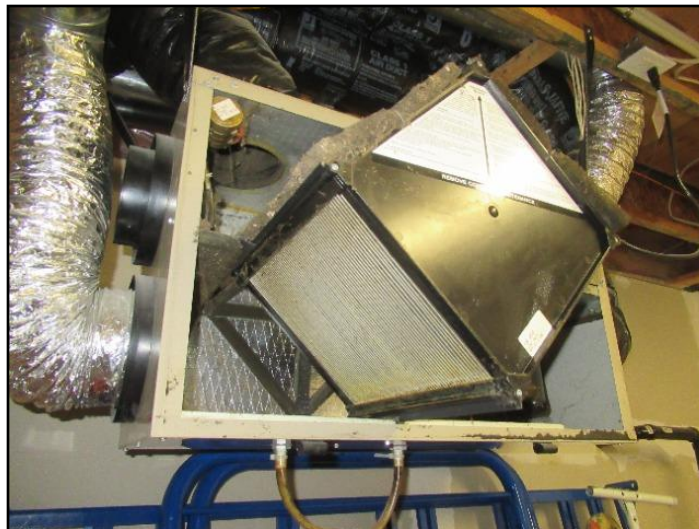
**13. Condition:** • Clean core - regular maintenance

30. Clean core - regular maintenance

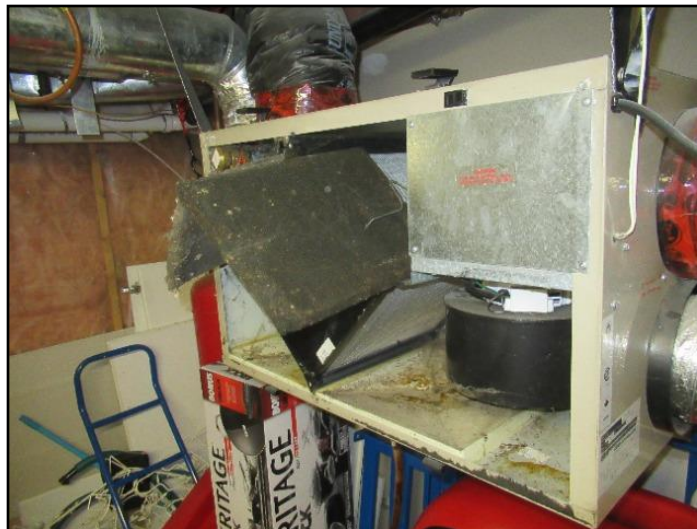
**14. Condition:** • Clean filters - regular maintenance

31. Clean filters - regular maintenance

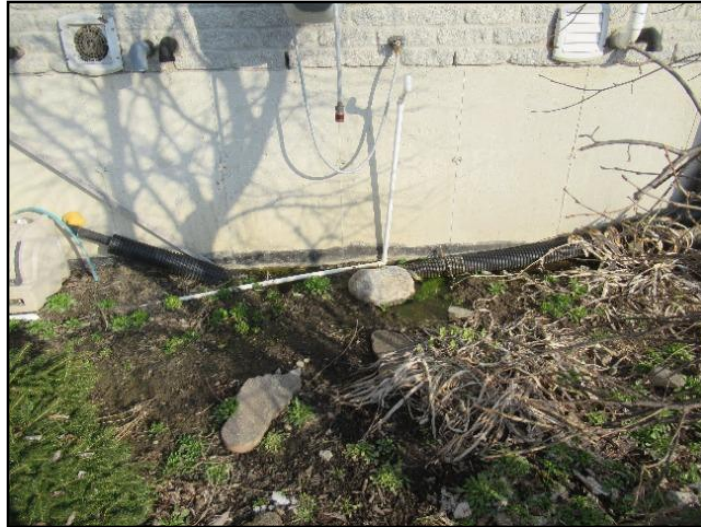
**17. Condition:** • Discharge pipe problems

Leak

**Implication(s):** Chance of water damage to structure, finishes and contents

**42.** *Discharge pipe problems*

**Task:** Repair or replace
