# INSPECTION REPORT

For the Property at:  
**1926 PARKWOOD CIRCLE**  
PETERBOROUGH, ON K9J 8C7

Prepared for: TEAM VANRAHAN  
Inspection Date: Thursday, June 22, 2023  
Prepared by: David Sharman

RE: Report No. 4371  
1926 Parkwood Circle  
Peterborough, ON  
K9J 8C7

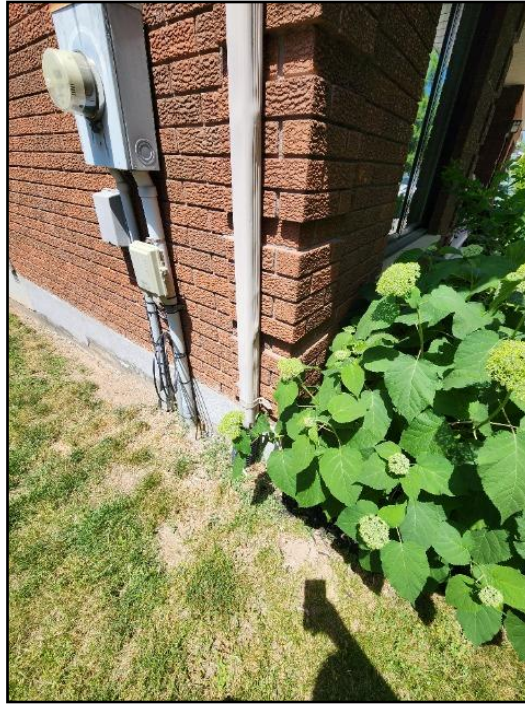
**2. Condition:** • Damage

**Implication(s):** Chance of water damage to structure, finishes and contents

**Location:** Front left corner

3. Damage

**Task:** Repair or replace

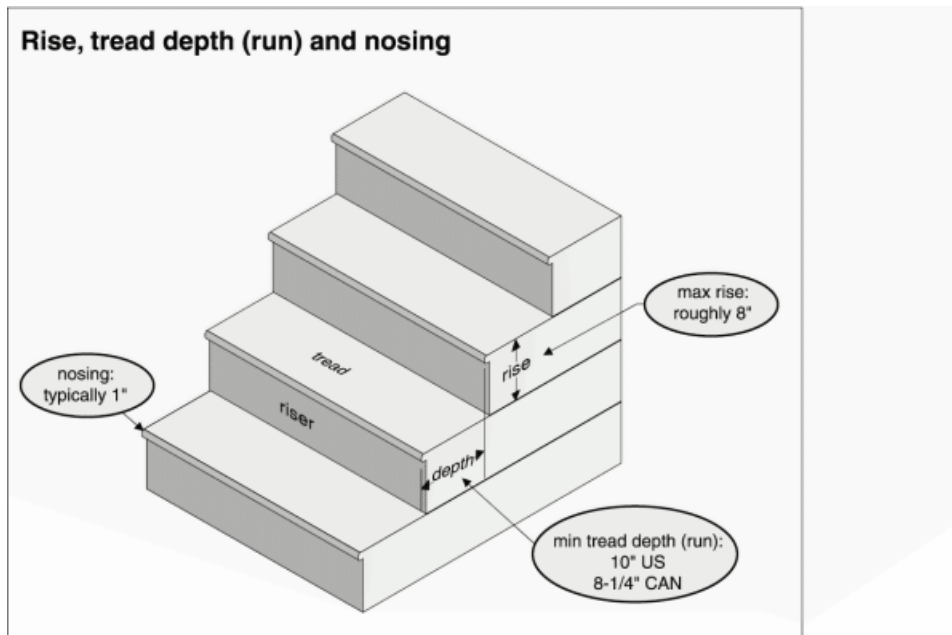
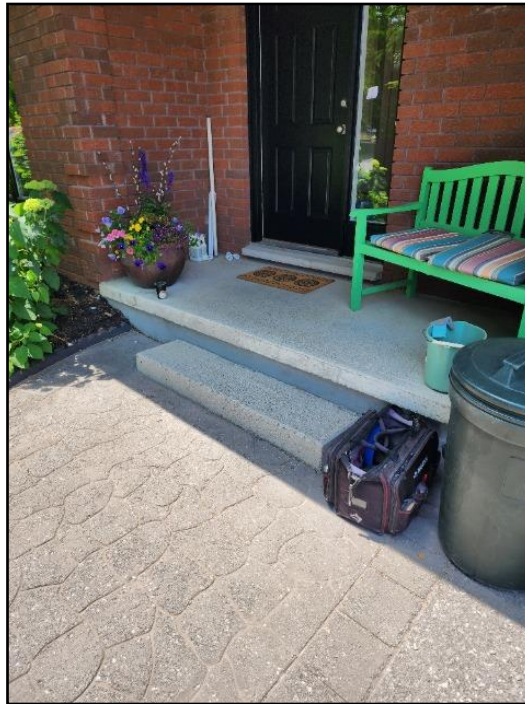
**3. Condition:** • Stair rise too big or not uniform

**Implication(s):** Trip or fall hazard

**Location:** Porch

4. Stair rise too big or not uniform

**Task:** Improve

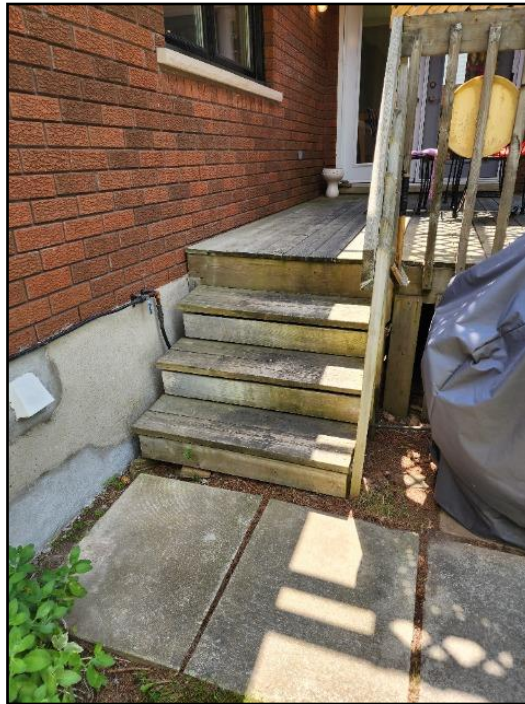
**4. Condition:** • Step damaged, loose or missing

**Implication(s):** Trip or fall hazard

**Location:** Raised decking

5. Step damaged, loose or missing

**Task:** Repair

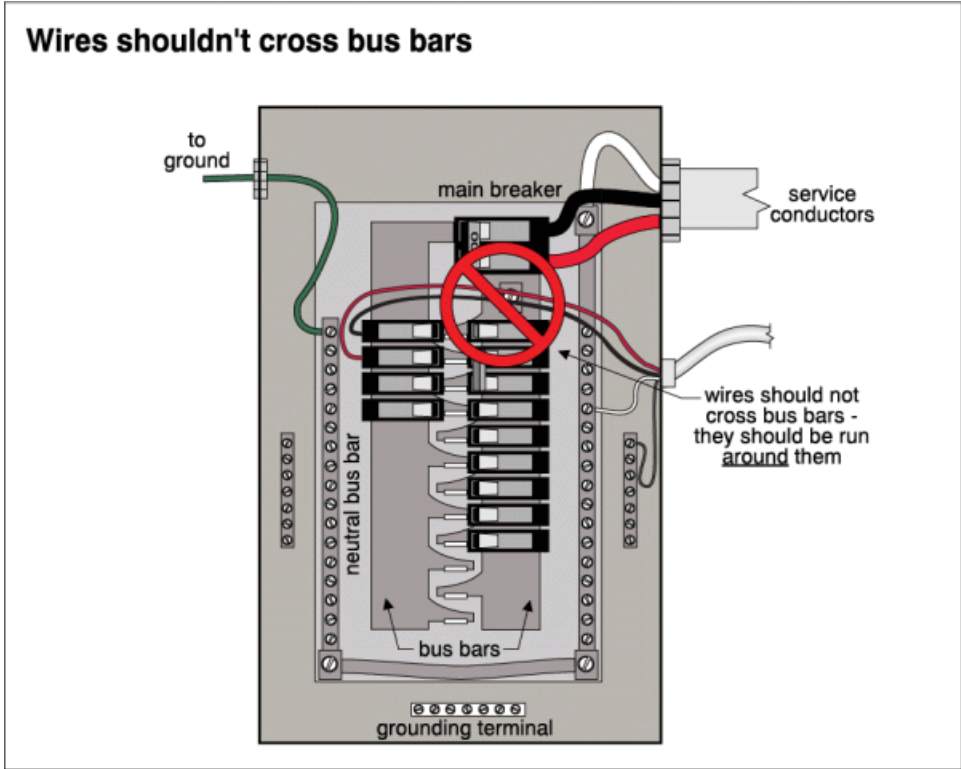
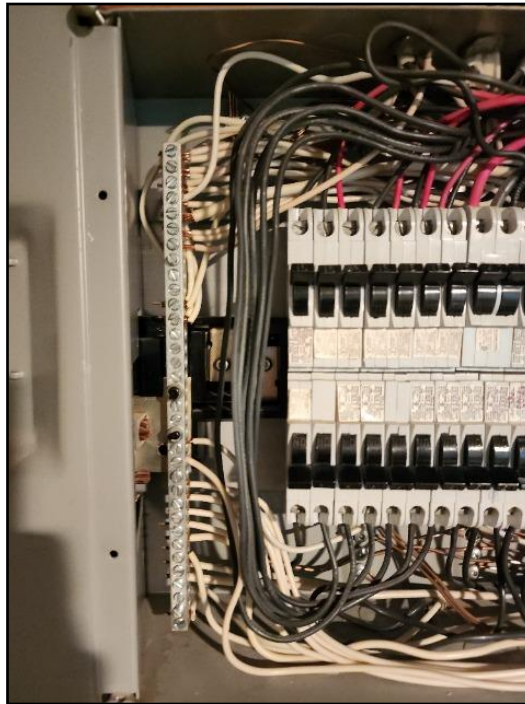
**6. Condition:** • Wire crossing bus connections

**Implication(s):** Electric shock | Fire hazard

**Location:** Distribution panel

8. *Wire crossing bus connections*

**Task:** Improve

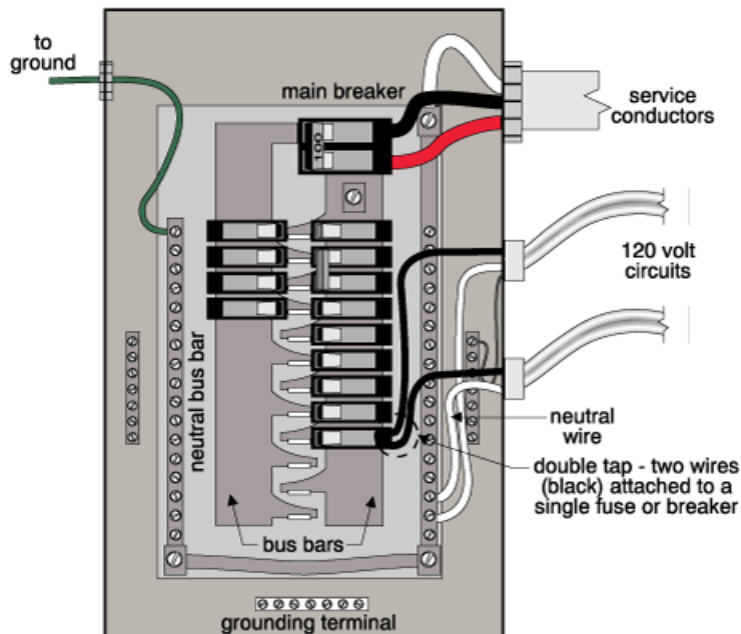
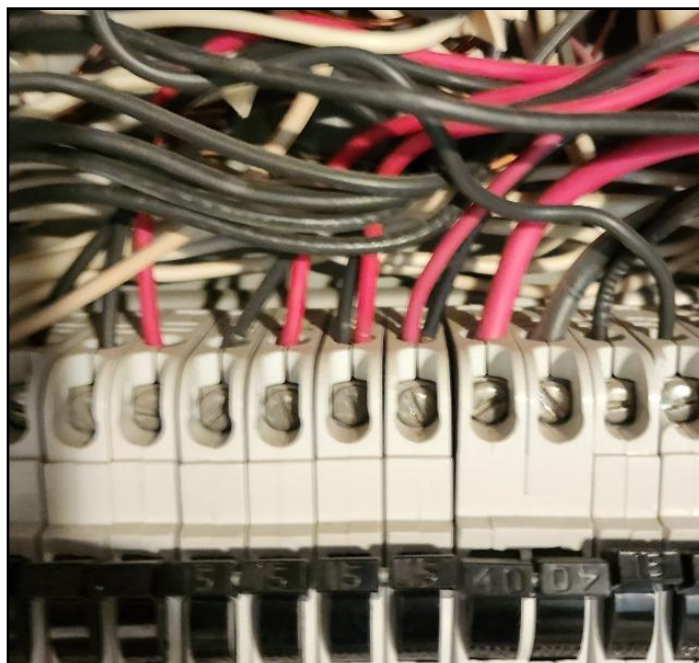
**7. Condition:** • Double taps

**Implication(s):** Fire hazard

**Location:** Distribution panel

9. Double taps

**Task:** Correct

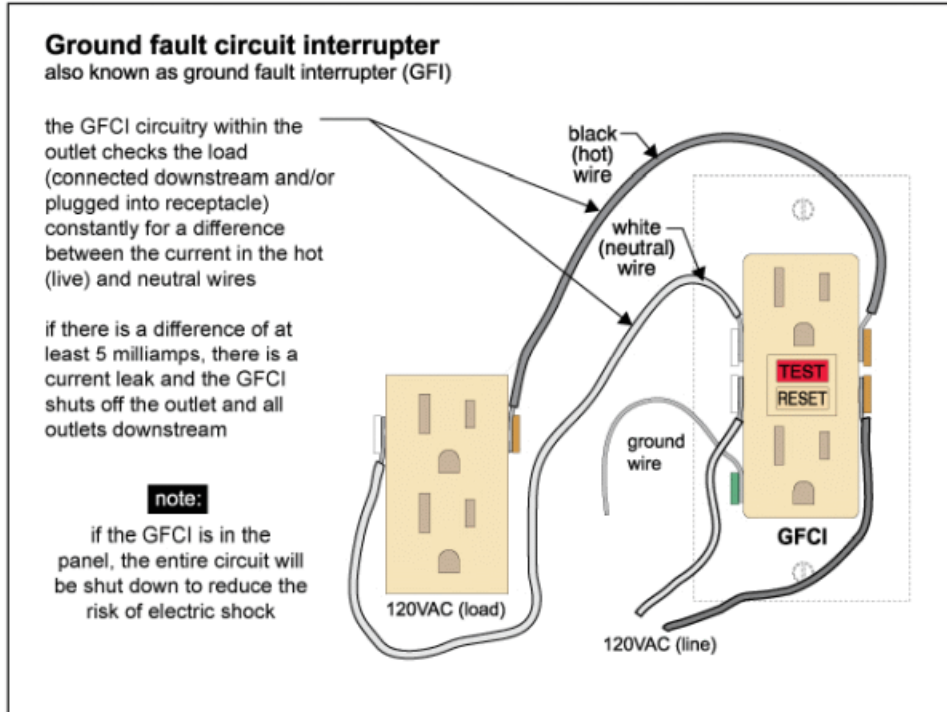
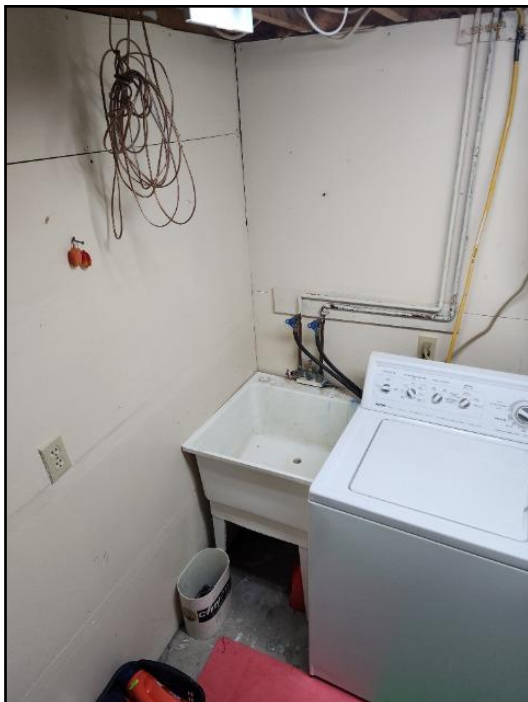
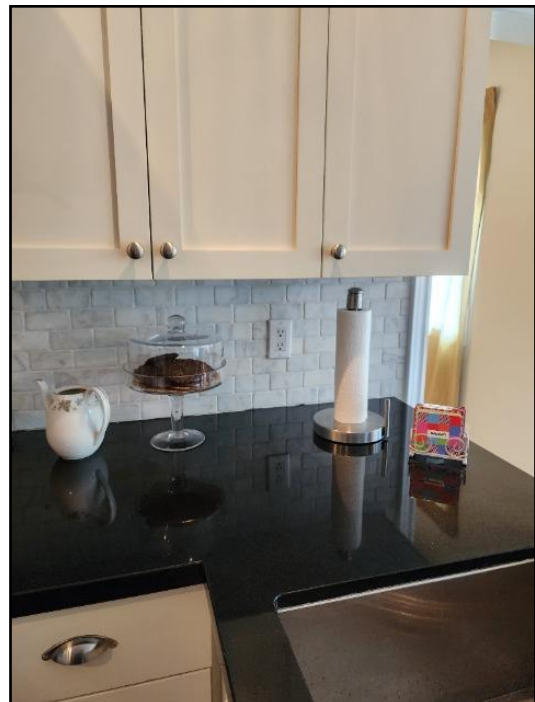
8. Condition: • No GFCI/GFI (Ground Fault Circuit Interrupter)

Although not a deficiency in a home of this age, safety may be improved by upgrading these receptacles

**Implication(s):** Electric shock

**Location:** Laundry & kitchen

10. No GFCI/GFI (Ground Fault Circuit...

**Task:** Upgrade

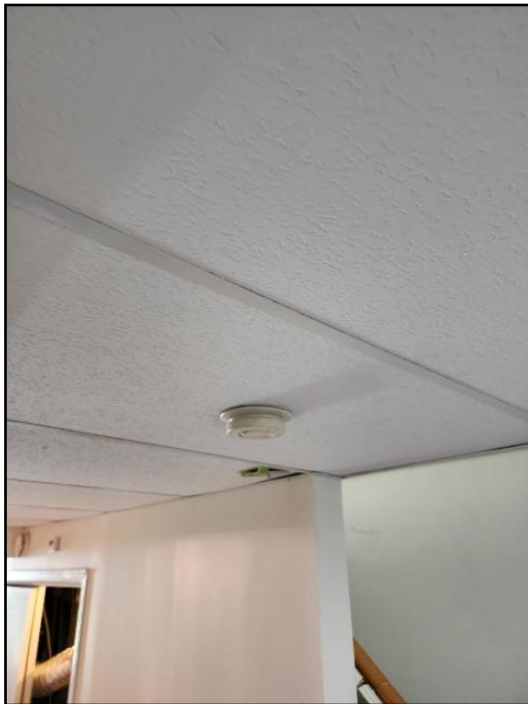
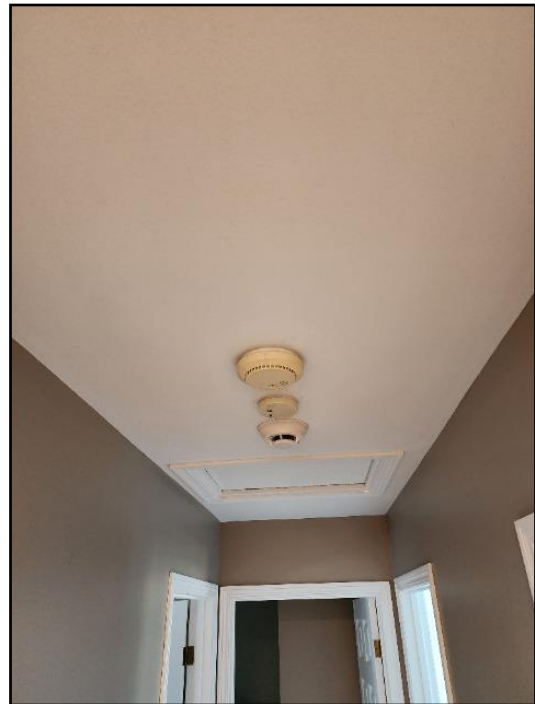
**10. Condition:** • More than 10 years old

**Implication(s):** Life safety hazard

**Location:** Basement & second floor

12. More than 10 years old

**Task:** Replace

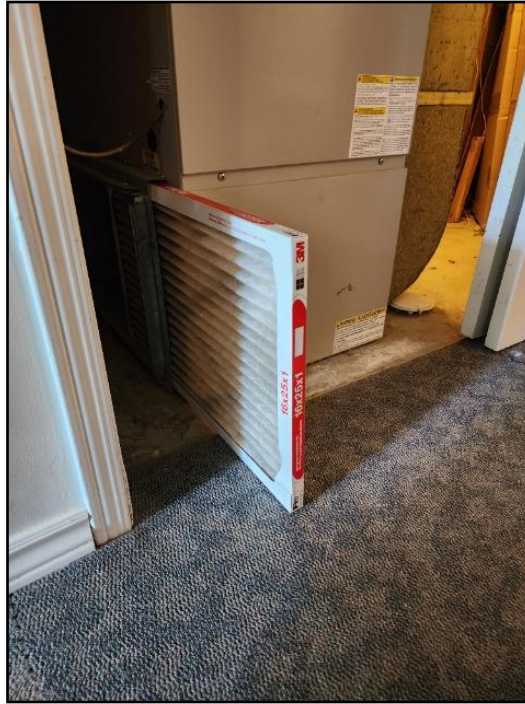
**13. Condition:** • Replace - regular maintenance

22. Replace - regular maintenance

**Task:** Replace

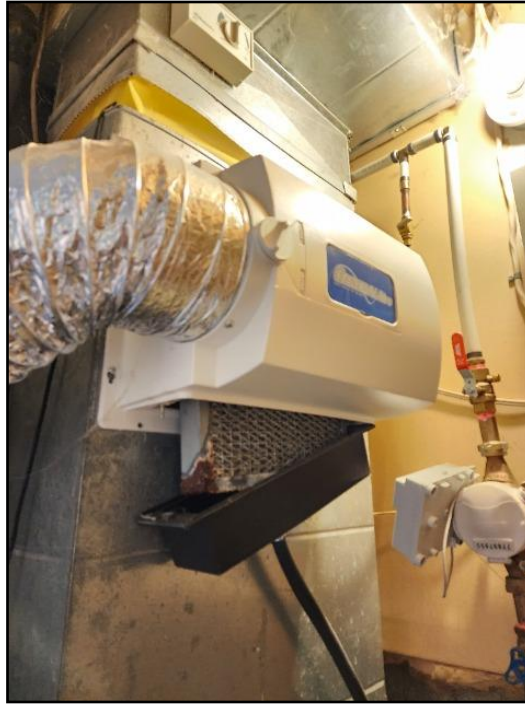
14. **Condition:** • Clean pad/mesh - regular maintenance

**23.** *Clean pad/mesh - regular maintenance*

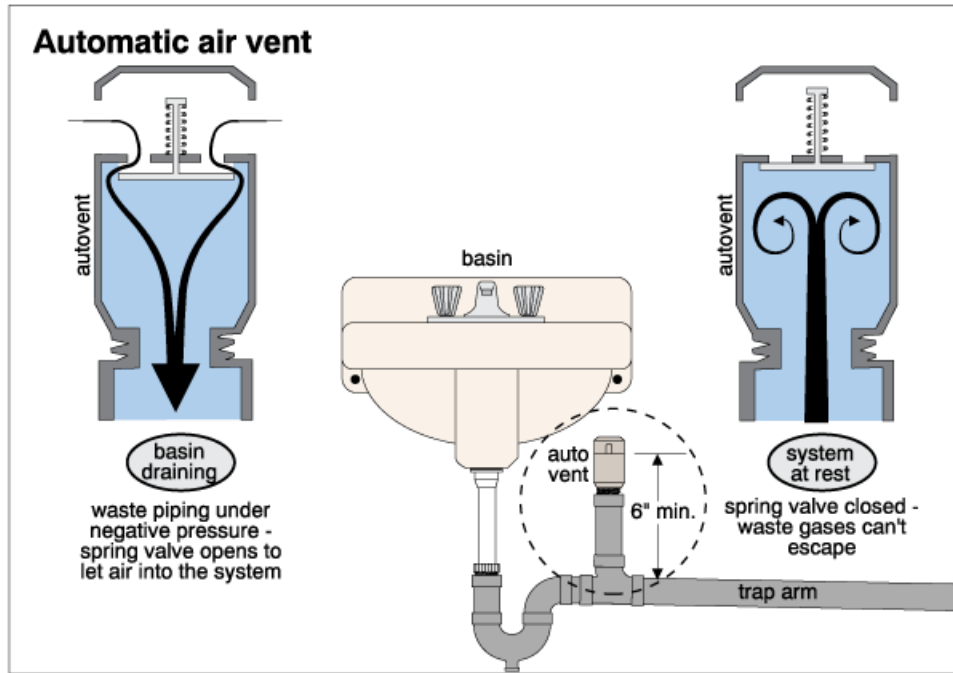
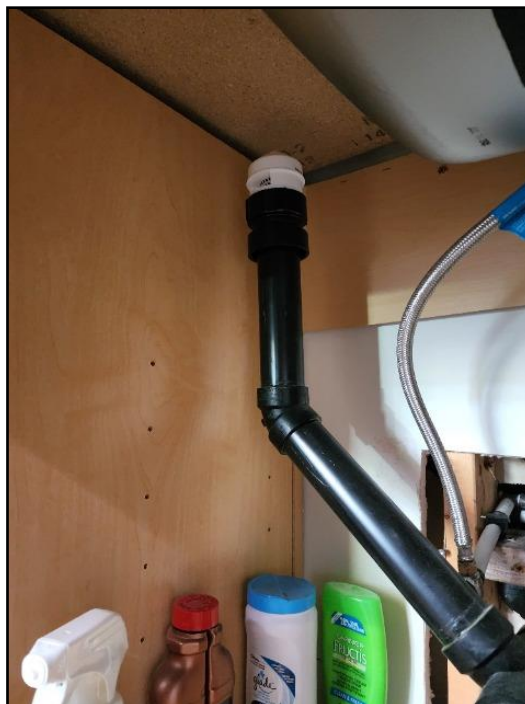
**18. Condition:** • Automatic air vents

**Implication(s):** Failure may allow sewer gasses to enter building

30. Automatic air vents

**Task:** Monitor
