# INSPECTION REPORT

For the Property at:  
**550 AYLMER STREET NORTH**  
PETERBOROUGH, ON K9H 3W7

Prepared for: TEAM VANRAHAN  
Inspection Date: Monday, January 20, 2025  
Prepared by: David Sharman

RE: Report No. 5130  
550 Aylmer Street North  
Peterborough, ON  
K9H 3W7

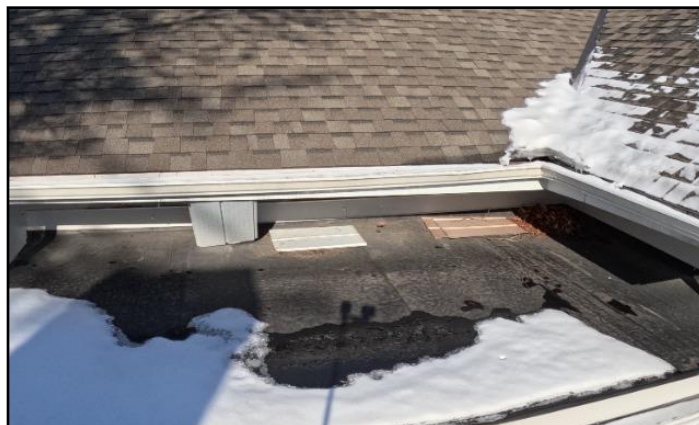
**2. Condition:** • Loose or missing pieces

**Implication(s):** Chance of water damage to structure, finishes and contents | Chance of pests entering building

**Location:** Right elevation

5. Loose or missing pieces

**Task:** Repair or replace

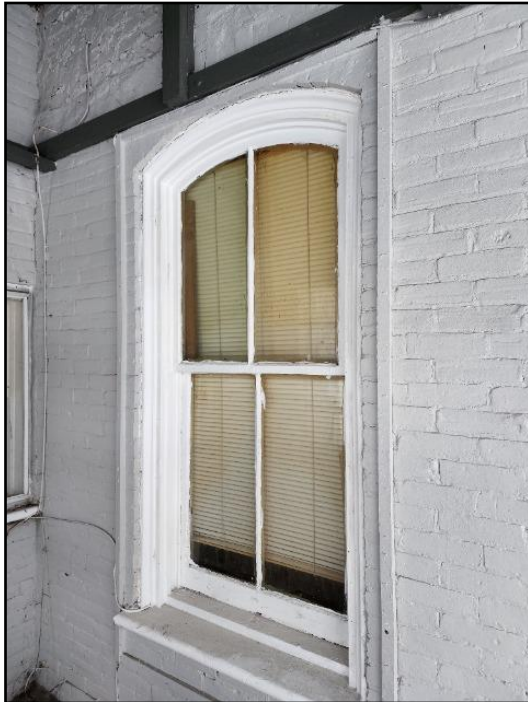
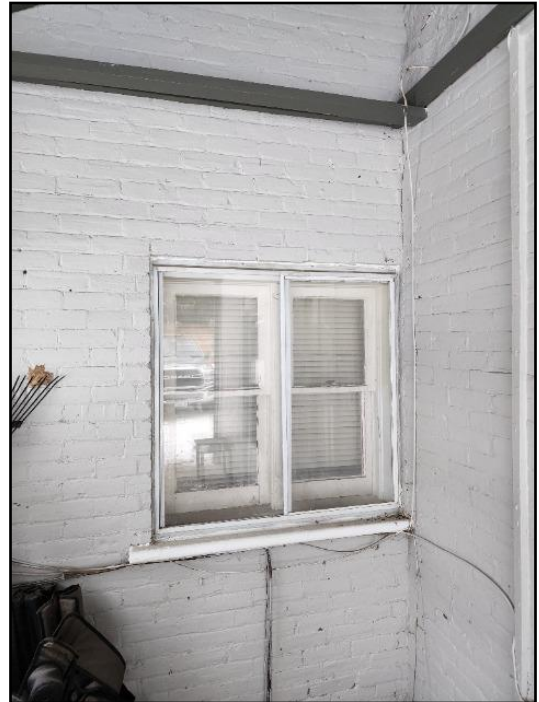
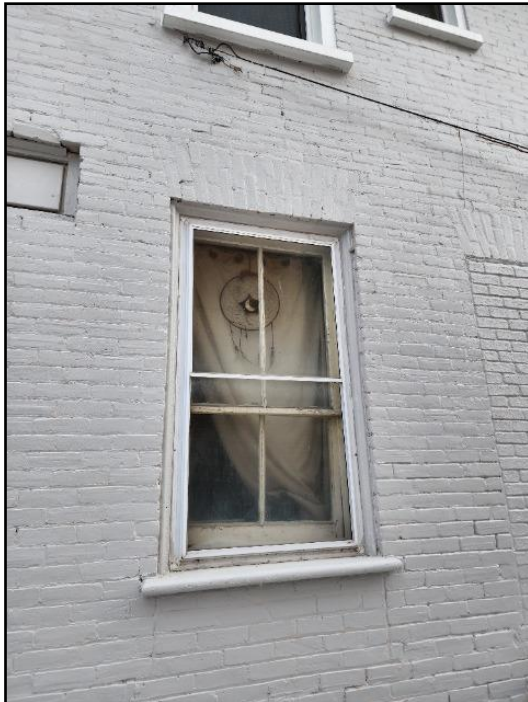
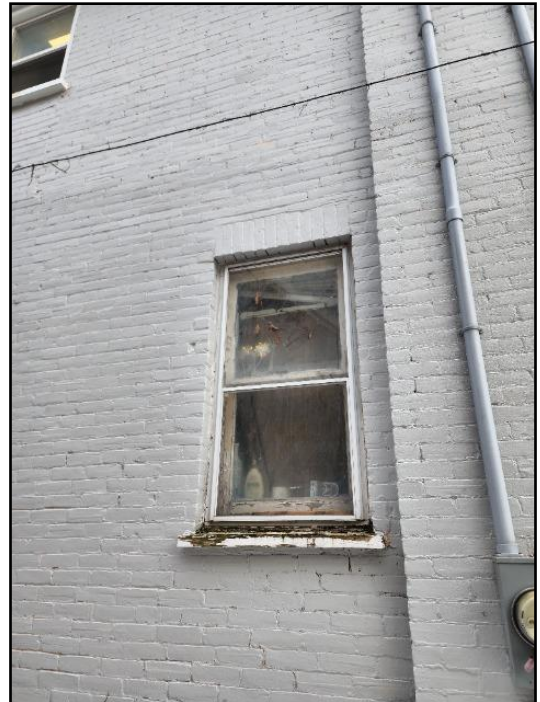
**3. Condition:** • Original lower quality units

**Implication(s):** Increased heating and cooling costs

**Location:** Various locations

6. Original lower quality units

**Task:** Upgrade

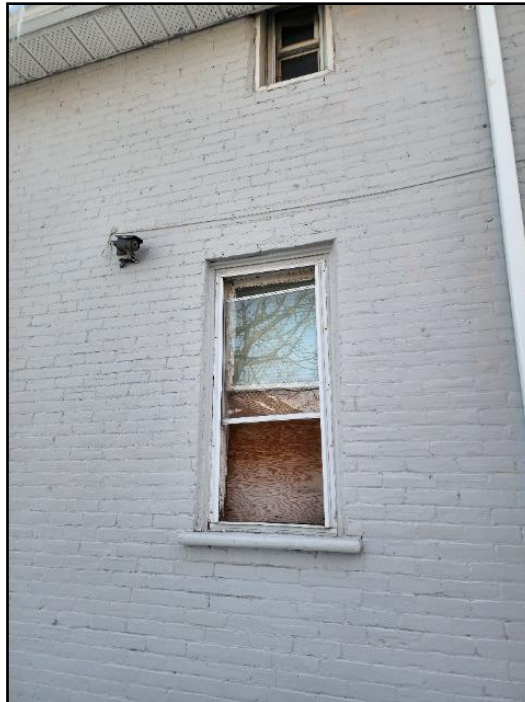
**4. Condition:** • Damaged

**Implication(s):** Chance of water damage to structure, finishes and contents | Material deterioration

10. *Damaged*

**Task:** Repair or replace

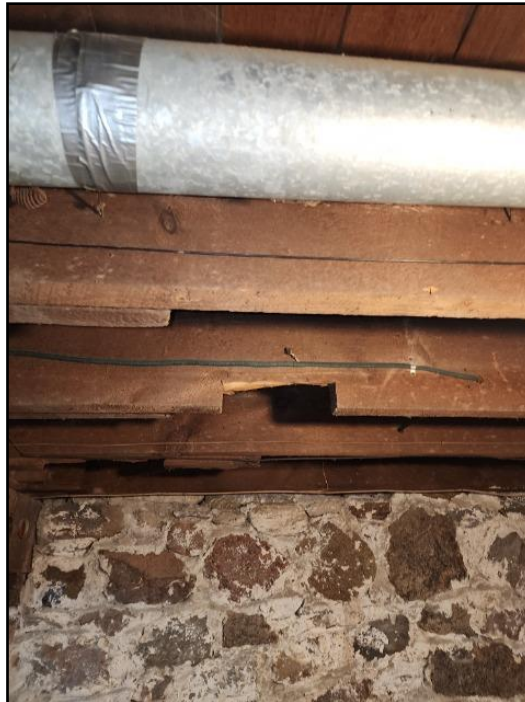
6. **Condition:** • Notches or holes

13. Notches or holes

**Task:** Repair

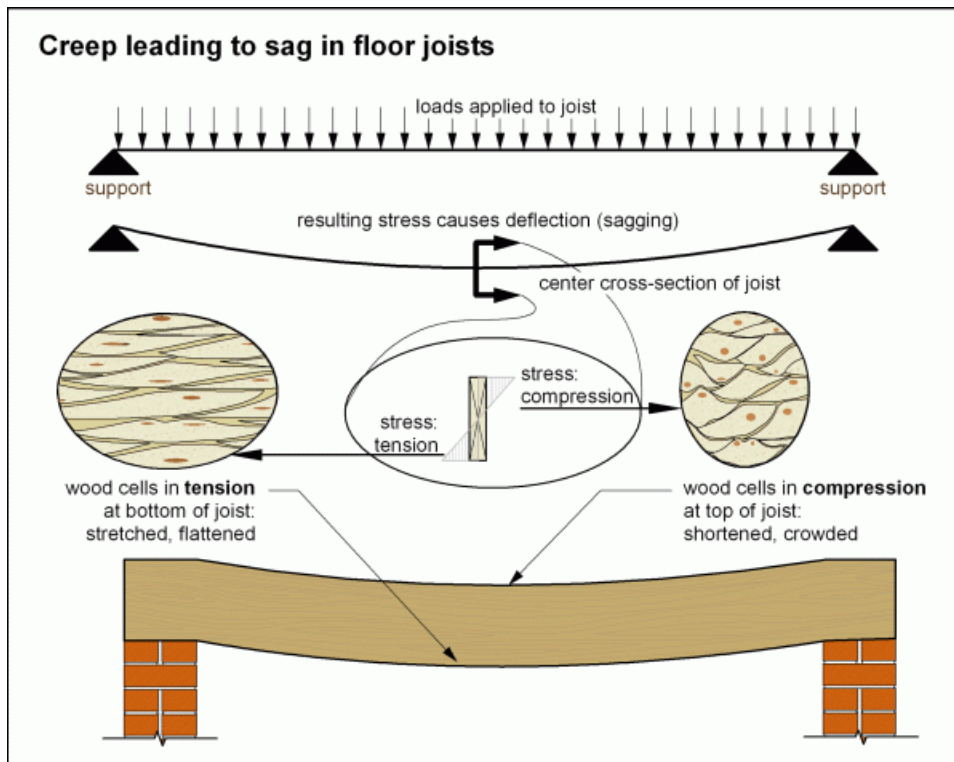
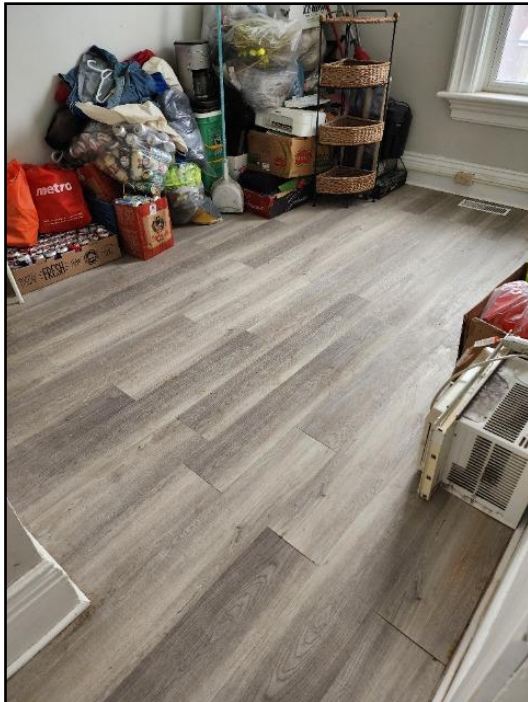
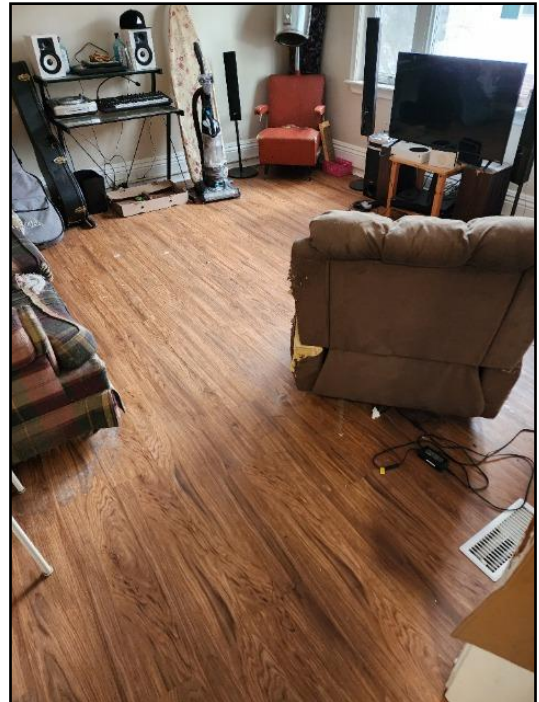
7. Condition: • Sag

14. Sag

Task: Monitor

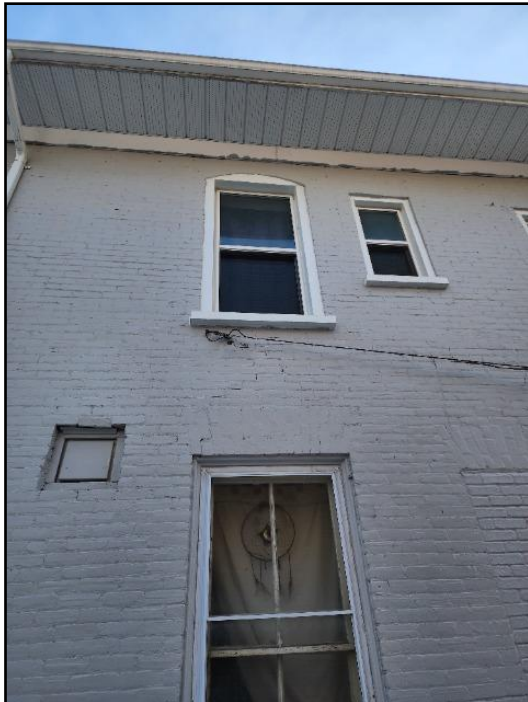
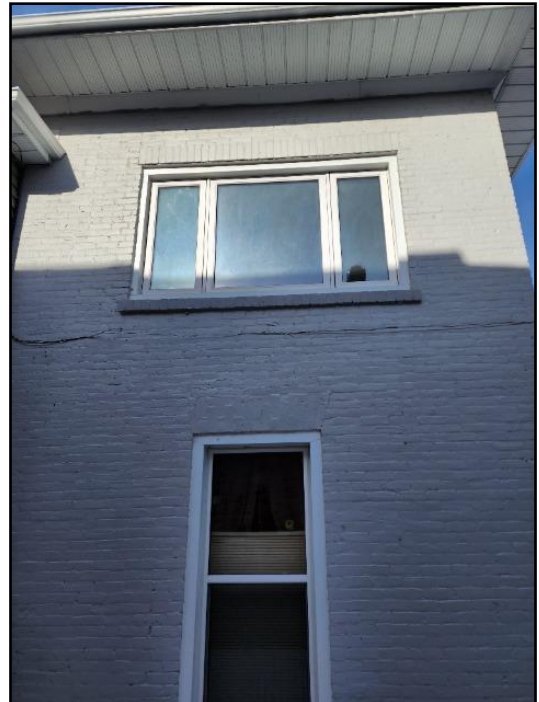
**8. Condition:** • Prior repairs

**Implication(s):** No implications exist for this condition

16. Prior repairs

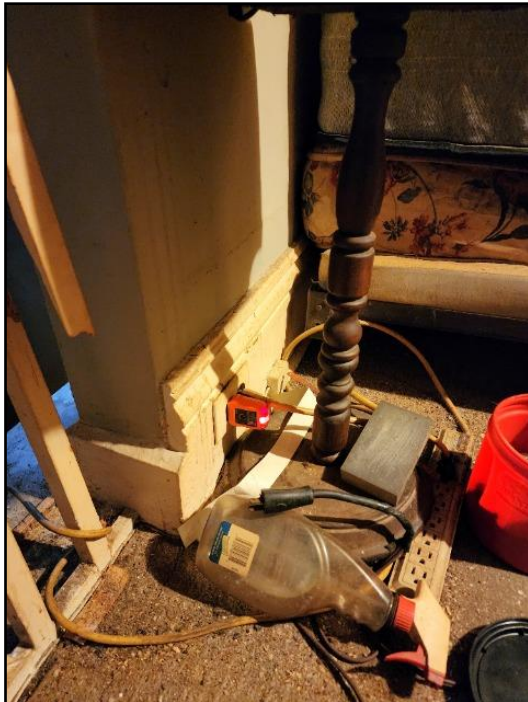
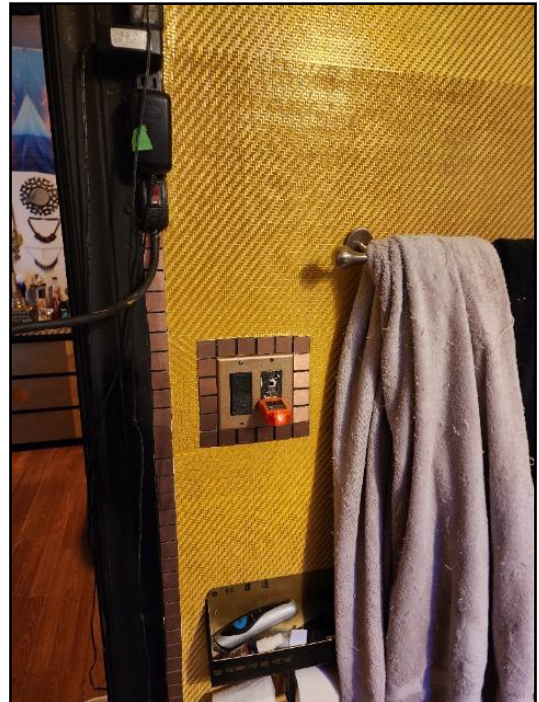
**10. Condition:** • Ungrounded

27. Ungrounded

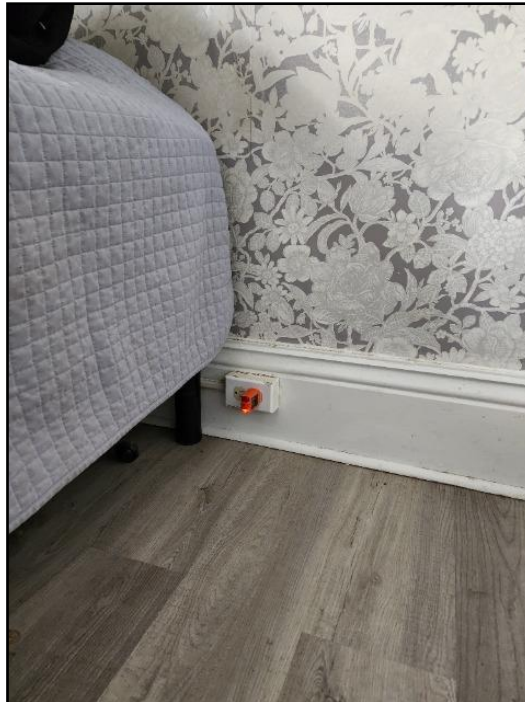
**11. Condition:** • Open neutral  
**Implication(s):** Electric shock  
**Location:** Unit #4  
**Task:** Repair  
**Time:** As soon as is practicable  
**Cost:** Minor

29. Open neutral

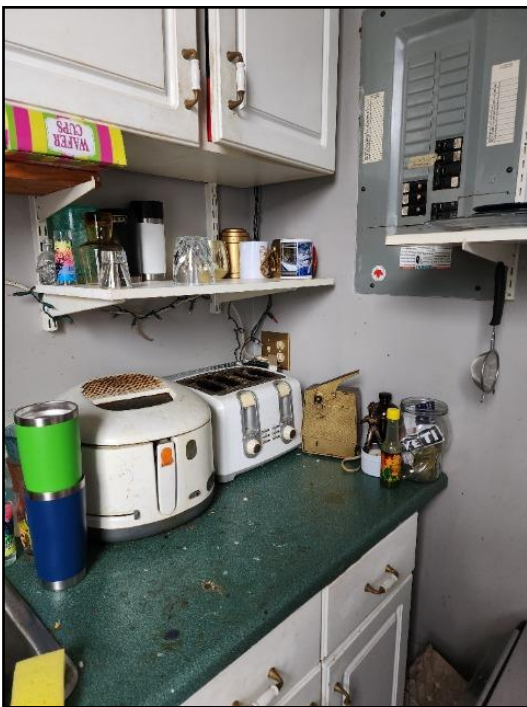
**12. Condition:** • No GFCI/GFI (Ground Fault Circuit Interrupter)

Although not a deficiency in a building of this age, safety may be improved by upgrading this receptacle

30. No GFCI/GFI (Ground Fault Circuit...

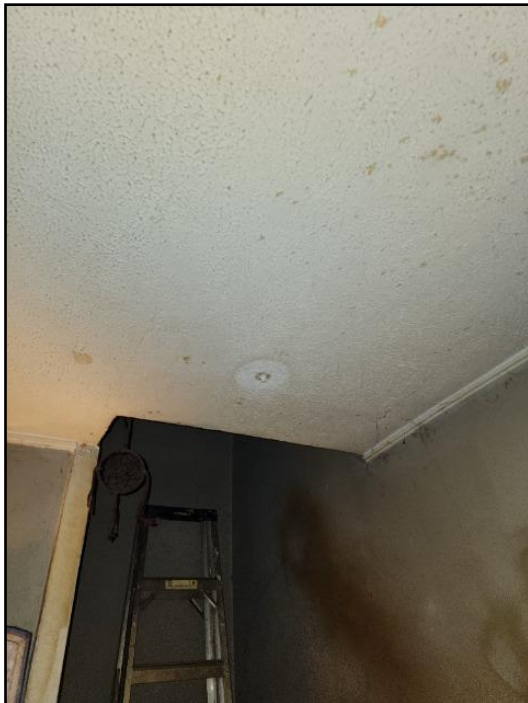
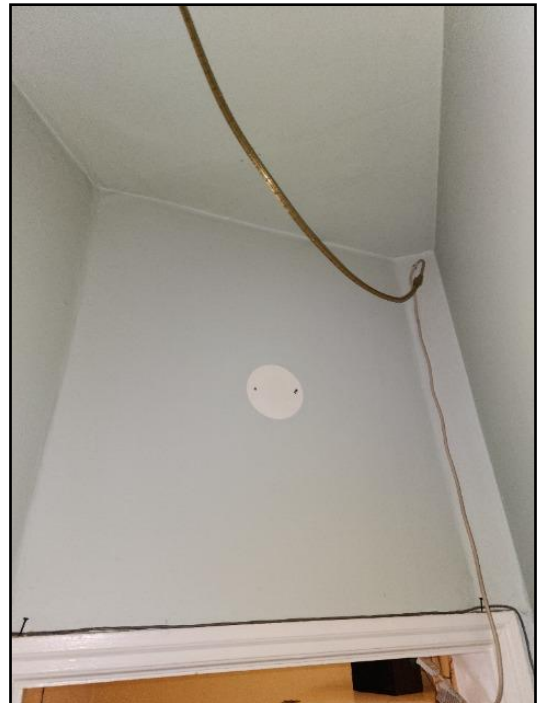
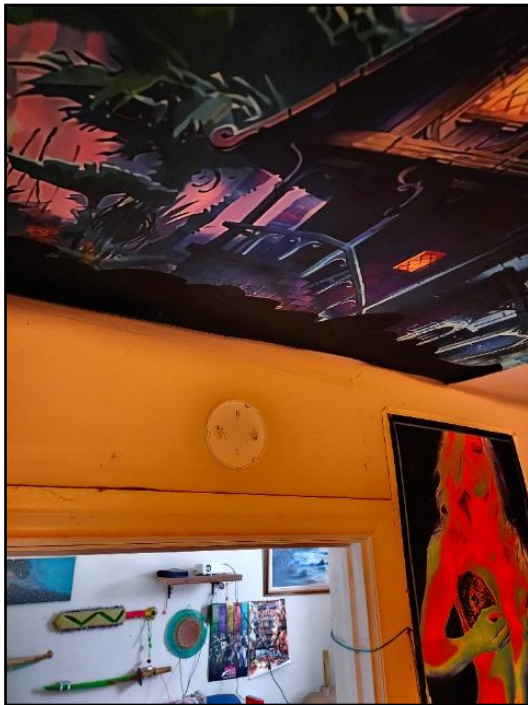
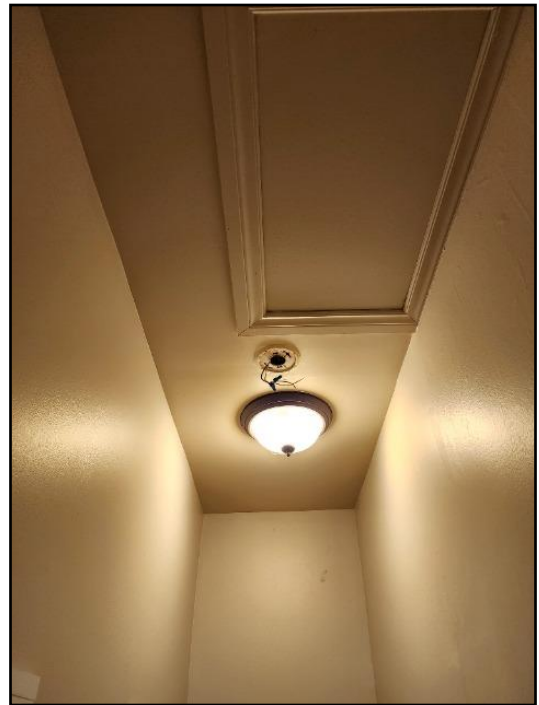
- 13. Condition: • Missing
- Implication(s): Safety issue
- Location: Various locations

**Task:** Replace

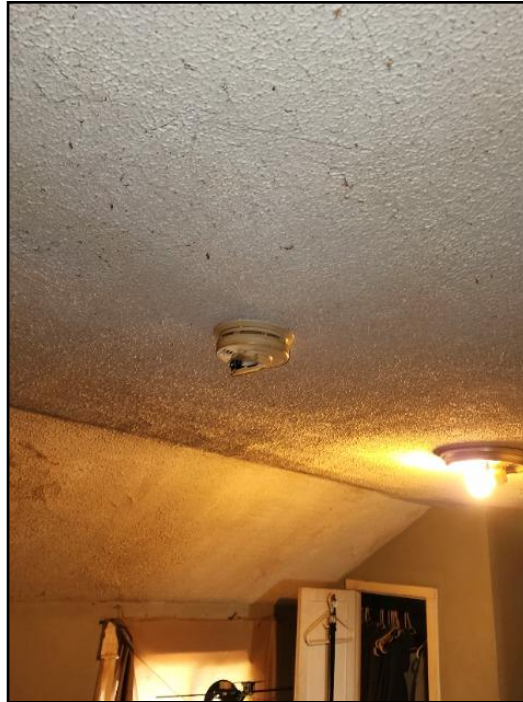
14. **Condition:** • More than 10 years old

**Implication(s):** Life safety hazard

35. *More than 10 years old*

**Task:** Replace

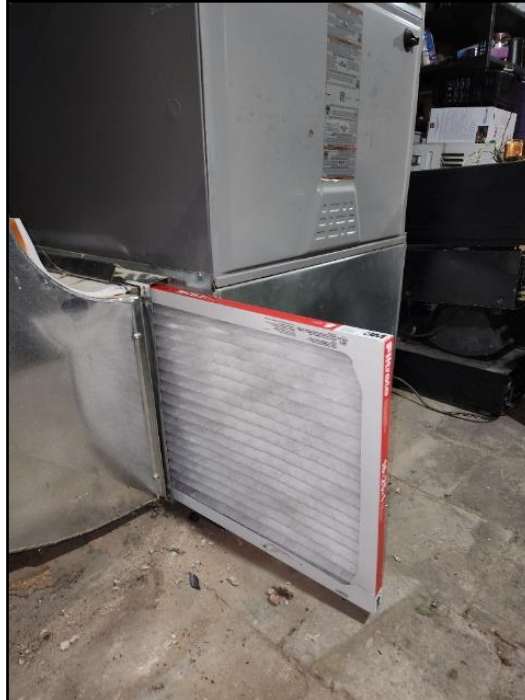
**16. Condition:** • Replace - regular maintenance

**45.** *Replace - regular maintenance*

**Task:** Replace - regular maintenance

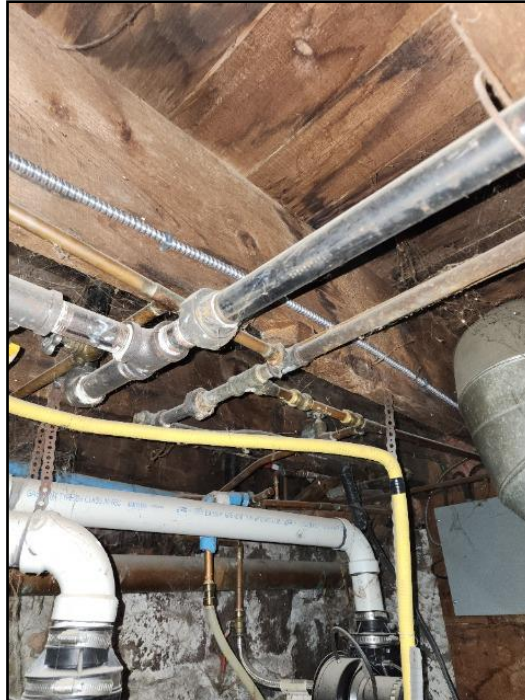
**18. Condition:** • Galvanized steel

50. Galvanized steel

**Task:** Replace

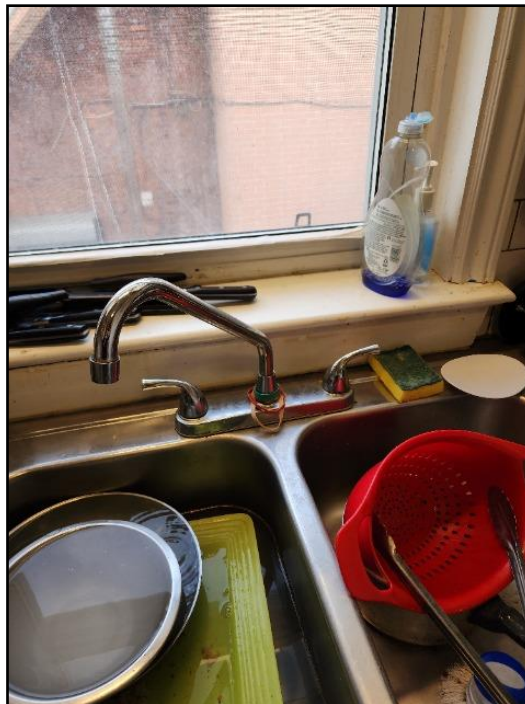
**19. Condition:** • Loose

**Implication(s):** Equipment failure. Water damage to Finishes, contents and structure

51. Loose

**Task:** Repair

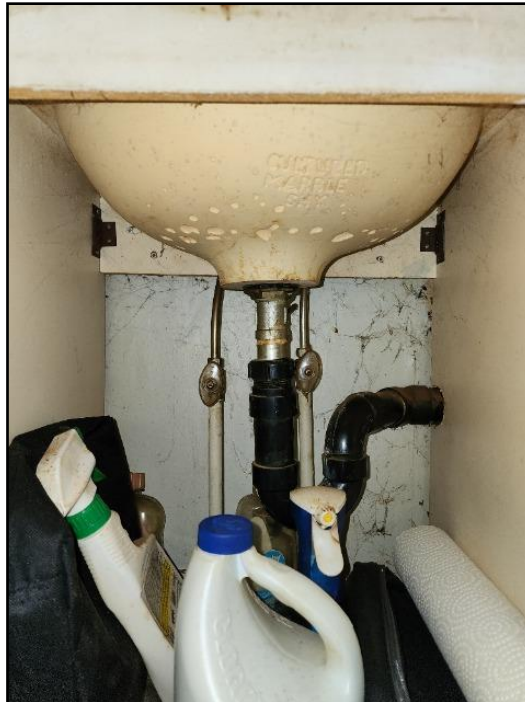
**20. Condition:** • Leak

**Implication(s):** Chance of water damage to structure, finishes and contents.

52. Leak

**Task:** Repair

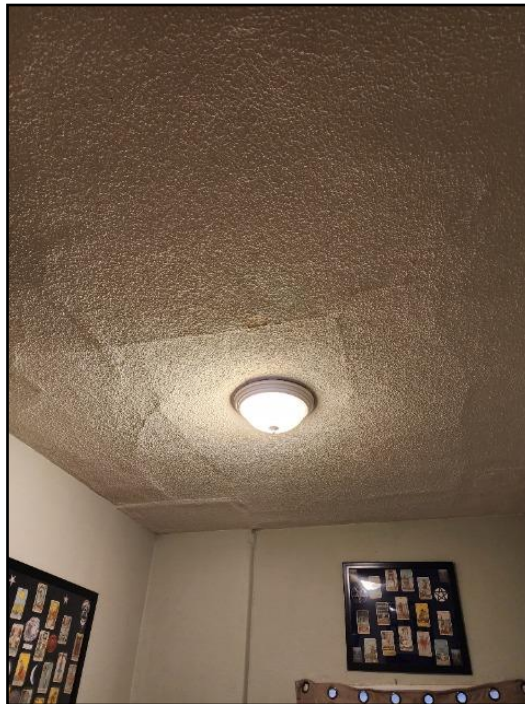
**22. Condition:** • Damage

**Implication(s):** Damage due to falling materials

**53. Damage**

**Task:** Repair or replace

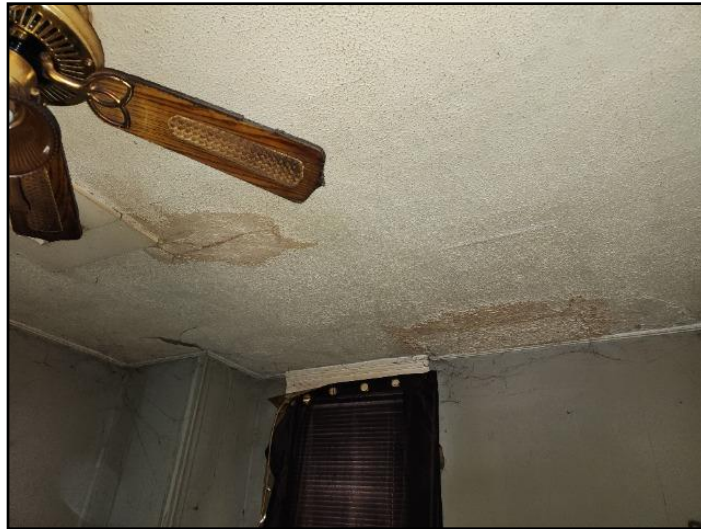
**23. Condition:** • Water damage

**Implication(s):** Chance of water damage to structure, finishes and contents | Material deterioration

54. Water damage

**Task:** Repair

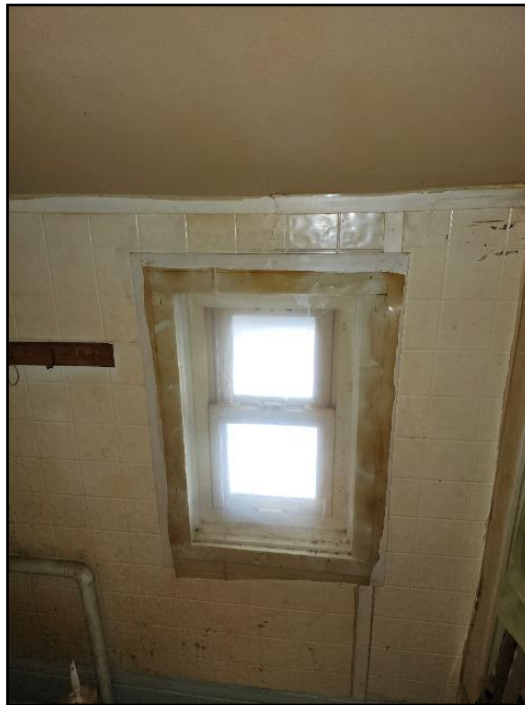
24. Condition: • Inoperative

55. Inoperative

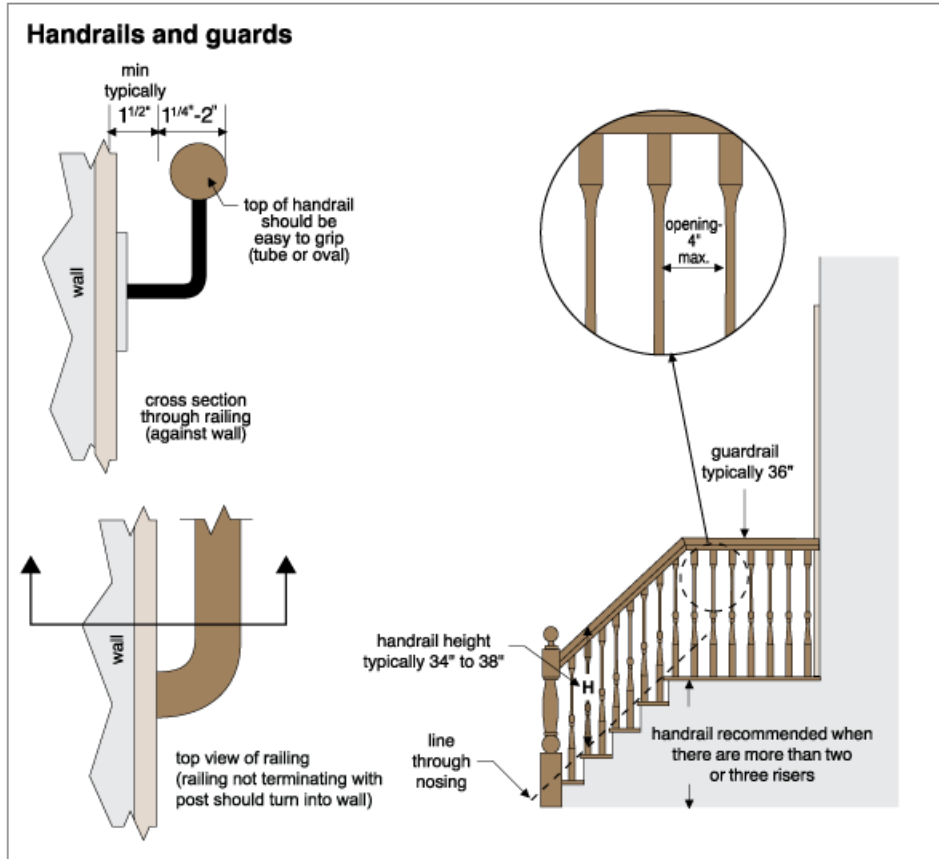
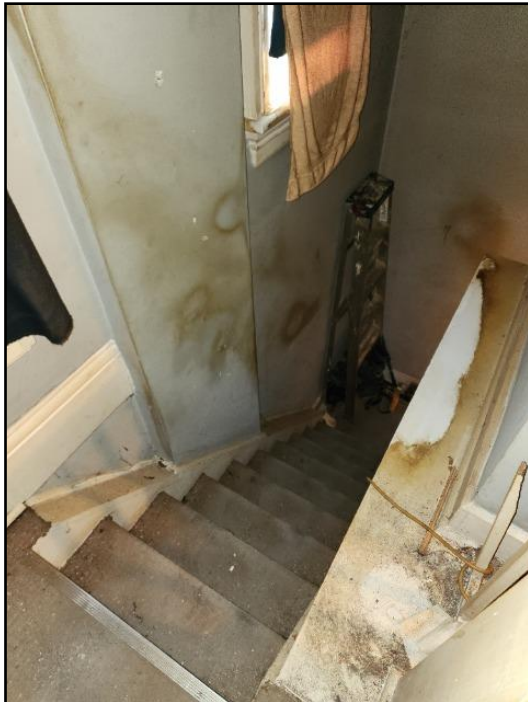
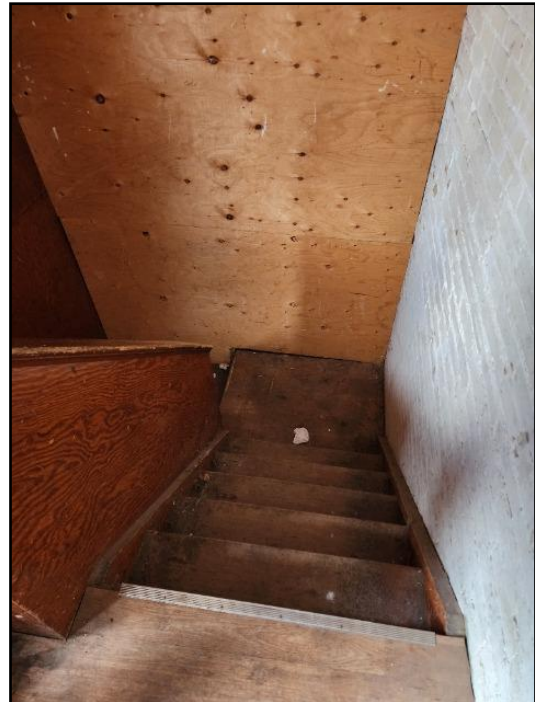
25. Condition: • Missing

**Implication(s):** Fall hazard

56. Missing

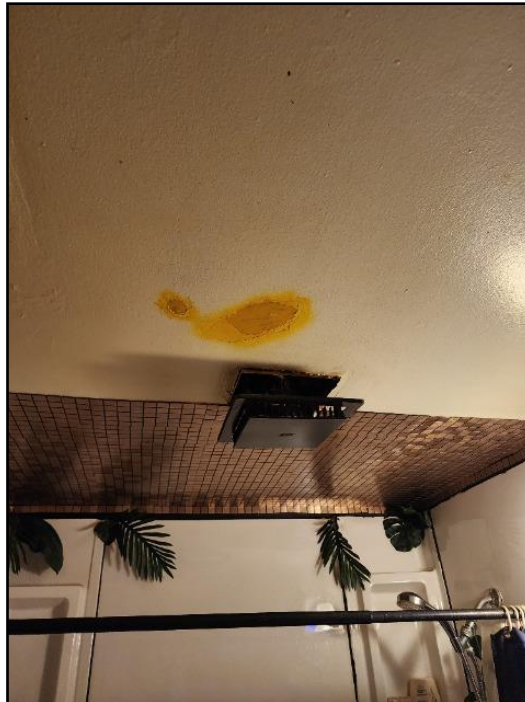
**26. Condition:** • Inoperative

**Implication(s):** Chance of condensation damage to finishes and/or structure

58. Inoperative

**Task:** Repair or replace
