# INSPECTION REPORT

For the Property at:  
**18 BAYVIEW DRIVE, SHADY ACRES**  
KEENE, ON

Prepared for: TEAM VANRAHAN  
Inspection Date: Tuesday, July 2, 2024  
Prepared by: David Sharman

RE: Report No. 4876  
18 Bayview Drive, Shady Acres  
Keene, ON

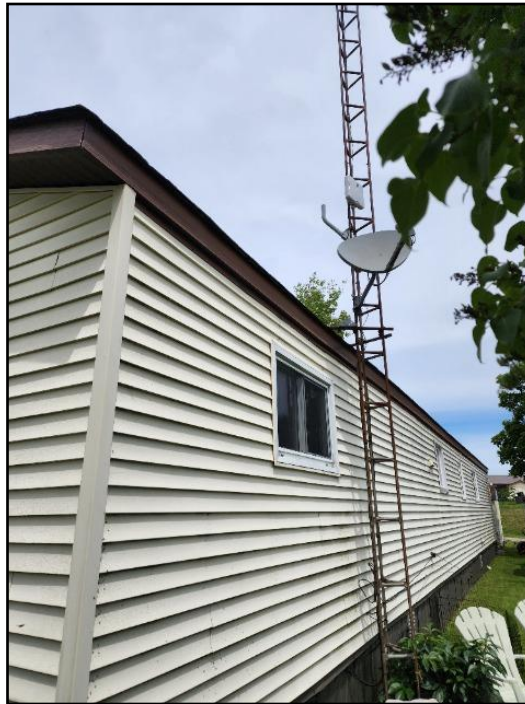
**2. Condition:** • Missing

**Implication(s):** Chance of water damage to structure, finishes and contents

**Location:** Rear elevation

4. Missing

**Task:** Provide

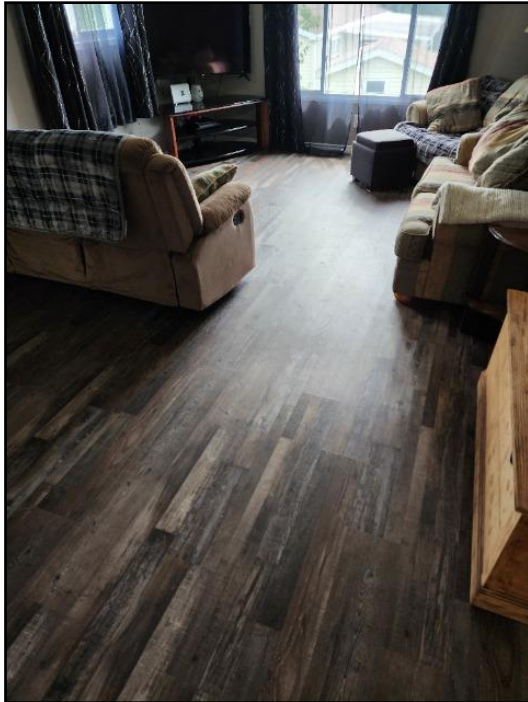
4. **Condition:** • Slope

**Implication(s):** Weekend structure, chance of continued movement

**Location:** Various locations

7. Slope

**Task:** Monitor

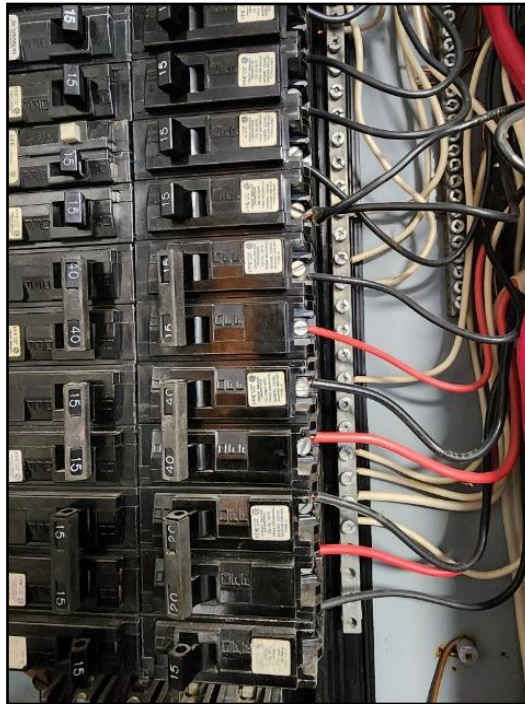
**5. Condition:** • Breakers too big

40 Amp breakers on a 10 gauge branch circuit wire. Although not a deficiency in a panel of this age, safety may be improved by replacing this breaker.

**Implication(s):** Equipment overheating | Fire hazard

**Location:** Distribution panel

11. Breakers too big

**Task:** Improve

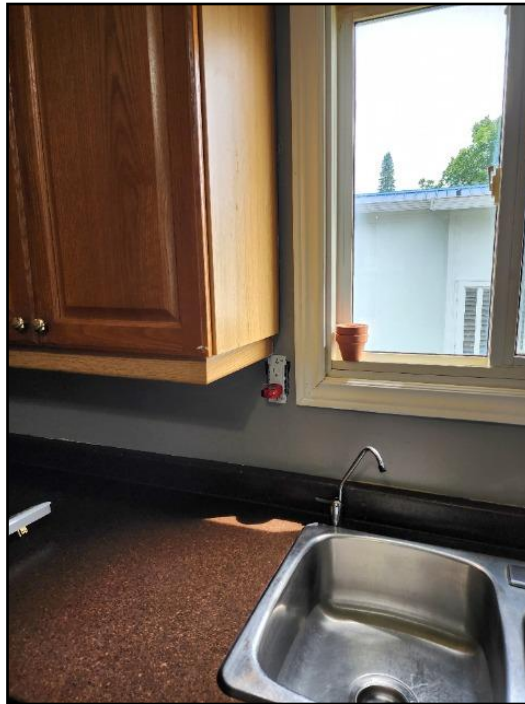
**6. Condition:** • Inoperative

**Implication(s):** Equipment inoperative

**Location:** Kitchen

12. Inoperative

**Task:** Replace

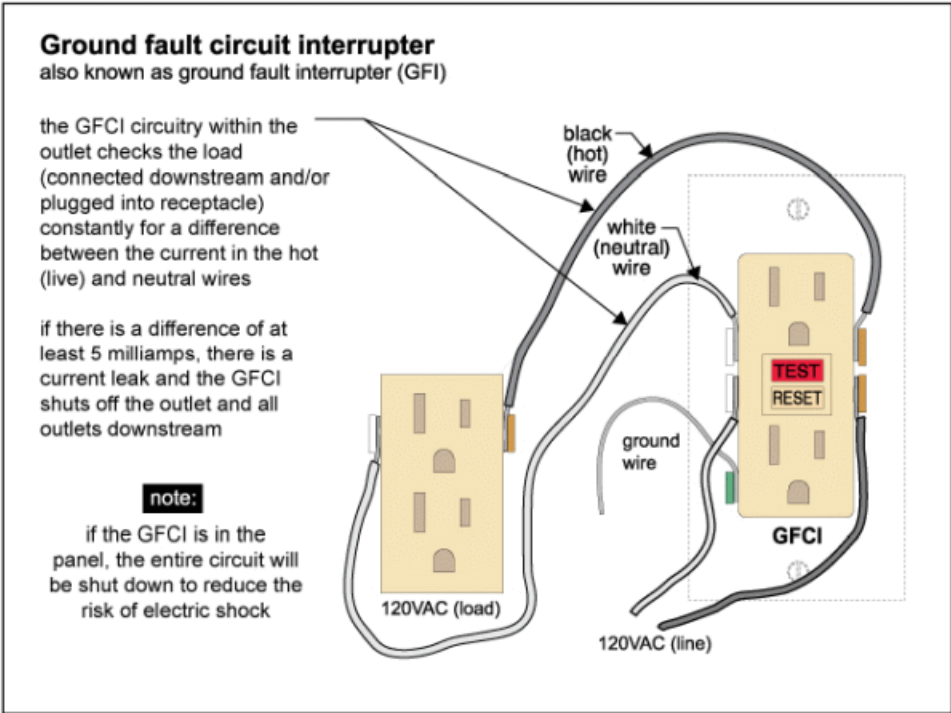
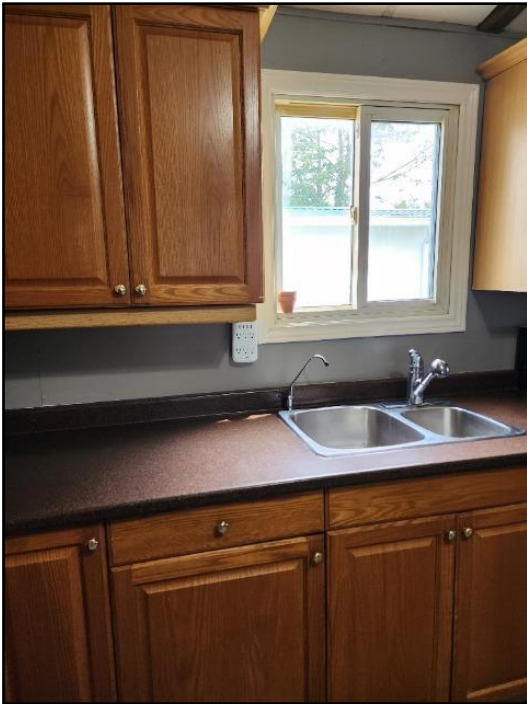
**7. Condition:** • No GFCI/GFI (Ground Fault Circuit Interrupter)

Although not a deficiency in a building of this age, safety may be improved by upgrading this receptacle

**Implication(s):** Electric shock

**Location:** Kitchen

13. No GFCI/GFI (Ground Fault Circuit...

**Task:** Upgrade

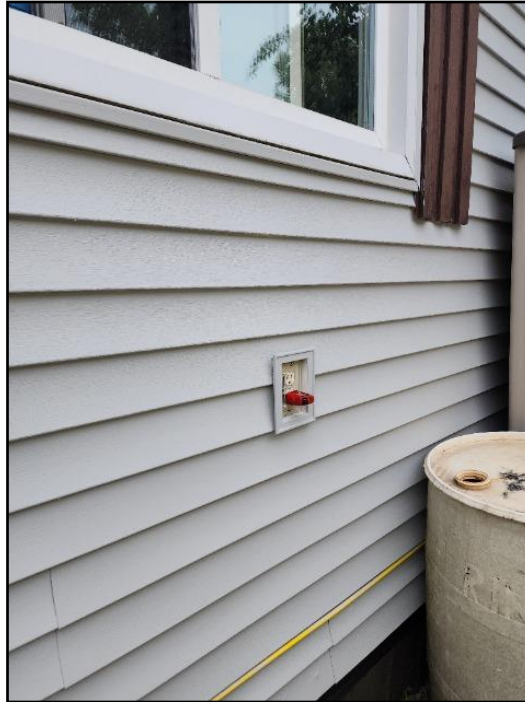
**8. Condition:** • No GFCI/GFI (Ground Fault Circuit Interrupter)

**Implication(s):** Electric shock

**Location:** Exterior wall

14. No GFCI/GFI (Ground Fault Circuit...

**Task:** Provide

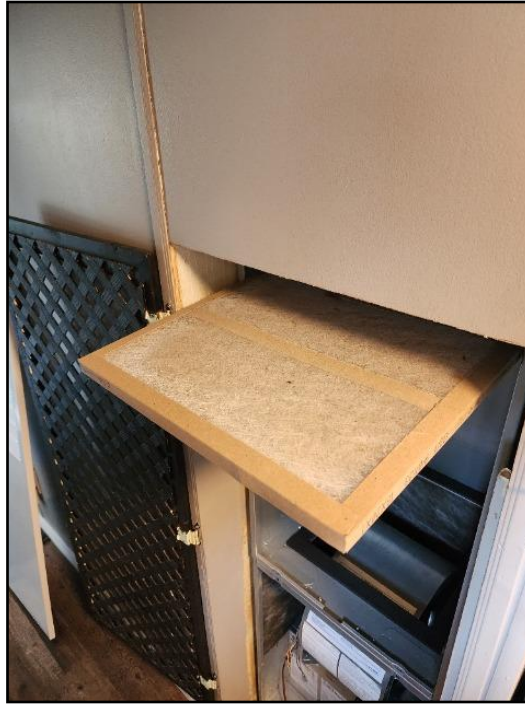
**9. Condition:** • Replace - regular maintenance

**Implication(s):** Increased heating & maintenance costs, Reduced comfort

**Location:** Cold air return

17. Replace - regular maintenance

**Task:** Replace - regular maintenance

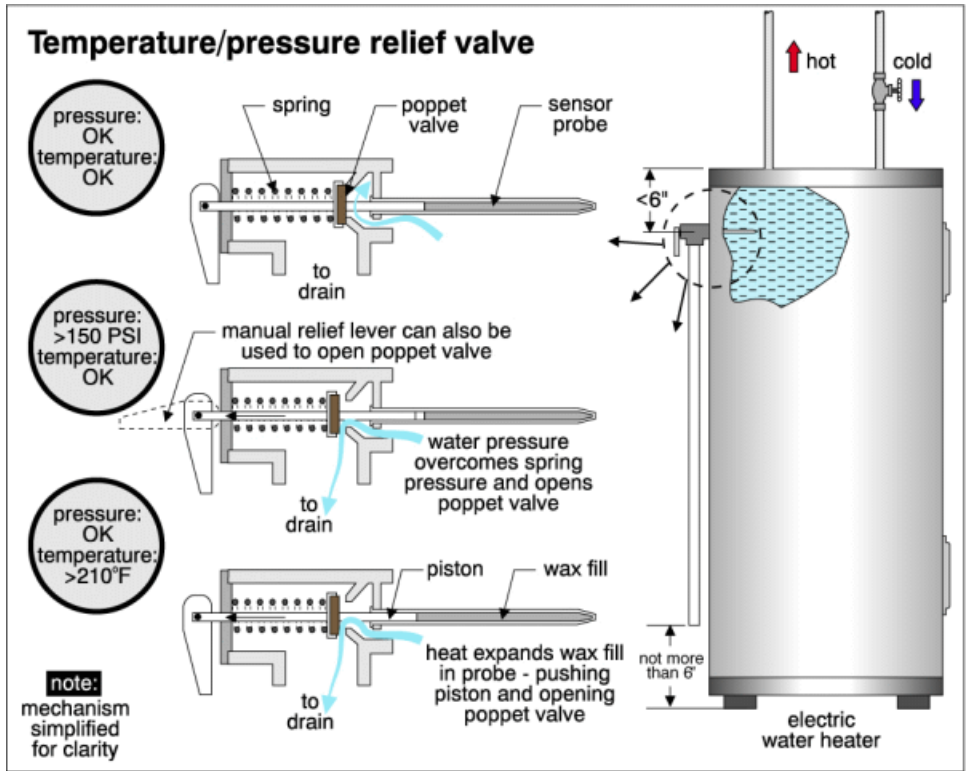
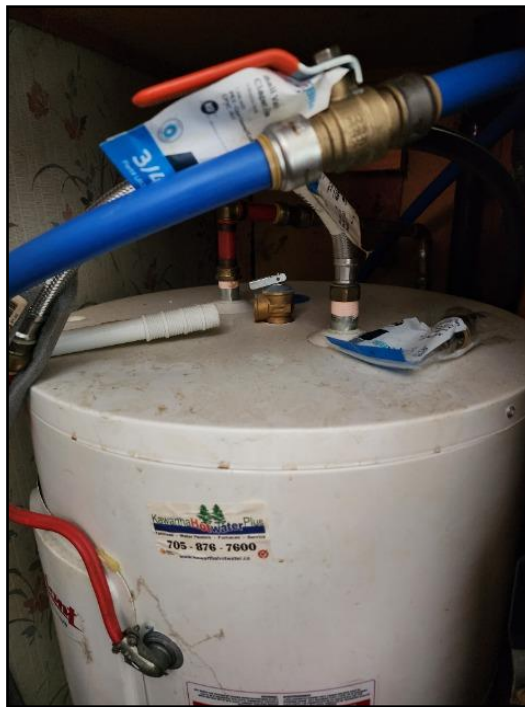
**12. Condition:** • Discharge tube missing

**Implication(s):** Scalding. Possible water damage to finishes, storage and structure

22. Discharge tube disconnected

**Task:** Repair

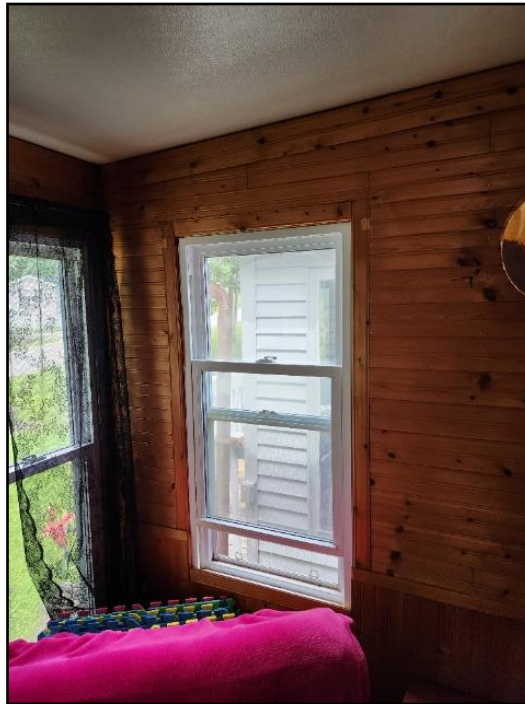
**WINDOWS \ Glass (glazing)**  
**13. Condition:** • Lost seal on double glazing  
**Implication(s):** Shortened life expectancy of material  
**Location:** Addition  
**Task:** Repair or replace  
**Time:** Discretionary  
**Cost:** Minor

23. Lost seal on double glazing

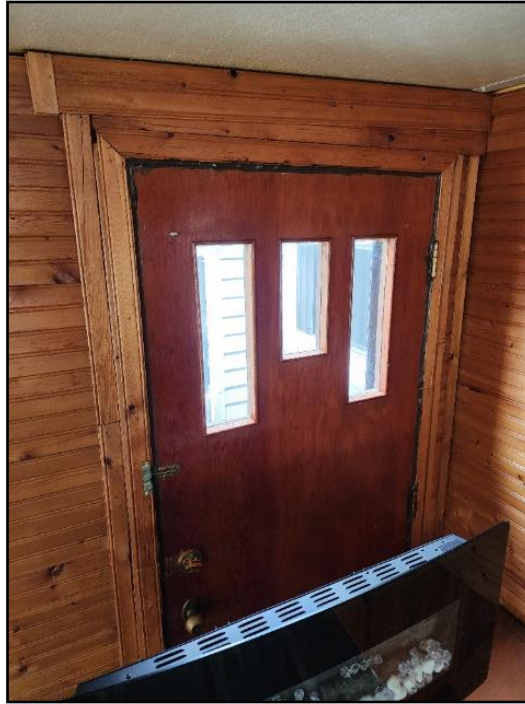
**14. Condition:** • Inoperable

24. Inoperable
