# INSPECTION REPORT

For the Property at:  
**64 REGENT STREET**  
LAKEFIELD, ON

Prepared for: TEAM VANRAHAN  
Inspection Date: Thursday, June 15, 2023  
Prepared by: David Sharman

RE: Report No. 4364  
64 Regent Street  
Lakefield, ON

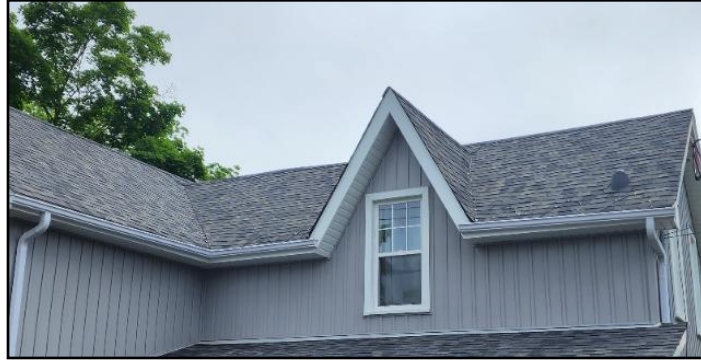
**1. Condition:** • Vulnerable to ice damming

**Implication(s):** Chance of water damage to structure, finishes and contents

**Location:** Front elevation

**4. Vulnerable to ice damming**

**Task:** Monitor

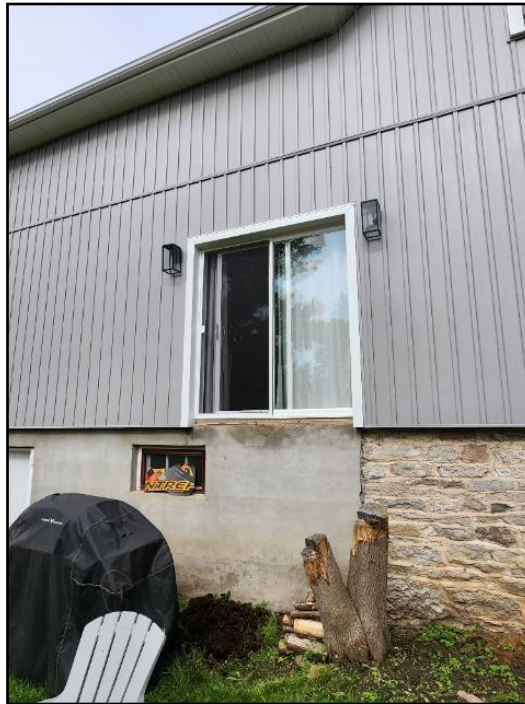
**2. Condition:** • Stairs and landing missing

**Implication(s):** Fall hazard

**Location:** Rear elevation

5. *Stairs and landing missing*

**Task:** Provide

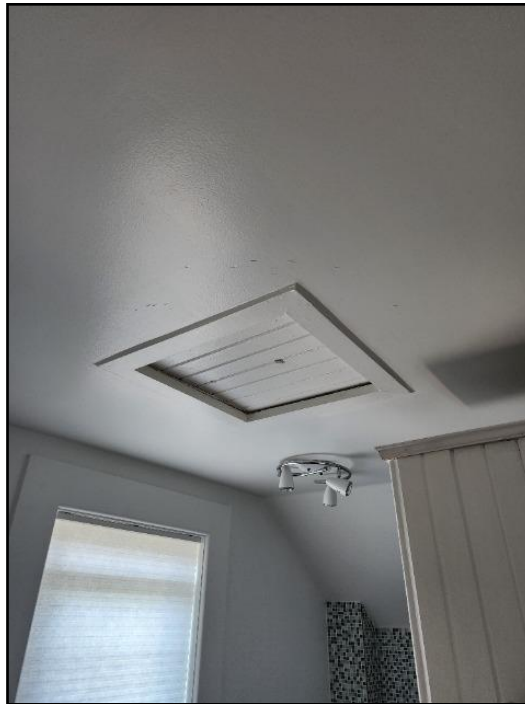
- Not entered
- Attic hatch covered in loose fill cellulose insulation

6. Not entered

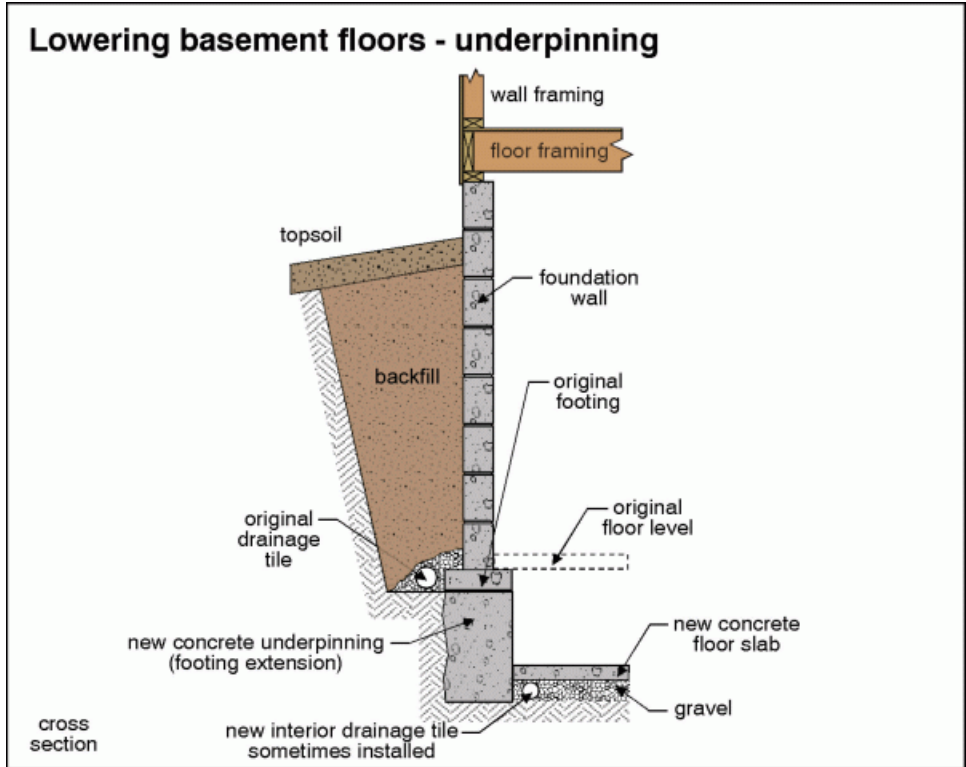
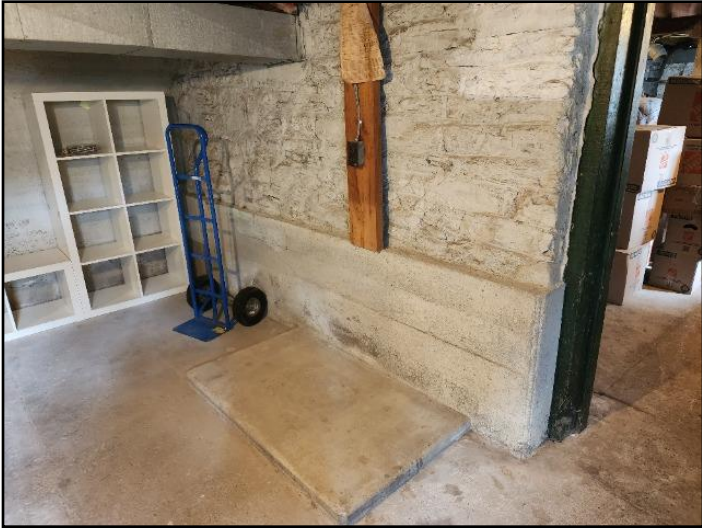
**3. Condition:** • Basement lowered

**Implication(s):** Chance of structural movement

**Location:** Various locations

7. Basement lowered

**Task:** Monitor

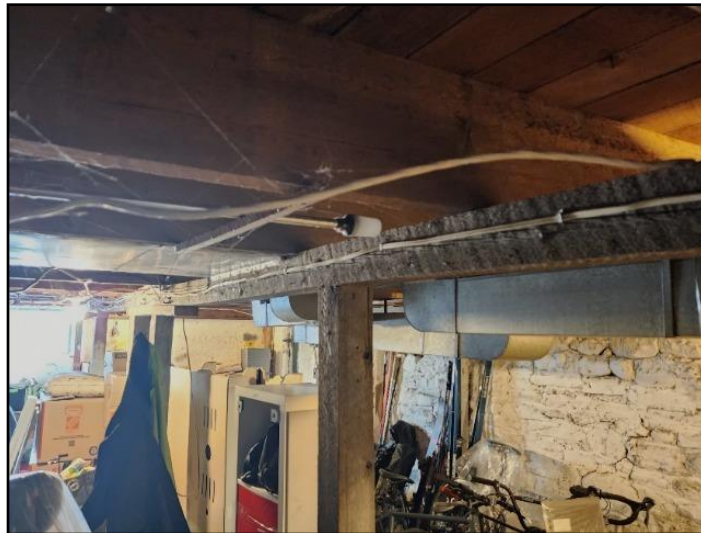
### **4. Condition:** • Sag

The sag may be indicative of both the beam & columns marginal size

**Implication(s):** Weakened structure | Chance of structural movement

**Location:** Basement

8. Sag

**Task:** Repair or replace

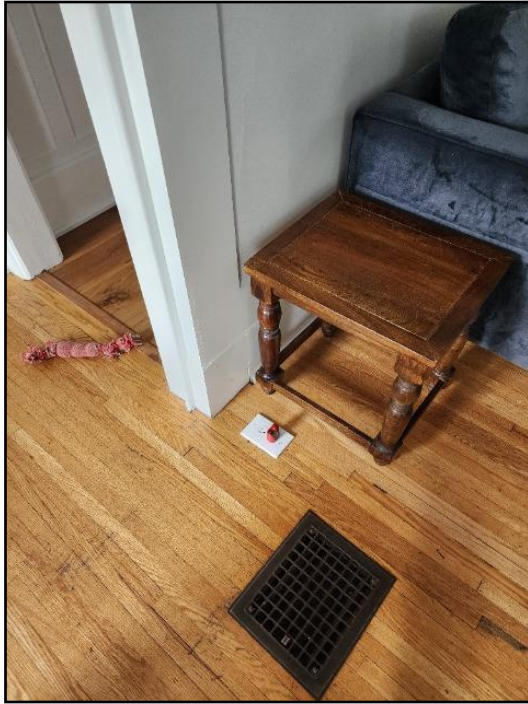
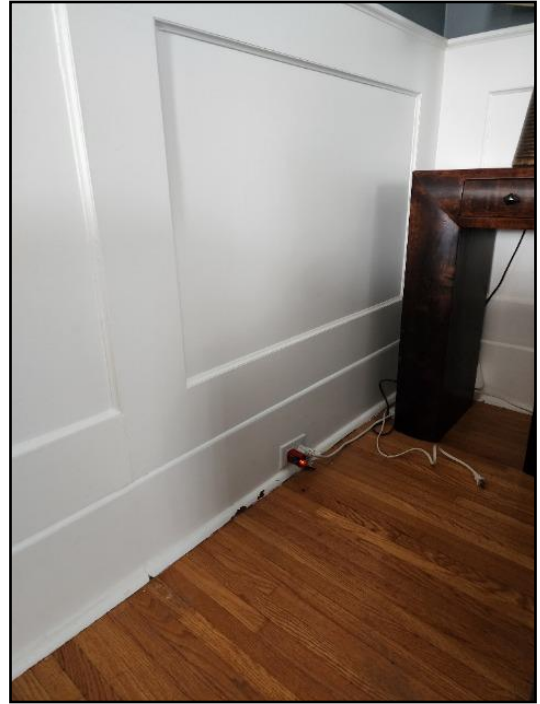
**DISTRIBUTION SYSTEM \ Outlets (receptacles)**  
**6. Condition:** • Ungrounded  
Although ungrounded service may be typical in a house of this age, safety may be improved by upgrading this receptacle.  
**Implication(s):** Electric shock  
**Location:** Living room  
**Task:** Upgrade  
**Time:** Discretionary  
**Cost:** Minor

11. Ungrounded

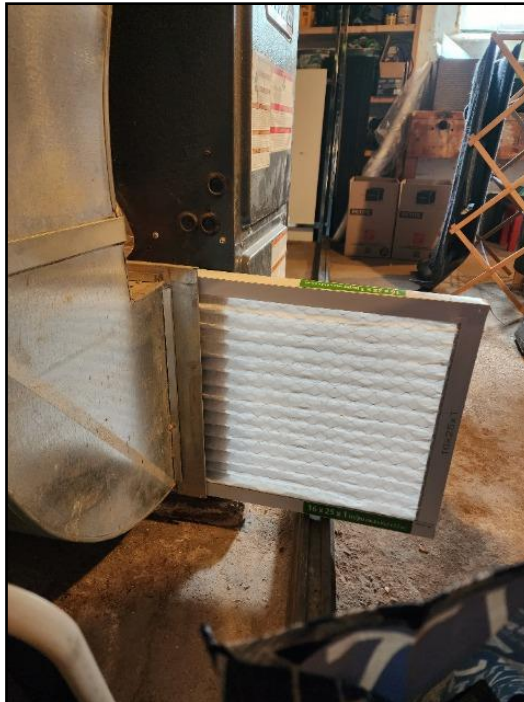
**8. Condition:** • Replace - regular maintenance

**Implication(s):** Increased heating & maintenance costs, Reduced comfort

**Location:** Cold air return

19. Replace - regular maintenance

**Task:** Replace

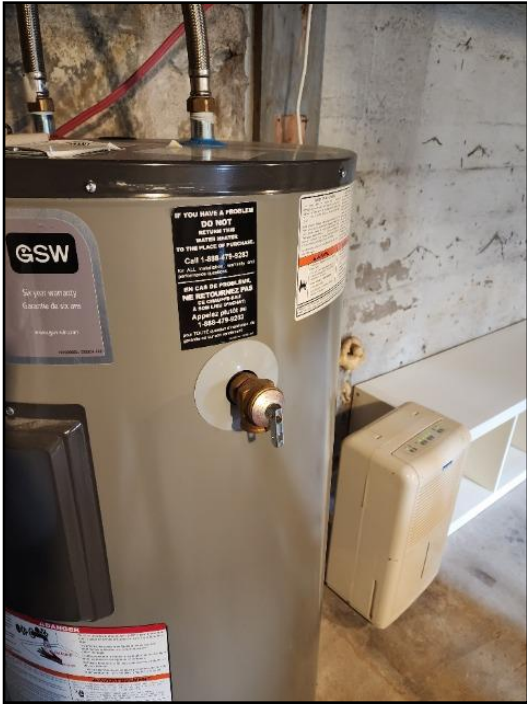
- WATER HEATER \ Temperature/pressure relief (TPR) valve**
- 11. Condition:** • Discharge tube missing
- Implication(s):** Scalding. Possible water damage to finishes, storage and structure
- Location:** Utility room
- Task:** Provide
- Time:** Discretionary
- Cost:** Minor

26. Discharge tube missing

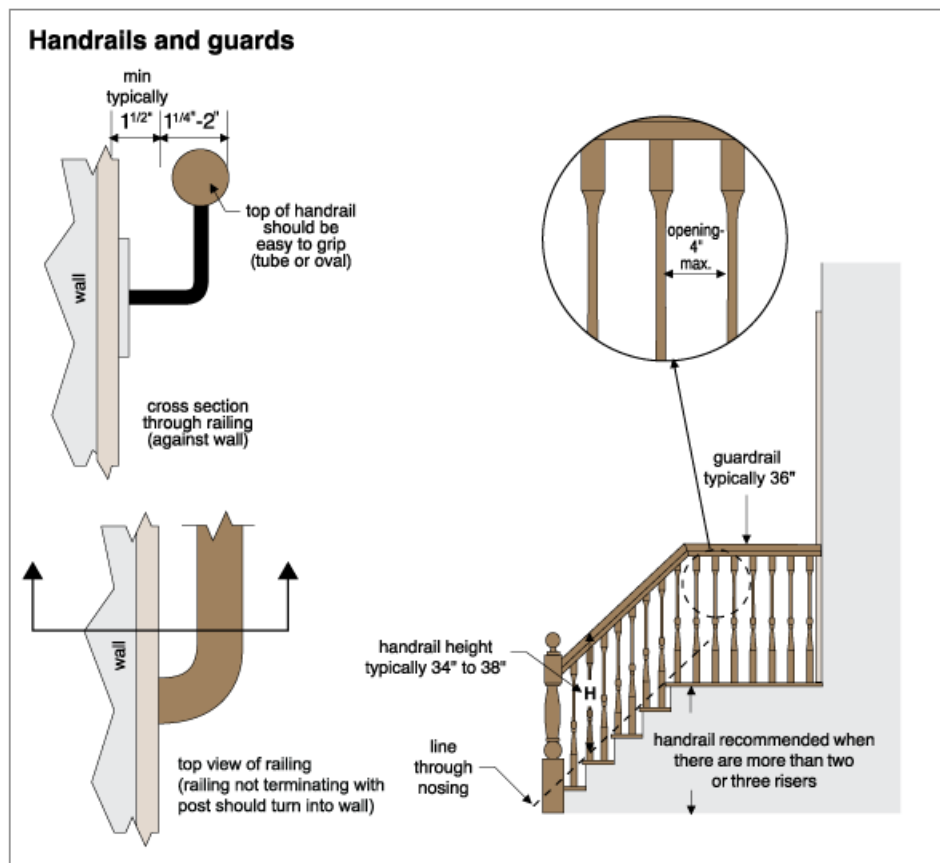
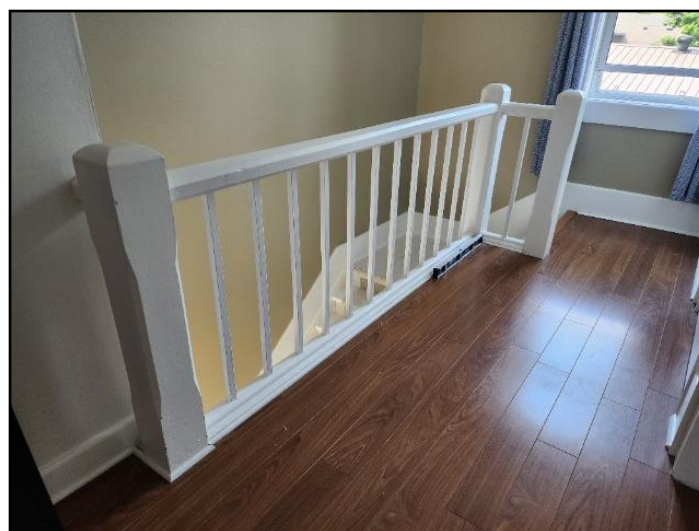
**12. Condition:** • Too far apart

**Implication(s):** Fall hazard

27. Too far apart

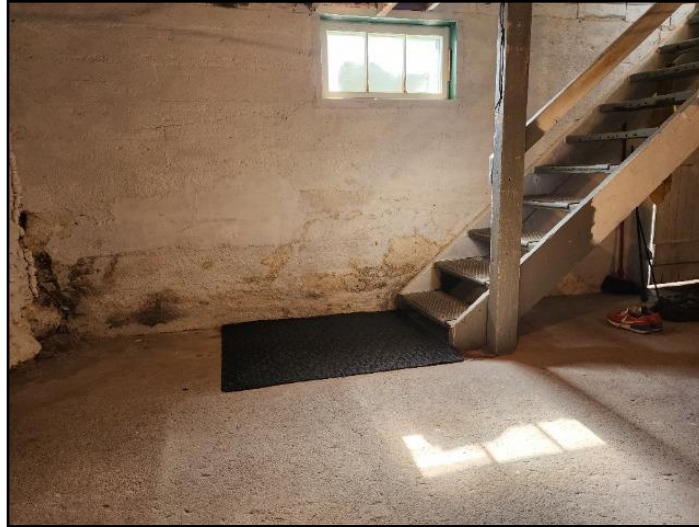
13. Condition: • Crumbling/spalling masonry, concrete or plaster

**Implication(s):** Chance of water damage to structure, finishes and contents | Material deterioration

28. Crumbling/spalling masonry, concrete or...

**Task:** Monitor

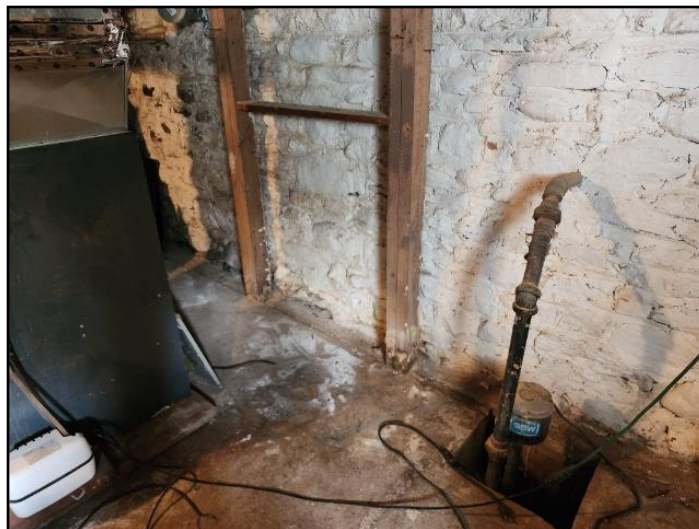
**14. Condition:** • Stains

**Implication(s):** Chance of water damage to structure, finishes and contents

29. Stains

**Task:** Monitor
