INSPECTION REPORT

For the Property at:
136 PARKDALE AVENUE
PETERBOROUGH, ON K9L 1K4

Prepared for: TEAM VANRAHAN
Inspection Date: Wednesday, January 15, 2025
Prepared by: David Sharman

RE: Report No. 5123
136 Parkdale Avenue
Peterborough, ON
K9L 1K4

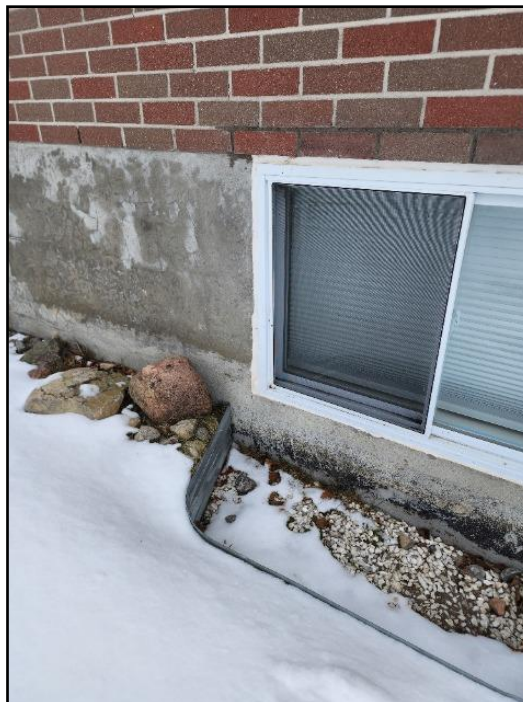
3. Condition: • Typical minor cracks

Implication(s): Material deterioration

Location: Front left corner

1. Typical minor cracks

Task: Monitor

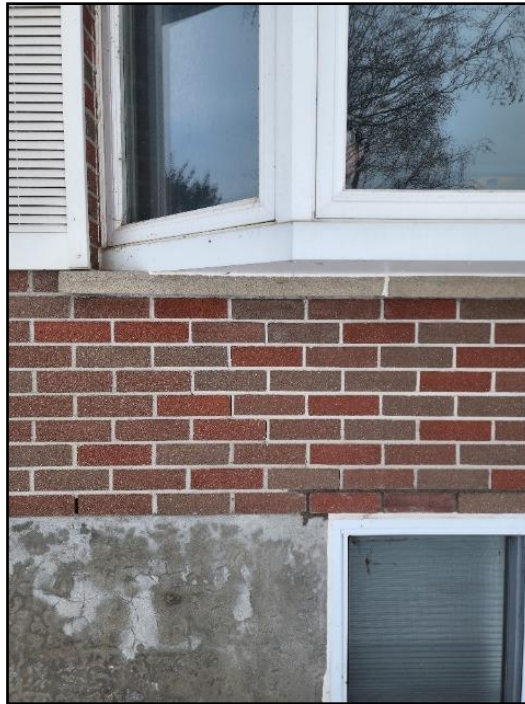
5. **Condition:** • Typical minor cracks

Implication(s): Chance of frost damage & material deterioration

Location: Rear left corner

2. *Typical minor cracks*

Task: Repair

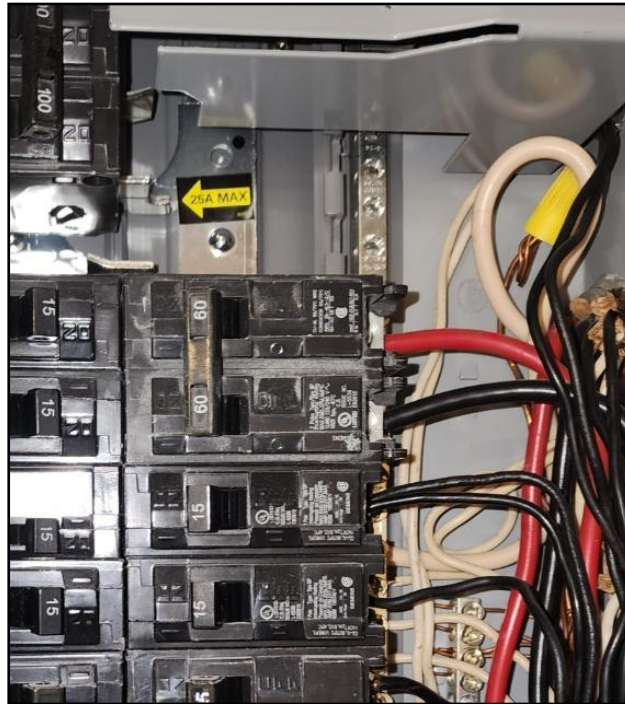
6. Condition: • Breakers too big

60 Amp breakers on a 8 gauge branch circuit wire

Implication(s): Equipment overheating | Fire hazard

6. Breakers too big

Task: Correct

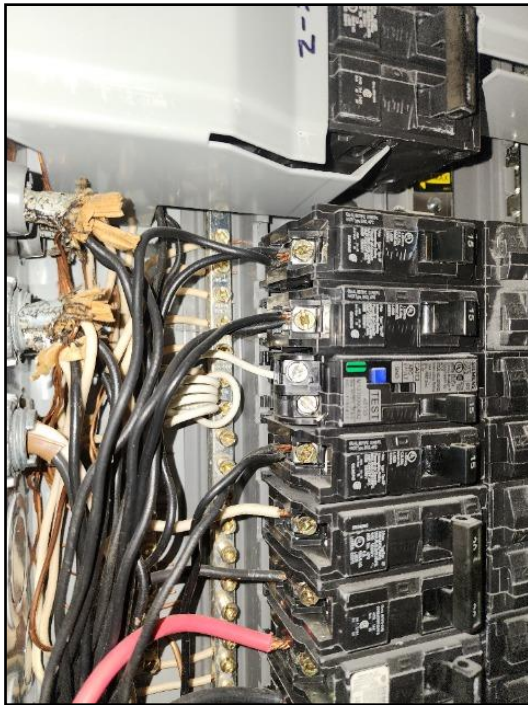
7. Condition: • Double taps

Implication(s): Fire hazard

7. Double taps

Task: Correct

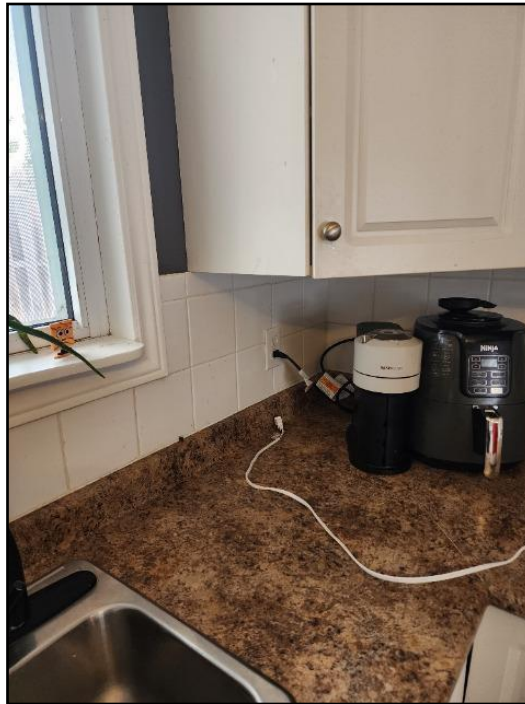
8. Condition: • No GFCI/GFI (Ground Fault Circuit Interrupter)

Although not a deficiency in a home of this age, safety may be improved by upgrading this receptacle.

Implication(s): Electric shock

9. No GFCI/GFI (Ground Fault Circuit...

Task: Upgrade

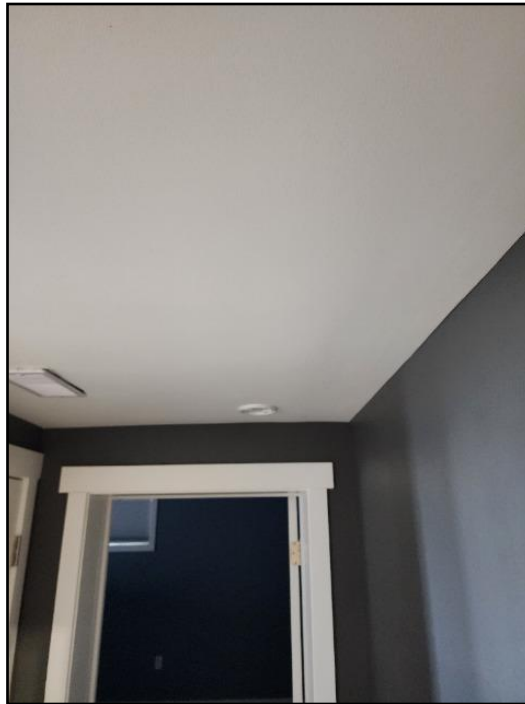
10. Condition: • Missing

Implication(s): Safety issue

10. Missing

Task: Replace

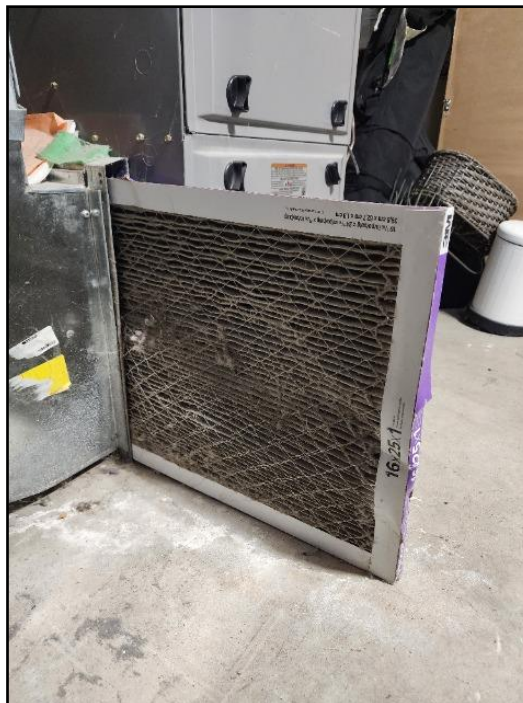
12. Condition: • Replace - regular maintenance

Implication(s): Increased heating & maintenance costs, Reduced comfort

17. Replace - regular maintenance

Task: Replace - regular maintenance

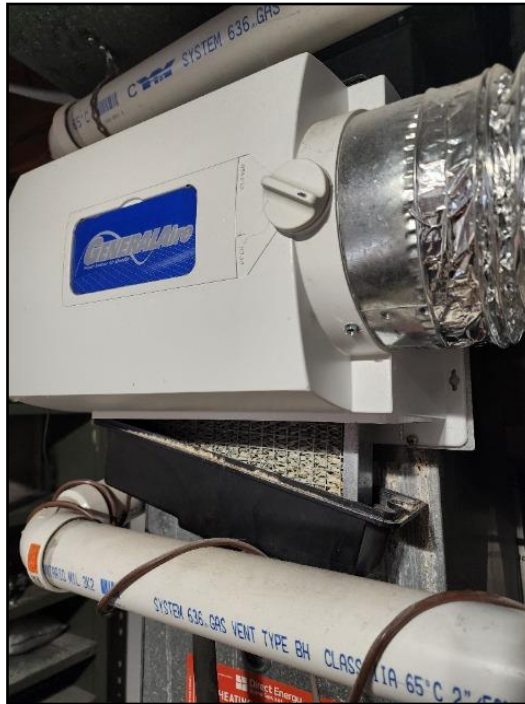
14. Condition: • Clean pad/mesh - regular maintenance

Implication(s): Equipment not operating properly

18. Clean pad/mesh - regular maintenance

Task: Clean - regular maintenance

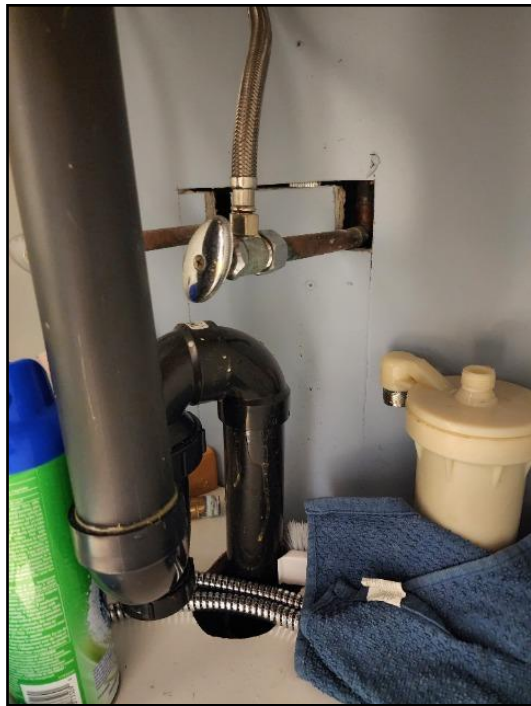
17. Condition: • Wrong type

26. Wrong type

Task: Monitor

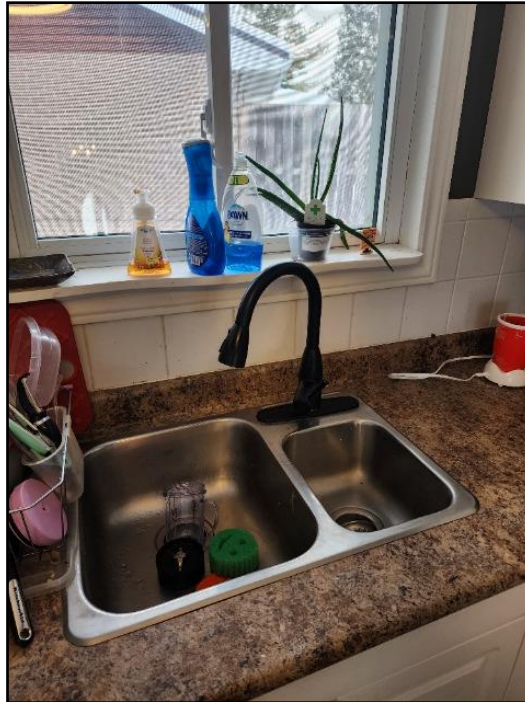
18. Condition: • Hot and cold reversed

27. Hot and cold reversed

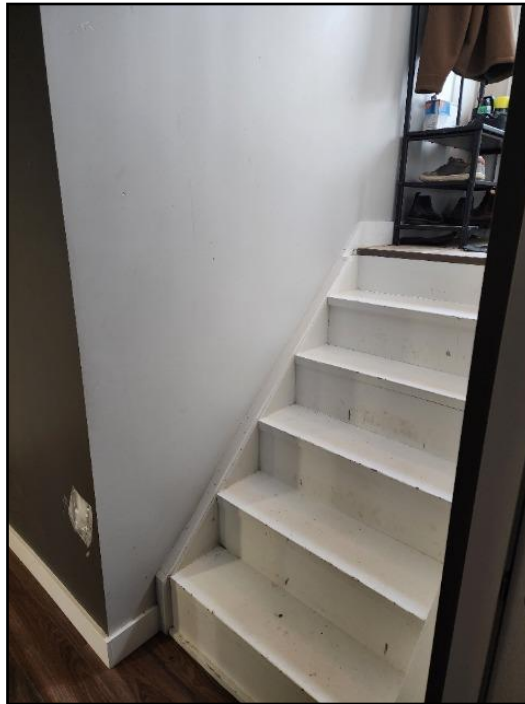
19. Condition: • Missing

Implication(s): Fall hazard

28. Missing

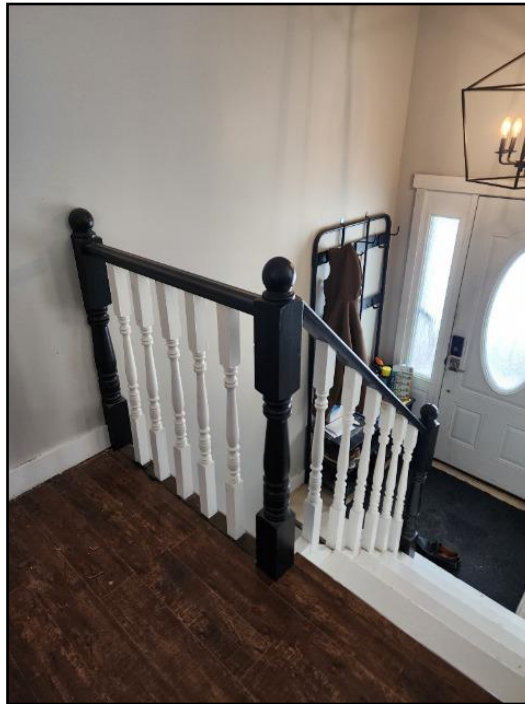
20. Condition: • Too far apart

Implication(s): Fall hazard

29. Too far apart

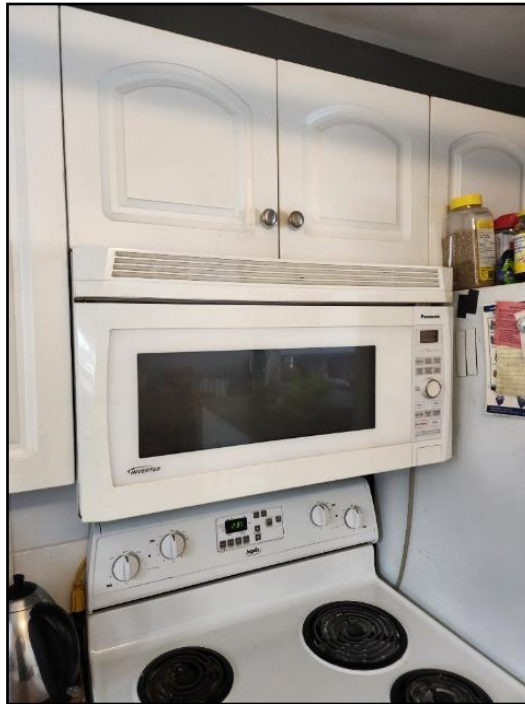
21. Condition: • Inoperative

30. Inoperative

Task: Repair or replace
