INSPECTION REPORT

For the Property at:
968 AVERY AVENUE
PETERBOROUGH, ON K9J 6X3

Prepared for: TEAM VANRAHAN
Inspection Date: Wednesday, February 8, 2023
Prepared by: David Sharman

RE: Report No. 4161
968 Avery Avenue
Peterborough, ON
K9J 6X3

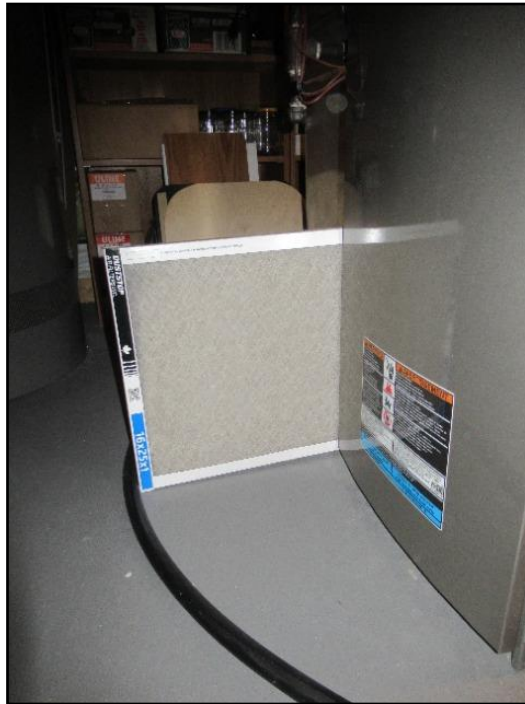
6. Condition: • Replace - regular maintenance

Implication(s): Increased heating & maintenance costs, Reduced comfort

Location: Cold air return

11. Replace - regular maintenance

Task: Replace

Time: Regular maintenance

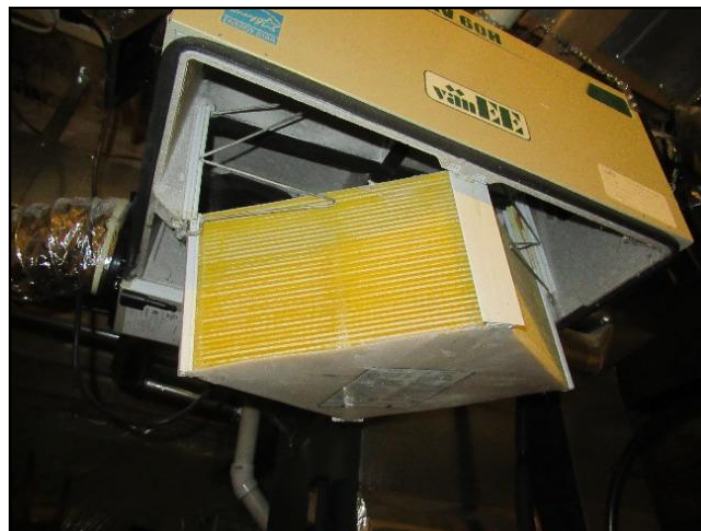
7. Condition: • Clean core - regular maintenance

Implication(s): Reduced operability & comfort

Location: Unit interior

12. Clean core - regular maintenance

Task: Clean

Time: Regular maintenance

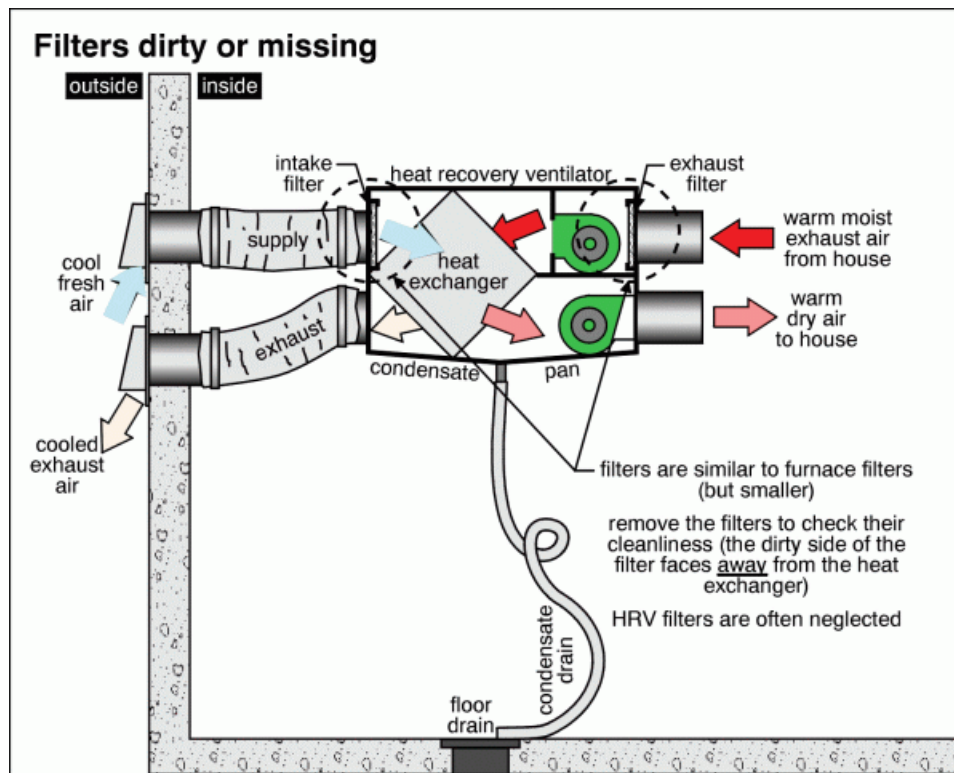
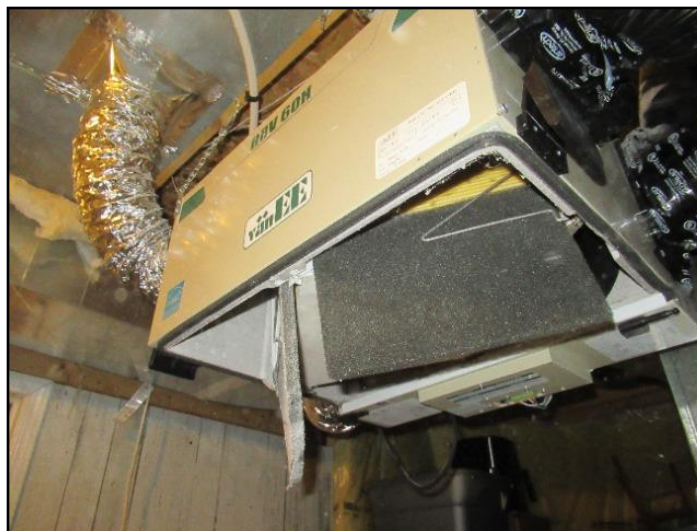
8. Condition: • Clean filters - regular maintenance

Implication(s): Reduced operability & comfort

Location: Unit interior

13. Clean filters - regular maintenance

Task: Clean

Time: Regular maintenance

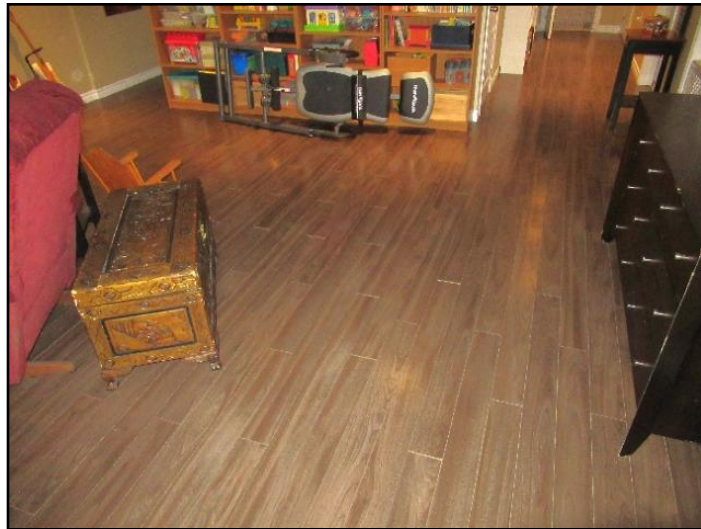
12. Condition: • Exposed tongues

22. *Exposed tongues*

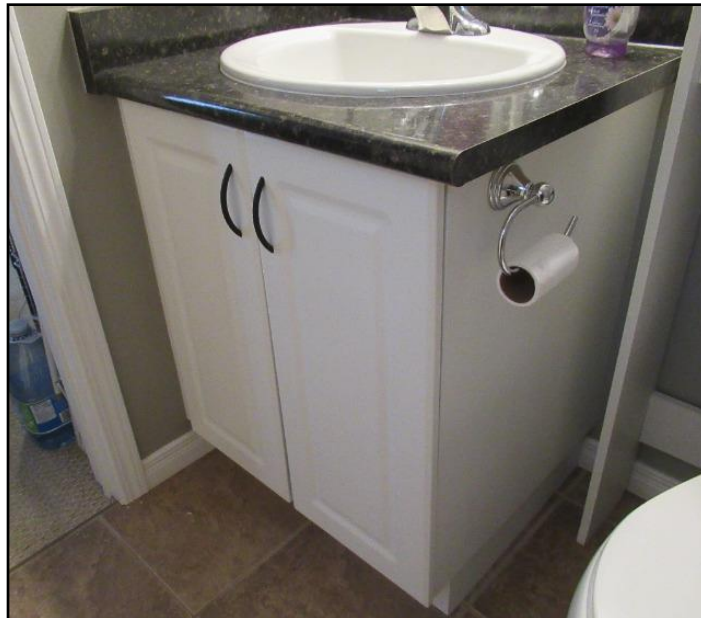
13. Condition: • Doors or drawers missing, loose or damaged

Implication(s): Nuisance | Damage or physical injury due to falling materials

23. *Doors loose or damaged*

Task: Repair

Time: Discretionary

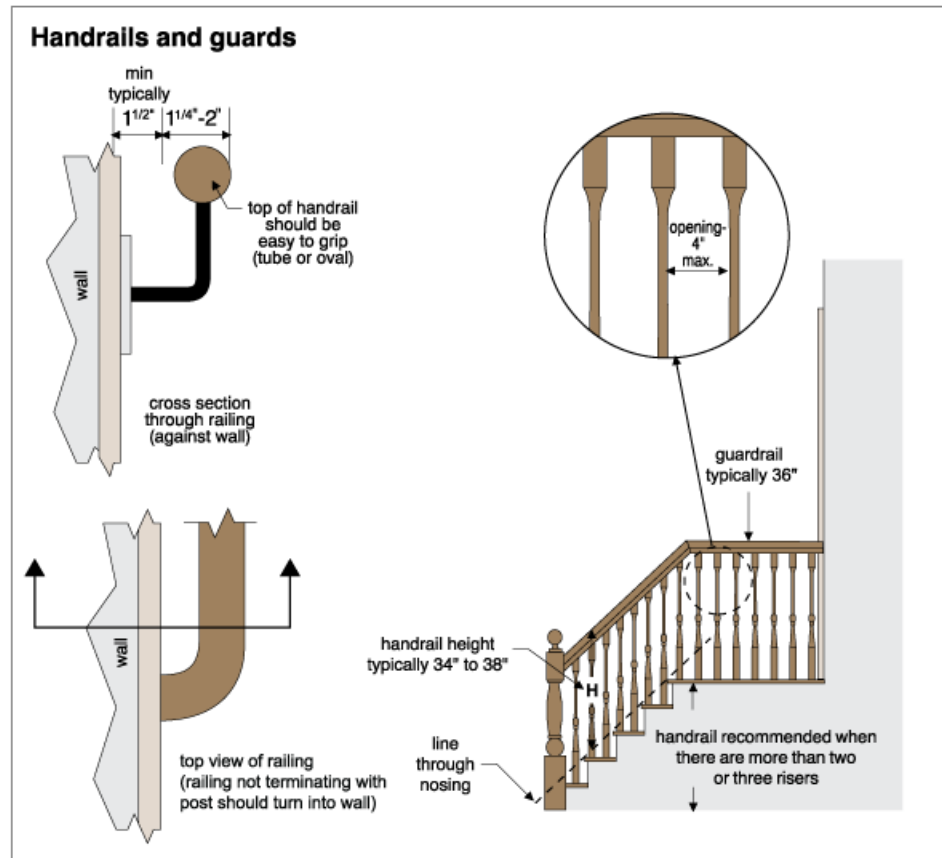
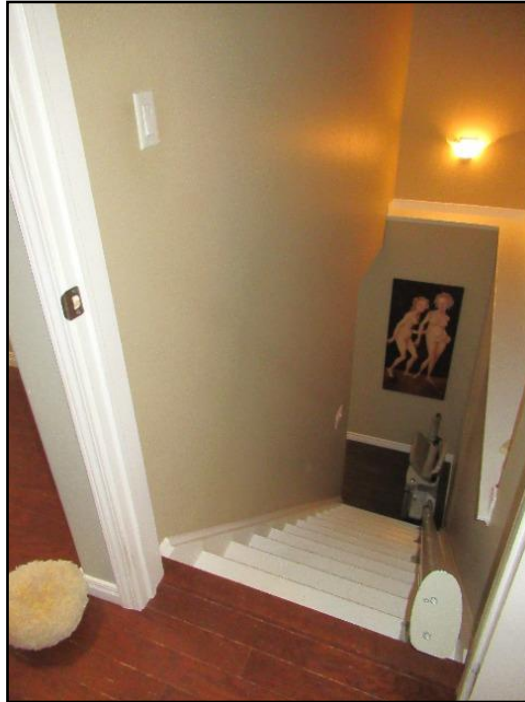
14. Condition: • Missing

Implication(s): Fall hazard

24. Missing

Task: Replace

Time: Discretionary
