# PROPERTY INSPECTION REPORT FORM

12318 Furrow Cove #A, Austin, TX 78753

09/06/2023 12:30 pm

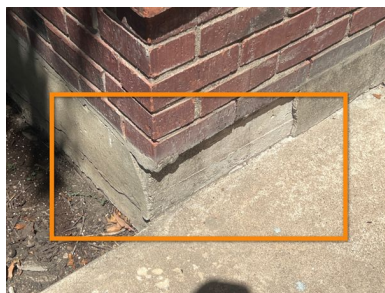
Concrete mortar/underpinning chipped/cracked at various locations.

Underpinning damaged - front exterior

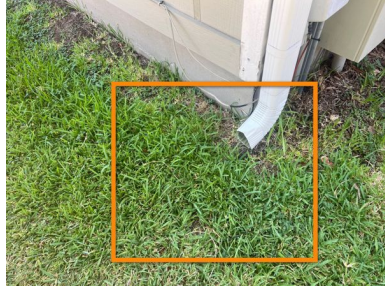
Missing splash blocks were observed at one or more gutter downspout locations. Splash blocks should be installed to help direct drainage away from the foundation and to prevent soil erosion in those areas.

Missing splash block - rear gutter down spout

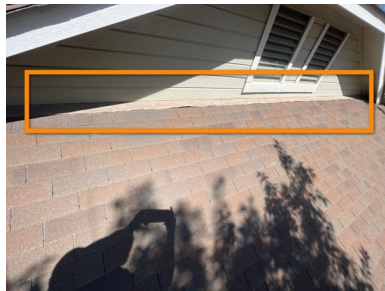
Nail/screw heads are exposed and missing roofing sealant. – Make sure flashing at various plumbing vent stacks, exhaust vents, Wall and or chimney flashing and roofing fasteners on the ridge caps are sealed. Roofing sealant can protect against moisture intrusion. Water running down the roof can seep in around the nails/screws into the roof decking, attic and or interior space causing damage. NOTE: Do not use a (Silicon) based caulk. Use only a roofing sealant/mastic.

Exposed nail heads at multiple locations throughout rooftop

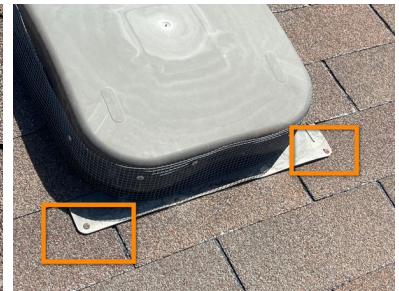
Exposed nail heads at multiple locations throughout rooftop

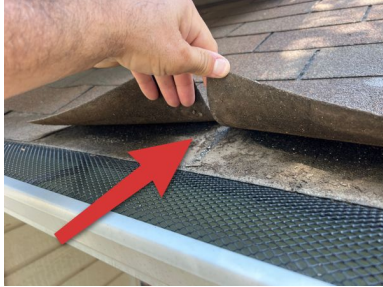
The “starter course” (first course of shingle) is improperly installed around the perimeter of the roof. This course should be installed so that a bead of roofing adhesive (tar) glues down the first visible course to prevent wind damage. This is a common installation error.

Starter course improporly installed at roof perimeter

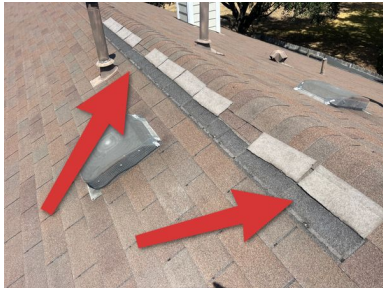
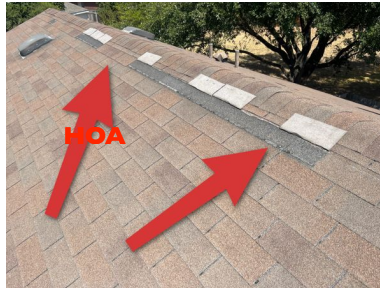
Torn/damaged/missing shingle/s observed at time of inspection. Repair is advised.

Loose torn shingles - roof ridge

Loose/ torn shingles - roof ridge

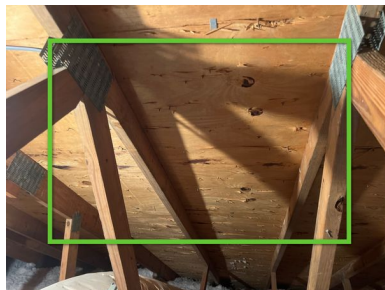
**Radiant barrier/sheathing was not observed at roof decking. Often, supply shortages have made it difficult for builders to acquire during the construction timeframe. As radiant barrier is currently a common practice among builders, and often required to achieve set energy standards, we recommend checking with builder to see if additional insulation or other mitigating factors were employed during construction.**

No radiant barrier observed at roof decking

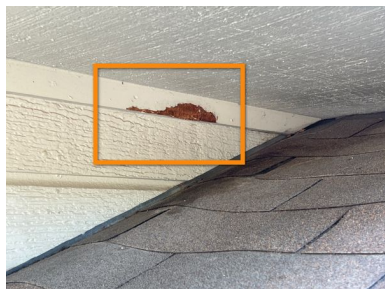
There appears to be rodent damage to frieze boards at one or more locations. Repair/replace as desired.

Rodent damage at frieze boards - front roof

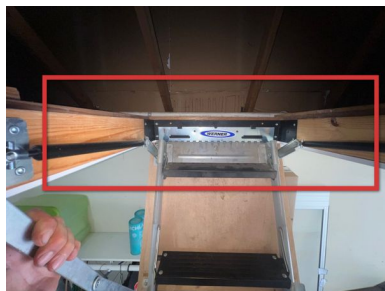
Attic access ladder - Framing installed with screws which do not have adequate strength, instead of 16 D nails or 1/4" X 3" Lag screws - Also the pivot arm brackets are missing 16d nails or 1/4" X 3" Lag screws. "3 on each side plus 2 in the pivot arm and 3 nails on each end = a minimum of 16 anchors" - as recommended by many folding ladder manufacturers - This is a safety issue.

Missing 16D nails at attic ladder assembly - garage

**Additional screws installed**

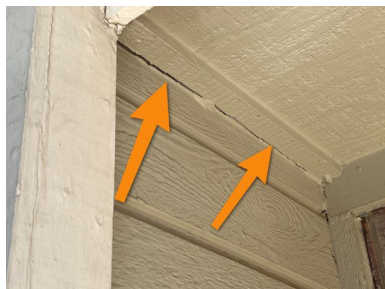
Routine Maintenance - The deteriorated caulk joints between the exterior cladding/veneer and ALL wall penetrations need to be properly sealed such as utility connections, downspouts, hose bibs, lighting fixtures, receptacles, etc with an exterior grade elastomeric sealant (caulking) to prevent wind driven rain/moisture from entering behind the exterior veneers, doors, windows and other wall penetrations.

Caulk and seal needed - multiple locations

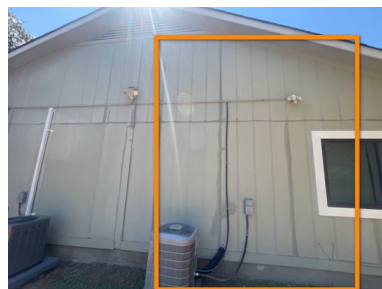
Caulk and seal needed - multiple locations

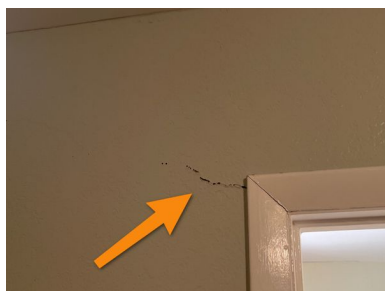
Wallboard/sheetrock has cracks at seam(s) in various locations. In most cases this occurs from normal settling/shifting of the structure and/or thermal expansion. Caulk and paint where needed (Homeowner Maintenance items)

Sheetrock crack - master bedroom

**Drywall repaired Sept 2023**

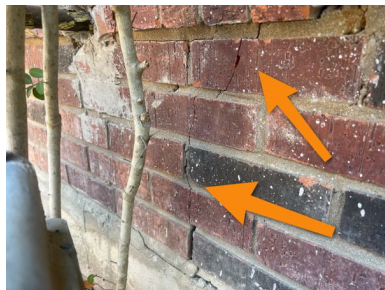
Brick/stone mortar is cracked at various locations. In most cases this occurs due to normal settling/shifting of the structure and/or thermal expansion. Point up mortar where needed to prevent moisture penetration.

Left exterior brick/mortar crack at exterior wall

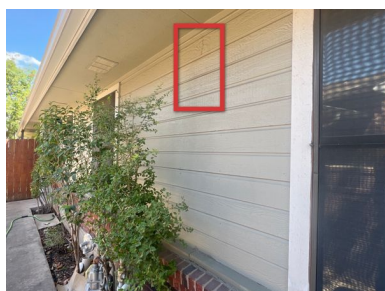
Damaged lap siding - left exterior wall

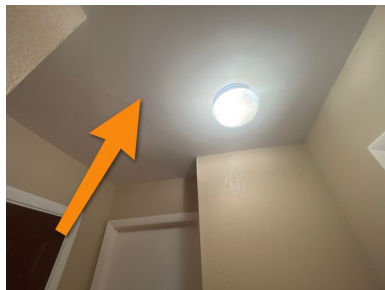
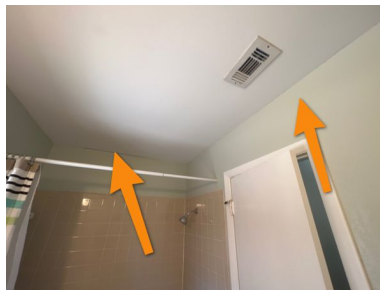
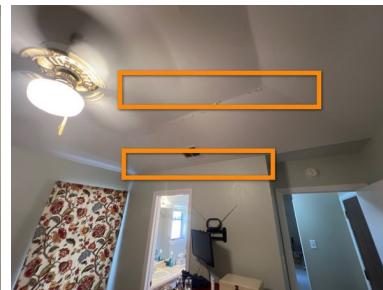
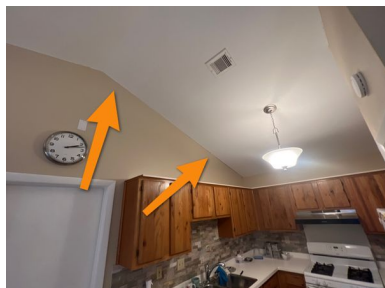
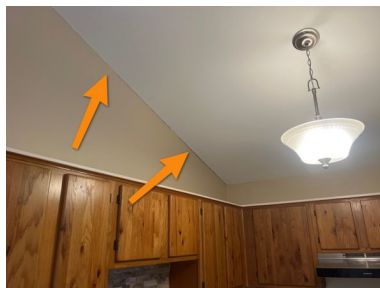
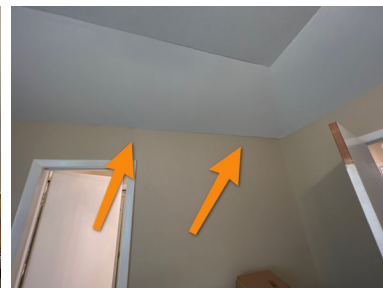
Cracks observed at sheet rock seam and ceiling/wall at various locations. In most cases this occurs from settling and shifting of the house.

Ceiling Sheetrock crack - garage hallway

Ceiling Sheetrock cracks - hall bathroom

Ceiling Sheetrock cracks - master bedroom

Ceiling Sheetrock cracks - draining room

Ceiling Sheetrock cracks - kitchen

Ceiling Sheetrock cracks - guest bedroom

**Repaired & painted Sept 2023**

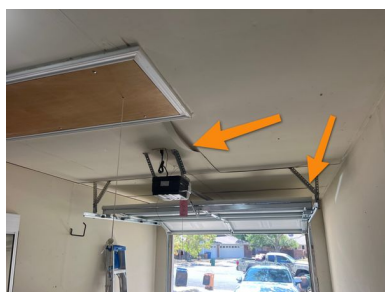
Peeling tape joints observed on the ceilings/walls in garage. This typically occurs due to absorption of humidity in an unconditioned space. Repair as desired.

Peeling tape joints - garage ceiling

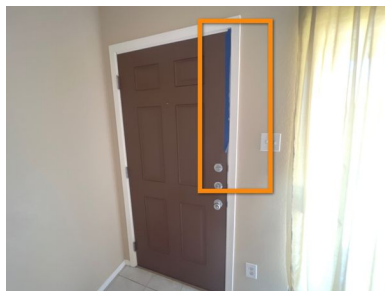
One or more gaps were observed and could result in energy loss. Recommend adjustment.

Noticeable gap - front door

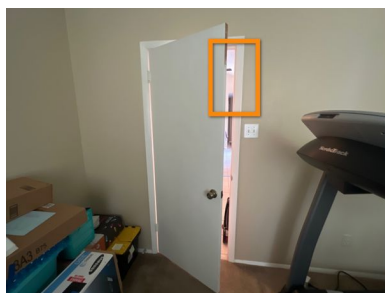
Some doors were observed to be sticking, not closing properly, out-of-level (ghosting), or missing and/or non-functional hardware.

Door rubs frame - guest bedroom entry

**Repaired Sept 2023**

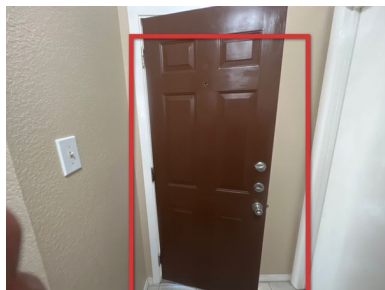
Self closing hinges at garage door have not been properly set/installed - These are recommended anytime garages have gas fired appliances or store any type of harmful liquids that could potentially spill and cause inhalation hazards. Cars also pose a threat due to the emissions of CO2 they emit through their engine exhaust.

Garage/home entry door not self closing

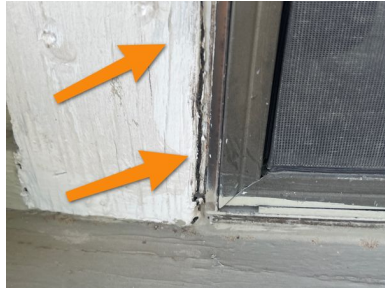
Cracks/Voids in caulk sealant around window frames. Recommend re-caulking various windows inside and out to help prevent window condensation/penetration.

Caulk and seal needed - multiple exterior windows

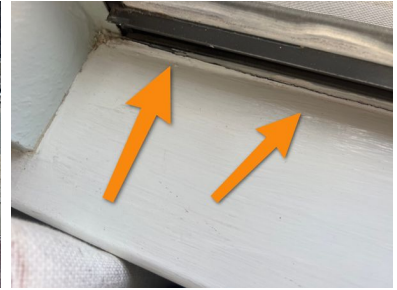
Caulk and seal needed at multiple interior windows

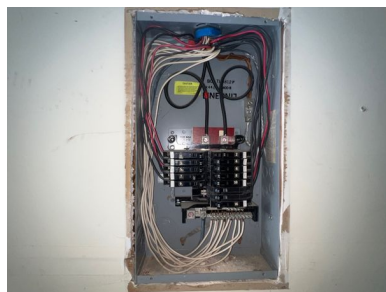
Sub panel - no AFCIs present - garage

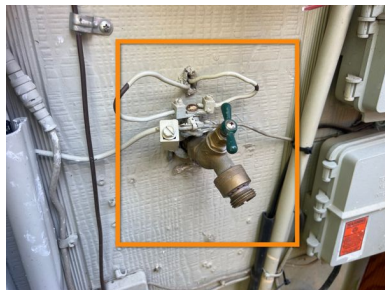
The service panel grounding conductor was not visually observed at the cold water supply or ground rod. The exact grounding termination point was undetermined at the time of the inspection

PEX line present - Could not verify bonding at left exterior hose bib

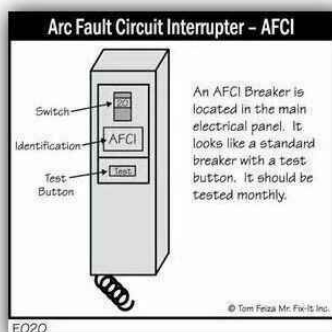
No ARC fault breakers {AFCI} were observed at the service panel at the time of the inspection; although this may not have been a requirement when the home was built. Beginning in 2008; AFCI breakers are required in the panel for 15A/20A branch circuits providing power to family rooms, dining rooms, living rooms, libraries, dens, bedrooms, sunrooms, recreation rooms, closets and hallways. AFCI breakers provide fire protection by opening the circuit when an arcing fault is detected. The construction of this house predates this standard and there is no requirement to add this equipment.

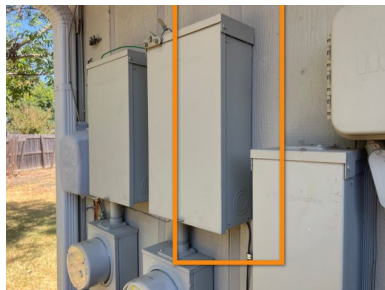
Gaps wider than {1/8"} around the service panels and mechanical secondary shut offs should be sealed to prevent moisture penetration.

Caulk and seal needed - electrical panels - left exterior wall

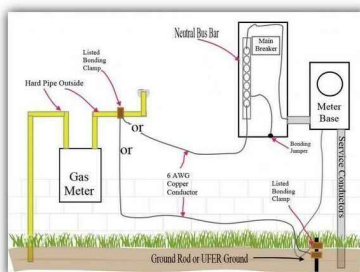
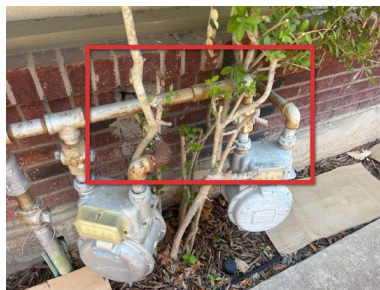
The gas piping system is not bonded to the grounding electrode system. Where metal piping servicing the house is capable of being energized, it should be bonded to the grounding electrode system. This is reflected in the 2012 International Residential Building Code as follows: E3609.7 Bonding other metal piping. Where installed in or attached to a building or structure, metal piping systems, including gas piping, capable of becoming energized shall be bonded to the service equipment enclosure, the grounded conductor at the service, the grounding electrode conductor where of sufficient size, or to the one or more grounding electrodes used. The bonding conductor(s) or jumper(s) shall be sized in accordance with Table E3908.12 using the rating of the circuit capable of energizing the piping. The equipment grounding conductor for the circuit that is capable of energizing the piping shall be permitted to serve as the bonding means. The points of attachment of the bonding jumper(s) shall be accessible.

Gas piping not bonded - left exterior gas meter

**Repaired  
Oct 2023**

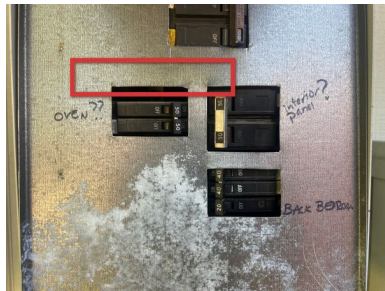
There are open breaker slots in the panel which presents a Safety Hazard.

Open breaker slot - main panel

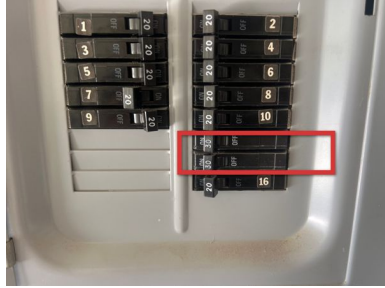
Dryer receptacle/breaker observed to lack ground fault circuit interrupter (GFCI) protection. Under current electrical standards, dryer receptacles should have GFCI protection.

Dryer not GFCI protected - sub panel

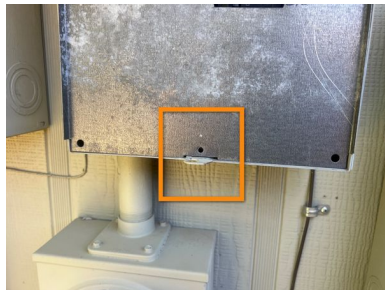
Missing screw to secure dead front at main panel.

Missing screw at dead front - main panel

**Repaired  
Oct 2023**

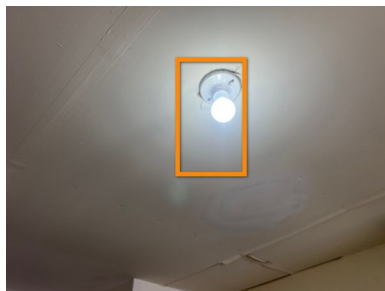
Light globe/lens (diffusers) cover missing and/or damaged. Under todays regulations all light bulbs in closets/attics should be protected. Recommend upgrading for your safety.

Missing protective globe - garage light fixture

**Repaired Sept 2023**

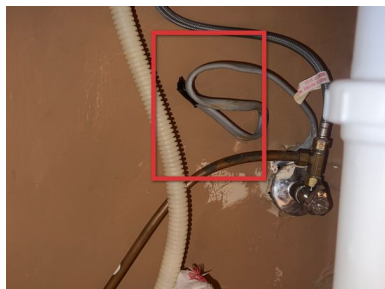
All wire connections & charged wires with exposed ends and splices should be covered in junction boxes for safety. Recommend a qualified electrician correct.

Improperly spliced/terminated wiring - under kit sink cabinet Sub Panel

**Repaired Oct 2023**

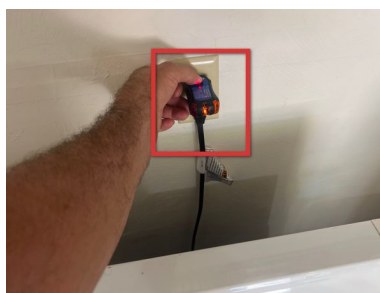
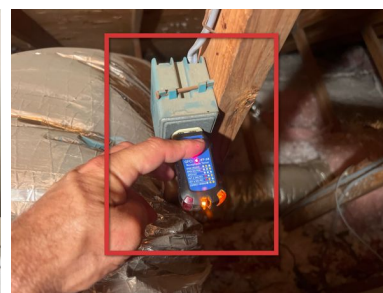
Section 210.8(B)(A) GFCI protection requirements. GFCI plugs are missing in one or more locations. GFCI protection is required on 15A/20A circuits providing power to kitchens, bathrooms, garages, laundry rooms, exterior receptacles, pools, spas and whirlpool tubs. GFCI receptacles are required in the kitchen and within 6' of water basins. All 125-volt through 250-volt receptacles (IE.cloths dryer) installed in the locations specified in 210.8(A)(1) through (A)(11) and supplied by single-phase branch circuits rated 150 volts or less to ground shall have ground-fault circuit-interrupter protection for personnel.

GFCIs missing in garage

GFCI missing in attic

**Repaired  
Oct 2023**

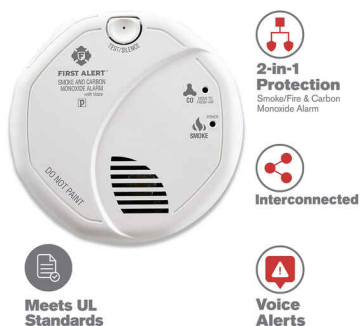
There are missing carbon monoxide alarms in the home. Carbon monoxide alarms should be installed in accordance with current standards, as follows: 2009 International Residential Code R315.2.1 New construction. Carbon monoxide alarms shall be provided in dwelling units when either or both of the following conditions exist. 1. The dwelling unit contains a fuel- fired appliance. 2. The dwelling unit has an attached garage with an opening that communicates with the dwelling unit. R315.3 Location. Carbon monoxide alarms in dwelling units shall be installed outside of each separate sleeping area in the immediate vicinity of the bedrooms. When a fuel-burning appliance is located within a bedroom or its attached bathroom, a carbon monoxide alarm shall be installed within the bedroom. Carbon monoxide is an odorless, colorless, and tasteless gas that is near impossible to identify without a proper detector. It is caused by fuels not burning completely, including wood, gasoline, coal, propane, natural gas, gasoline, and heating oil. This unburned fuel can come from anything from clothes dryers, water heaters, and ovens to ranges, a fire-burning fireplace, or a car left running in a closed garage. Master bedroom hallway

**Installed**

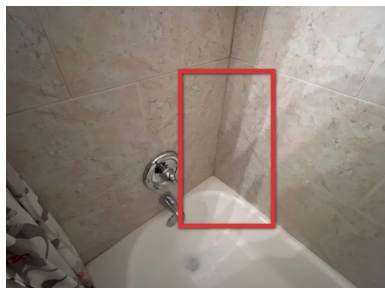
Cracks/voids in grout/caulk, at bathtub/shower surround(s) and base(s) observed. Recommend re-grouting/sealing to prevent moisture intrusion. It is beyond the scope of this inspection to determine if moisture penetration has occurred and/or is present in non visible areas, such as behind wall coverings.

Cracked tile surrounds - guest bathroom

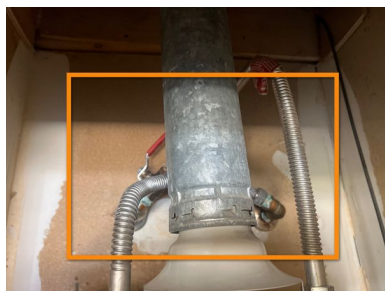
Water lines not insulated at garage water heater unit

Recommend correcting to increase efficiency

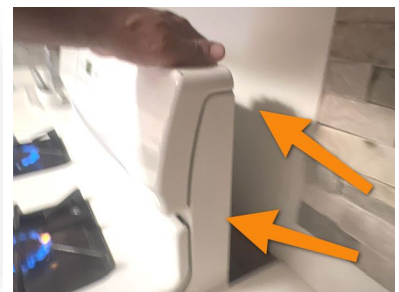
The anti-tip device is missing or non-functional for the oven/range. It is recommended that one be installed for safety.

Missing anti tip device - stove

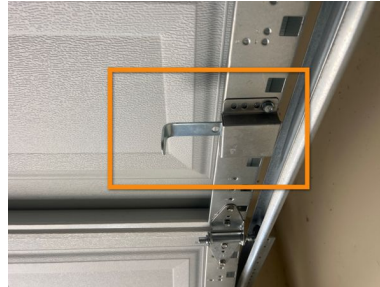
The overhead door lock should be disabled because there is an automatic garage door operator in place. This will help prevent accidentally activating the automatic opener when the door is locked, which may result in damage to the door and/or the automatic operator.

Manual lock not disabled - garage door
