Inspection Report

G2 Home Inspections

Property Address 5207 Crane Dr West Richland Wa

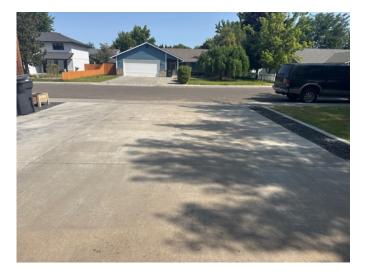
1.2) Driveway Conditions

Cracks and surface deterioration were observed at the driveway. Recommend repair as needed/desire.

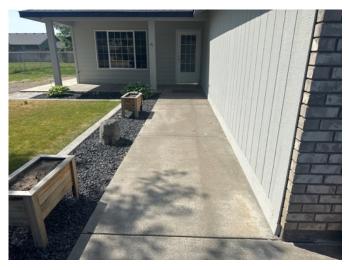
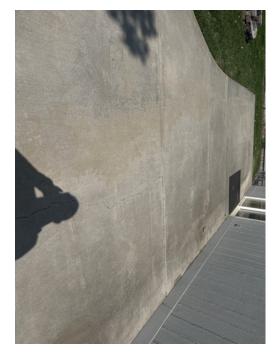
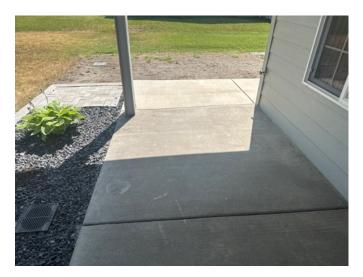
1.3) Sidewalk Conditions

There were common settlement cracks observed at the back patio.

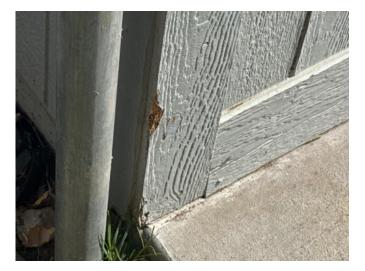
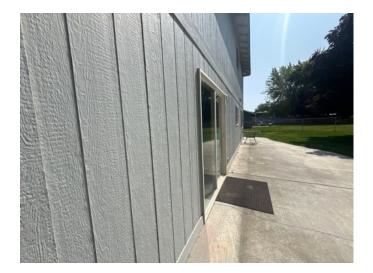
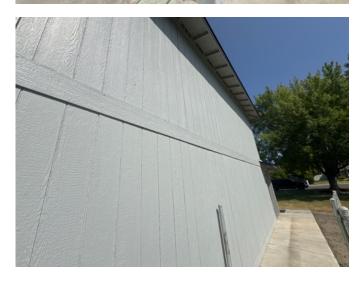
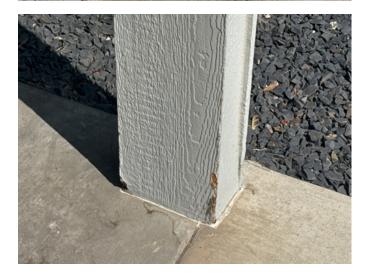
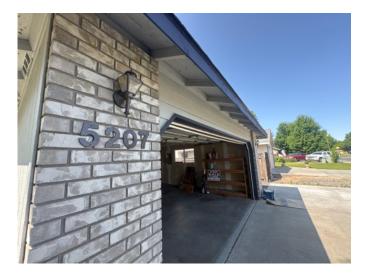
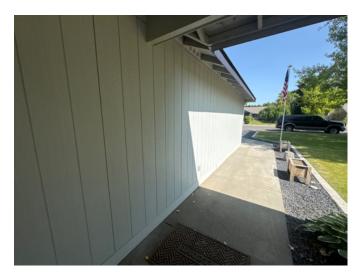
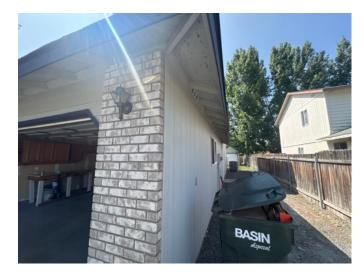
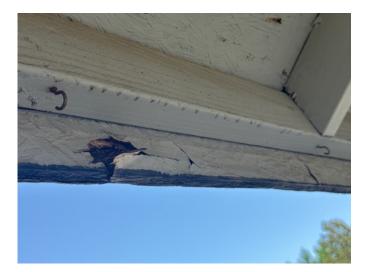
2.1) Exterior Wall Conditions

There was evidence of moisture exposure and damage observed at the facia boards at the west side of the garage

There was no evidence of moisture exposure in minor damage, observed at the bottom edge of siding at the west side of the home.

There was minor swelling/evidence of moisture exposure, observed at the trim halfway up the wall at the back of the home.

There was weathered, paint and minor damage observed at the corner trim, and several areas around the home.

There is evidence of moisture exposure and minor damage observed at the bottom edge of the trim at the front posts

They were gaps in the caulk at siding and trim joints in several areas around the home.

Recommend repair/maintenance by qualified contractor.

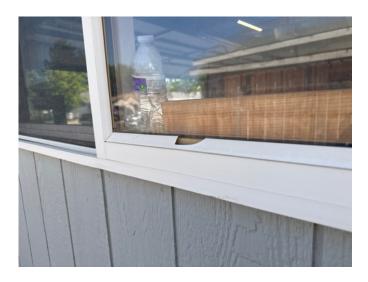
2.2) Window Conditions

The vinyl glazing strip at the bottom of the garage window was damaged. Recommend repair.

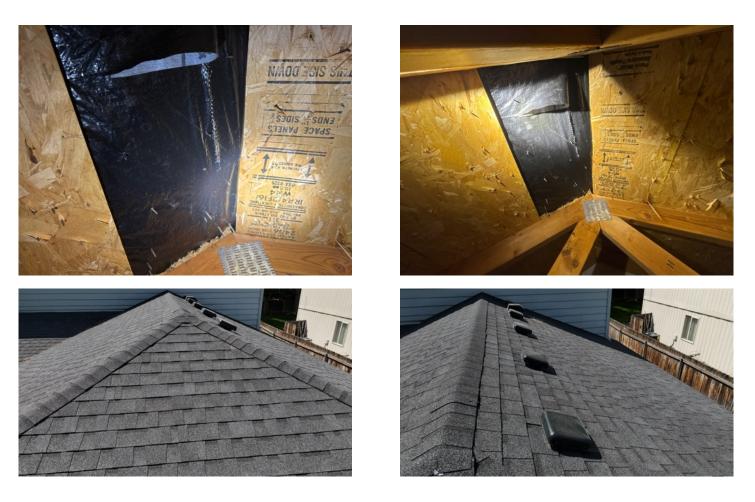
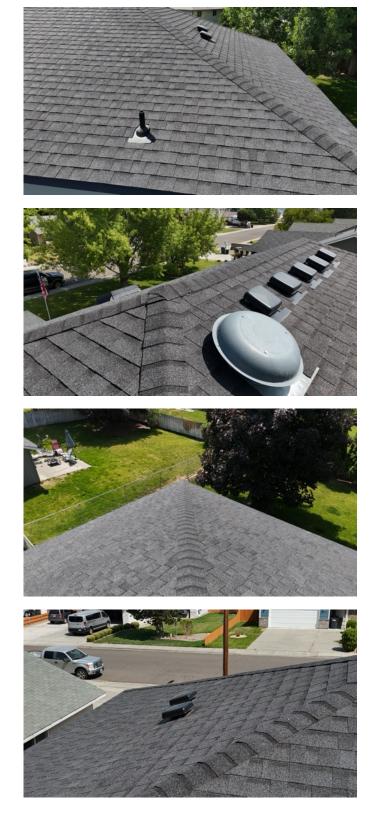
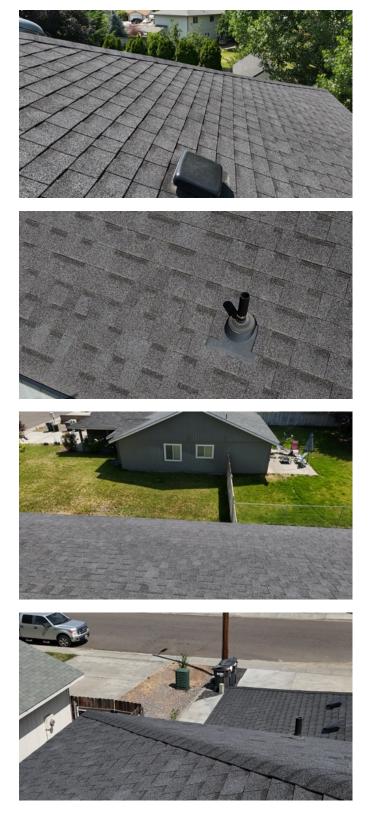
3.1) Roof Covering Condition

There is a small piece of missing roof sheathing near the peak of the roof above the garage just above the garage attic access. Recommend repair.

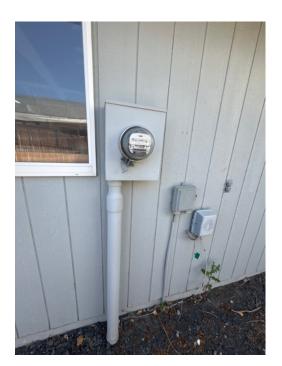
5.1) Electrical Service Conditions

Recommend installing a strap at the conduit below the electrical meter base.

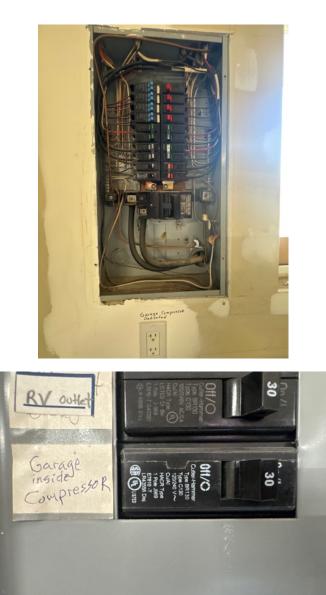
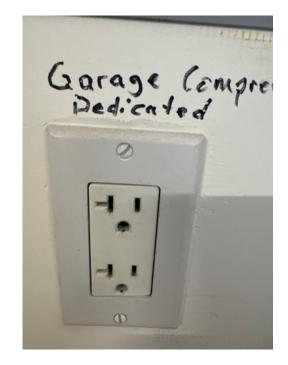
5.3) Electrical Panel Conditions

The receptacle below the electrical panel is fed from the bottom left breaker in the panel. This is a 30 amp single pole breaker. Receptacle is only rated for 20 A. Recommend replacing breaker with a 20 amp single pole breaker.

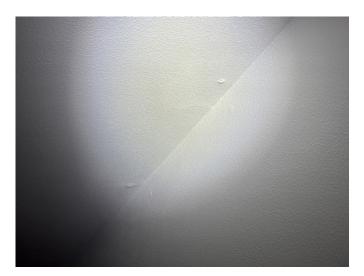
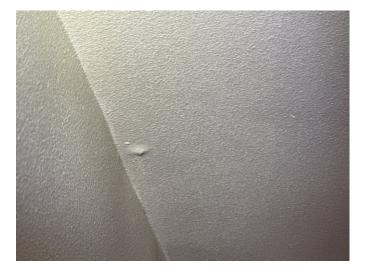
7.2) Ceiling Conditions

There were Pops drywall screws, observed at the ceiling near the walls in several areas at the upper level of the home. Recommend maintenance and repair as needed.

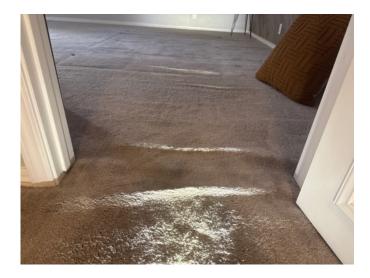
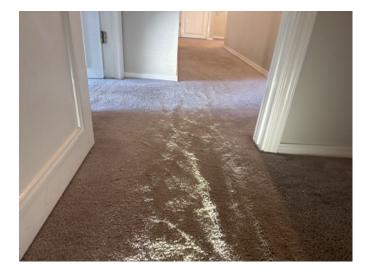
7.3) Floor Conditions

The carpet was loose in several areas. Recommend stretching carpet.

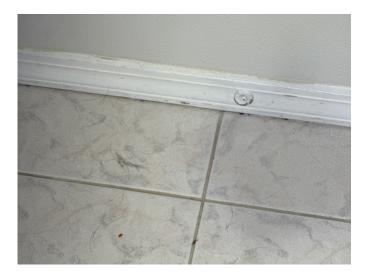
7.5) Interior Door Conditions

The doorstop for the front exterior door was missing. Recommended install doorstop to prevent wall damage.

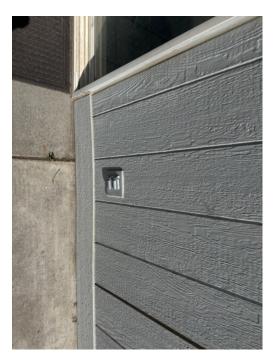
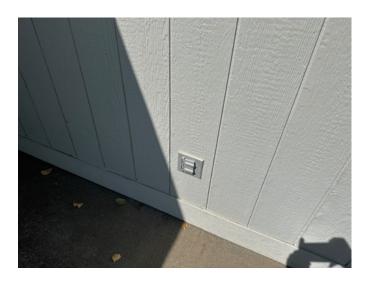
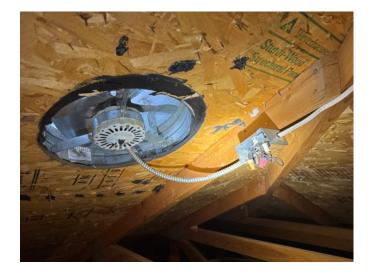
7.6) Electrical Conditions

Several of the kitchen countertop receptacles are not GFCI protected. It is recommended to install GFCI protection for All kitchen receptacles.

Recommend installing GFCI protection for the exterior receptacle of the back patio

Recommend installing GFCI protection for the exterior receptacle at the front patio.

There is an open junction box in the attic above the garage to the left of the attic access when facing the home. Recommend recommend installing a cover at this junction box.

The cover was missing for the thermostat control for the attic fan. Recommend installing a cover for this device. The fan did not appear to be operational at the time of inspection. Recommend repair or replacement if desired.

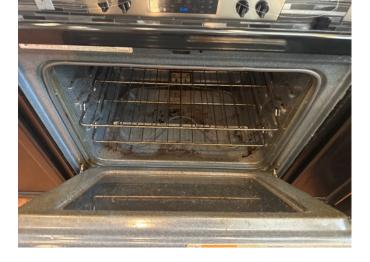
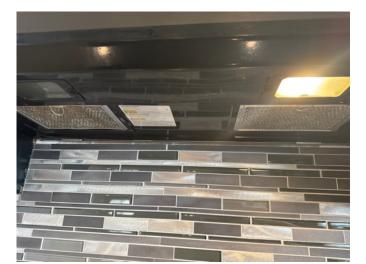
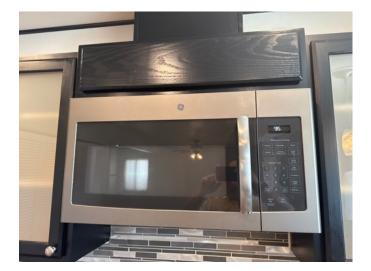
8.6) Hood Fan Conditions

The left light below the microwave did not operate at the time of inspection. Recommend replacing bulb.

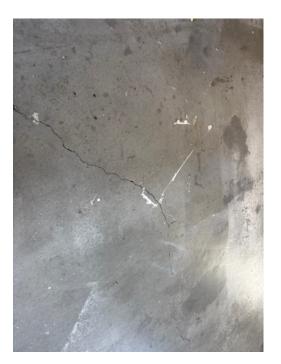
10.3) Floor Conditions

There were common settlement cracks observed at the garage floor.

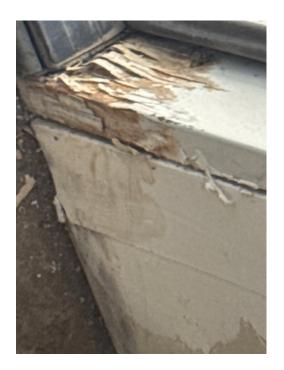
10.4) Door Conditions

There was evidence of moisture exposure and damage observed at the door casing at the side garage door. Recommend repair. Install installing a gutter at the eve outside of the garage door would help prevent further damage.

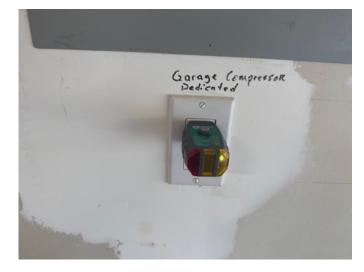
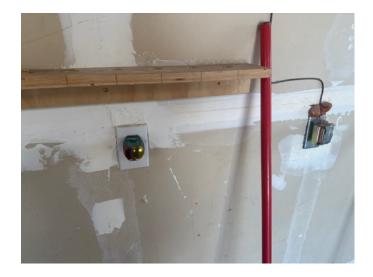
10.6) Electrical Conditions

Several receptacles in the garage are not GFCI protected. It is recommended that all garage receptacles be GFCI protected. Recommend installing GFCI protection.

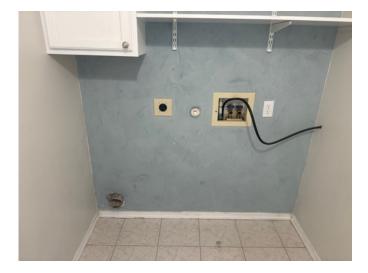
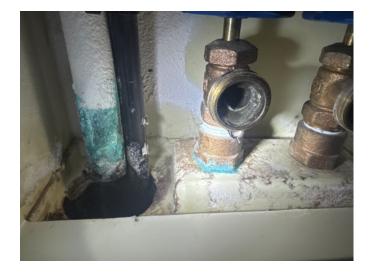
10.8) Laundry Room Conditions

The hot water value at the washing machine hook up was dripping slowly at the time of inspection. Recommend repair by qualified plumbing contractor.
