# INSPECTION REPORT

For the Property at:  
**479 ALBERTUS AVENUE**  
PETERBOROUGH, ON K9J 6A1

RE: Report No. 4923  
479 Albertus Avenue  
Peterborough, ON  
K9J 6A1

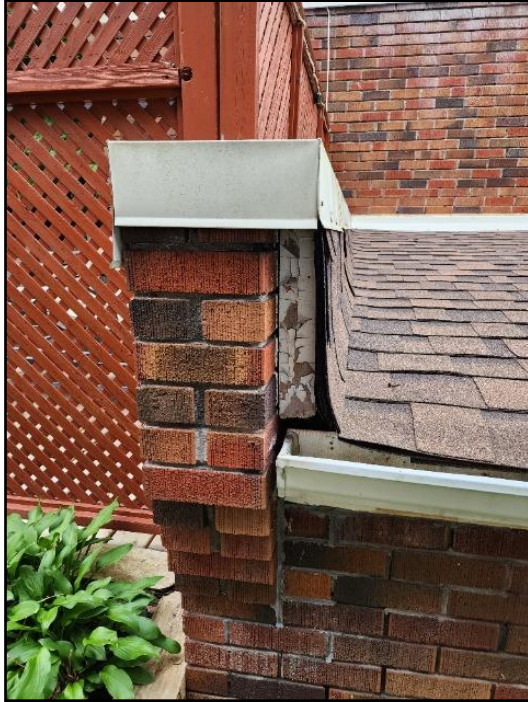
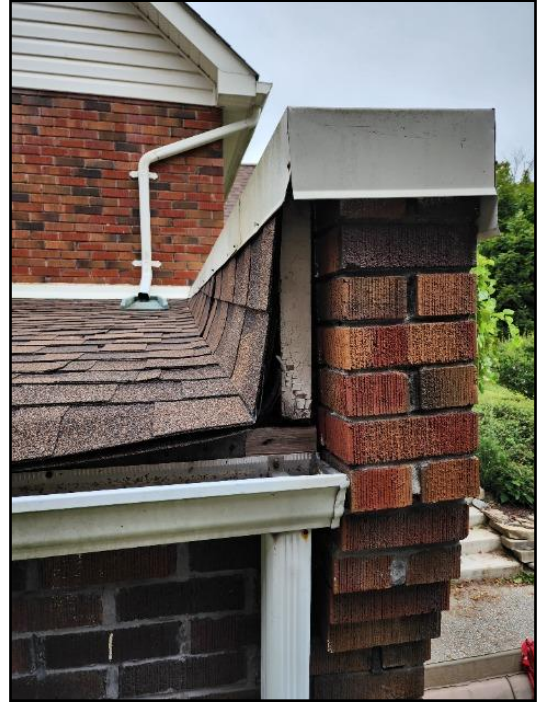
2. **Condition:** • Missing

**Implication(s):** Chance of water damage to structure, finishes and contents

3. Missing

**Task:** Provide

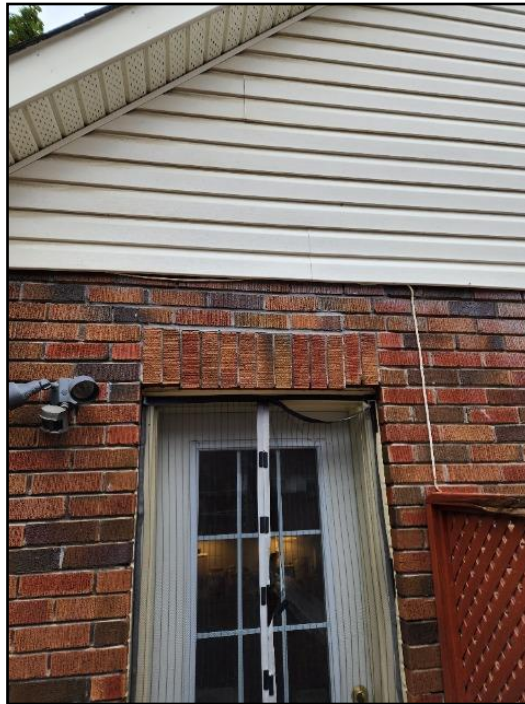
**5. Condition:** • Prior repairs

**Implication(s):** No implications exist for this condition

5. *Prior repairs*

**Task:** Monitor

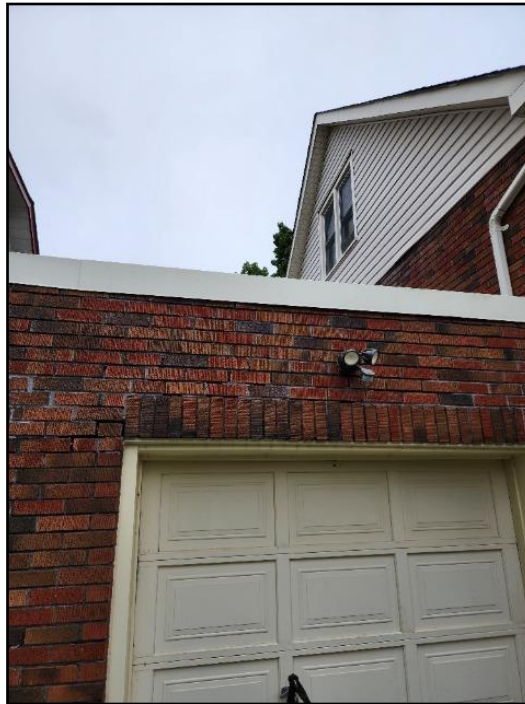
**6. Condition:** • Mortar deteriorating

**Implication(s):** Weakened structure | Chance of structural movement

6. Mortar deteriorating

**Task:** Repair

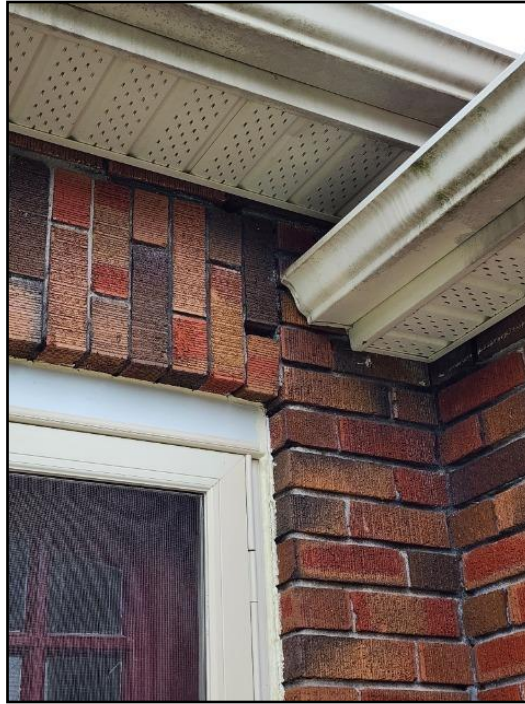
**7. Condition:** • Masonry units moving

**Implication(s):** Material deterioration

*7. Masonry units moving*

**Task:** Repair

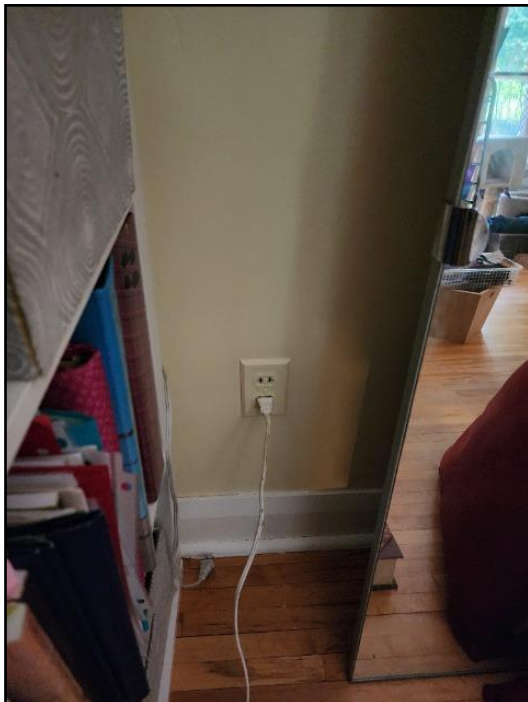
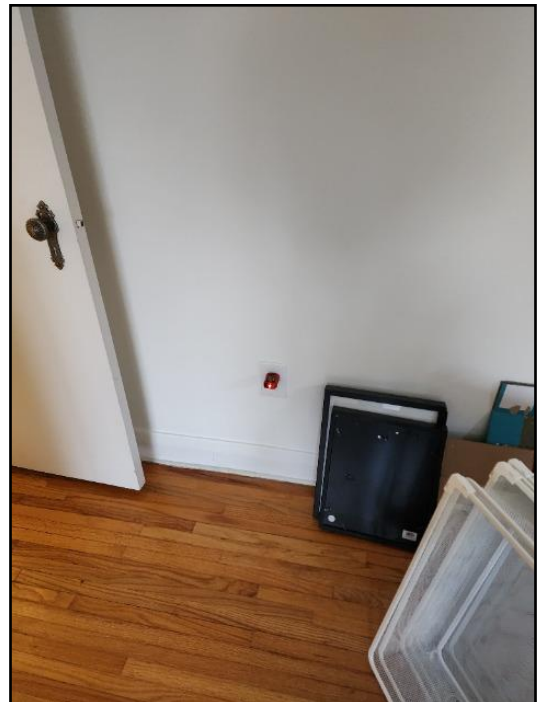
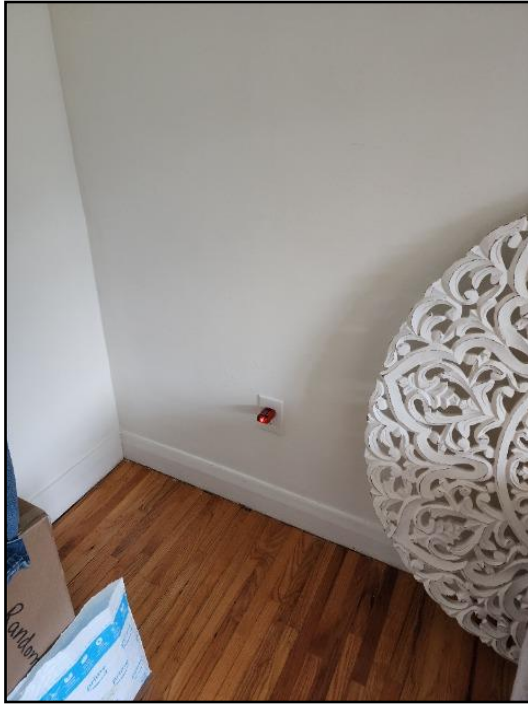
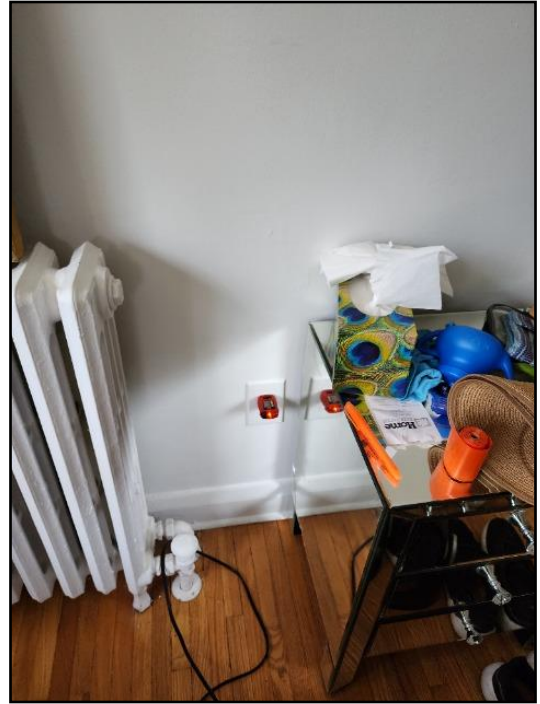
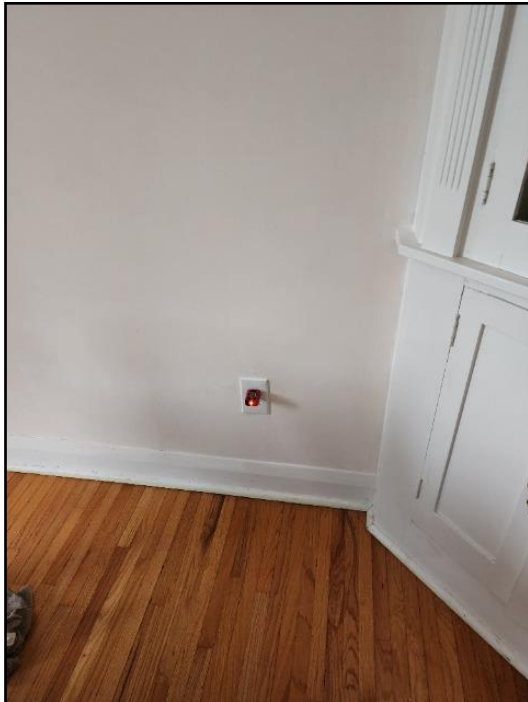
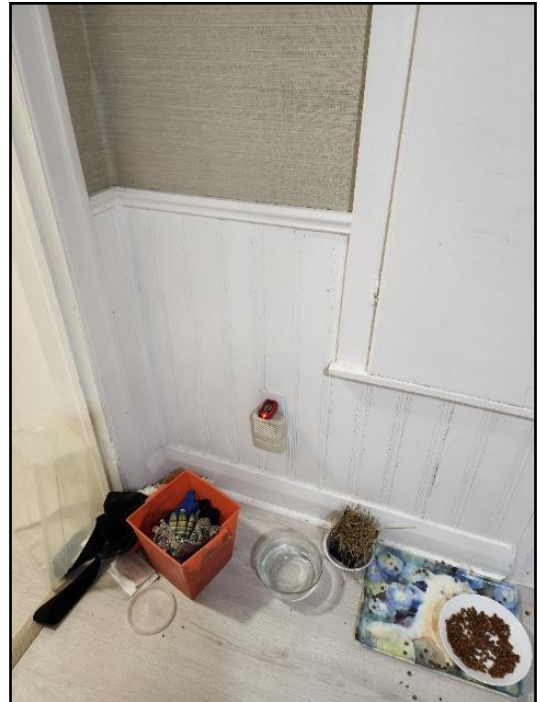
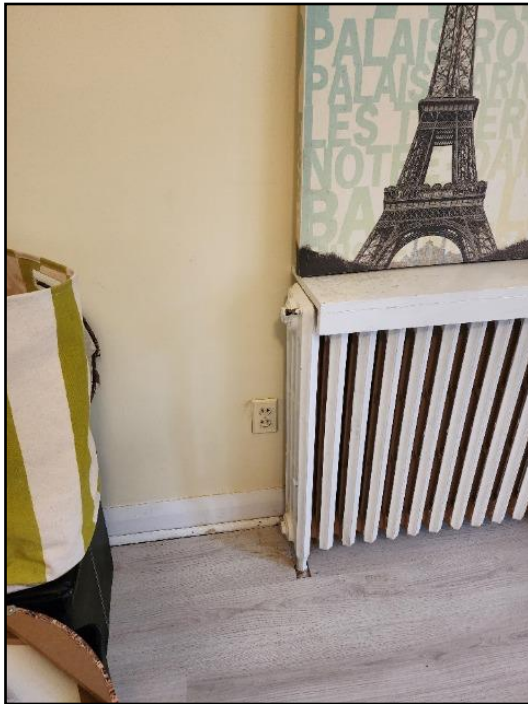
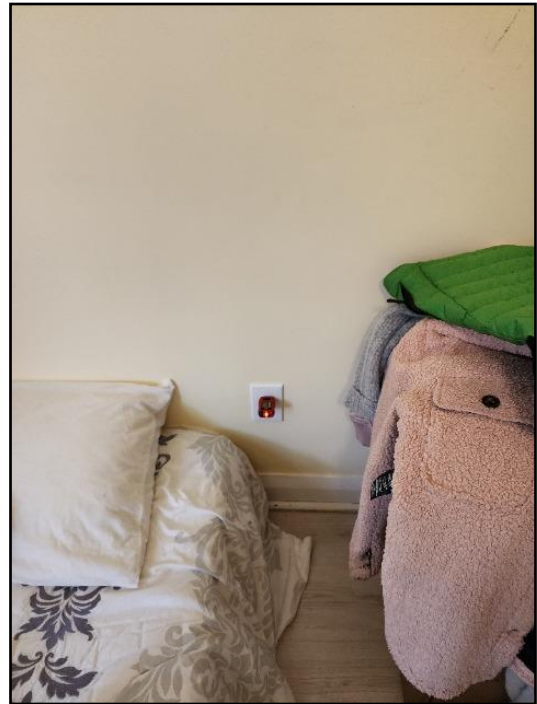
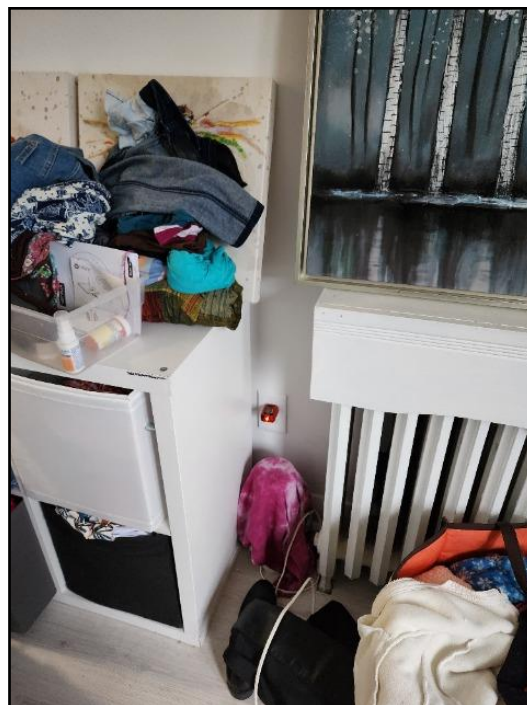
**8. Condition:** • Ungrounded

Although ungrounded service may be typical in a house of this age, safety may be improved by upgrading these receptacles.

**Implication(s):** Electric shock

10. Ungrounded

**Task:** Upgrade

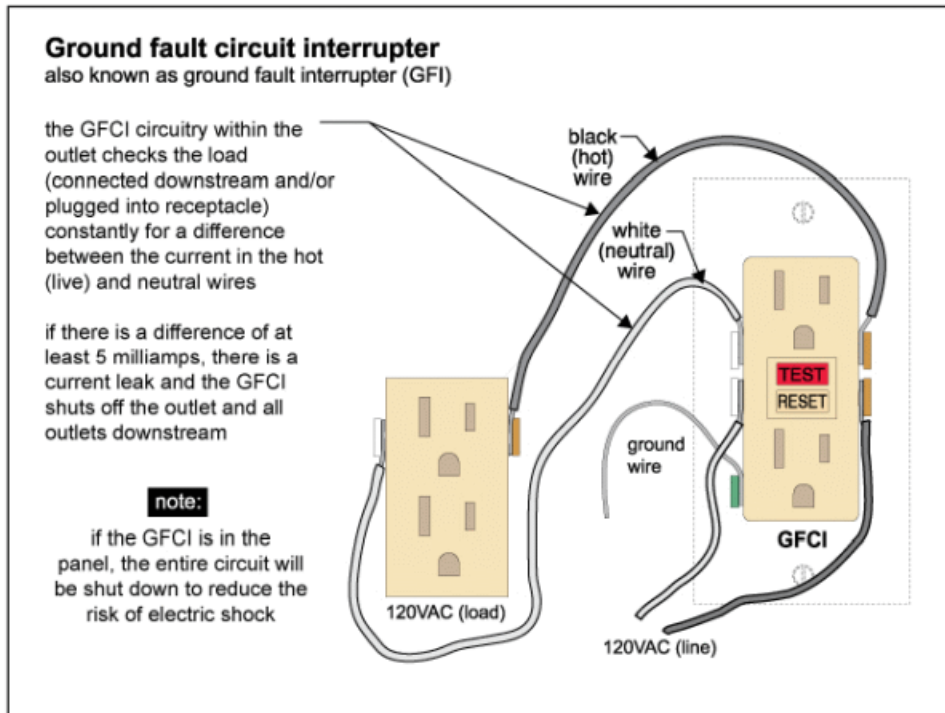
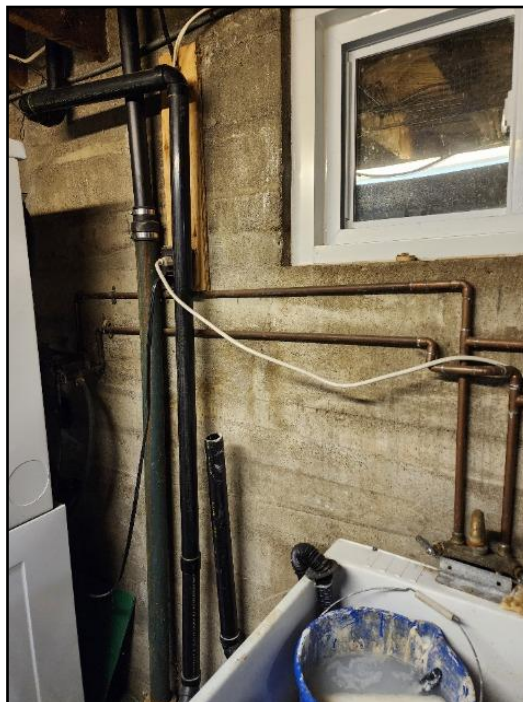
**9. Condition:** • No GFCI/GFI (Ground Fault Circuit Interrupter)

Although not a deficiency in a home of this age, safety may be improved by upgrading this receptacle

**Implication(s):** Electric shock

19. No GFCI/GFI (Ground Fault Circuit...

**Task:** Upgrade

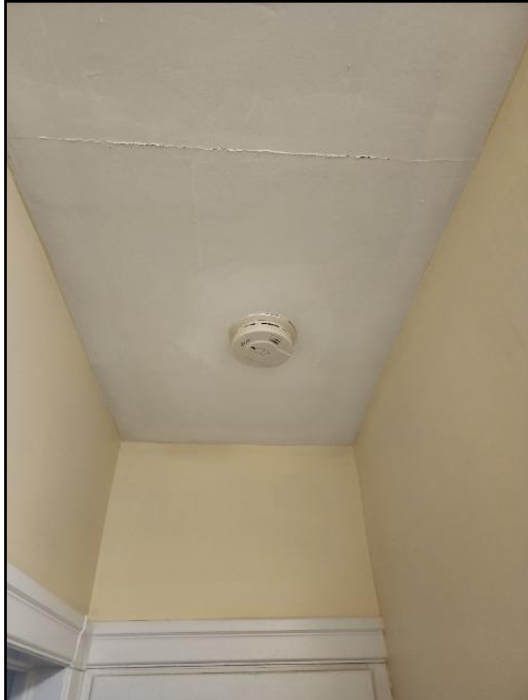
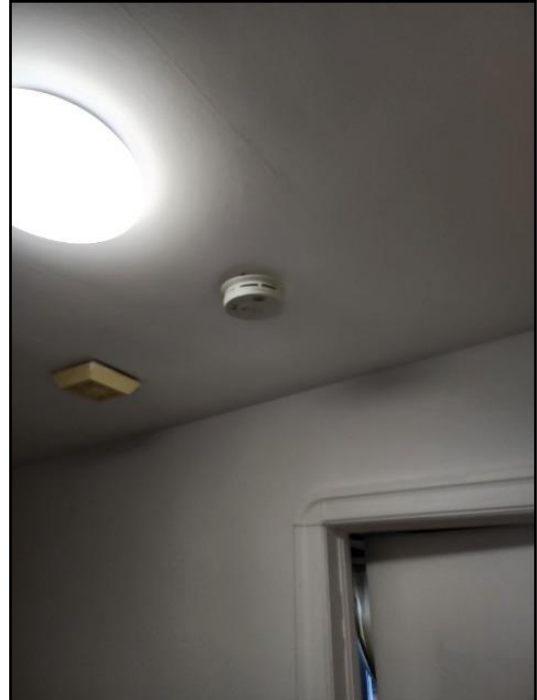
**10. Condition:** • More than 10 years old

**Implication(s):** Life safety hazard

20. More than 10 years old

**Task:** Replace

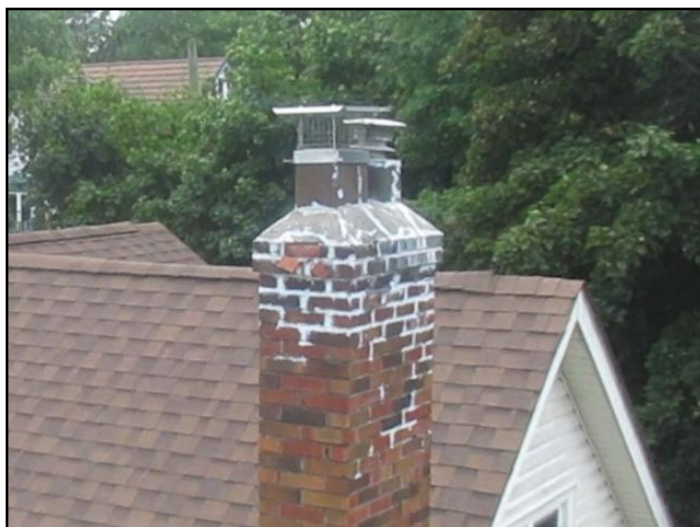
**13. Condition:** • Prior repair

**Implication(s):** No implications exist for this condition

27. Prior repair

**Task:** Monitor

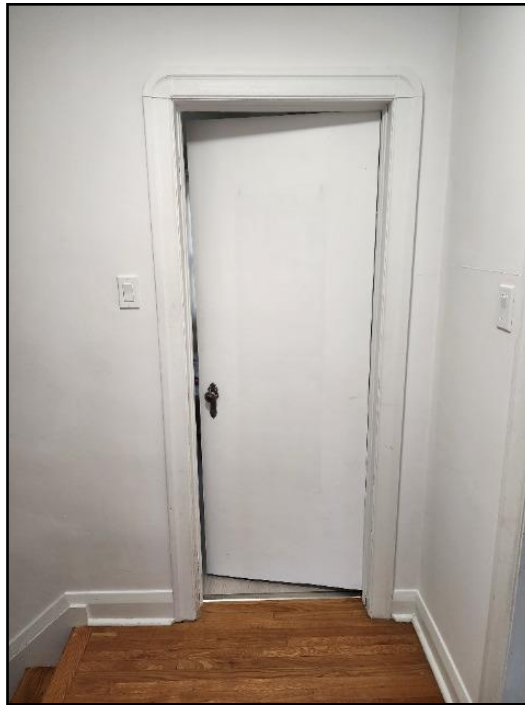
**17. Condition:** • Binds

**33.** *Binds*
