INSPECTION REPORT

For the Property at:
74 MCDONNELL STREET
PETERBOROUGH, ON K9H 2V7

Prepared for: TEAM VANRAHAN
Inspection Date: Thursday, September 21, 2023
Prepared by: David Sharman

RE: Report No. 4505
74 McDonnel Street
Peterborough, ON
K9H 2V7

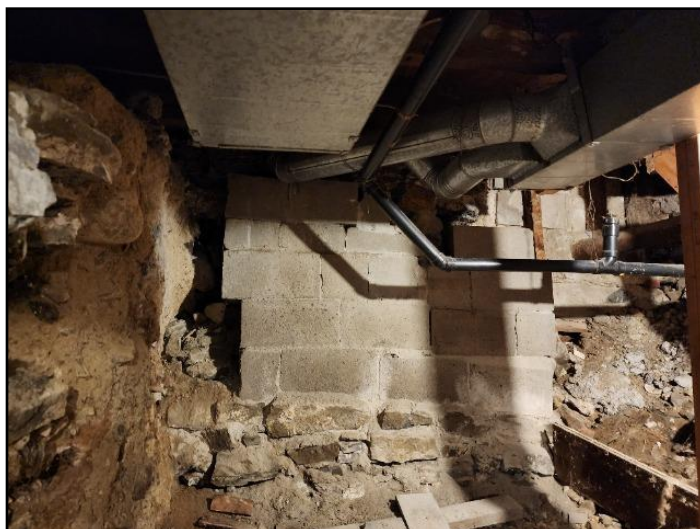
- 3. Condition:** • Prior repairs
- Implication(s):** Weakened structure
- Location:** Rear left corner
- Task:** Monitor
- Time:** Ongoing

3. *Prior repairs*

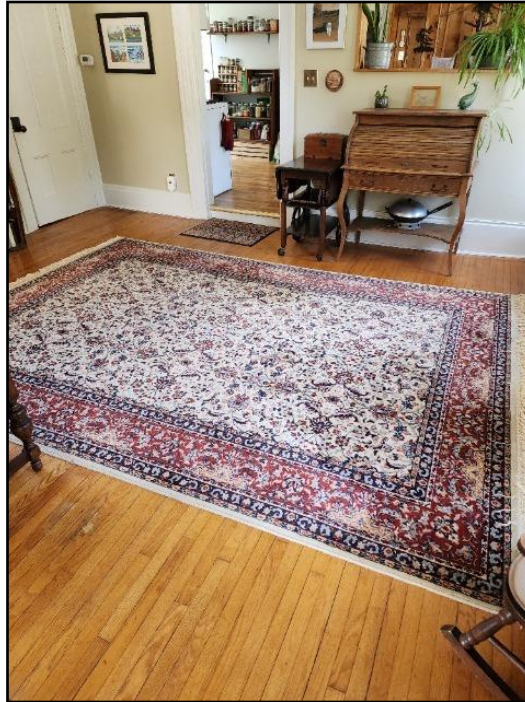
5. Condition: • Sag

Implication(s): Chance of structural movement | Bouncy, springy floors

Location: Dining room

4. Sag

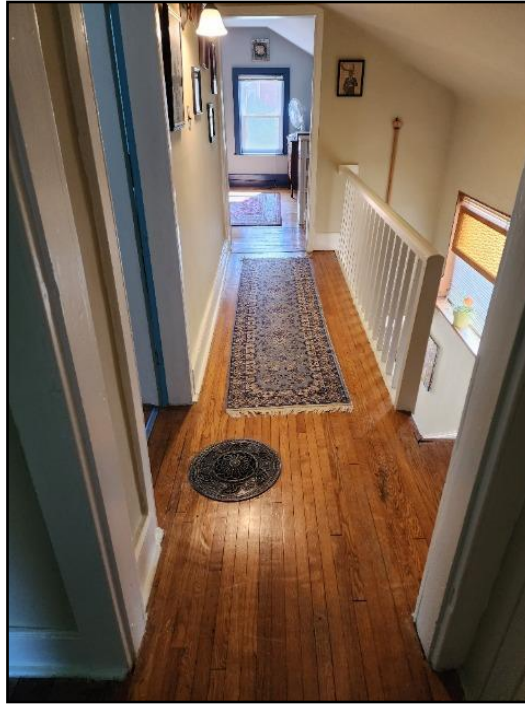
6. Condition: • Slope

Implication(s): Weekend structure, chance of continued movement

Location: Throughout

5. Slope

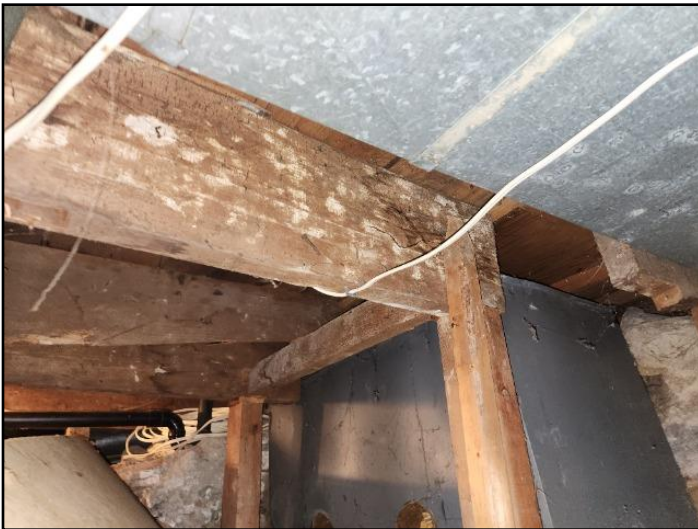
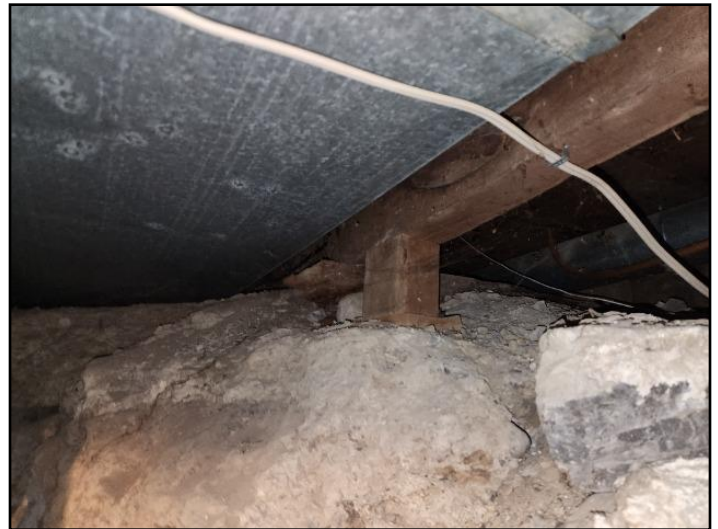
7. Condition: • Prior repairs

Location: Basement

6. Prior repairs

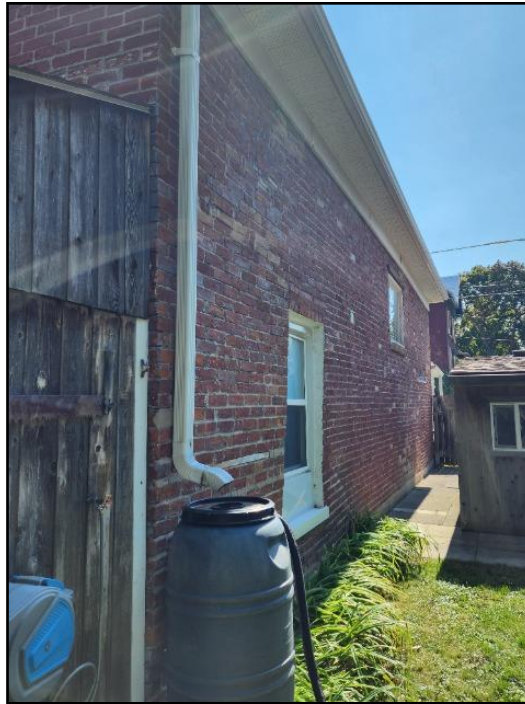
8. Condition: • Prior repairs

Implication(s): No implications exist for this condition

Location: Various locations

8. *Prior repairs*

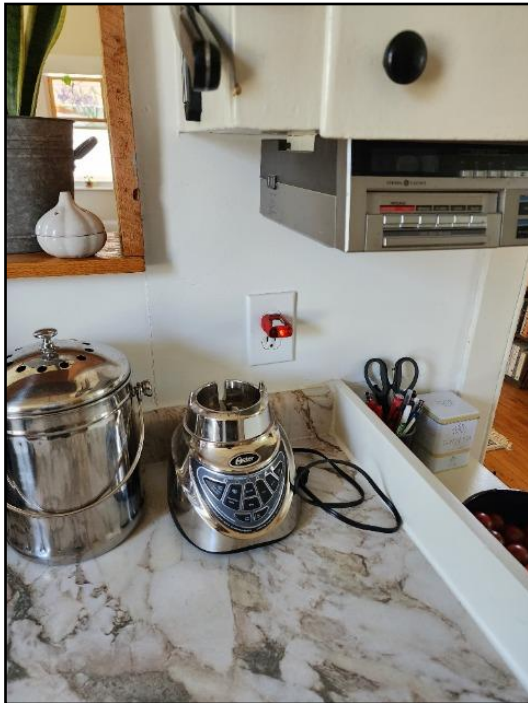
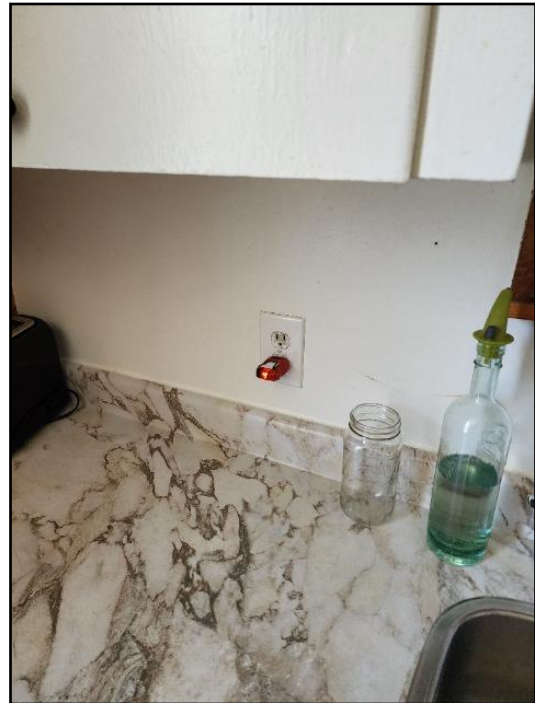
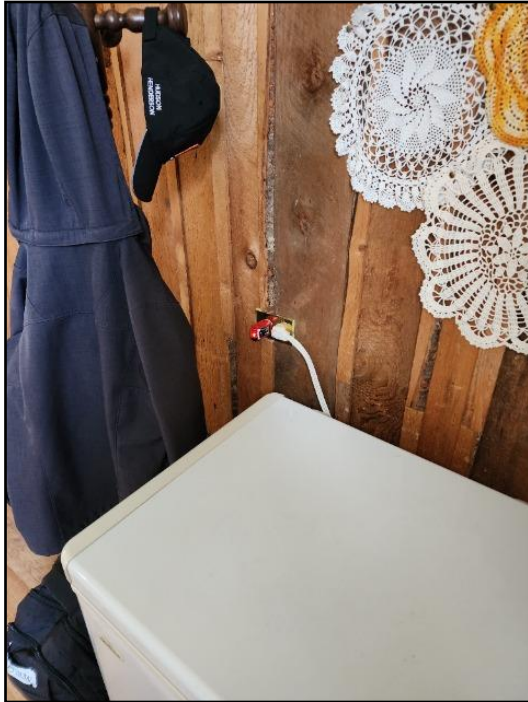
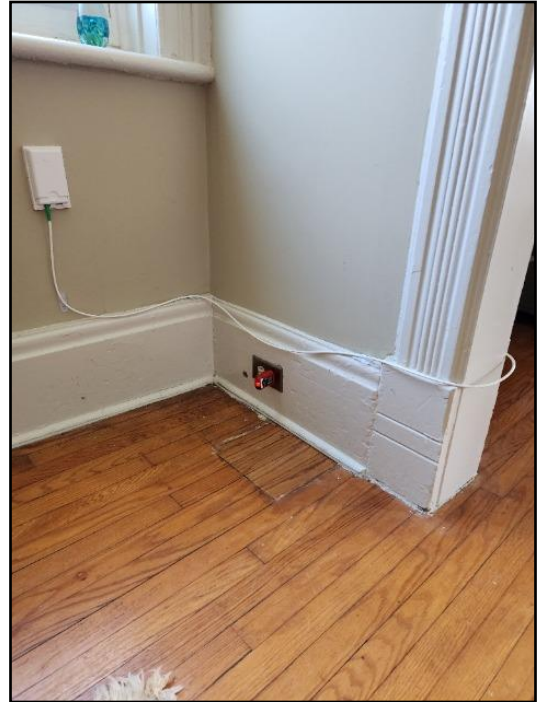
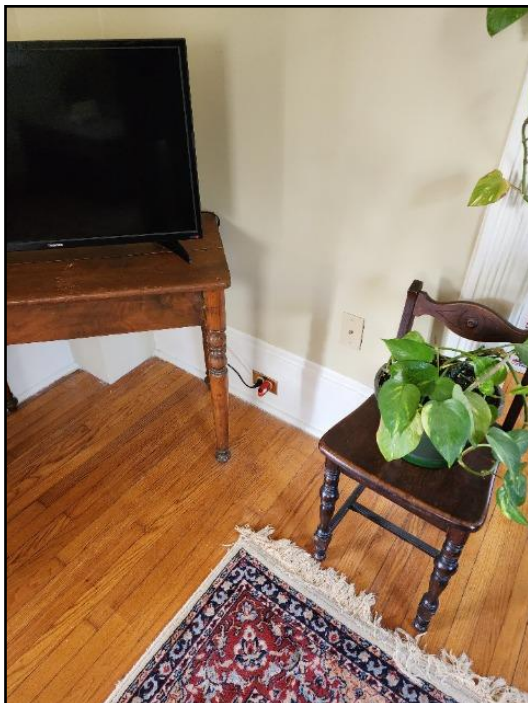
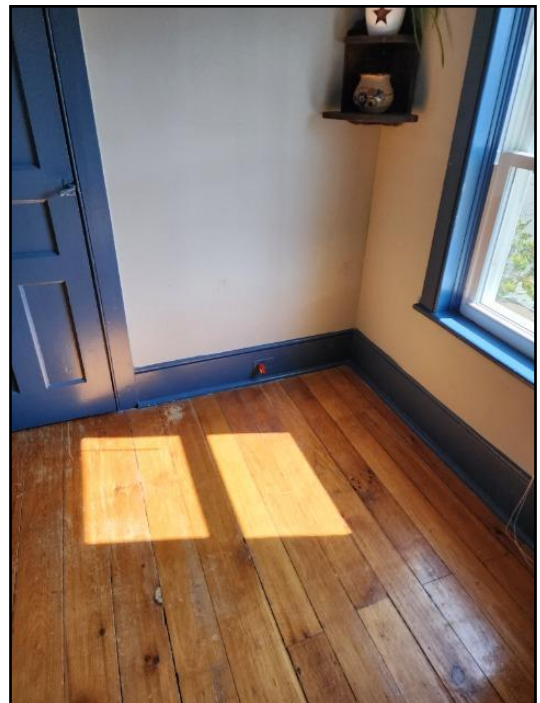
9. Condition: • Ungrounded

Although ungrounded service may be typical in a house of this age, safety may be improved by upgrading these receptacles.

Implication(s): Electric shock

11. *Ungrounded*

Task: Upgrade

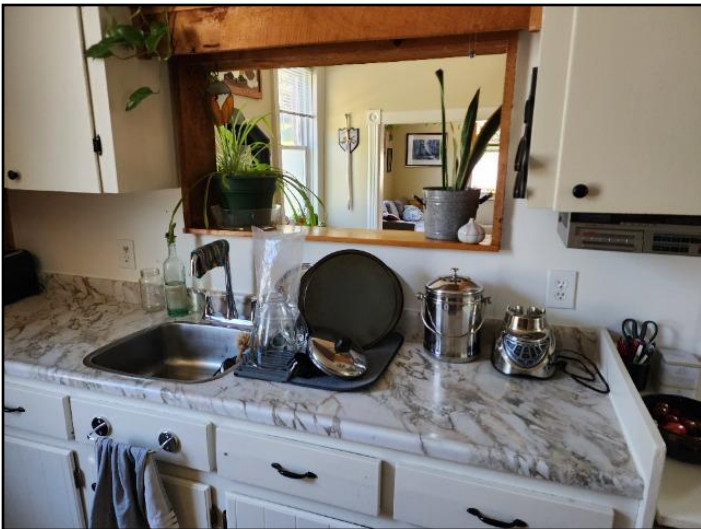
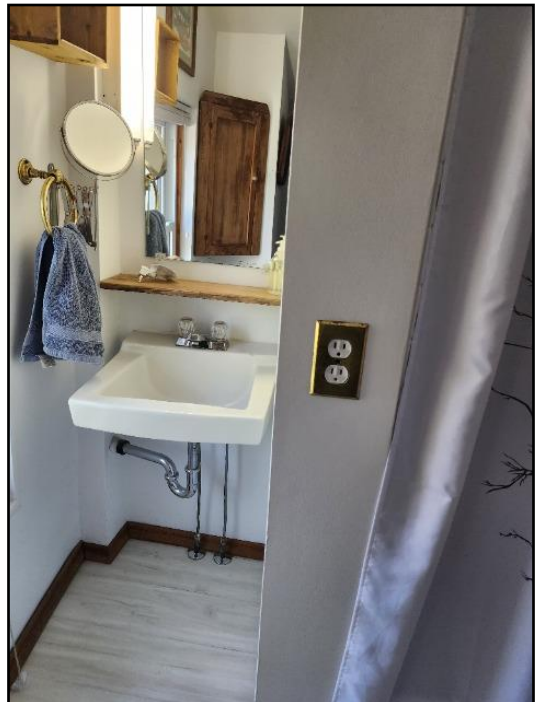
10. Condition: • No GFCI/GFI (Ground Fault Circuit Interrupter)

Although not a deficiency in a home of this age safety may be improved by upgrading these receptacles

Location: Kitchen & bathroom

21. No GFCI/GFI (Ground Fault Circuit...

Task: Upgrade

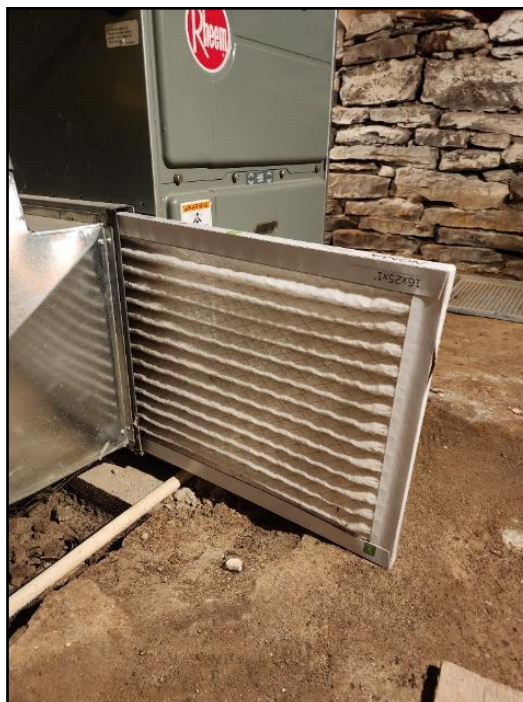
12. Condition: • Replace - regular maintenance

Implication(s): Increased heating & maintenance costs, Reduced comfort

Location: Cold air return

29. Replace - regular maintenance

Task: Replace

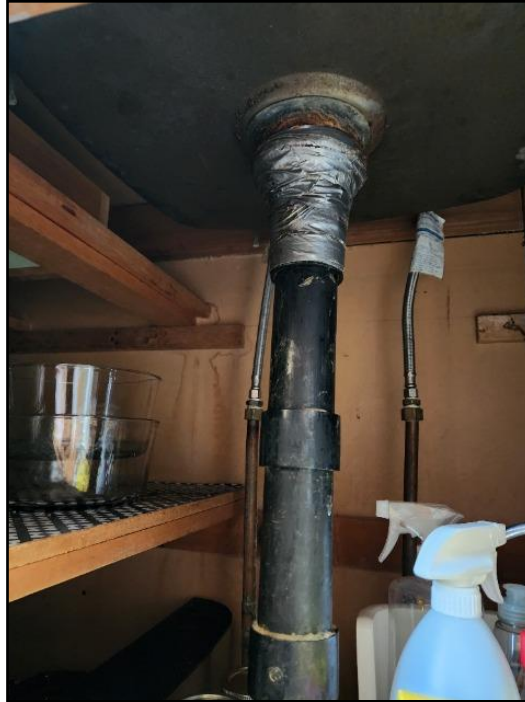
16. Condition: • Leak

Implication(s): Sewage entering the building | Chance of water damage to structure, finishes and contents

36. Leak

Task: Repair or replace

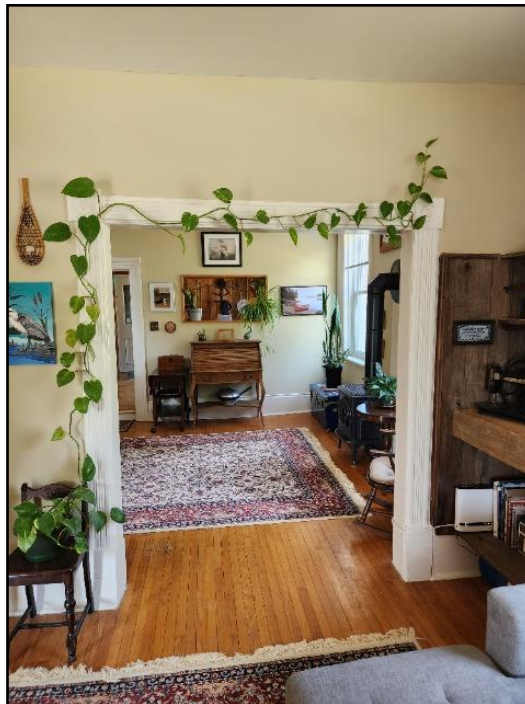
17. Condition: • Racked/out-of-square

Implication(s): Chance of damage to finishes and structure

37. Racked/out-of-square

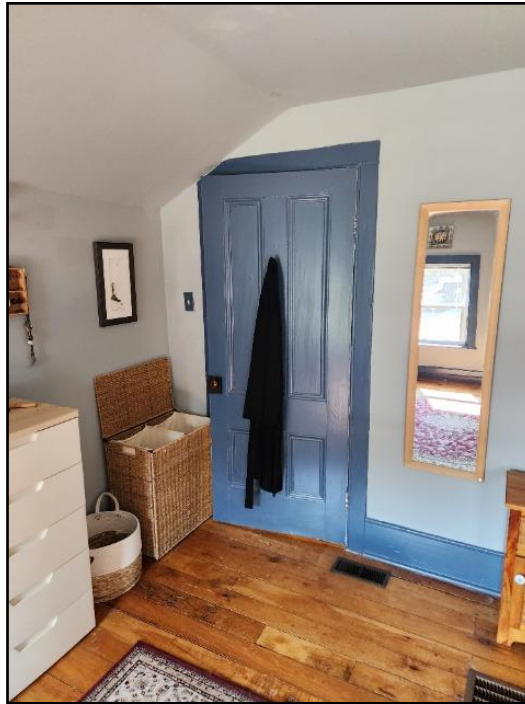
18. Condition: • Binds

38. *Binds*

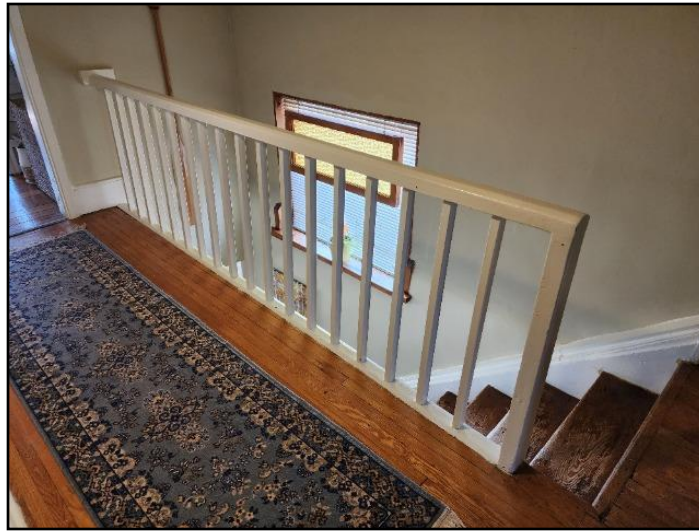
19. Condition: • Too far apart

Implication(s): Fall hazard

39. *Too far apart*

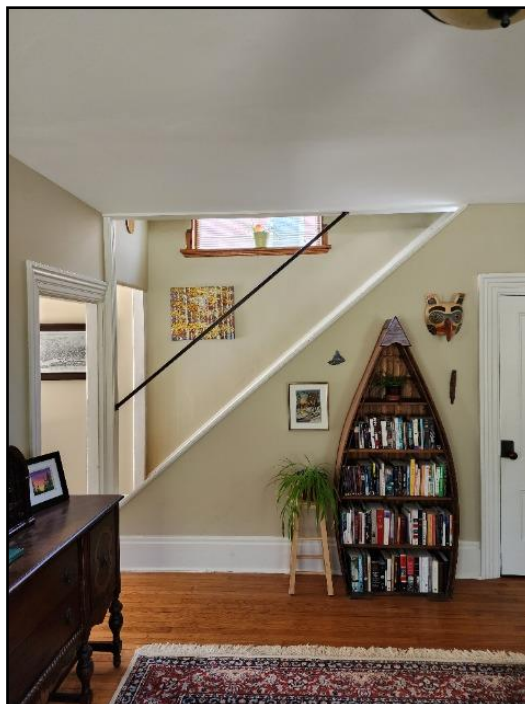
20. Condition: • Missing
Implication(s): Fall hazard
Location: First floor
Task: Provide
Time: Discretionary
Cost: Minor

40. Missing

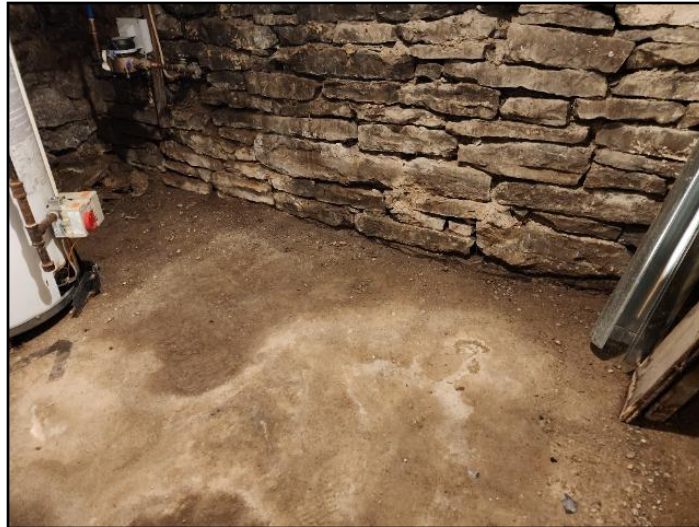
21. Condition: • Dampness on floor or walls

Implication(s): Chance of water damage to structure, finishes and contents | Material deterioration

41. Dampness on floor or walls
