INSPECTION REPORT

For the Property at:
494 CHARLOTTE STREET
PETERBOROUGH, ON K9J 2W3

Prepared for: TEAM VANRAHAN
Inspection Date: Monday, July 29, 2024
Prepared by: David Sharman

RE: Report No. 4915
494 Charlotte Street
Peterborough, ON
K9J 2W3

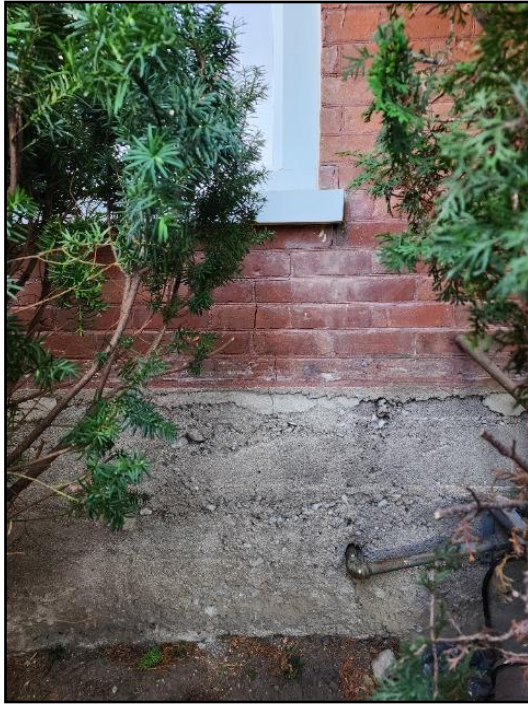
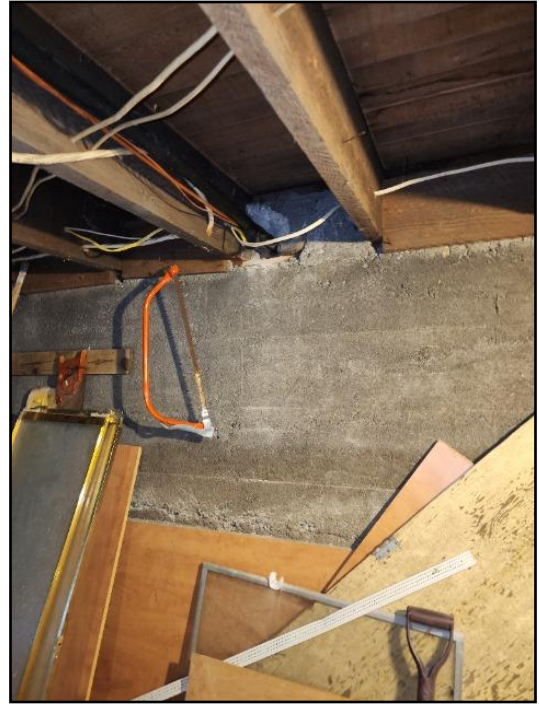
3. Condition: • Typical minor cracks

Implication(s): Material deterioration

Location: Front & right elevations

5. Typical minor cracking

Task: Monitor

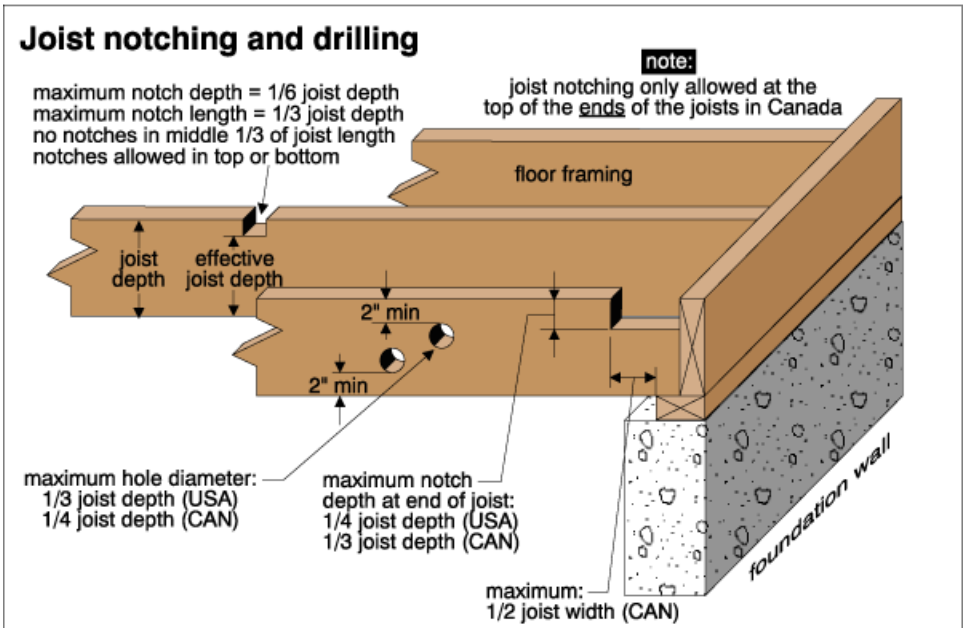
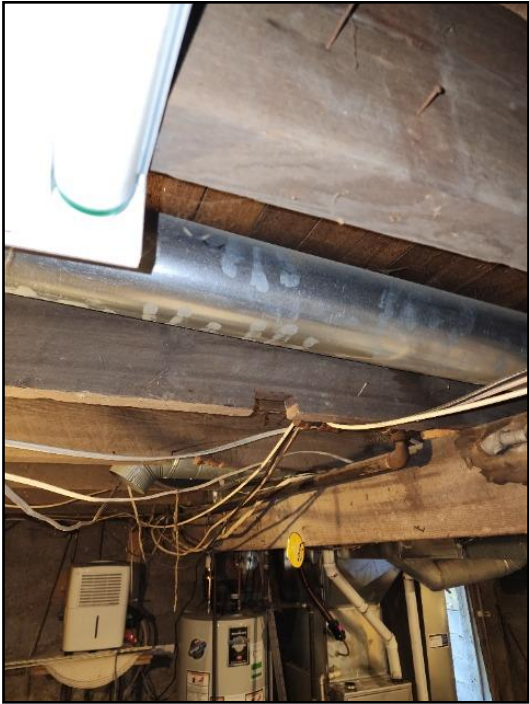
5. Condition: • Notches or holes

Implication(s): Weakened structure

Location: Basement

7. Notches or holes

Task: Repair

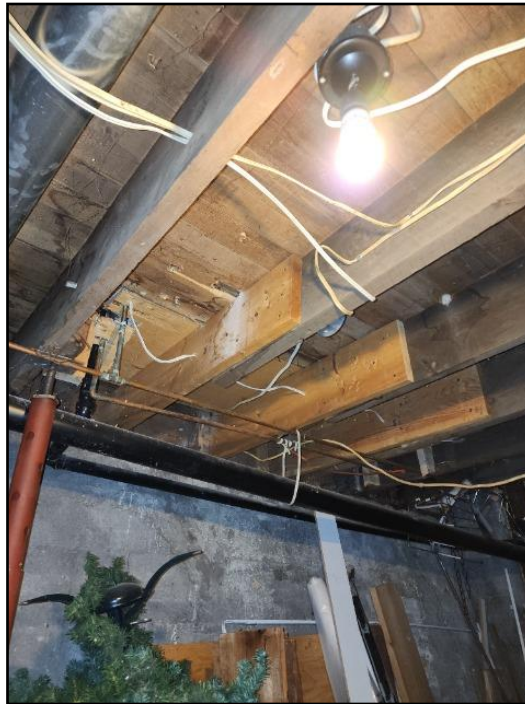
6. Condition: • Prior repairs
Implication(s): Possible weekend structure, Chane of structural movement
Location: Basement
Task: Monitor
Time: Ongoing

8. *Prior repairs*

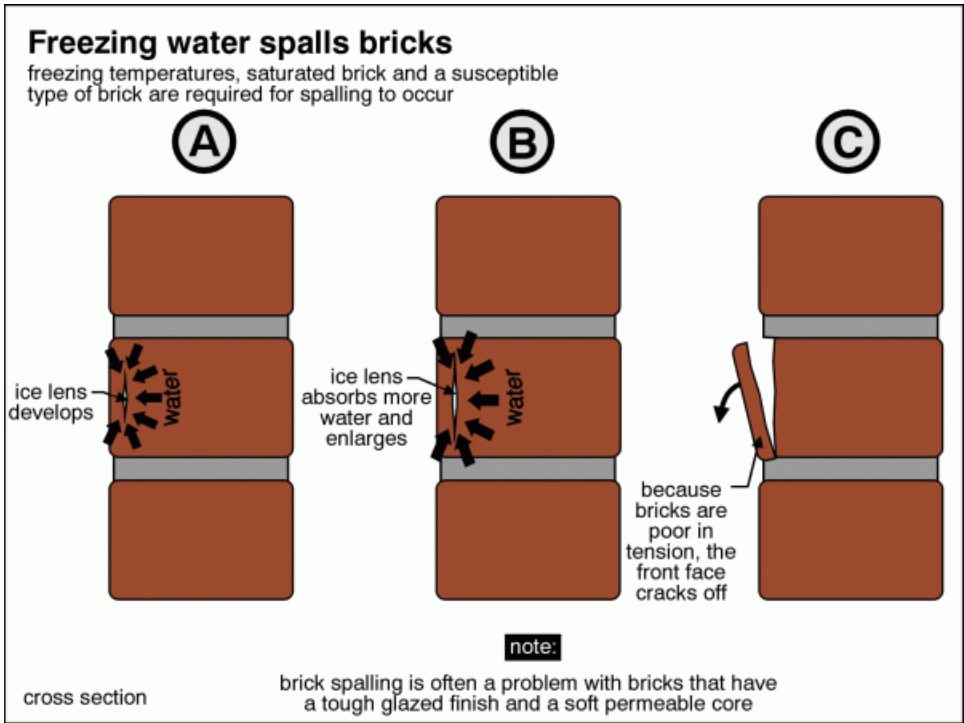
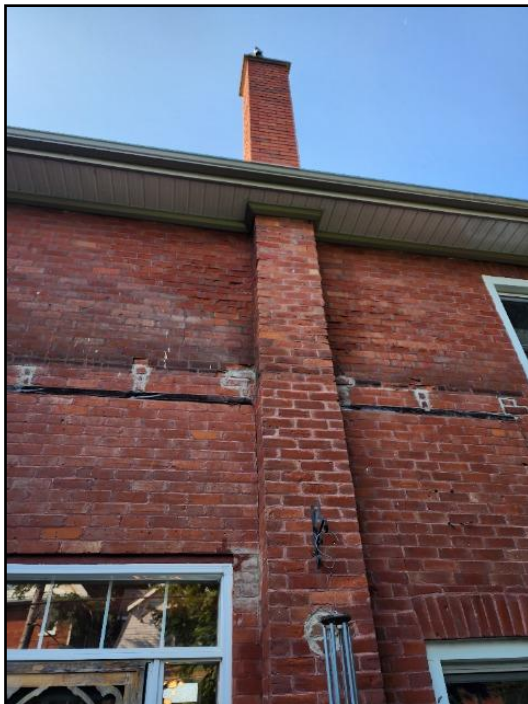
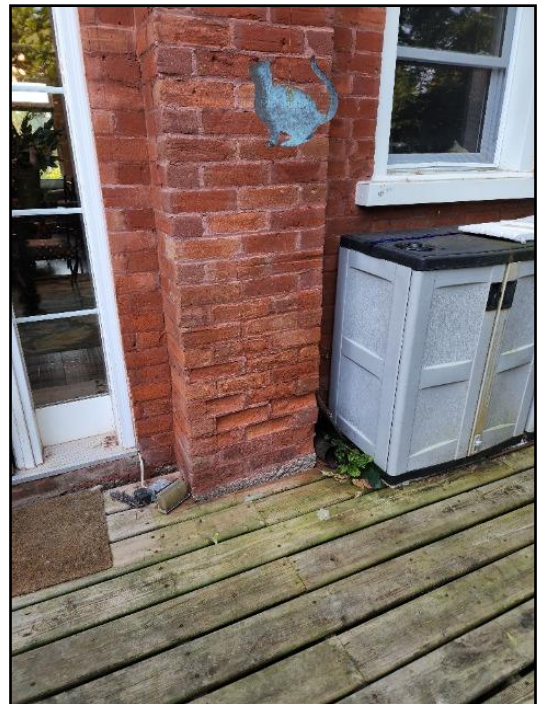
7. Condition: • Masonry deteriorated or spalling

Implication(s): Weakened structure | Chance of structural movement

Location: Rear elevation

9. Masonry deteriorated or spalling

Task: Repair

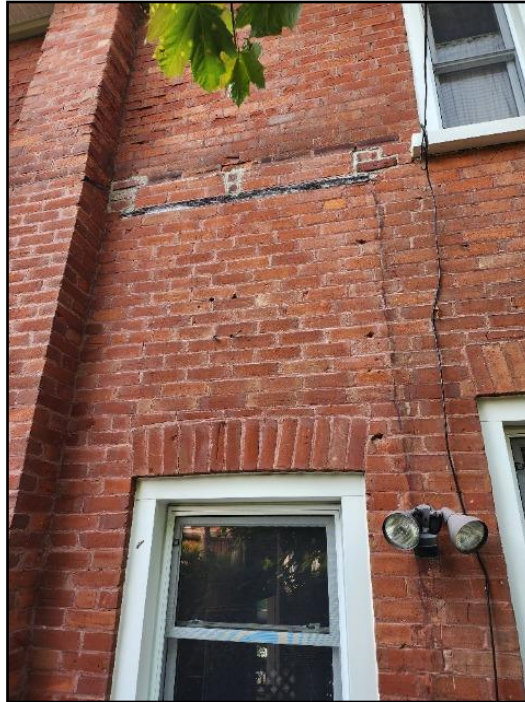
8. Condition: • Typical minor cracking

Implication(s): Material deterioration

Location: Front & rear elevations

11. *Typical minor cracking*

Task: Repair

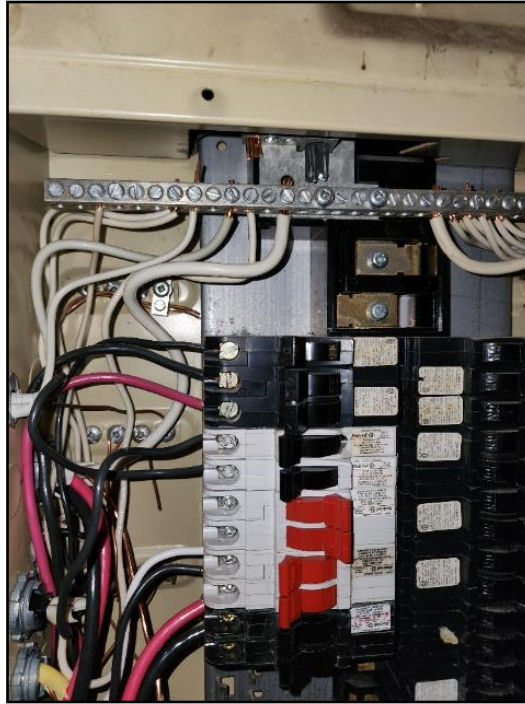
9. Condition: • Breakers too big

40 Amp breakers on a 10 gauge branch circuit wire. Although not a deficiency in a panel of this age, safety may be improved by replacing this breaker.

Implication(s): Equipment overheating | Fire hazard

14. Breakers too big

Task: Improve

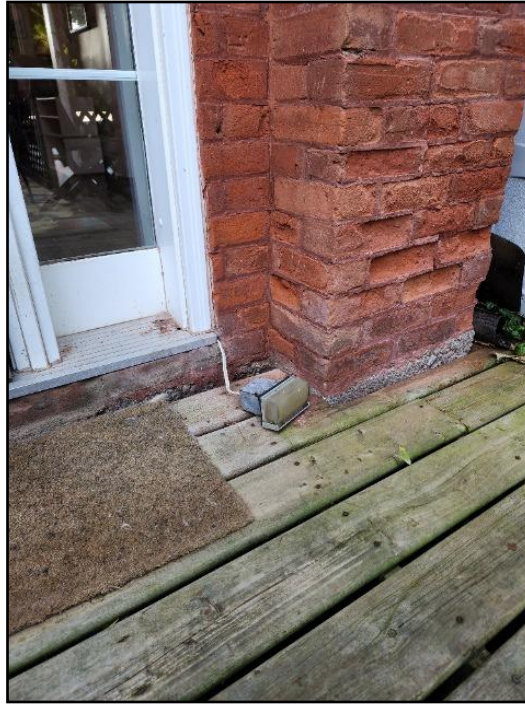
10. Condition: • Loose

Implication(s): Electric shock | Fire hazard

Location: Exterior wall

15. Loose

Task: Repair

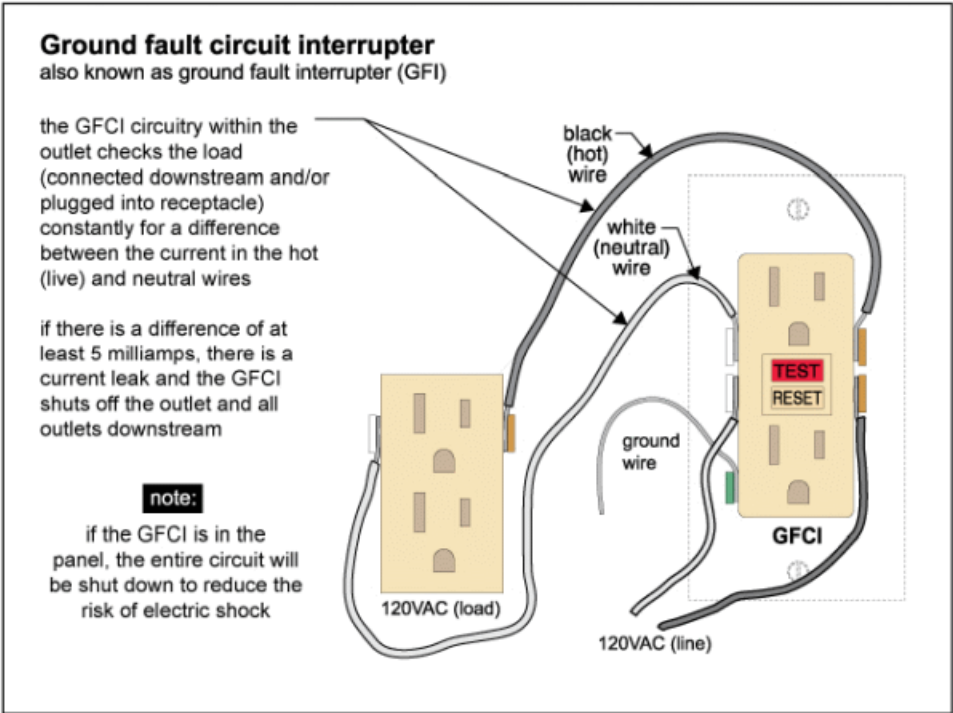
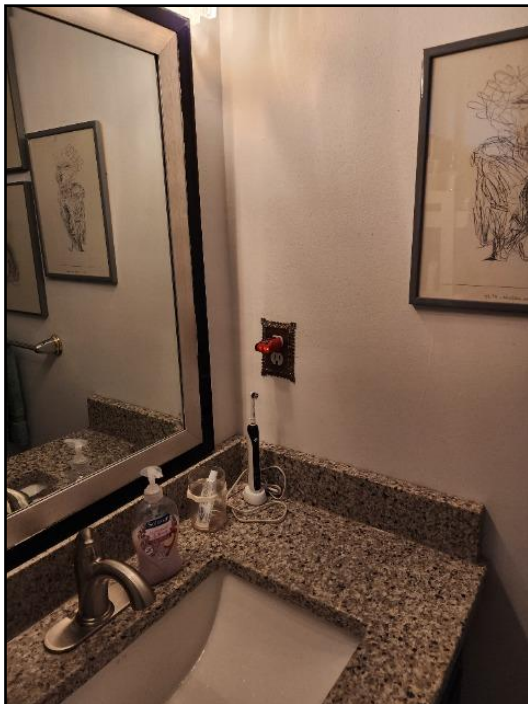
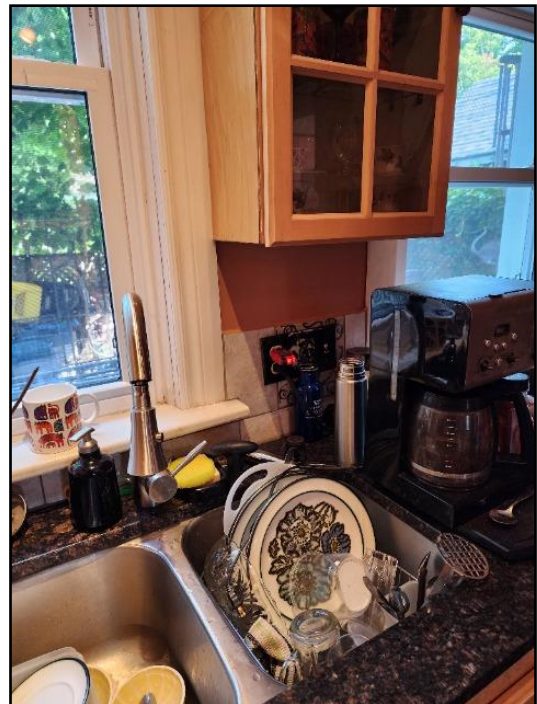
11. Condition: • No GFCI/GFI (Ground Fault Circuit Interrupter)

Although not a deficiency in a home of this age safety may be improved by upgrading these receptacles.

Implication(s): Electric shock

Location: Kitchen & bathroom

16. No GFCI/GFI (Ground Fault Circuit...

Task: Upgrade

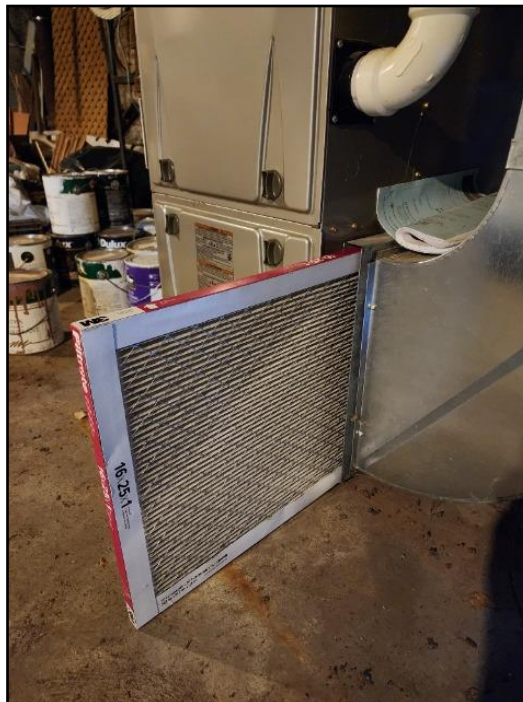
13. Condition: • Replace - regular maintenance

Implication(s): Increased heating & maintenance costs, Reduced comfort

Location: Cold air return

22. Replace - regular maintenance

Task: Replace - regular maintenance

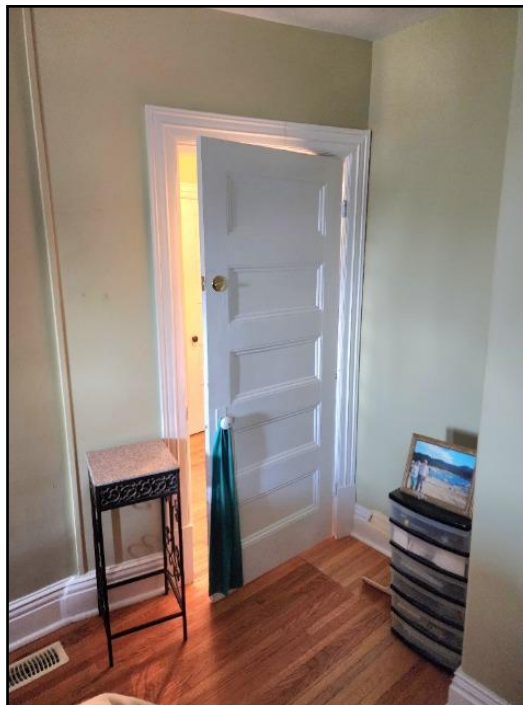
17. Condition: • Binds

29. *Binds*

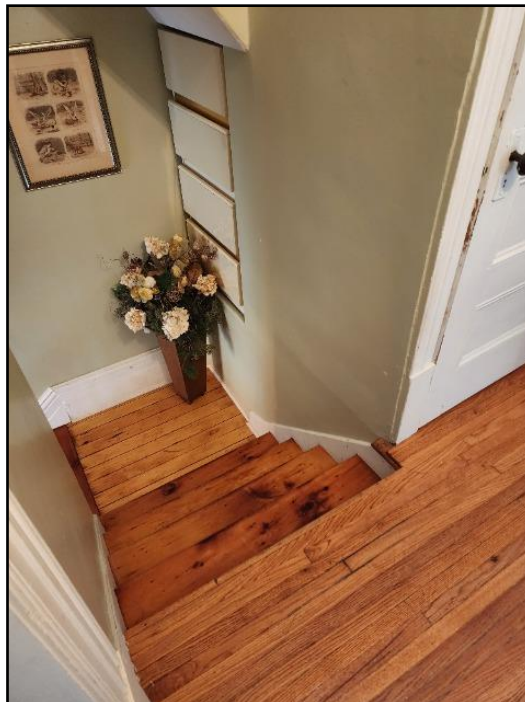
18. Condition: • Missing

Implication(s): Fall hazard

30. Missing

Task: Replace
