INSPECTION REPORT

For the Property at:
608 FREDRICK STREET
ENNISMORE, ON

Prepared for: TEAM VANRAHAN
Inspection Date: Wednesday, May 17, 2023
Prepared by: David Sharman

RE: Report No. 4322
608 Fredrick Street
Ennismore, ON

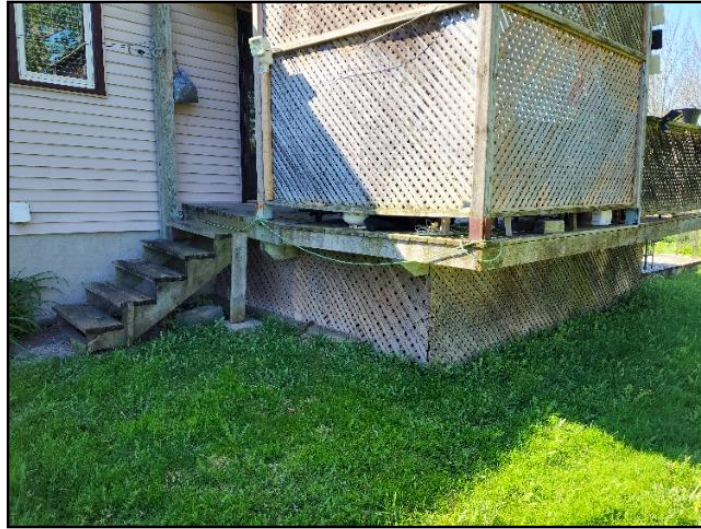
PORCHES, DECKS, STAIRS, PATIOS AND BALCONIES \ Columns / Posts

2. Condition: • Settled

Implication(s): Chance of movement | Weakened structure

Location: Raised decking

3. Settled

Task: Repair

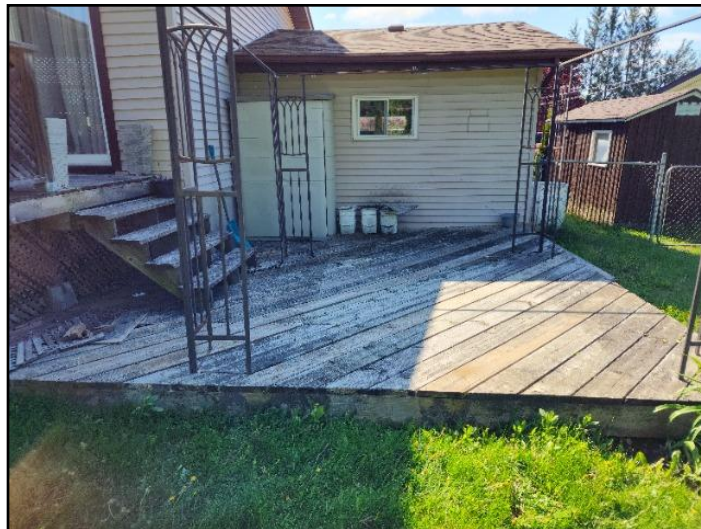
PORCHES, DECKS, STAIRS, PATIOS AND BALCONIES \ Floors

3. Condition: • Rot

Implication(s): Material deterioration | Chance of movement | Weakened structure

Location: Rear decking

4. Rot

Task: Repair

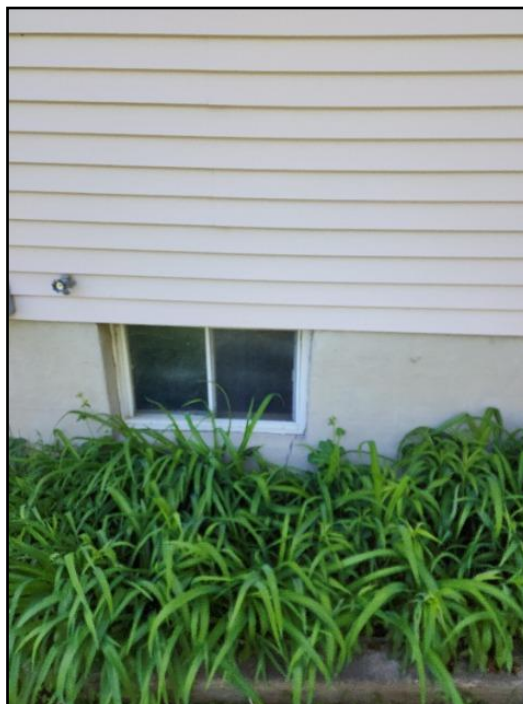
4. Condition: • Typical minor cracks
Implication(s): Material deterioration
Location: Rear elevation
Task: Repair
Time: Discretionary
Cost: Minor

5. Typical minor cracks

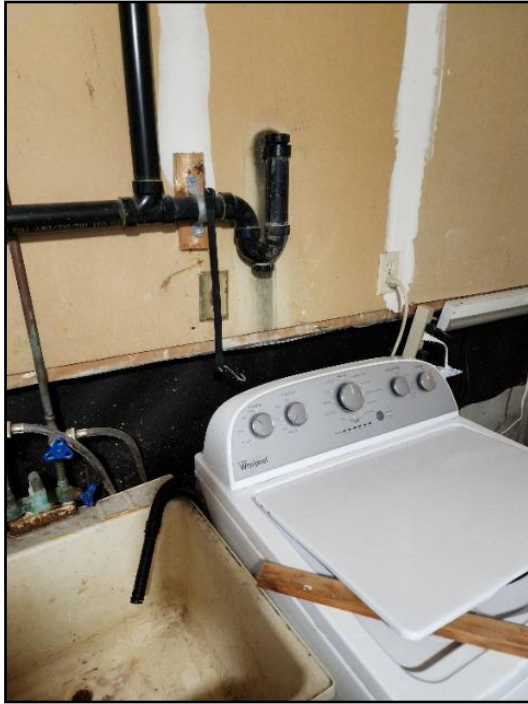
6. Condition: • No GFCI/GFI (Ground Fault Circuit Interrupter)

Although not a deficiency in a home of this age, safety may be improved by upgrading these receptacles.

Implication(s): Electric shock

Location: Laundry & kitchen

8. No GFCI/GFI (Ground Fault Circuit...

Task: Upgrade

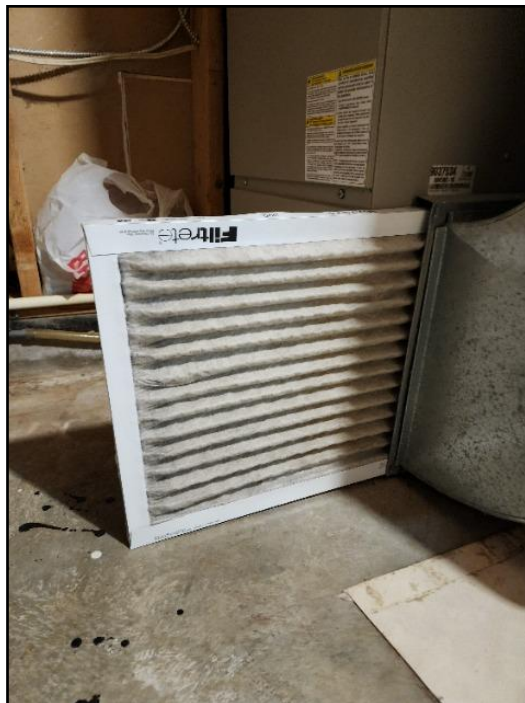
GAS FURNACE \ Mechanical air filter

8. Condition: • Replace - regular maintenance

Implication(s): Increased heating & maintenance costs, Reduced comfort

Location: Cold air return

16. Replace - regular maintenance

Task: Replace

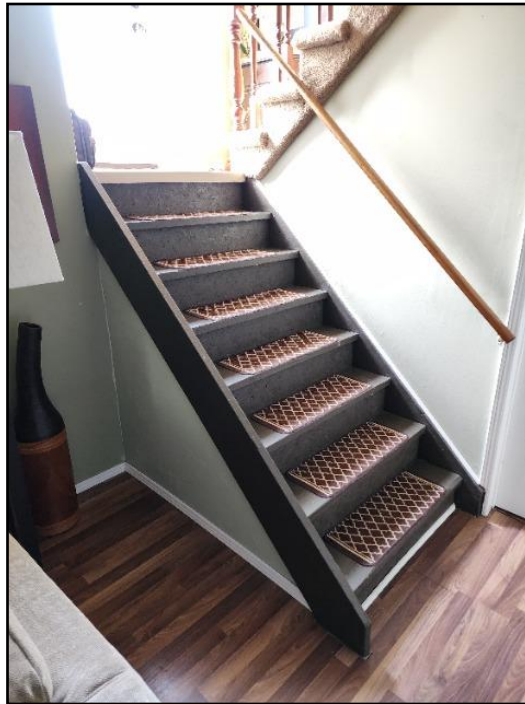
STAIRS \ Guardrails

13. Condition: • Missing
Implication(s): Fall hazard
Location: Basement
Task: Provide
Time: Discretionary
Cost: Minor

28. Missing

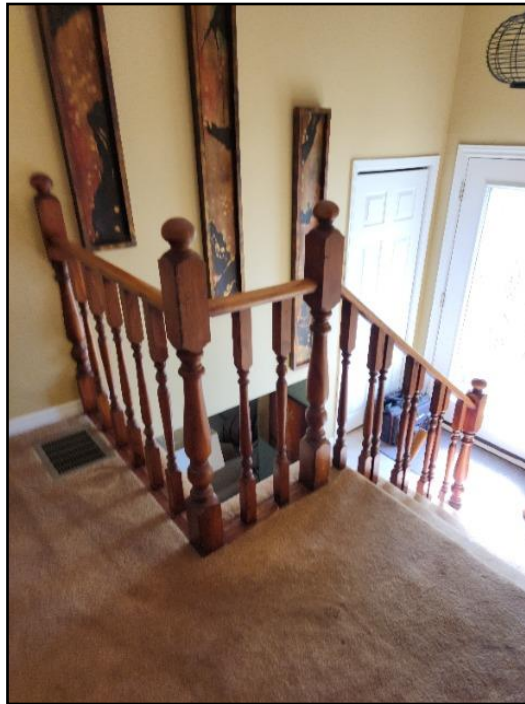
STAIRS \ Spindles or balusters

14. Condition: • Too far apart

Implication(s): Fall hazard

29. *Too far apart*
