England Home Inspections LLC  
102 Benoir Trail  
Madison,, AL 35756

133 Dustin Lane NW  
Madison, Alabama 35757

## Marginal Summary

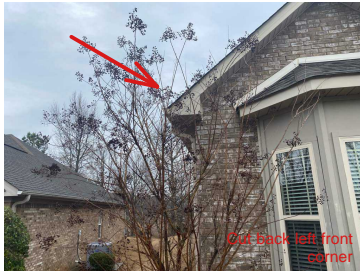
1. Vegetation Trees and Shrubs - Recommend cutting back all trees and shrubs that are close enough to touch the house during windy conditions to prevent damage to the house. See pictures for locations.

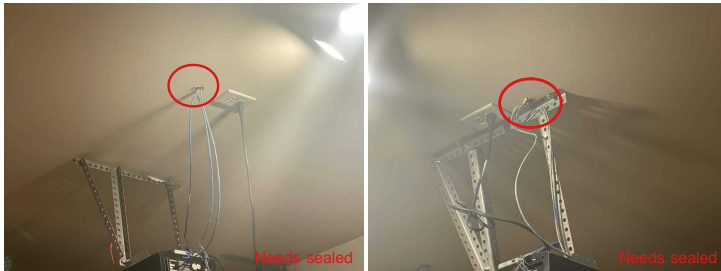
2. Attached Garage Ceiling/Walls/Firewall Drywall and Paint - Recommend sealing the garage ceiling where the wiring for the vehicle door(s) opener passes through. This hole hurts fire integrity for the firewall in the garage.

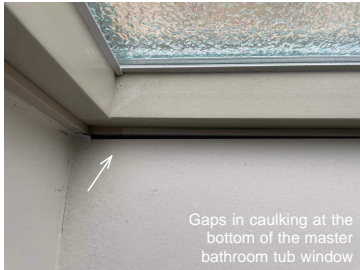
4. Interior Living Space Interior Doors Recommend Repairs - The doorknob was loose for the master bedroom closet door at time of inspection. Recommend evaluation and repairs. **TBD**
5. Interior Living Space Windows Vinyl slider - Gaps were noted in the caulking at the bottom of the interior frame of the master bathroom tub window. See picture. Recommend evaluation and repairs. **AS IS**
  - - Minor gaps were noted in the interior caulking around the interior frames for multiple windows throughout the house at time of inspection. Repairs would be cosmetic.
  - - Note: The blinds at the back left bedroom windows did not function properly during the inspection. The pull strings at the left side of the blinds to alter the position of the blinds to block out and allow sunlight did not function properly. Repairs would be considered an upgrade.

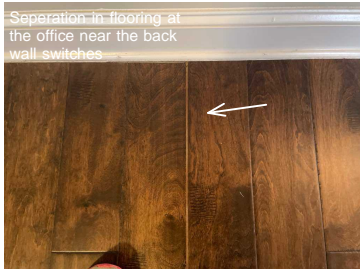
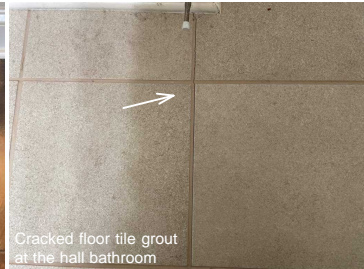
6. Interior Living Space Floors Wood, Carpet, and Tile - An area of minor separation was noted in the wood flooring at the front right office area near the back right corner switches. Repairs would be cosmetic.
- - Areas of cracked floor tile grout were noted at the hall bathroom flooring at time of inspection. No sharp edges were present. Repairs would be cosmetic.

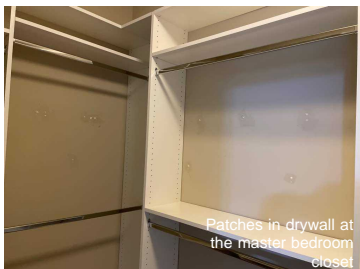
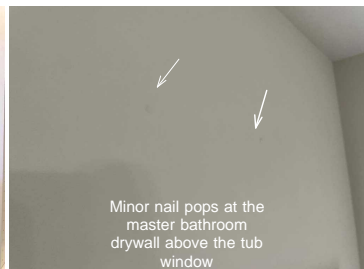
7. Interior Living Space Walls Drywall - Minor patches were noted in the drywall at the master bedroom closet walls and at the master bathroom linen closet. Repairs would be cosmetic.
- - Minor nail pops were noted in the drywall throughout the house at time of inspection. Repairs would be cosmetic.

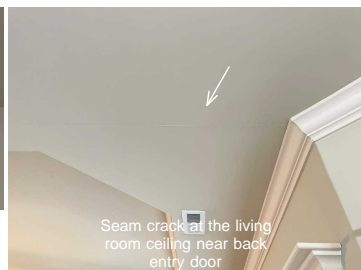
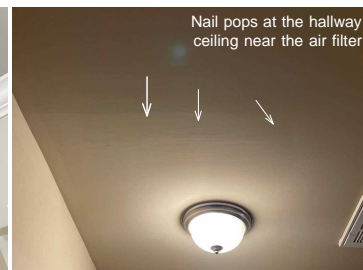
8. Interior Living Space Ceilings Drywall - Nail pops were noted in the ceiling drywall throughout the house at time of inspection. Repairs would be cosmetic. **AS IS**
- - A seam crack was noted in the living room ceiling drywall near the back exterior door at time of inspection. Repairs would be cosmetic.

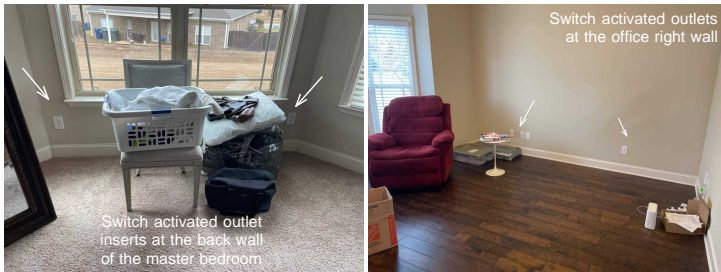
9. Interior Living Space Interior Outlets Appears Serviceable - Note: The top outlet inserts tested as being switch activated for the two outlets at the back wall of the master bedroom. **AS IS**
- - Note: The top outlet inserts tested as being switched activated for the two office outlets at the right wall.

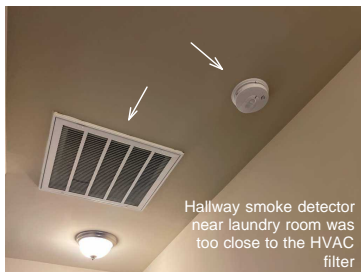
10. Interior Living Space Smoke Detectors Recommend Repairs - The smoke detector at the hallway area near the laundry room appeared to be installed too close to the HVAC air register at time of inspection. Smoke detectors are not allowed to be installed within 3 feet of an HVAC air register. In my opinion this does not impede the functionality of smoke detectors significantly. Recommend evaluation and possible repairs to relocate the smoke detector.

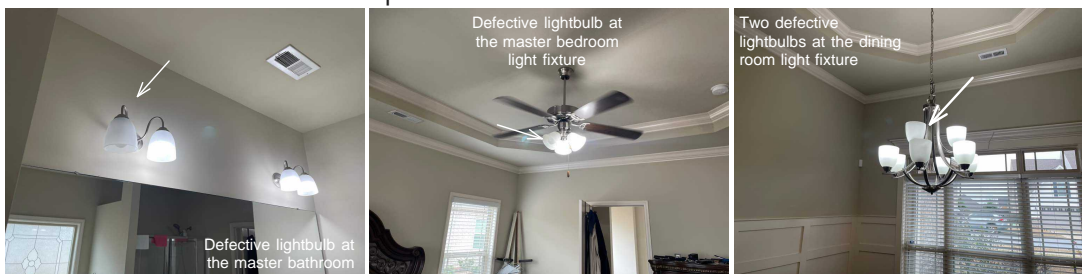
11. Interior Living Space Ceiling Fans Recommend Repairs - The ceiling fan at the master bedroom was out of balance and wobbled during operation. Recommend evaluation and possible repairs. **AS IS**
- The ceiling fan at the living room was out of balance and wobbled during operation. Recommend evaluation and possible repairs.
12. Interior Living Space Interior Lighting Recommend Repairs - One of the master bathroom lightbulbs above the left master bathroom sink was defective. Recommend evaluation and repairs. **TBD**
- One of the lightbulbs at the master bedroom light fixture did not function during the inspection. Recommend evaluation and repairs.

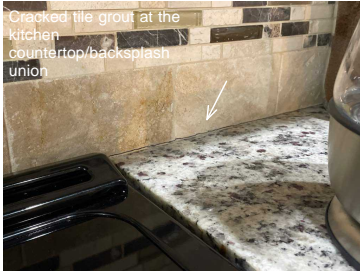
14. Main Floor Kitchen Counter Tops: Granite - Gaps/cracks were present in the tile grout at the backsplash/countertop unions in the kitchen. Repairs would be cosmetic.
