Hanna Home Inspection

Home Inspection Report

1248 Enfield, Forest Glade, ON

Inspection prepared for: Al Teshuba
Date of Inspection: 9/7/2024

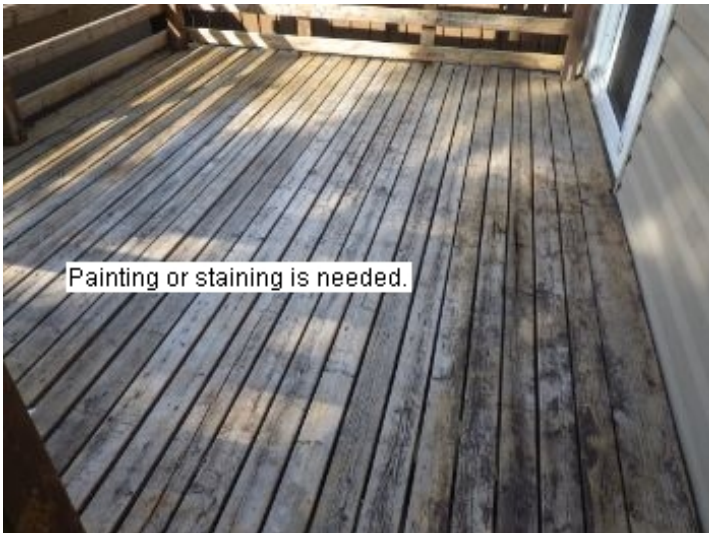
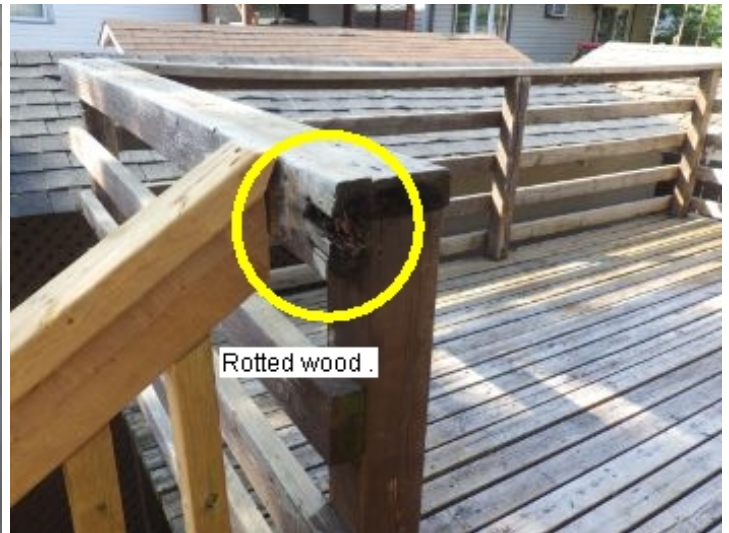
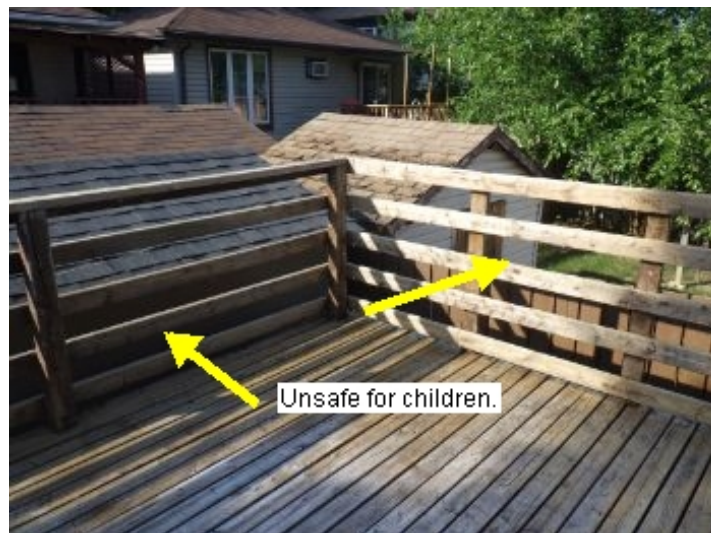
11. Deck Condition

- Peeling paint observed, suggest scraping and painting as necessary.
- Wood deterioration observed. Suggest repairs/replacement as needed.
- Deck railing is non-compliant as it offers "climbing bars" which will allow children to climb over railing. Recommend replacement by railing with vertical spacing not exceeding 4".

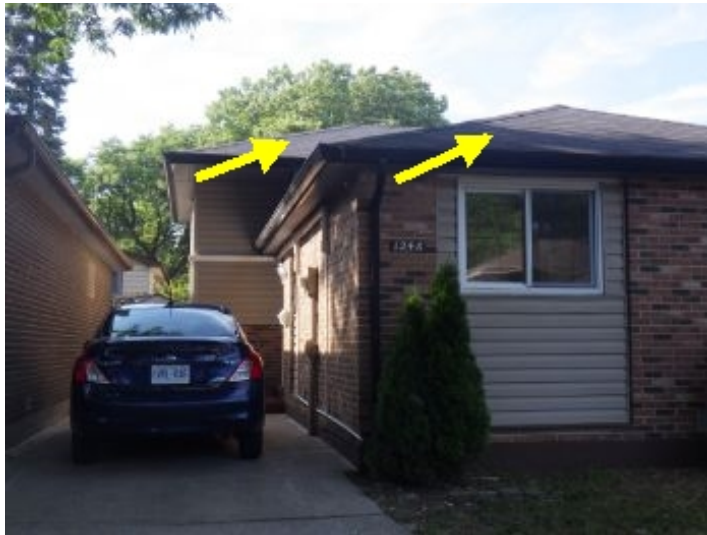
3. Roof Comments

- Roof appeared serviceable at time of inspection. No prediction of future performance or warranties can be offered.

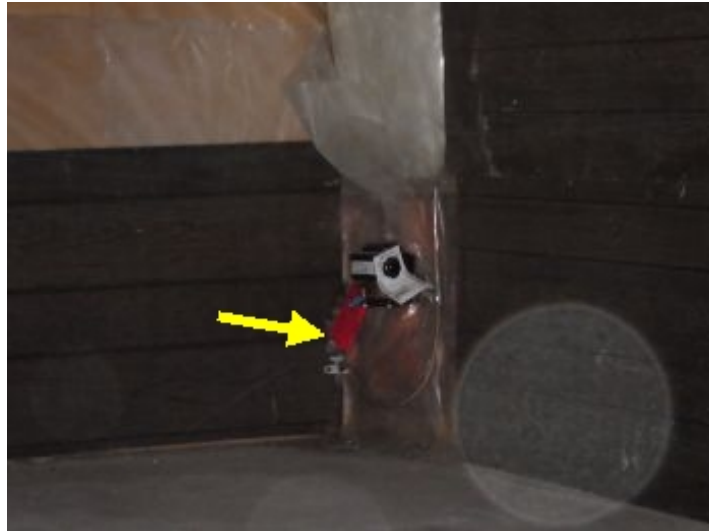
1. Main Shutoff Location

- Ground wire in place. Compliant 3/4" copper supply line.
- Crawlspace
- Since main shutoff valves are operated infrequently, it is not unusual for them to become frozen over time. They often leak or break when operated after a period of inactivity. For this reason main shutoff valves are not tested during a home inspection. We suggest caution when operating shutoffs that have not been turned for a long period of time. All shutoff valves and angle stops should be turned regularly to ensure free movement in case of emergency.

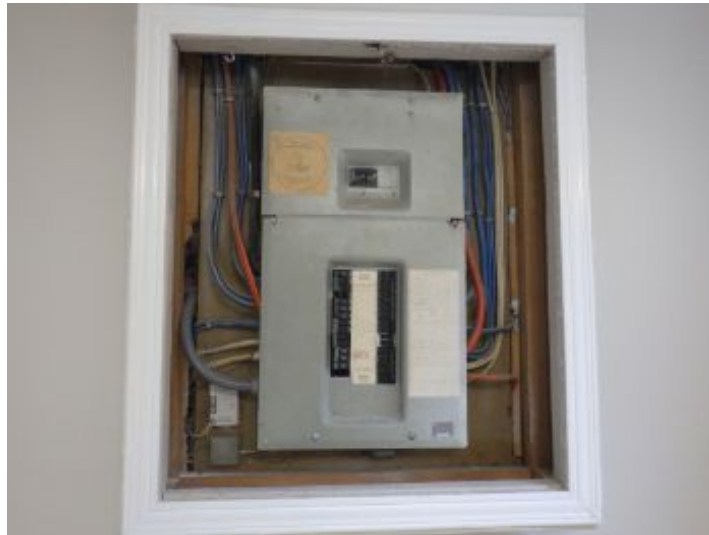
3. Main Panel Comments

- **AFCI** protection in bedroom branch circuits in a new requirement, not present in this house.
- Minor corrosion noted in panel.

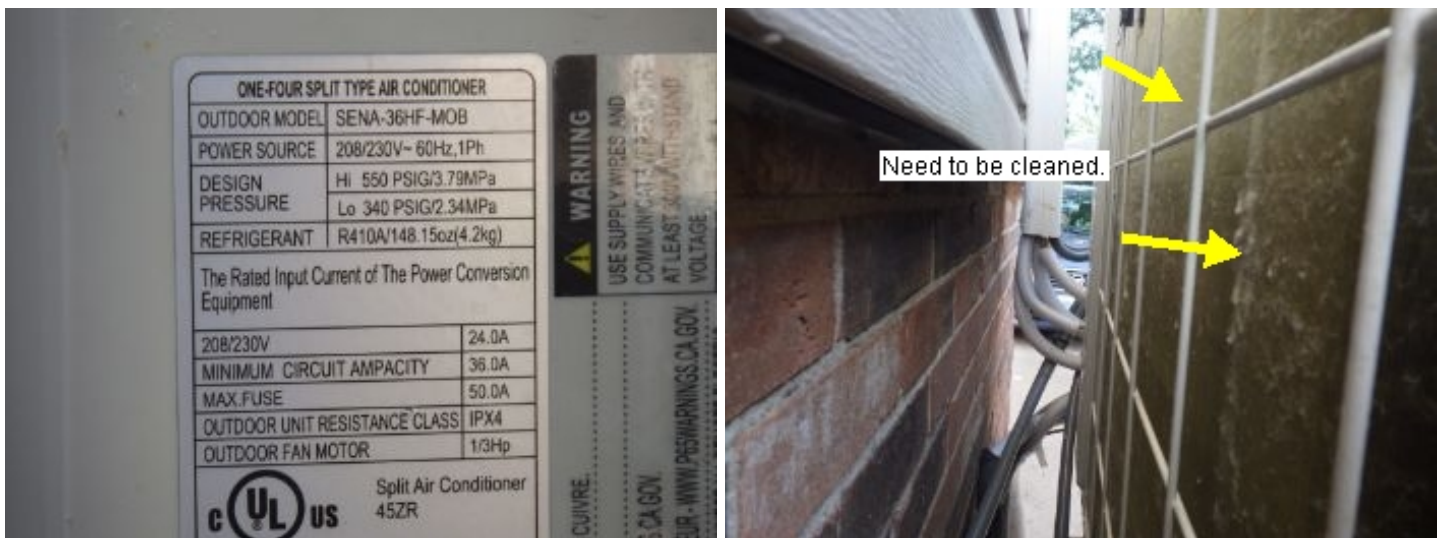
1. Air Conditioning Comments

- Air conditioning operational during inspection and appeared to be performing satisfactorily. Buyer is advised to verify satisfactory operation prior to close.
- **Coils are dirty or full of debris, suggest cleaning coils regularly for proper operation.**

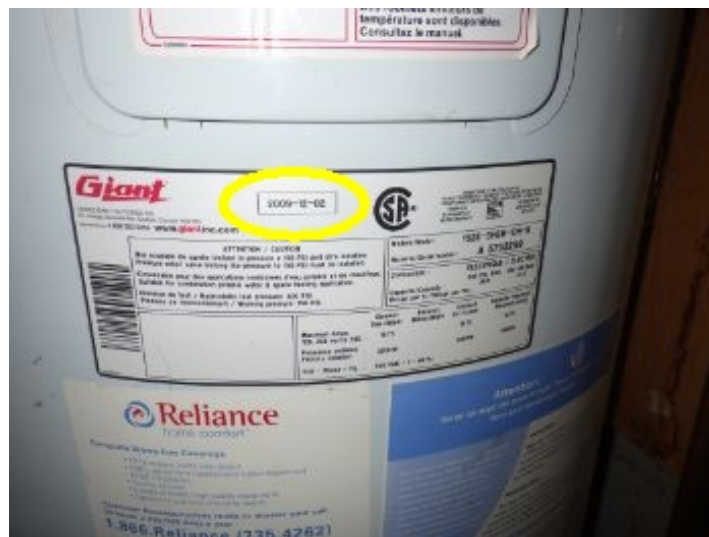
3. Water Heater Comments

The water heater is located in the laundry room, has a 40 gallon capacity, and is about 15 years old. Average life expectancy is about 12-15 years.

- Children should be kept away from water heater as the high pressure release valve, if disturbed, can cause scalding.
- Serviceable at time of inspection. No warranties can be offered on this or any other appliance.

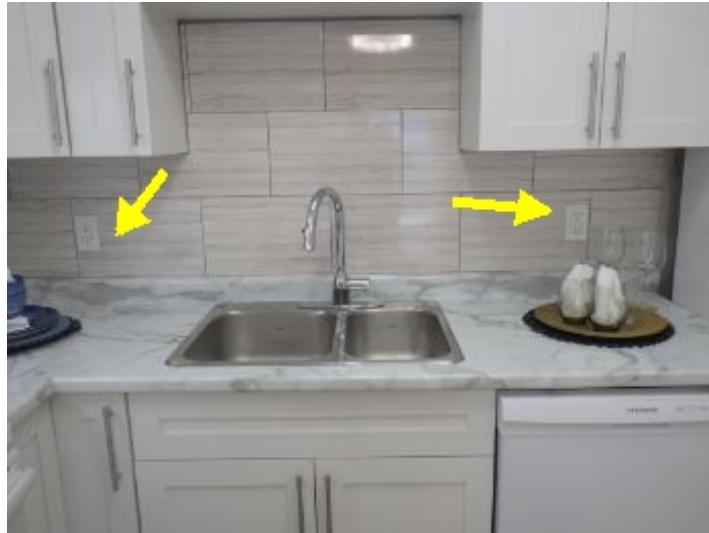
1. Kitchen Electrical Condition

- **GFCI** protected receptacles may not have been required when the house was built. We suggest buyer consider upgrading with GFCI's at all receptacles near water sources.

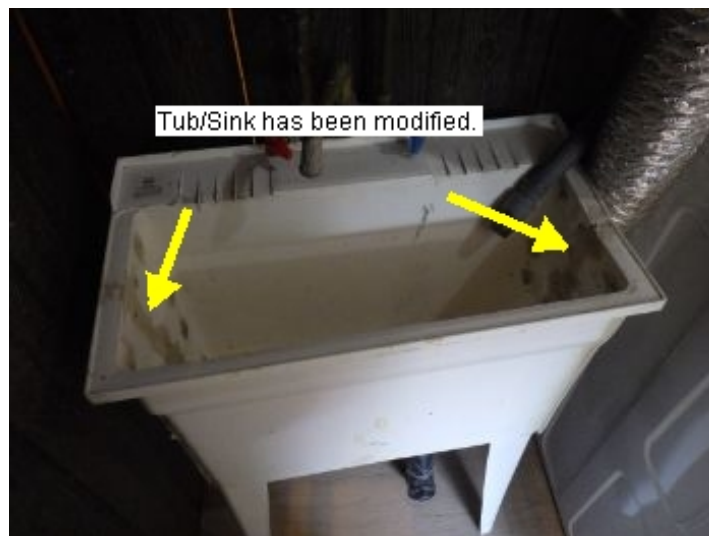
2. Laundry Tub/Sink Condition

- In the inspectors opinion the sink is near the end of its useful life due to Cut in half.
- Recommend review for repair or replacement as necessary.

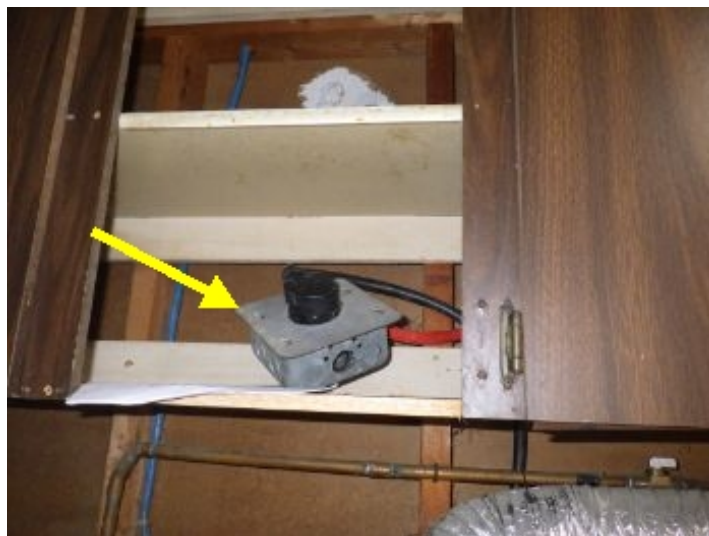
3. Electrical Conditions

- Improper use of dryer cord observed. Electrical box/cords should not be loose or be routed through walls, floors or partitions. Needs to be secured to the wall properly.

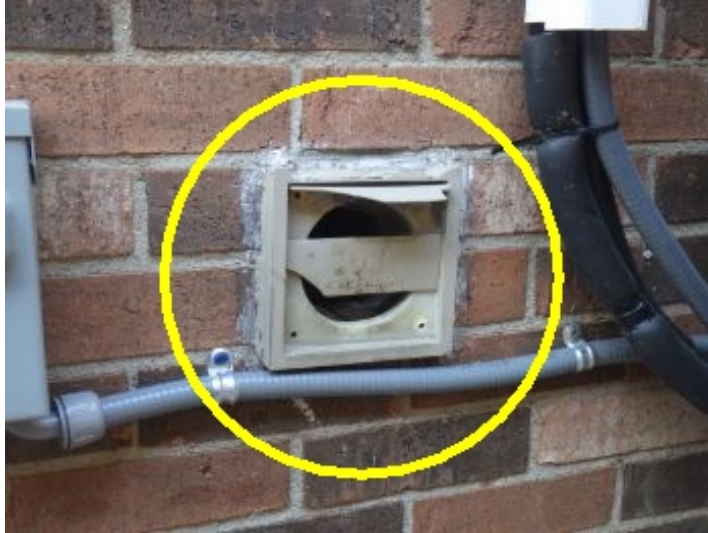
5. Dryer Hook-ups

- Electric
- Dryer exhaust outlet needs to be replaced.
