# YOUR INSPECTION REPORT

3182 Monck Road  
Kawartha Lakes, ON K0M 2L0

RE: Report No. 4070  
3182 Monck Road  
Kawartha Lakes, ON  
K0M 2L0

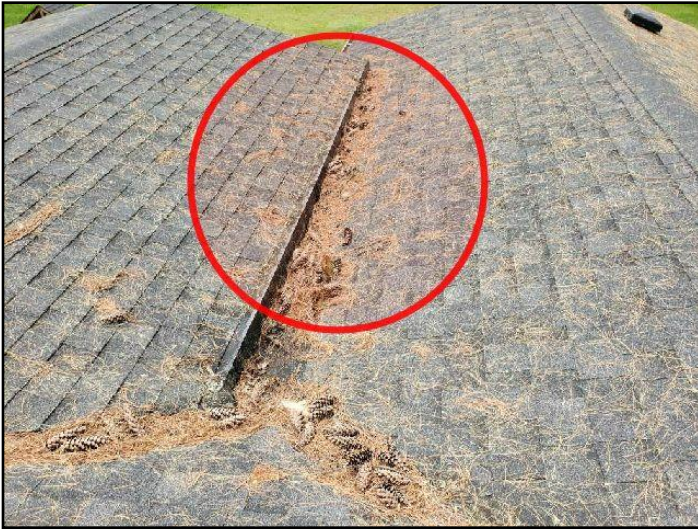
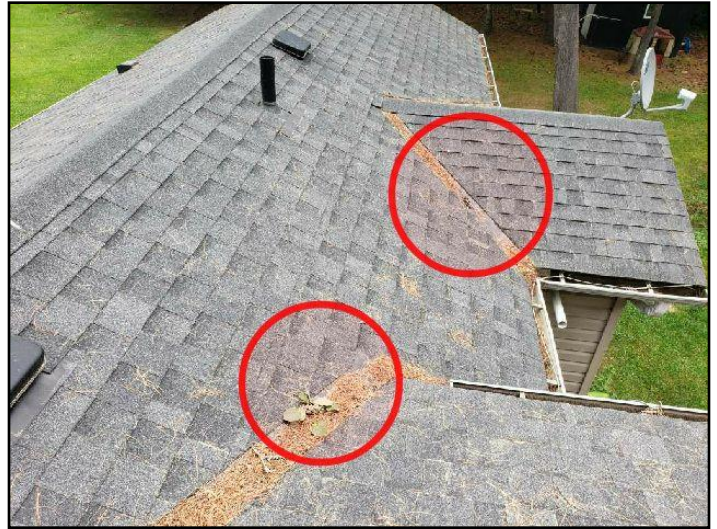
**1. Condition:** • Debris

**Implication(s):** Chance of water entry,damage

**Location:** Roof flashings

Debris

**Task:** Clean as required

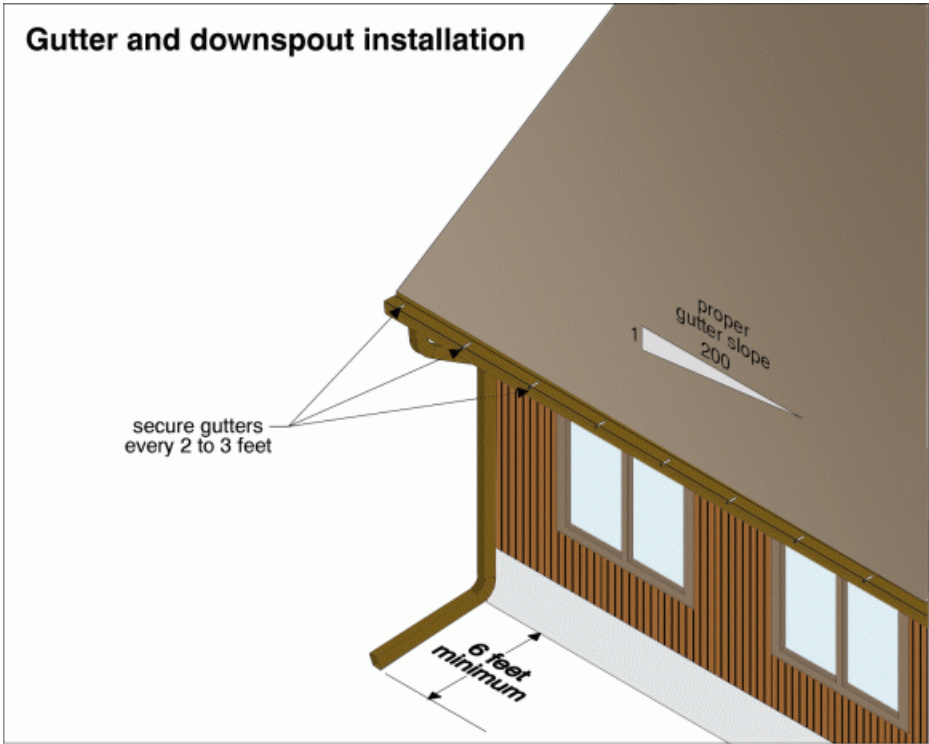
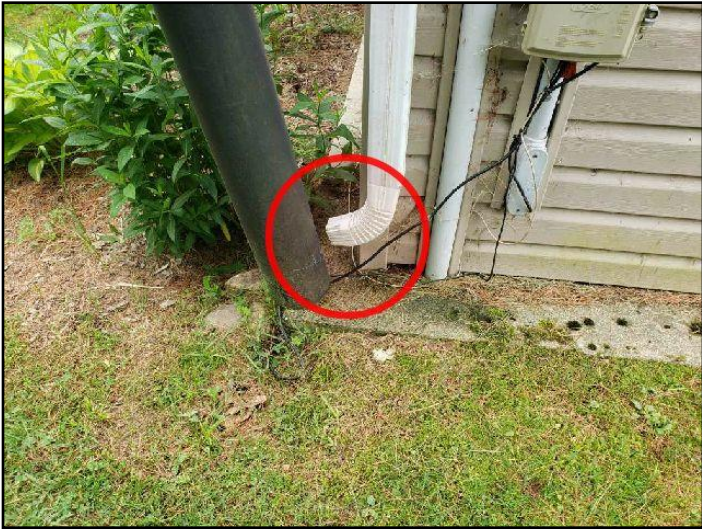
- 2. Condition:** • Discharge too close to building
- Implication(s):** Chance of water damage to structure, finishes and contents
- Location:** Various downspouts
- Task:** Improve discharge location
- Time:** Regular maintenance

*Discharge too close to building*

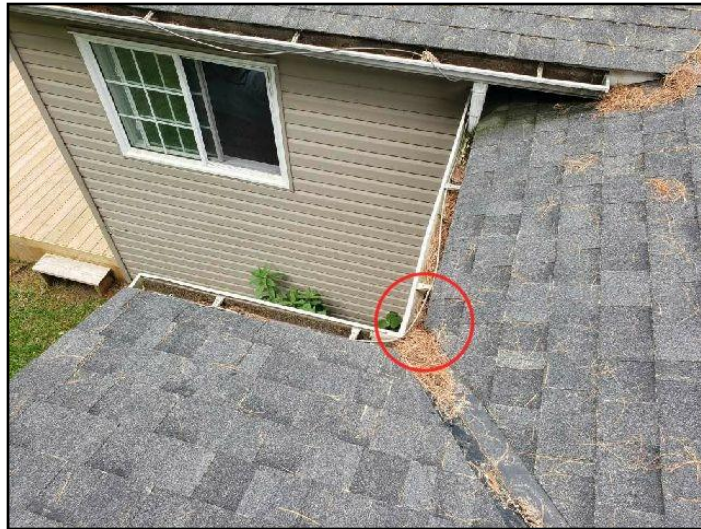
- 3. Condition:** • Dirty /clogged
- Implication(s):** Chance of water damage to structure, finishes and contents
- Location:** Various gutters
- Task:** Clean and improve drainage as required
- Time:** Regular maintenance

Dirty /clogged

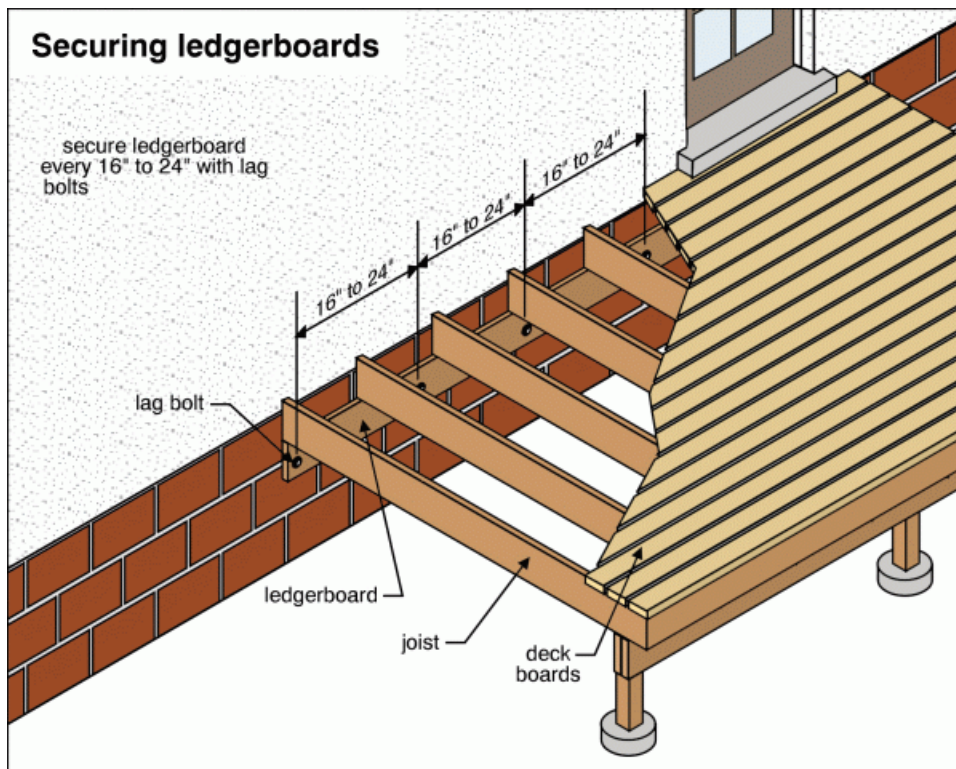
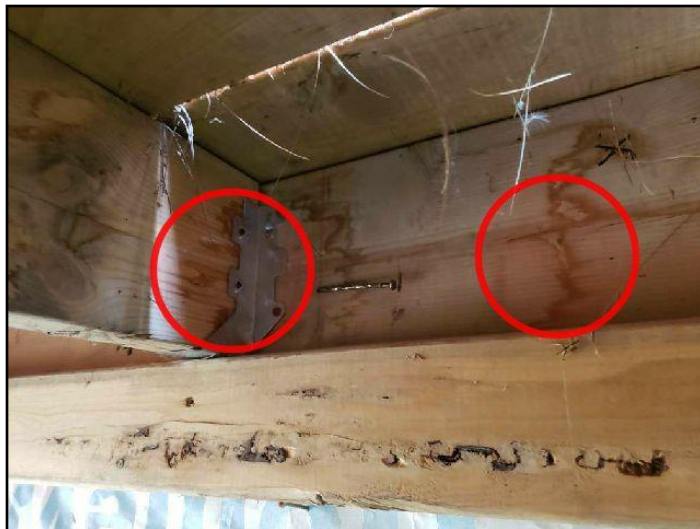
**4. Condition:** • Missing Lag Bolts

**Implication(s):** Chance of movement, collapse.

**Location:** Pool deck

Missing Lag Bolts

**Task:** Provide fasteners as required

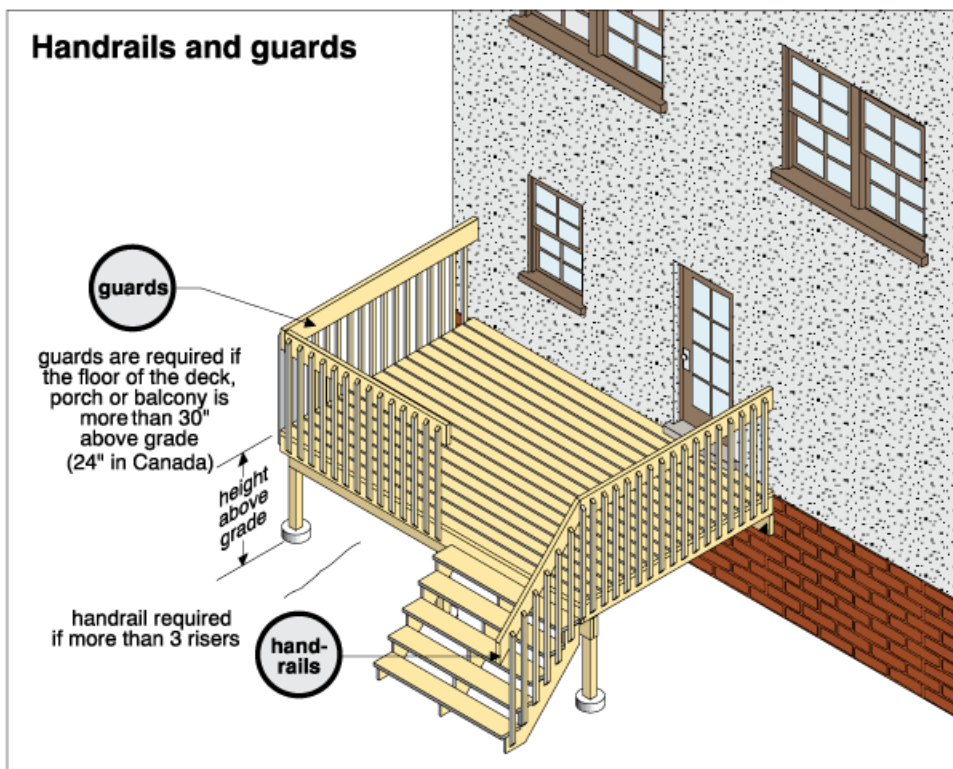
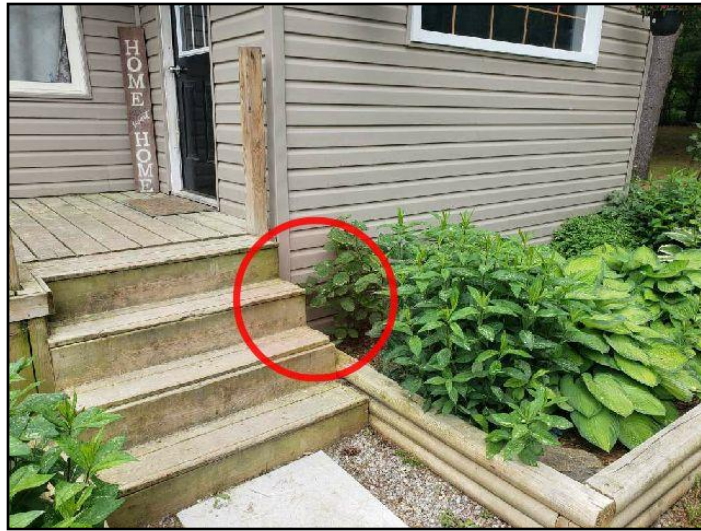
**5. Condition:** • Missing

**Implication(s):** Fall hazard

**Location:** Front porch steps

*Missing*

**Task:** Provide handrails, railings and spindles as required

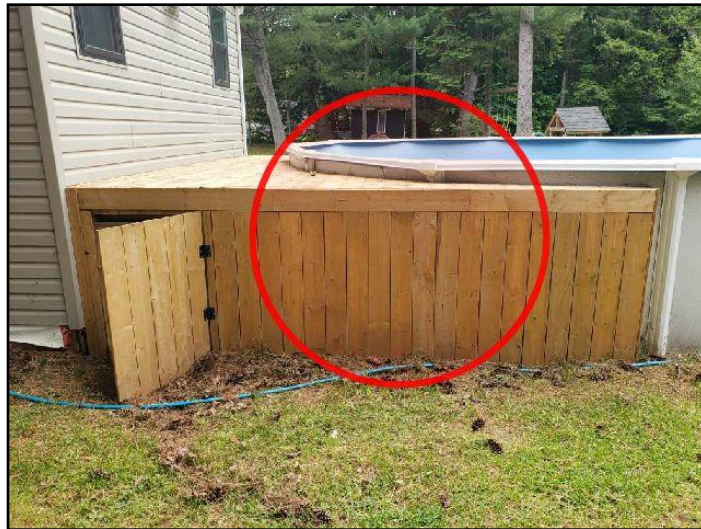
**6. Condition:** • Missing

**Implication(s):** Fall hazard

**Location:** Pool deck

*Missing*

**Task:** Provide handrails, railings and spindles as required

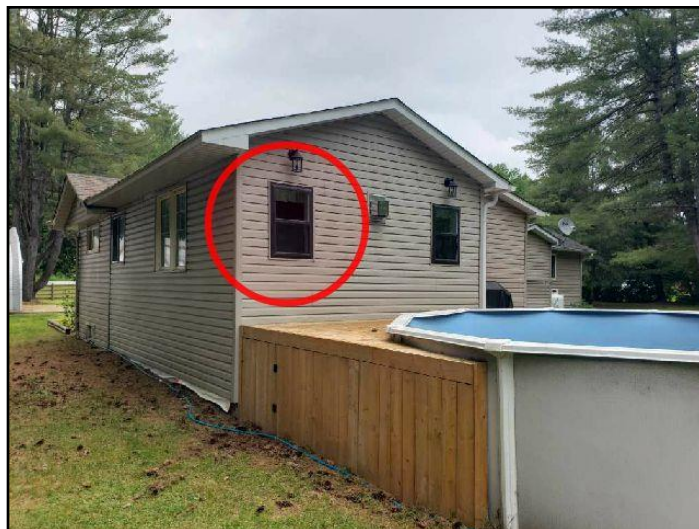
**7. Condition:** • Renovation

**Implication(s):** Unknown scope of work completed.

**Location:** Addition

Renovation

**Task:** Disclosure of permits not obtained

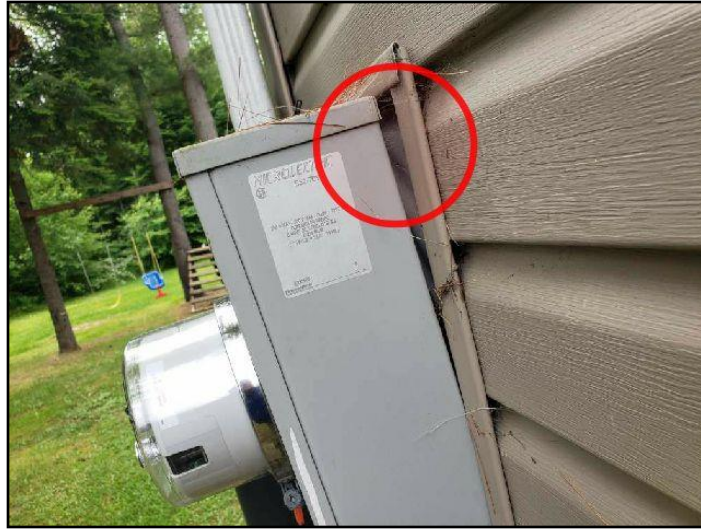
**8. Condition:** • Meter

**Implication(s):** Electric shock hazard, chance of fire.

**Location:** Meter base

Meter

**Task:** Secure meter base

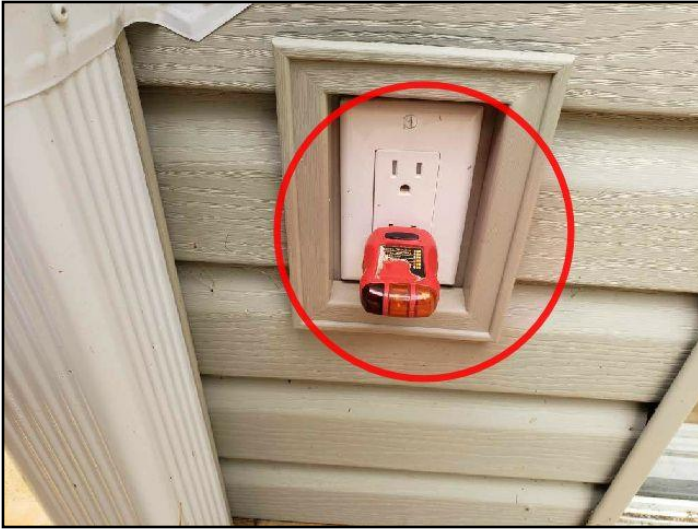
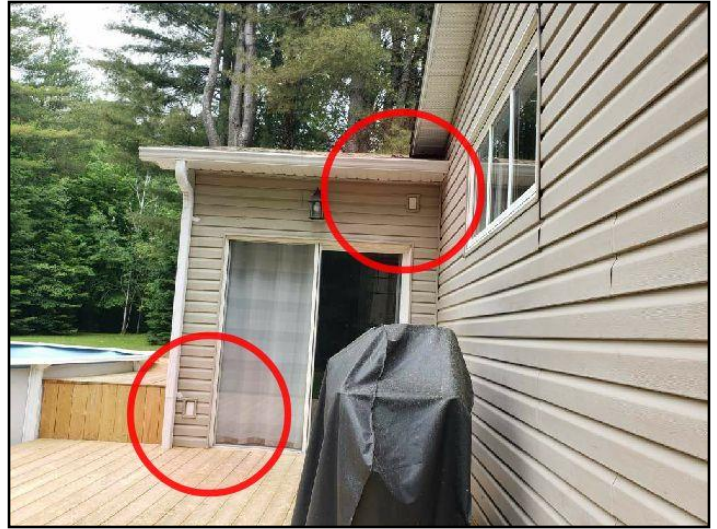
**9. Condition:** • GFCI/GFI needed (Ground Fault Circuit Interrupter)

**Implication(s):** Electric shock hazard

**Location:** Rear exterior receptacles

GFCI/GFI needed (Ground Fault Circuit...

**Task:** Provide GFCI protection and cover

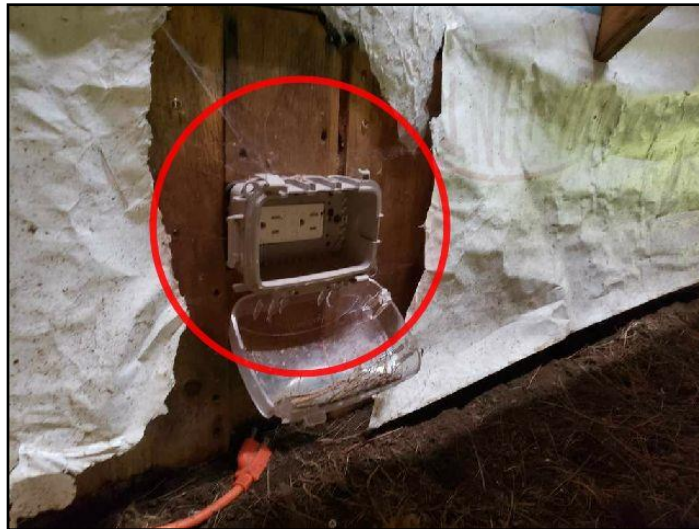
**10. Condition:** • GFCI/GFI needed (Ground Fault Circuit Interrupter)

**Implication(s):** Electric shock hazard

**Location:** Under pool deck

GFCI/GFI needed (Ground Fault Circuit...

**Task:** Provide GFCI protection

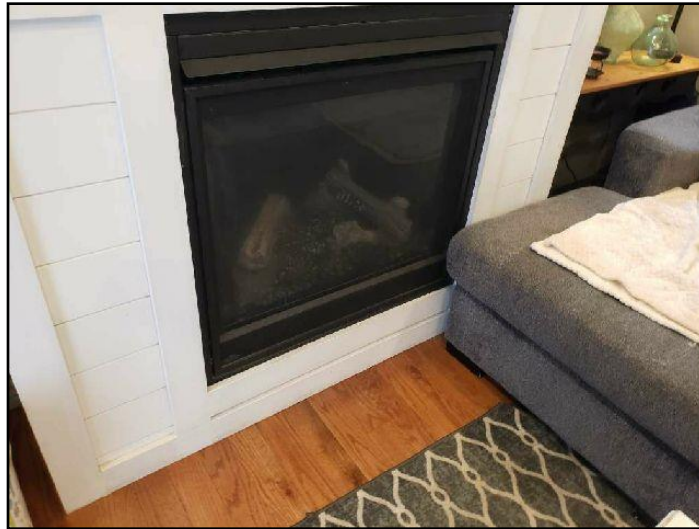
**13. Condition:** • Not operational

Pilot light only

**Implication(s):** No heat from unit

**Location:** Family Room fireplace

*Not operational*

**Task:** Further evaluation of no heat

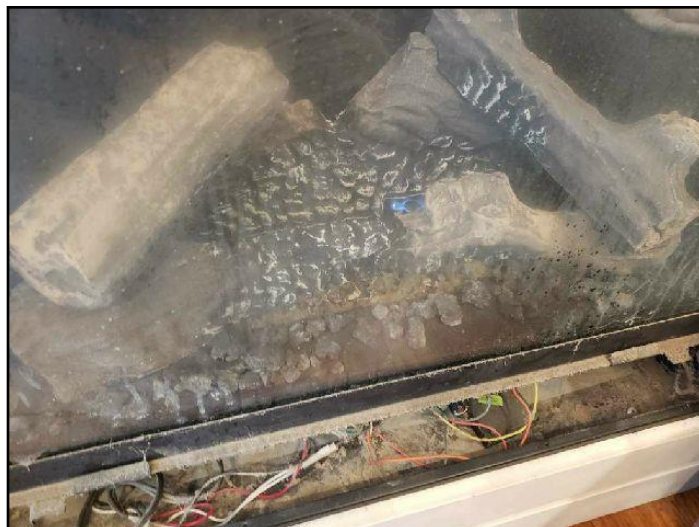
**14. Condition:** • Data Plate

**Implication(s):** May be required to decommission

**Location:** Family room fireplace

*Data Plate*

**Task:** Further evaluation of data plate location, information

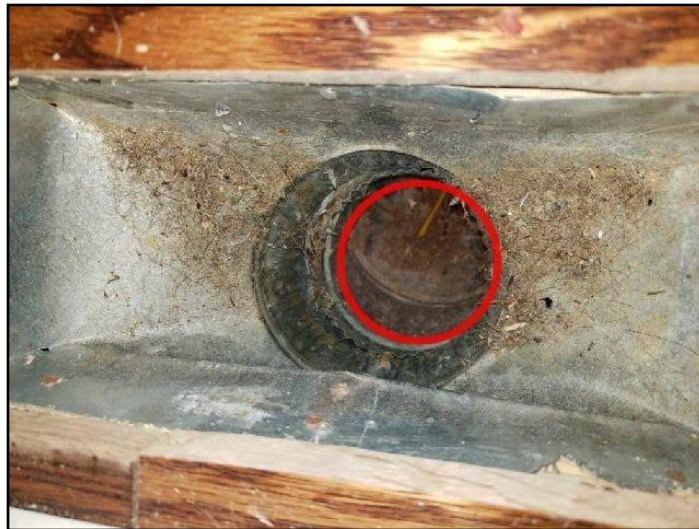
15. Condition: • [Dirty](#)

Implication(s): Increased heating and cooling costs | Reduced comfort

Location: Heating ducts

Dirty

Task: Clean, service ducts as required

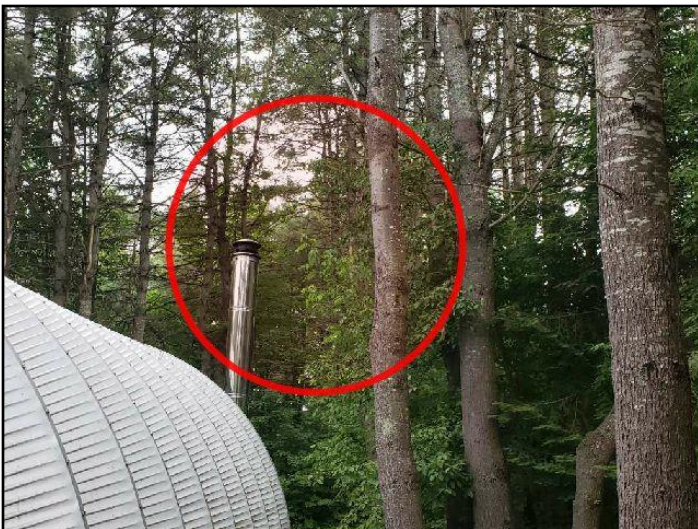
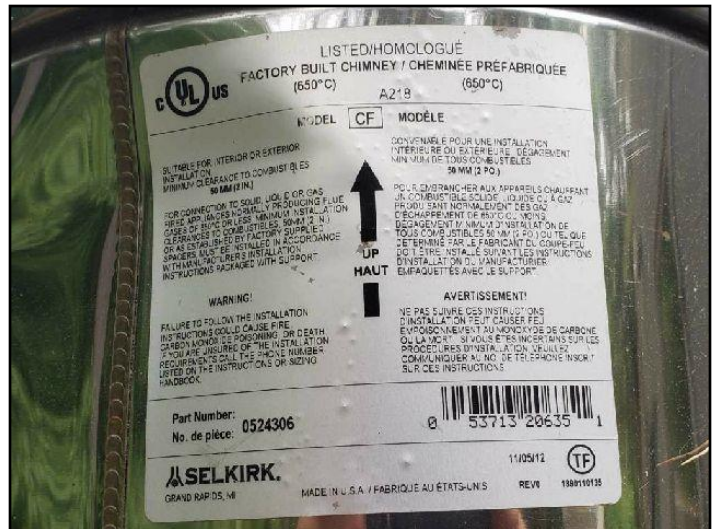
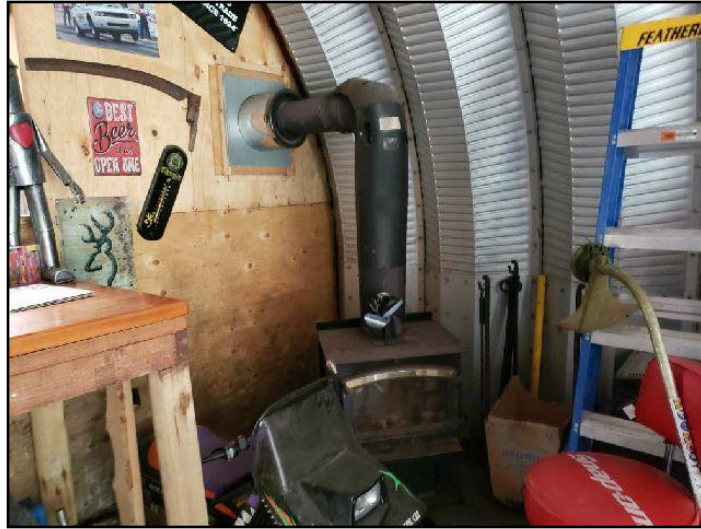
16. Condition: • [WETT Inspection](#)

Implication(s): Inspection of solid fuel appliance and chimney for Code Compliance.

Location: Garage solid fuel appliance

WETT Inspection

*WETT Inspection Not performed*

Task: Further evaluation for safe operation and code compliance

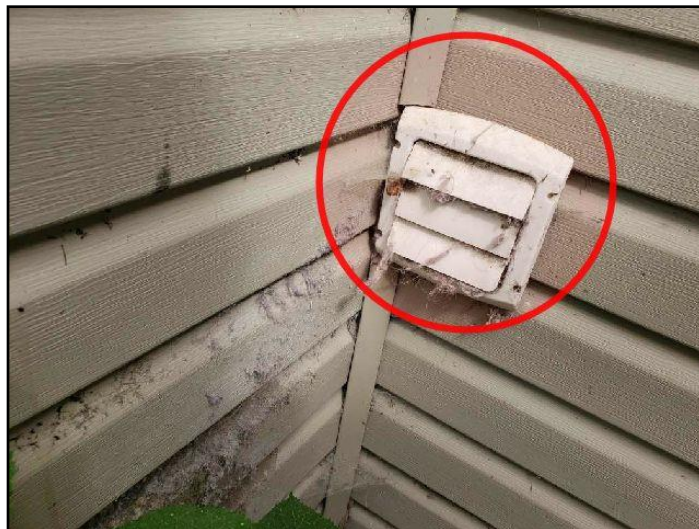
**17. Condition:** • Dirty Vent

**Implication(s):** Reduced exhaust flow, fire hazard.

*Dirty Vent*

**Task:** Service ,clean as required

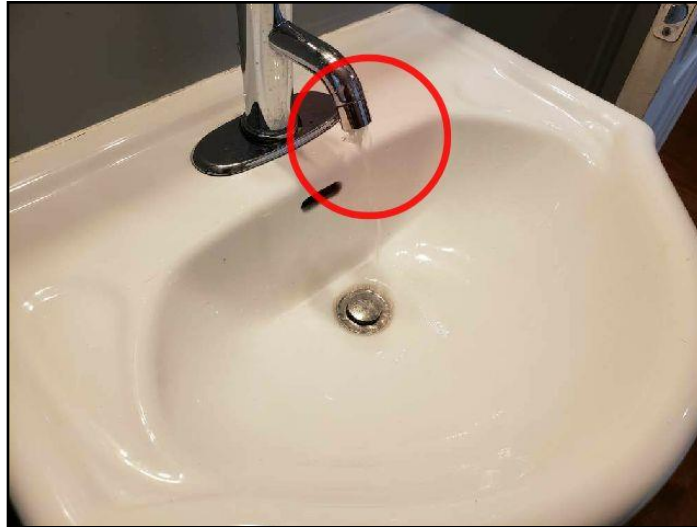
**18. Condition:** • [Aerator obstructed](#)

*Aerator obstructed*

**Task:** Clean or replace aerator

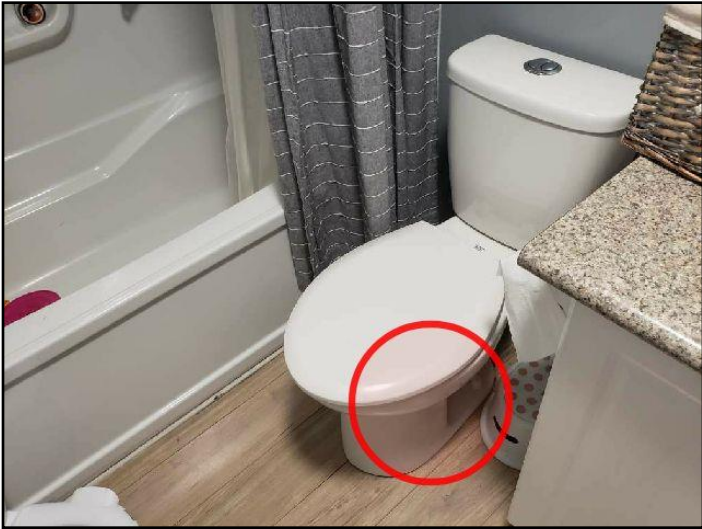
**19. Condition:** • Loose

**Implication(s):** Chance of water, sewage damage to finishes and contents | Possible hidden damage

Loose

**Task:** Repair as required

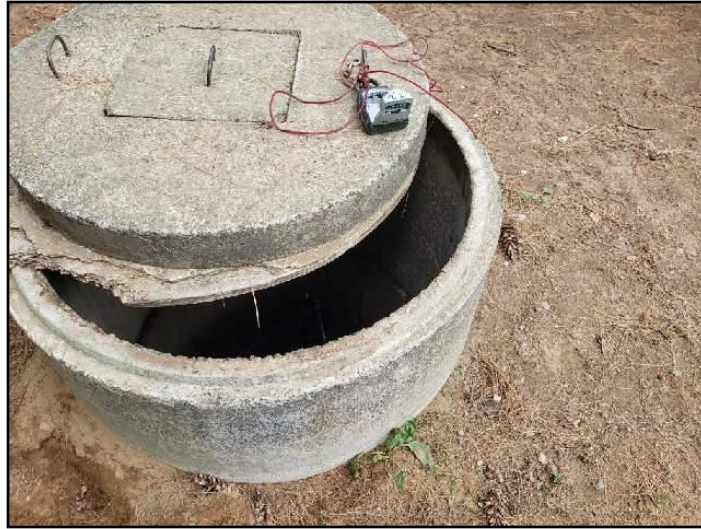
**20. Condition:** • Lid Missing, Damaged.

*Lid Missing, Damaged.*

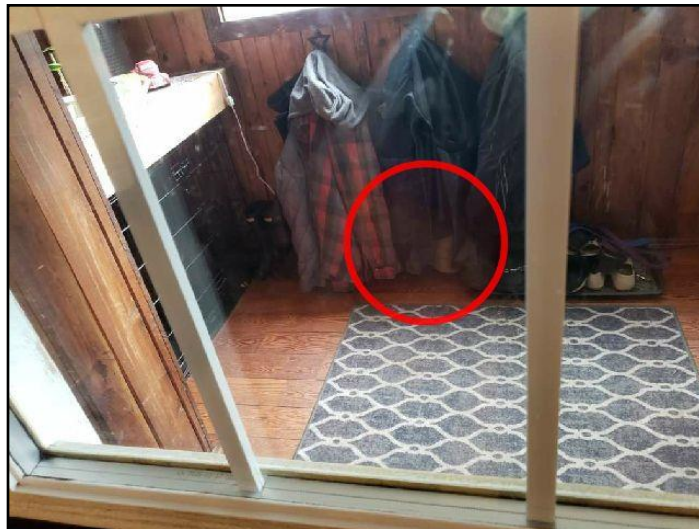
**21. Condition:** • No access

**Location:** Front porch

No access

**Task:** Disclosure of no access(pets present)

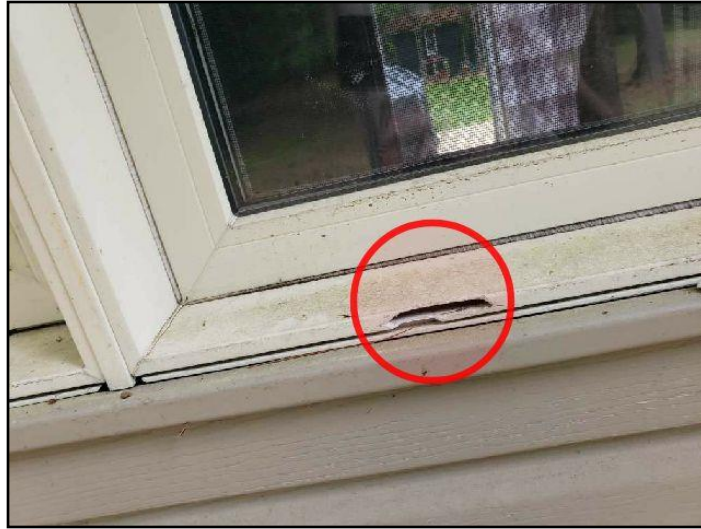
**22. Condition:** • Damaged

**Implications:** Chance of water entry, further material deterioration.

*Damaged*

**Task:** Repair damage as required
