INSPECTION REPORT

For the Property at:
2185 WALKER AVENUE, 204
PETERBOROUGH, ON K9L 1T6

Prepared for: TEAM VANRAHAN
Inspection Date: Wednesday, November 8, 2023
Prepared by: David Sharman

RE: Report No. 4575
2185 Walker Avenue, 204
Peterborough, ON
K9L 1T6

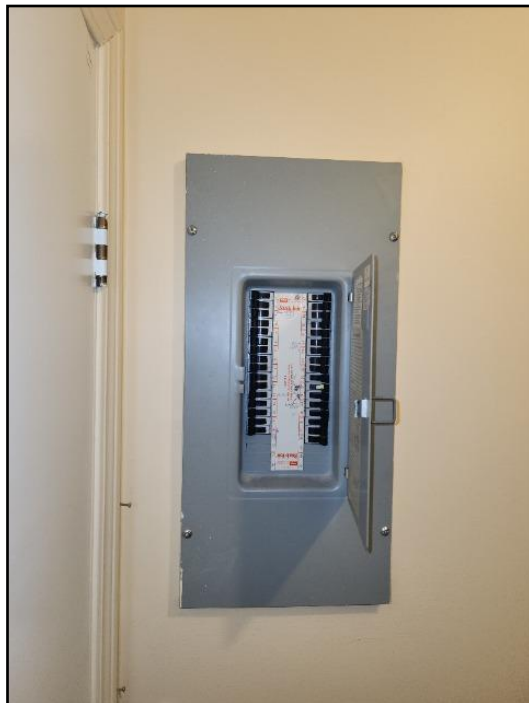
1. Distribution panel

Electrical panel manufacturers: • FPE Stab-Lok

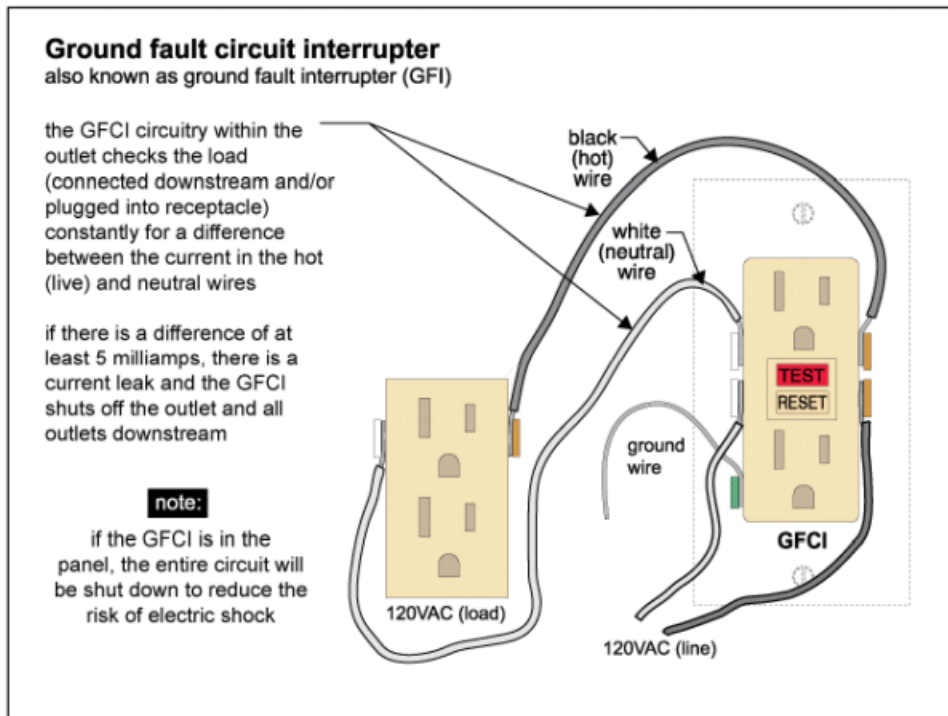
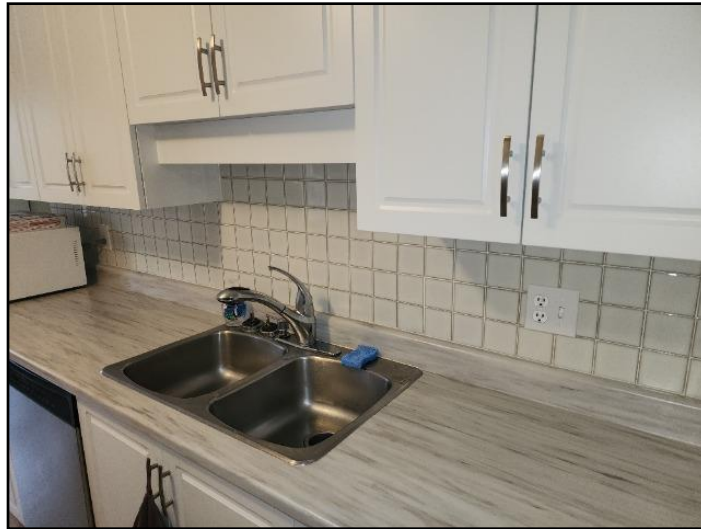
4. Condition: • No GFCI/GFI (Ground Fault Circuit Interrupter)

Although not a deficiency in a home of this age, safety may be improved by upgrading these receptacles

Implication(s): Electric shock

Location: Kitchen

3. No GFCI/GFI (Ground Fault Circuit...

Task: Upgrade

Time: Discretionary

Cost: Minor

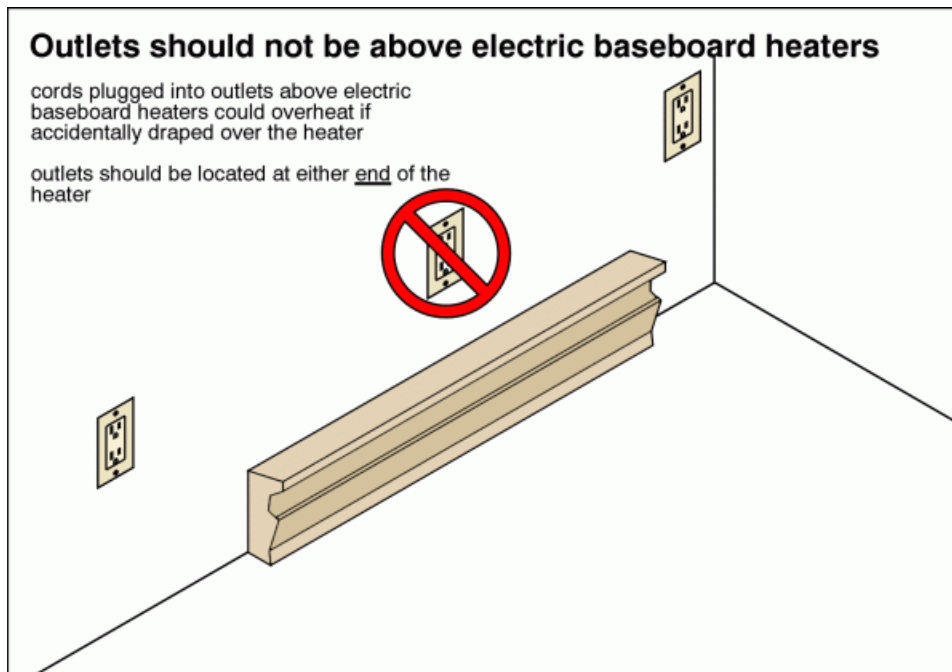
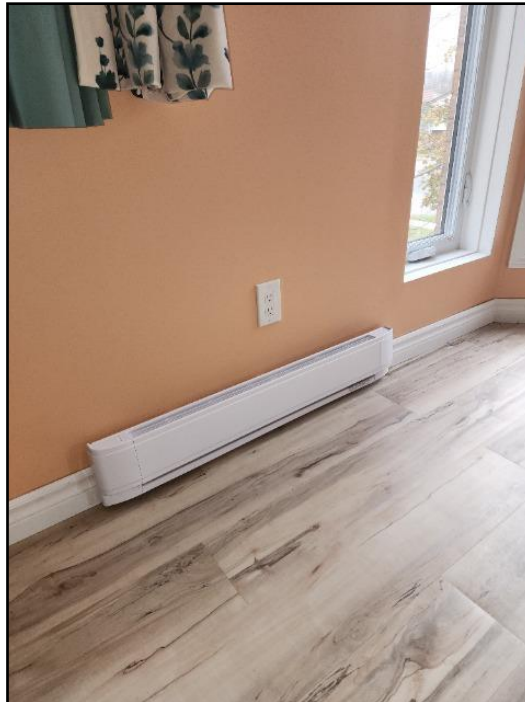
5. Condition: • Electrical receptacle above heater

Implication(s): Fire hazard

Location: Dining room

4. *Electrical receptacle above heater*

Task: Improve

Time: Discretionary

Cost: Minor

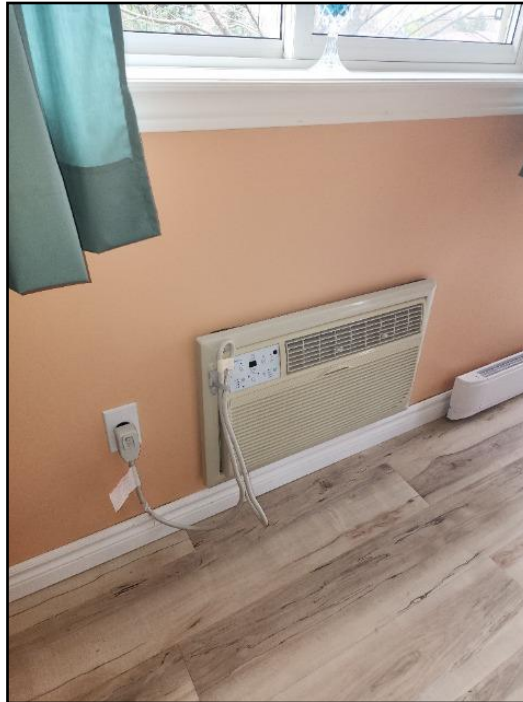
5. Air cooled

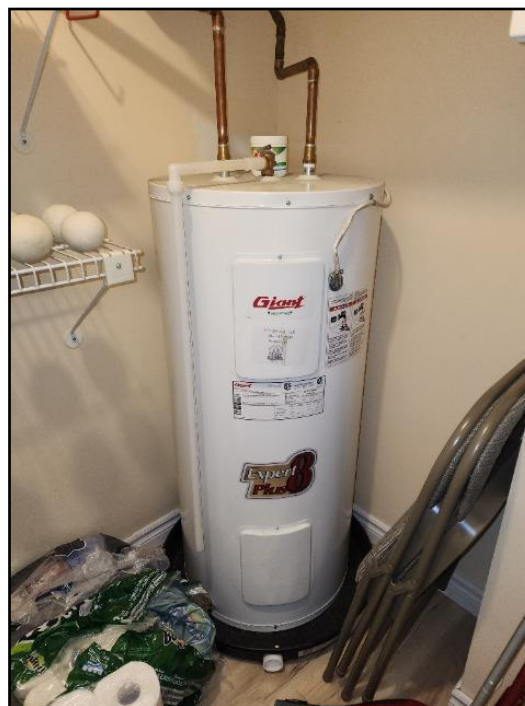
6. Electric
