# **Inspection Report**

# **G2** Home Inspections

Property Address 903 Willard Ave Richland Wa

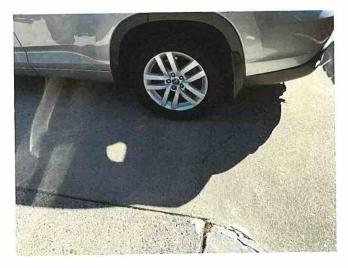
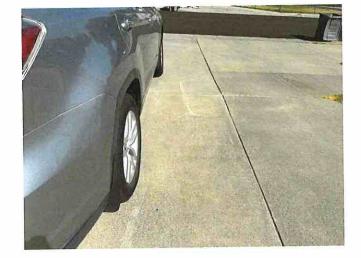
1.2) Driveway Conditions

Common cracks were observed in the driveway.

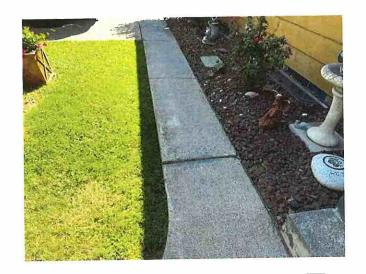
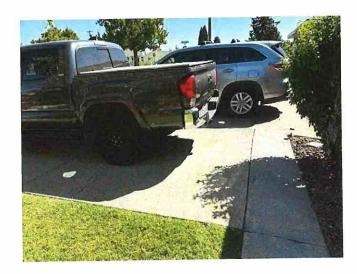
1.3) Sidewalk Conditions

Minor settlement observed

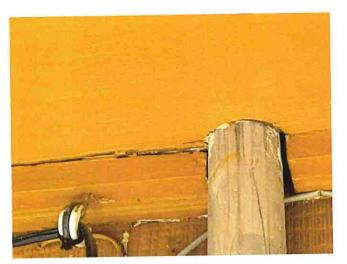
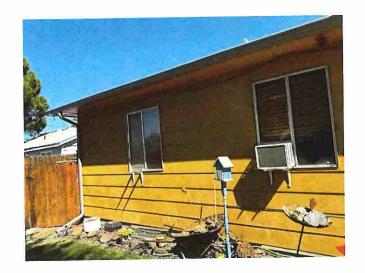
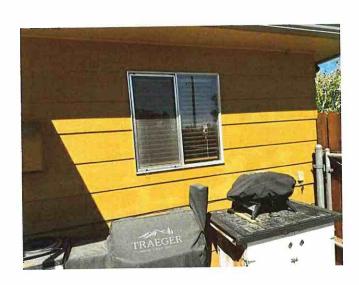
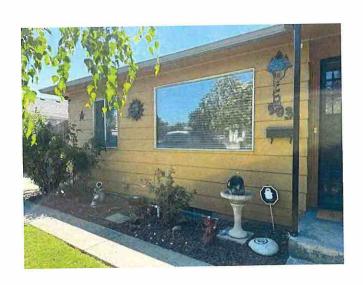
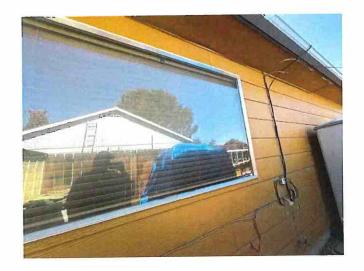
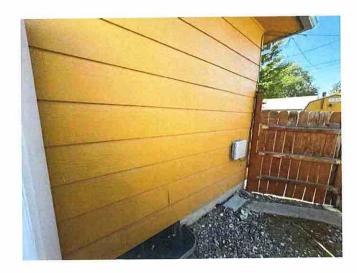
#### 2.1) Exterior Wall Conditions

There was cracking caulk, observed at siding and trim joints in several areas around the home. Recommend maintenance as needed.

There was weathered paint observed at the trim around the south exterior door. Recommend repainting Kepainted trim.

The exterior paint was slightly weathered in some areas. Recommend repainting as needed.

There was weathered paint observed at the trim around the south exterior door. Recommend repainting trim.

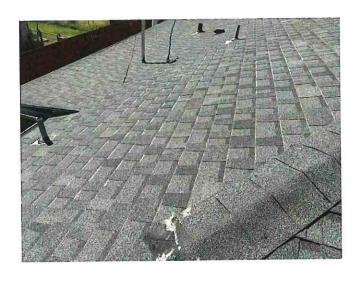
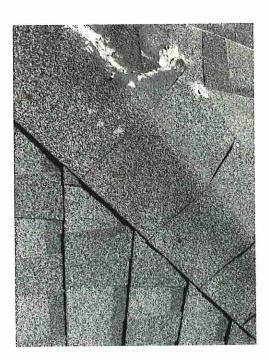
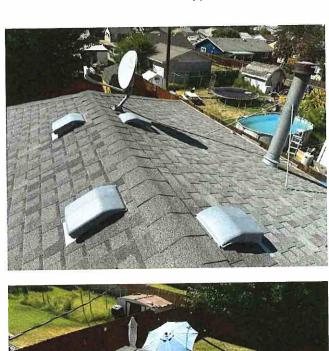
3.1) Roof Covering Condition

There was significant granular loss observed at areas of the roof covering.

There were exposed nailhead observed at the roof covering.

There was moss on the roof covering in some areas.

There was a damaged shingle at the ridge cap at the Southeast facing portion of the roof.

Recommend further evaluation of the roof by an by a qualified contractor and repair/replace as recommended. repaired by contractor

Recommend further evaluation of the roof by an by a qualified contractor and repair/replace as recommended.

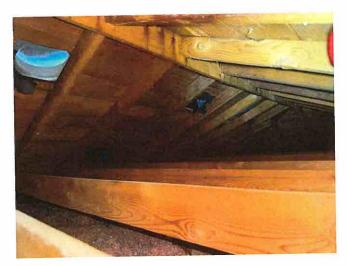
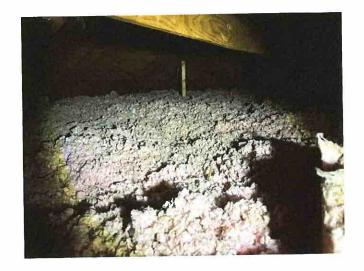
3.4) Attic Conditions

There was dark mildew, like staining, observed at the underside of the roof sheathing above the bathroom area. This may have been caused by excessive moisture in the attic or the fan may have not been properly vented. Recommend for the evaluation and any needed repair by a qualified contractor.

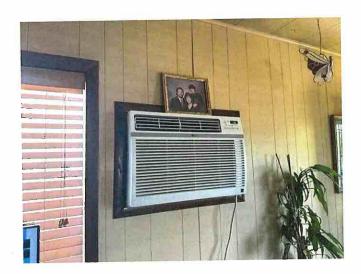
4.2) AC Unit Conditions

Window or wall air conditioning units were present and are not tested as part of our inspection. Only central air conditioning units are inspected as part of our services.

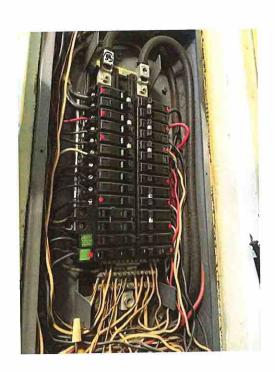
5.3) Electrical Panel Conditions

The main panel appeared to be in serviceable condition at the time of the inspection.

The electrical panel is located in a cabinet, which makes it difficult to access. Today standards require 36 inches of clear space in front of an electrical panel for proper working clearance.

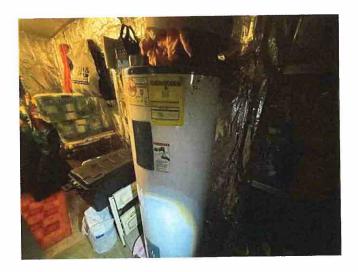
6.4) Water Heater Conditions

The water heater was operational at the time of inspection. This is not an indication of future operation or condition.

There was some rust visible on the outside of the water heater.

The water heater is likely near the end of its expected lifespan. Replacement as needed.

Recommended selling seismic straps at the water heater. replaced a added straps

Recommend recommend extending the discharge pipe for the TPR valve, so it reaches within 6 inches of replaced

Recommended selling seismic straps at the water heater.

Recommend recommend extending the discharge pipe for the TPR valve, so it reaches within 6 inches of the floor.

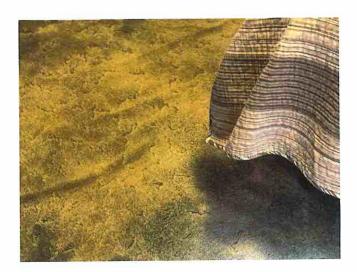
# 7.3) Floor Conditions

The carpets were loose in some areas. Recommend rest stretching/replacement as needed or desired. Loose carpet can be a tripping hazard.

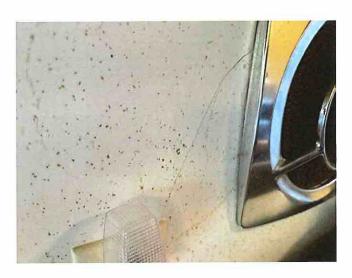
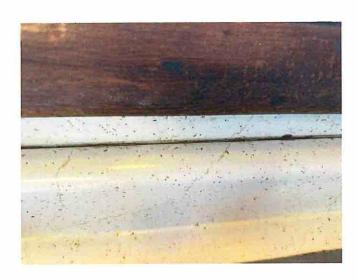
#### 8.1) Counter Conditions

Recaulking crack near fan

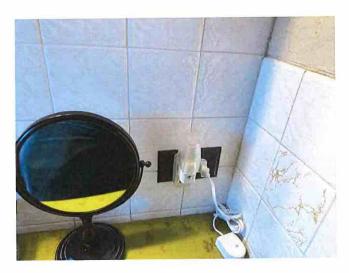
#### 9.1) Electrical Conditions

Recommend selling GFCI protection for the bathroom receptacle

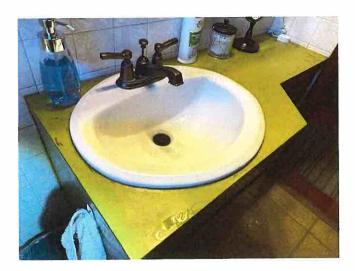
9.4) Counter - Cabinet Conditions

There was minor wear observed at the bathroom vanity countertop. Recommend repair as needed.
