SUMMARY REPORT

Client: Tim Petersen
Inspection Address: 6712 Panther Creek Dr, Sparks, NV 89436
Inspection Date: 8/6/2024 Start: 9:00 am
Inspected by: Tony Midmore - NV Lic. #2802-R

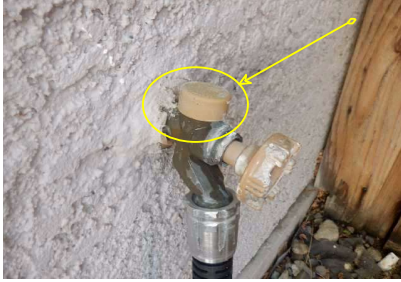
- The front hose bibb leaks at the anti-siphon valve during use.

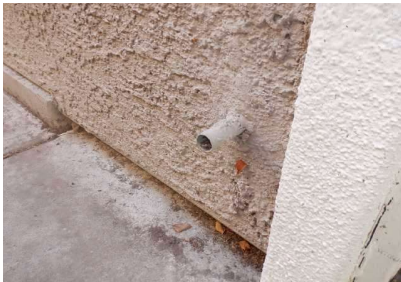
- The end of the temperature/pressure relief valve plumbing, at the north exterior wall, should have a 90-degree elbow fitting to direct and drain water/steam to the ground.

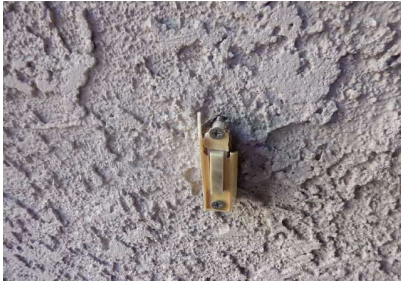
- The doorbell button was broken and should be replaced.

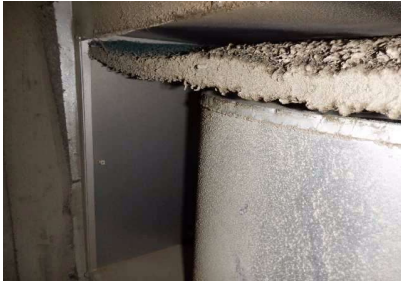
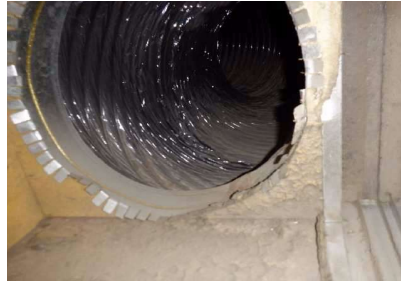
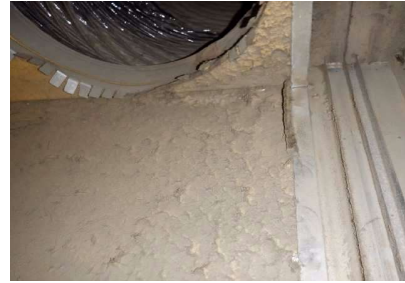
- Due to the dirty condition of the plenums and ducting, it is recommended that the heating unit be evaluated and serviced as needed by a licensed HVAC professional.

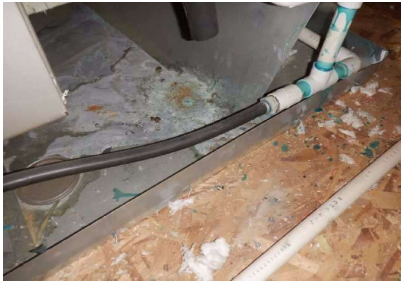
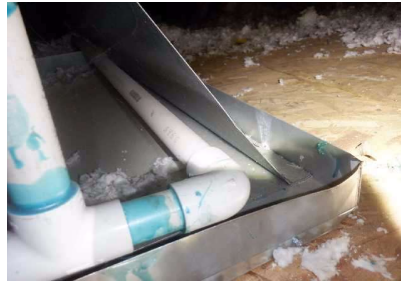
- There is no heat tape installed on the attic condensate drain line for the furnace, to prevent freezing and moisture damage. Recommend heat tape be installed.

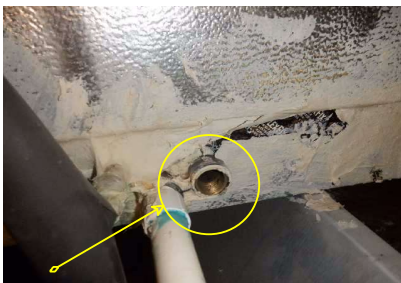
- The secondary drain port was open, but not plumbed. Recommend a fitting be installed, to direct any drain water into the pan, below.

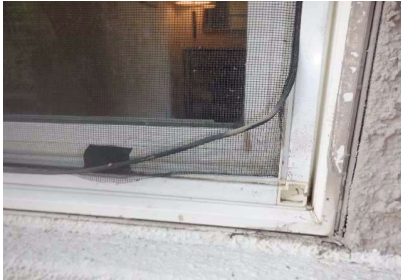
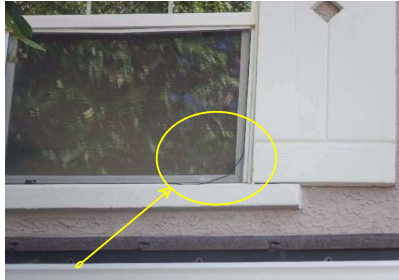
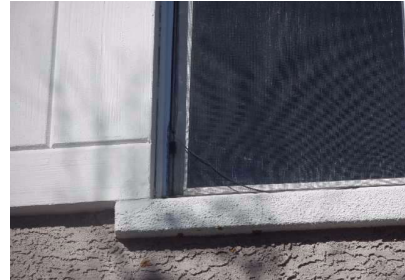
- Many of the window screens are damaged.

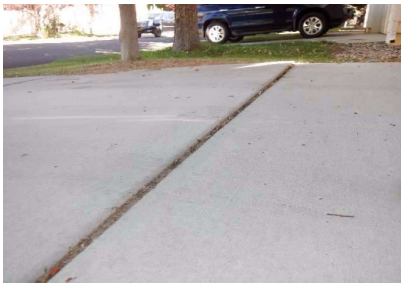
- There is a raised edge in the concrete flatwork at the driveway. This area can be a tripping hazard and should be repaired.

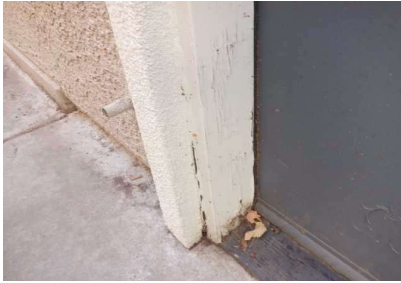
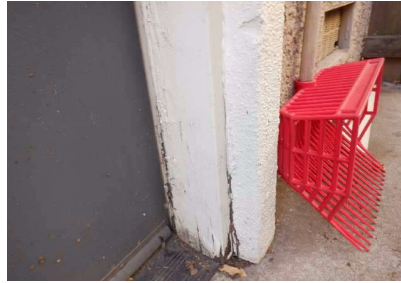
- The frame and exterior wood trim, at the garage side door, was weathered/exposed and should be sealed/painted as needed to help prevent further deterioration.

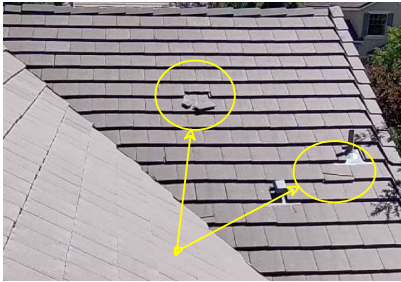
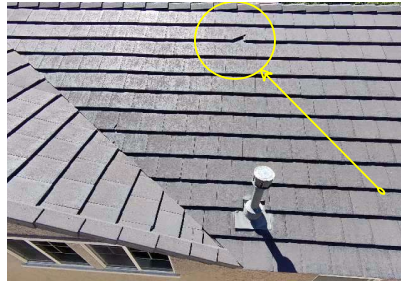
- There were broken roof tiles on the west face, which were separated. On the north face, there was a tile with a large broken corner. Recommend that these known faults be repaired by a licensed roofing contractor and, at that time, that the roof cover be evaluated for any additional needed repairs.

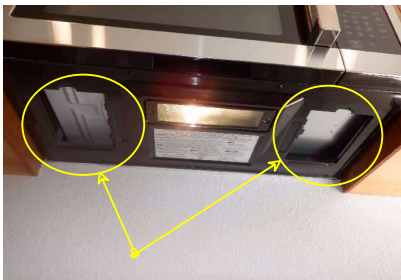
- The surface exhaust fan screens were missing and should be replaced.

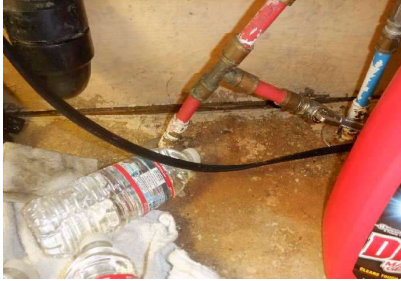
- There was evidence of exposure to excess moisture at the floor of the kitchen sink cabinet. The exact cause of this condition is unknown and further damage may exist in hidden areas. Consult with the seller for additional information and consider having the cabinet floor removed to investigate further.

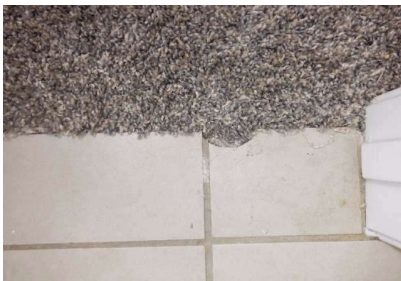
- There was a chipped tile at the threshold to the closet.

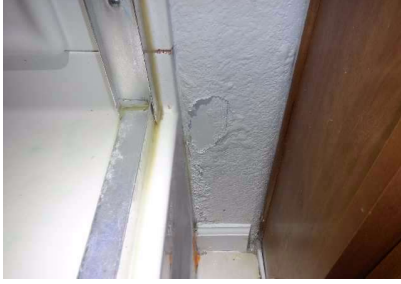
- Staining and/or damage at the wall to the right of the tub indicates prior exposure to excess moisture. Hidden damage may exist and you may consider further investigation. These areas should be repaired and kept well sealed to prevent further moisture damage.

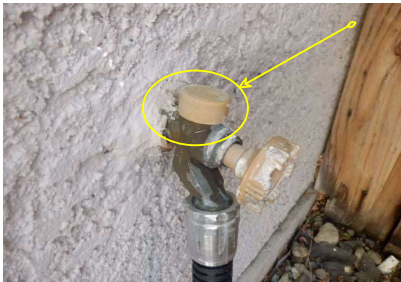
The front hose bibb leaks at the anti-siphon valve during use.

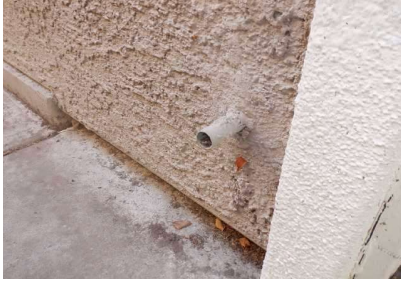
The end of the temperature/pressure relief valve plumbing, at the north exterior wall, should have a 90-degree elbow fitting to direct and drain water/steam to the ground.

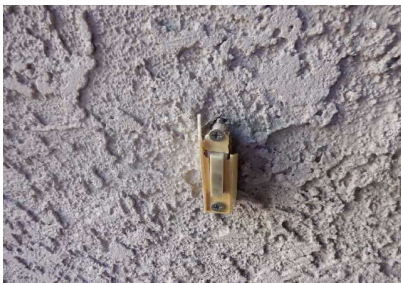
The doorbell button was broken and should be replaced.

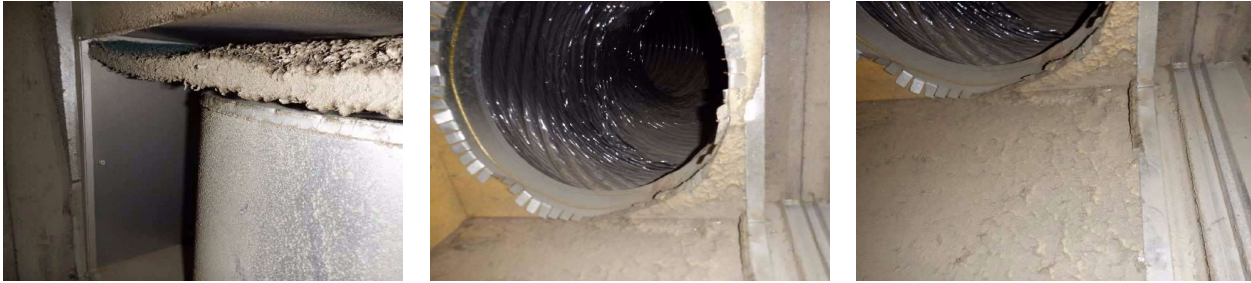
Due to the dirty condition of the plenums and ducting, it is recommended that the heating unit be evaluated and serviced as needed by a licensed HVAC professional.

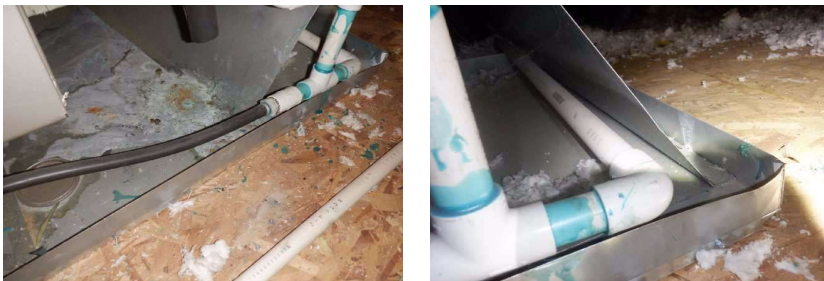
There is no heat tape installed on the attic condensate drain line for the furnace, to prevent freezing and moisture damage. Recommend heat tape be installed.

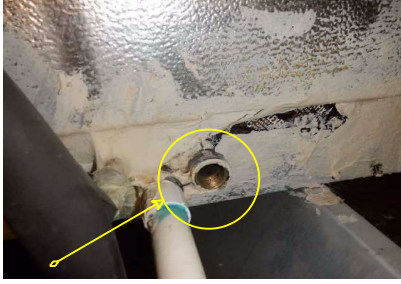
The secondary drain port was open, but not plumbed. Recommend a fitting be installed, to direct any drain water into the pan, below.

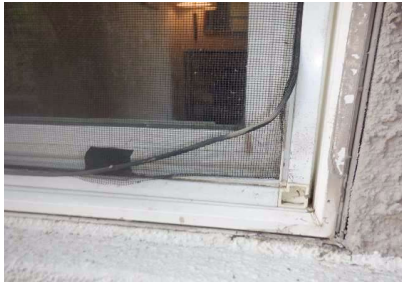
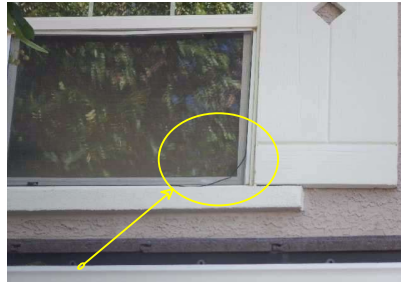
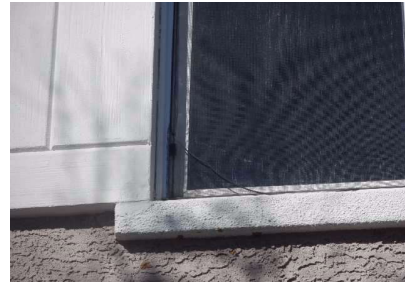
Many of the window screens are damaged.

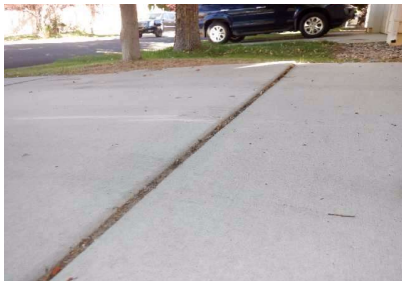
There is a raised edge in the concrete flatwork at the driveway. This area can be a tripping hazard and should be repaired.

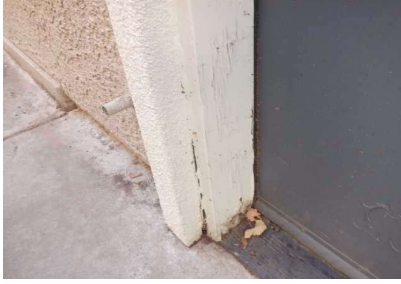
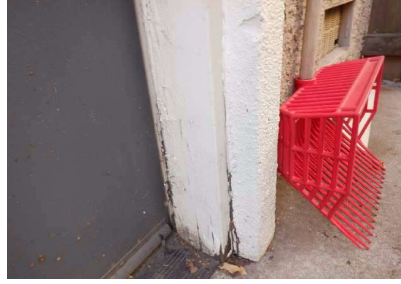
The frame and exterior wood trim, at the garage side door, was weathered/exposed and should be sealed/painted as needed to help prevent further deterioration.

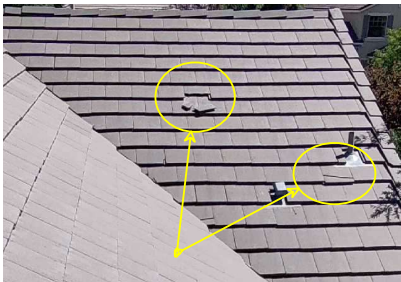
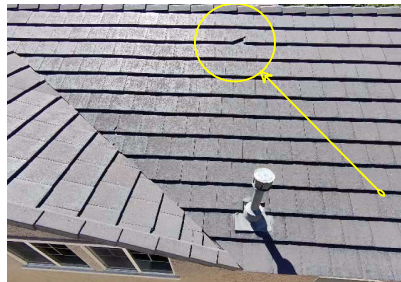
There were broken roof tiles on the west face, which were separated. On the north face, there was a tile with a large broken corner. Recommend that these known faults be repaired by a licensed roofing contractor and, at that time, that the roof cover be evaluated for any additional needed repairs.

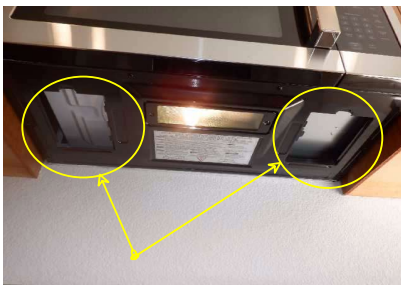
The surface exhaust fan screens were missing and should be replaced.

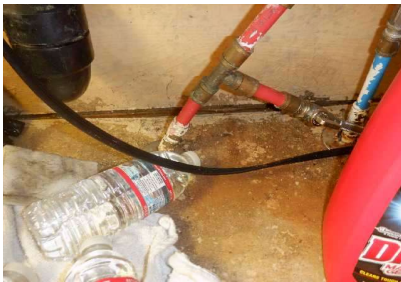
There was evidence of exposure to excess moisture at the floor of the kitchen sink cabinet. The exact cause of this condition is unknown and further damage may exist in hidden areas. Consult with the seller for additional information and consider having the cabinet floor removed to investigate further.

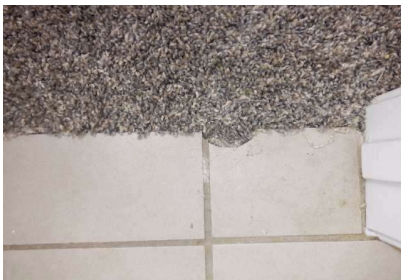
There was a chipped tile at the threshold to the closet.

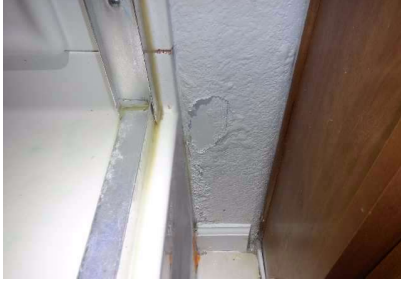
Staining and/or damage at the wall to the right of the tub indicates prior exposure to excess moisture. Hidden damage may exist and you may consider further investigation. These areas should be repaired and kept well sealed to prevent further moisture damage.
