Inspection Report

1748 Bernard
Windsor ON

Mailloux Home Inspections

Date: 2023-11-23	Time: 11:00	Report ID: 112301
Property: 1748 Bernard Windsor ON	Customer: Al Teshuba	Real Estate Professional:

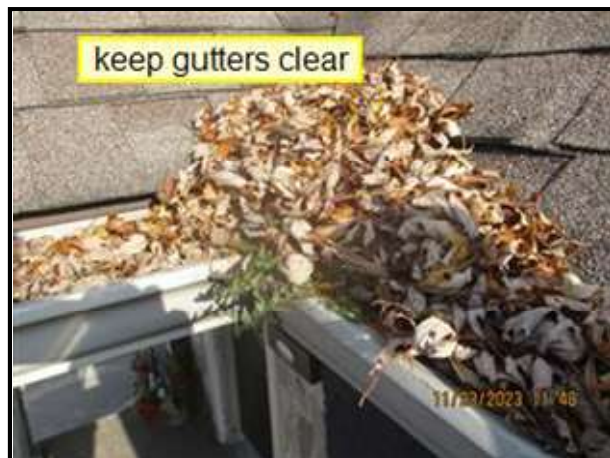
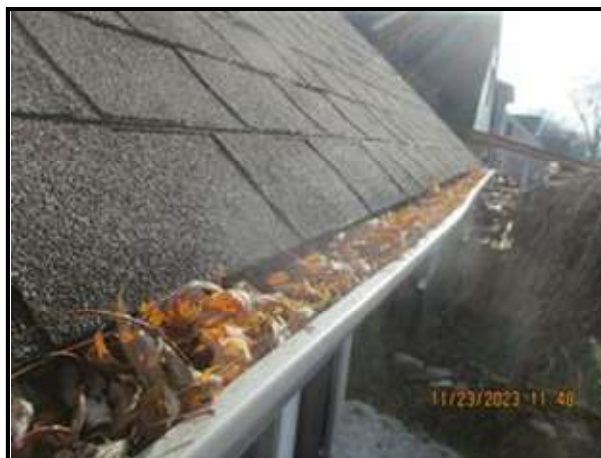
1.5 Gutters in the front are currently clogged with leaves and debris which requires cleaning to operate properly. Failure to clean the gutters can result in water backing up and possibly seeping in behind, causing hidden damage. All gutters should be checked for damage, blockage, or overflow on a regular basis (at least twice annually). Gutter guards may help in cases where leaves and other debris routinely accumulate in a short period of time.

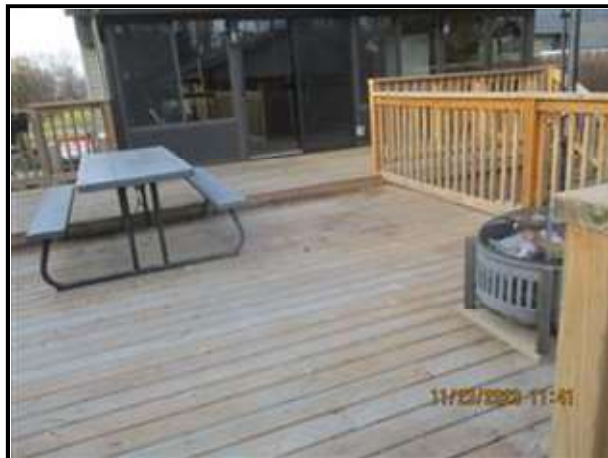
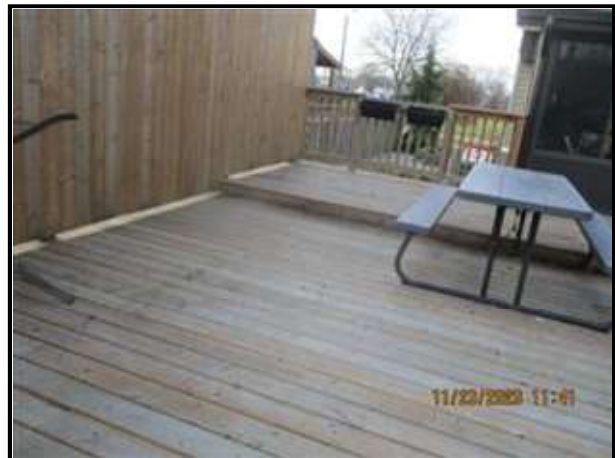
2.4 Deck was surrounded with skirting and visible from the top only. Unable to assess the framing.

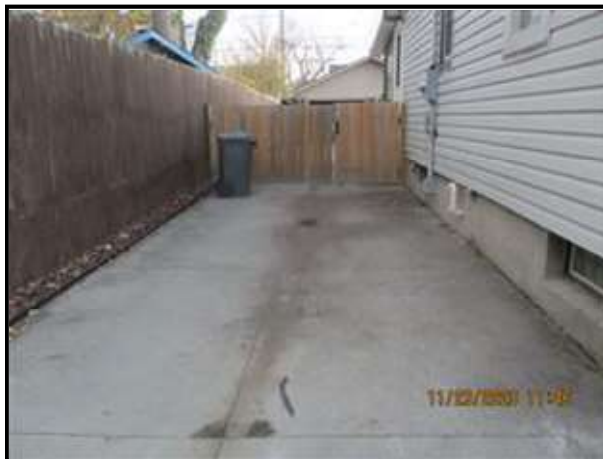
3.1 Picture 1

3.1 Some cracks and patched areas typical of older materials.

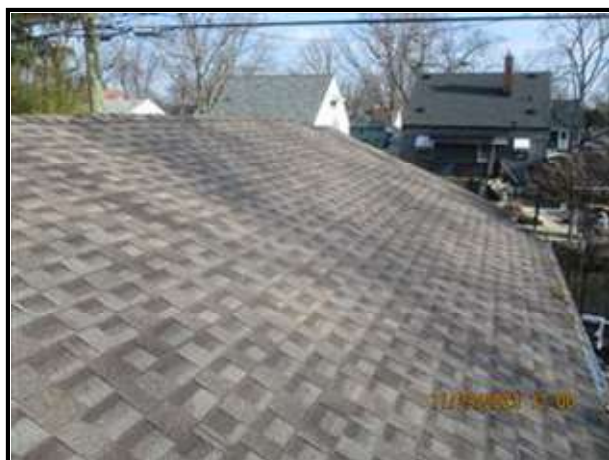
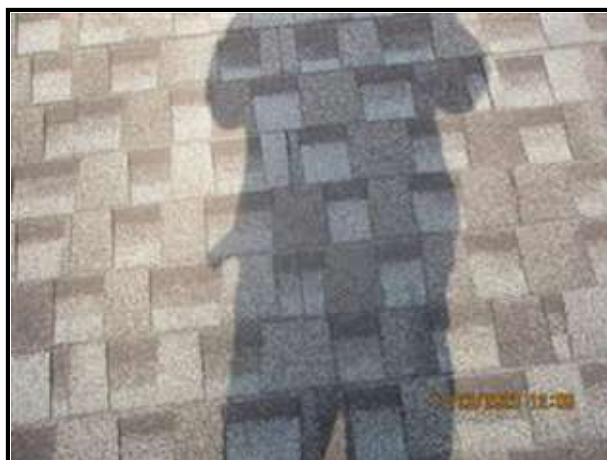
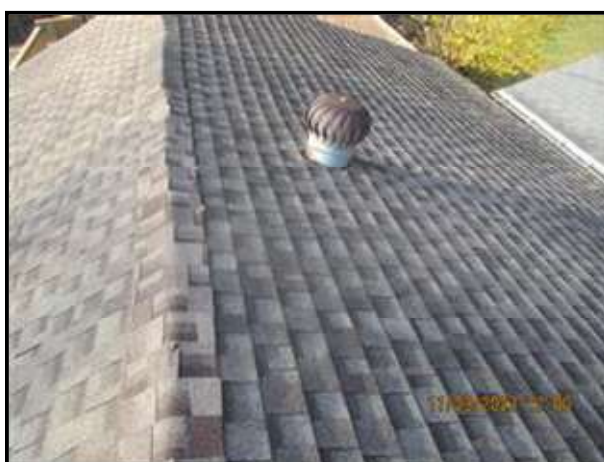
4.0 Refer to comments in the Main Roofing Section.

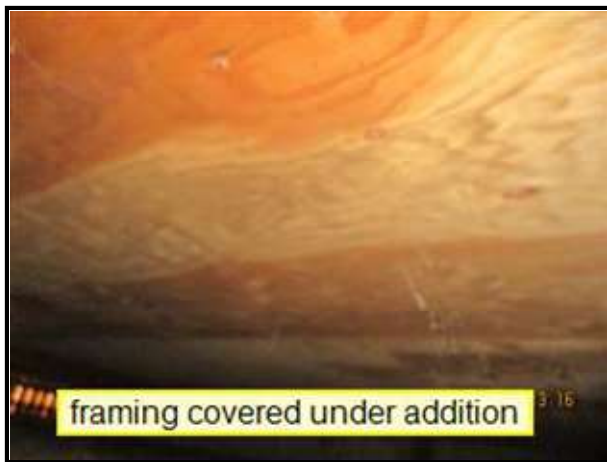
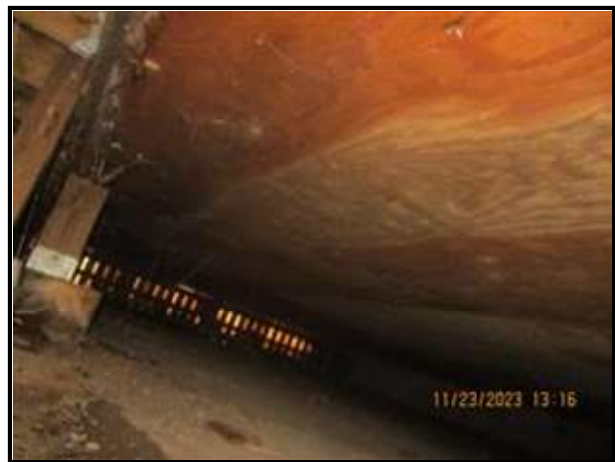
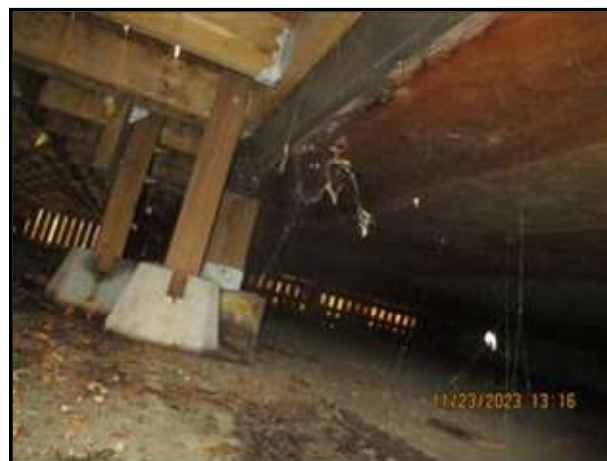
9.2 Note: All framing in the crawl space area was completely enclosed and not visible for inspection.

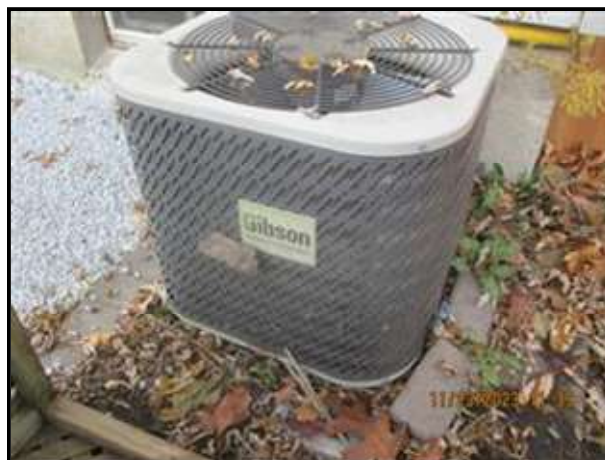
12.1 Picture 1

12.0 The unit was not operated due to temperatures below the safe operating range. Check with owner on prior history before removal of conditions.

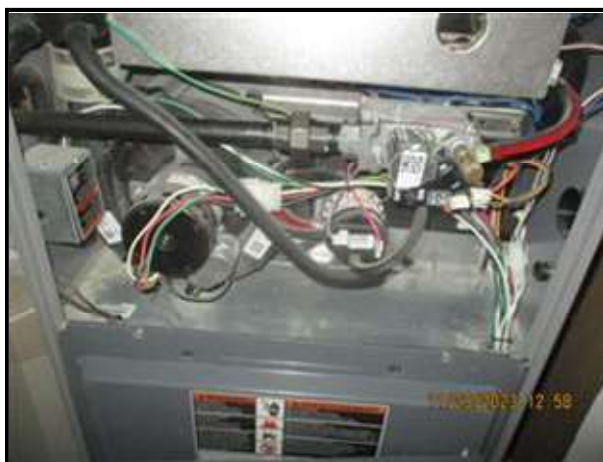
13.0 Picture 1

13.0 High efficiency heating units operate at lower exhaust temperatures; therefore, proper venting and condensate drainage provisions are critical to service life and function. Each unit's requirements vary and cannot be readily assessed during a standard inspection. Clogged condensate lines are a common occurrence with a high efficient unit. While there may not have been any signs of an existing condensate leak at the time of inspection, this can develop with normal use. Check inside the cabinet door when changing or replacing filters as discussed during the inspection and have any condensate leak addressed immediately by a qualified HVAC contractor.

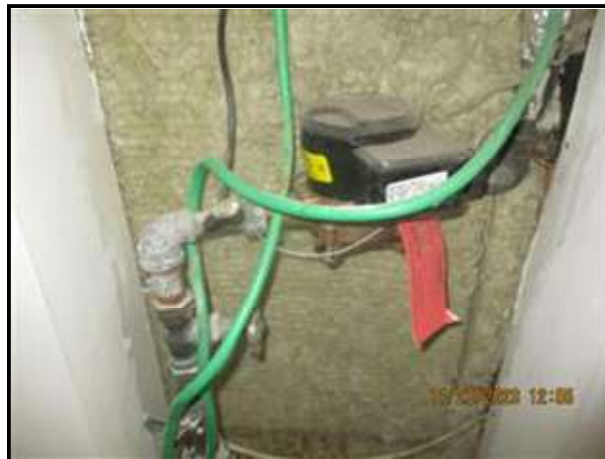
14.0 Picture 1

14.0 All visible piping in the house was copper or newer plastic piping.

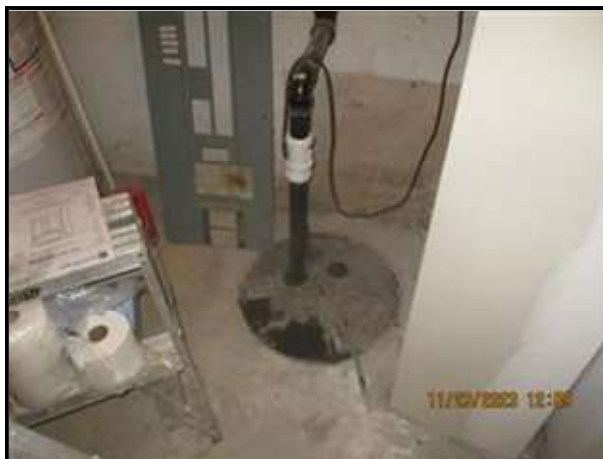
14.4 Picture 1

14.4 There was a waste pump in the basement that appears to be abandoned. Unable to find anything that drained into this pit. The drain pipes are newer ABS and it is suspected this has eliminated the need for a waste pump.
