# Inspection Report

**Al Teshuba**

3404 Victoria  
Windsor ON

<b>Date:</b> 2025-03-20	<b>Time:</b> 10:00	<b>Report ID:</b> 032001
<b>Property:</b> 3404 Victoria Windsor ON	<b>Customer:</b> Al Teshuba	<b>Real Estate Professional:</b>

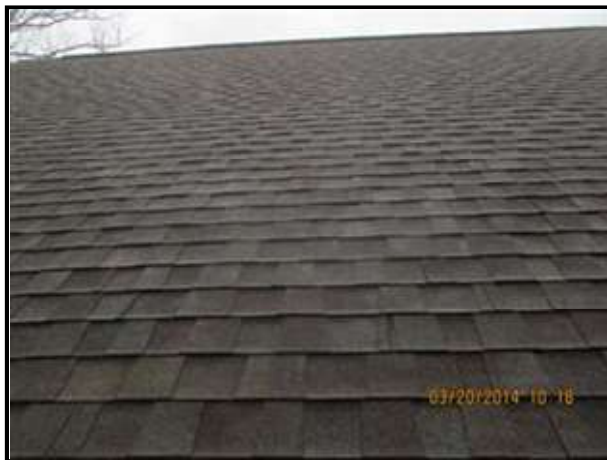
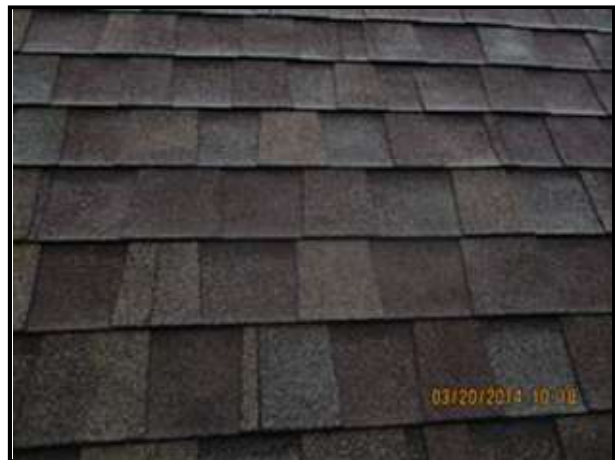
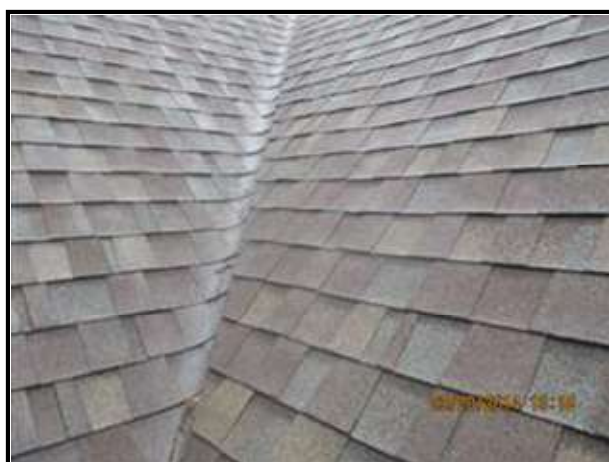
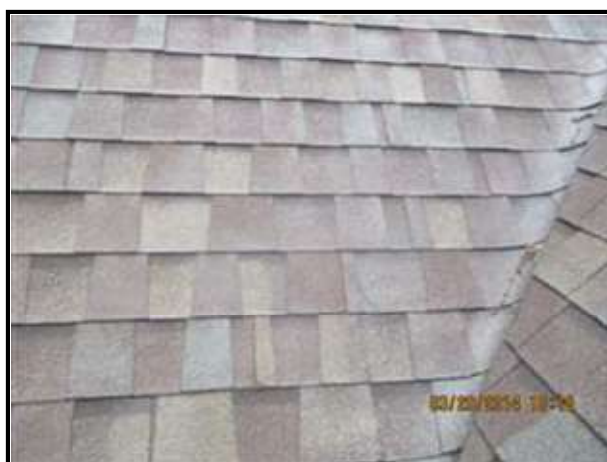
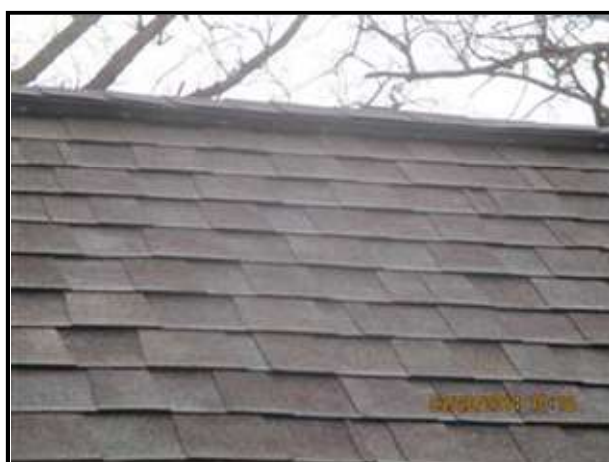
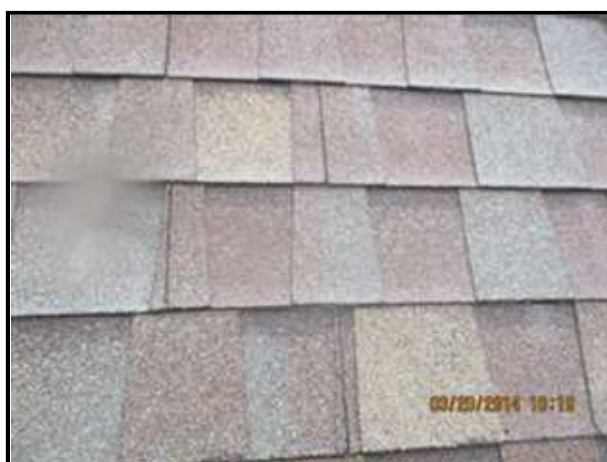
**1.0** Normal wear noted for age, no visible defects as viewed from a ladder from various places. The roof was wet and too steep to walk safely. Viewing was limited to the visible areas from the eaves.

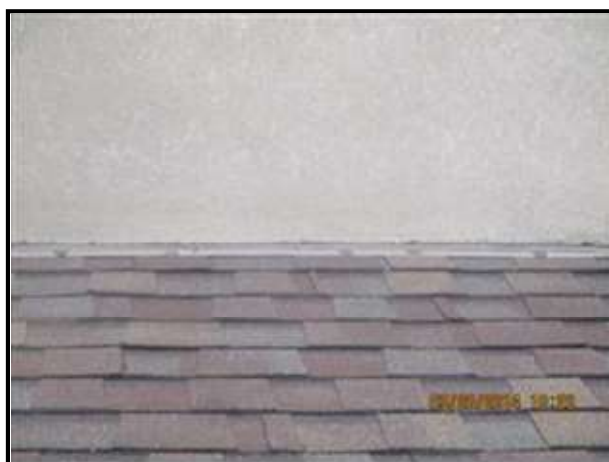
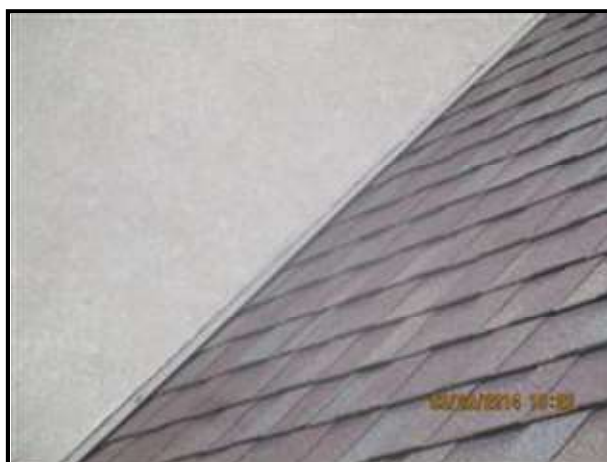
**1.1** While there were no visible defects, initial roof leaks and/or recurring roof leakage problems are often due to inadequate or damaged flashing. Ensure all flashings at chimneys, rooftop vents and plumbing stacks are checked on a regular basis and properly sealed to prevent leakage and deterioration to roof sheathing.

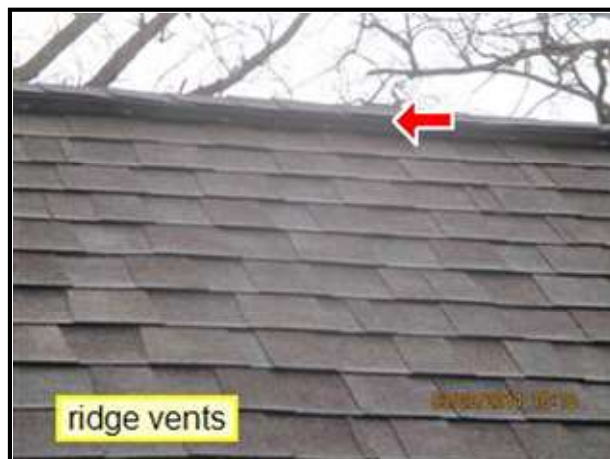
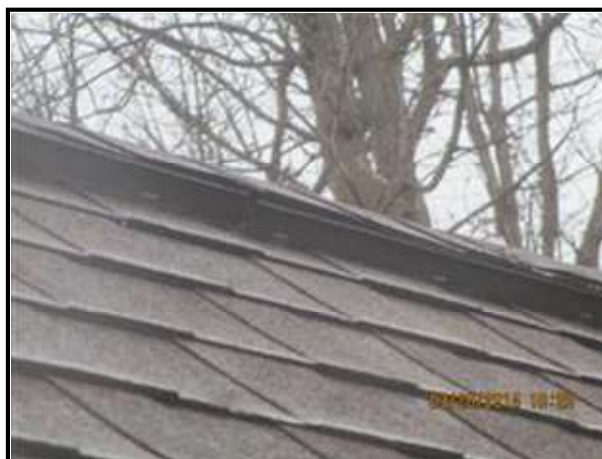
**1.3** Ridge vents noted. This type venting will provide the most even air exchange throughout the attic area.

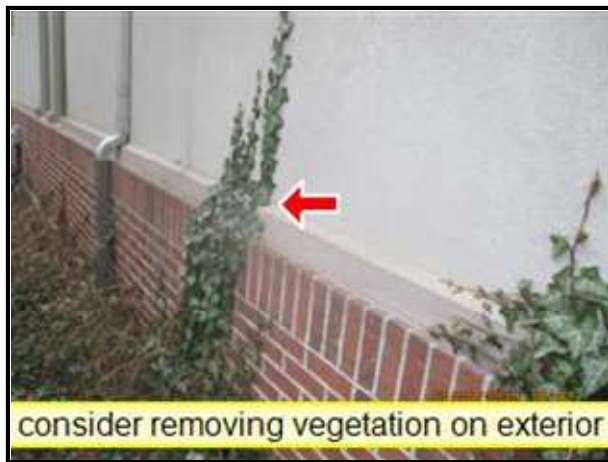
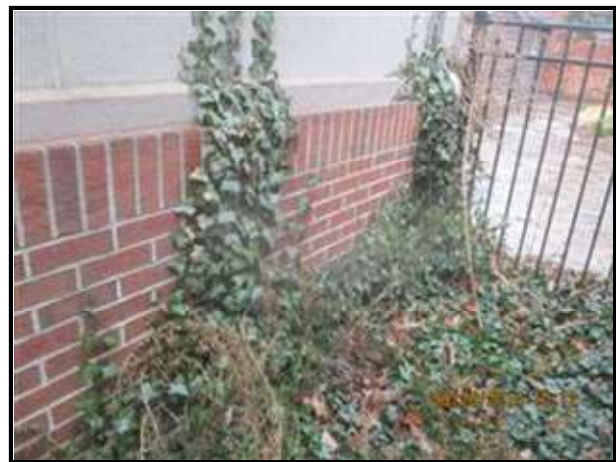
**2.0** Vegetation and vines growing against or close to the outside finish will trap moisture against the and increase the risk of insects. Some plants & vines are more destructive than others and need to be monitored over time. Be sure to trim vines and other vegetation away from gutters to prevent blockage to the roof drainage system.

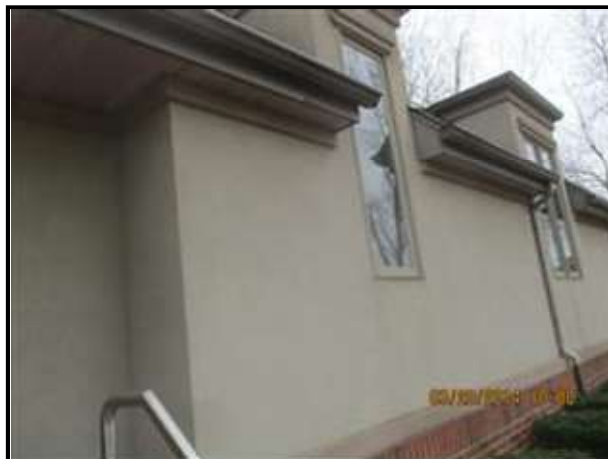
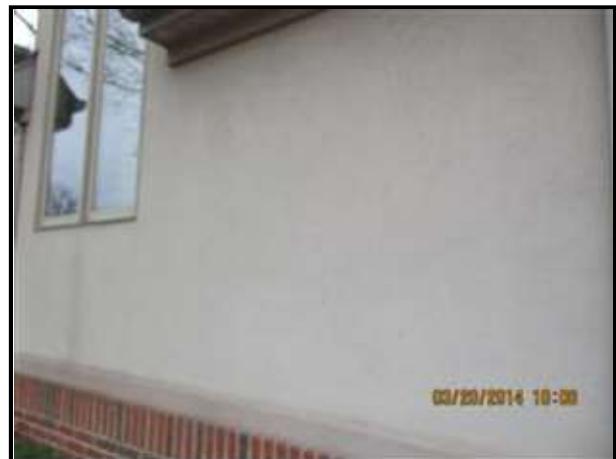
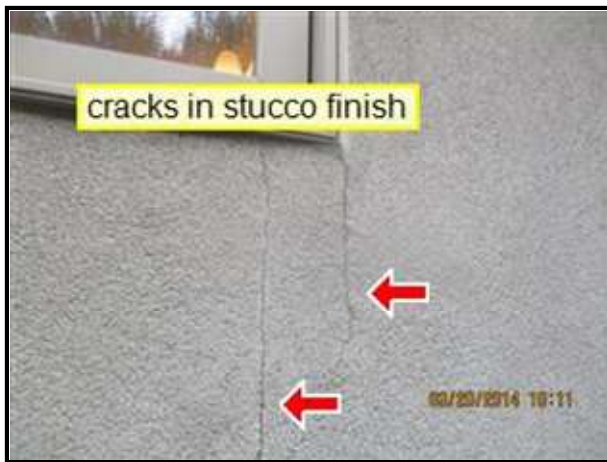
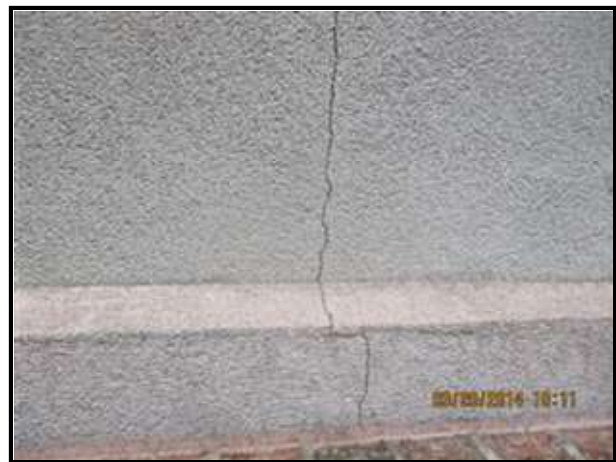
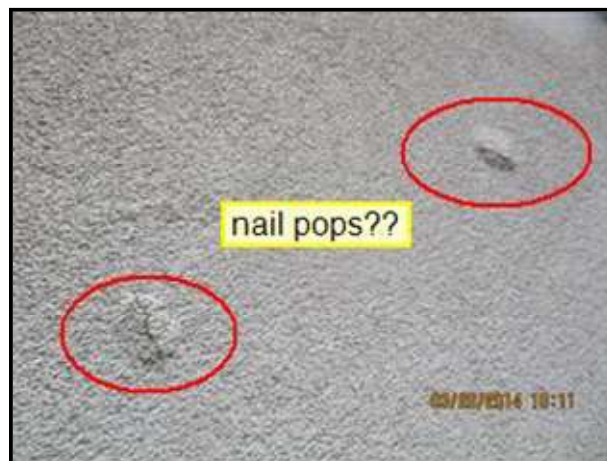
**2.1** Synthetic siding (EIFS) noted. This material requires periodic maintenance to seal any cracks that may occur. Cracks or other openings can allow moisture to infiltrate behind the finish and cause hidden damage not detectable in the course of a standard home inspection. Reinspect periodically, especially at seams and repair any openings. Certain EIFS products and/or installation methods create conditions that are highly susceptible to moisture infiltration and subsequent mold growth and/or structural damage due to water infiltration at penetrations, joints, and roof terminations. No test was performed for possible water intrusion, as this is a separate specialized testing service; contact a certified EIFS inspector to evaluate conditions.

There were some cracks and what appeared to be nail pops in the siding on the south side of the house. The area where this occurred is where the kitchen was located. It is suspected renovations were performed in the kitchen that caused the damage to the stucco walls. These areas need to be repaired to help prevent water from entering and causing hidden damage. No evaluation was made to the material behind the finish wall. Installers of this material also perform repairs as needed when issues occur.

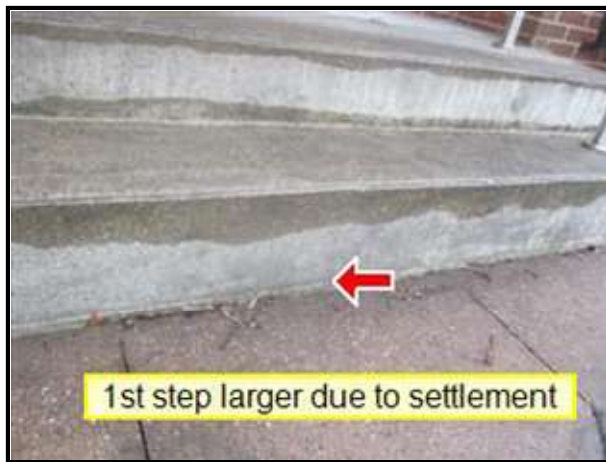
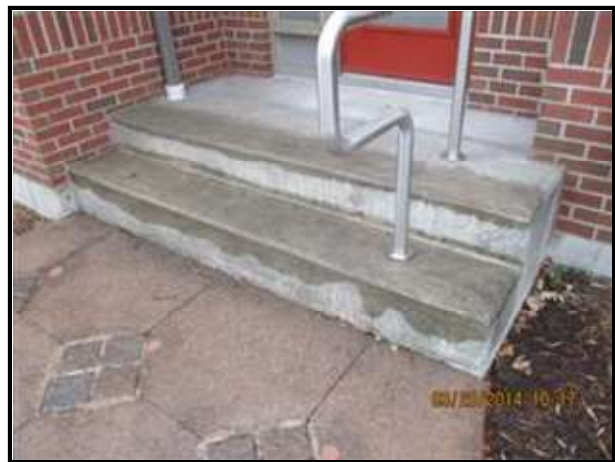
2.5 Settlement of the sidewalk on the north side has created a large 1st step. Replacement of the walkway or corrections such as concrete lifting will improve the height of the step and make the use safer.

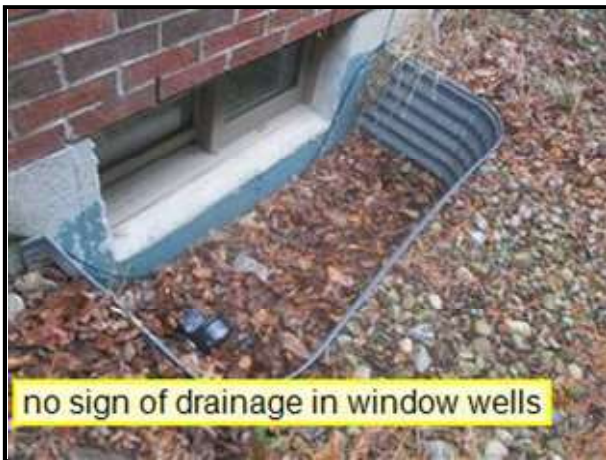
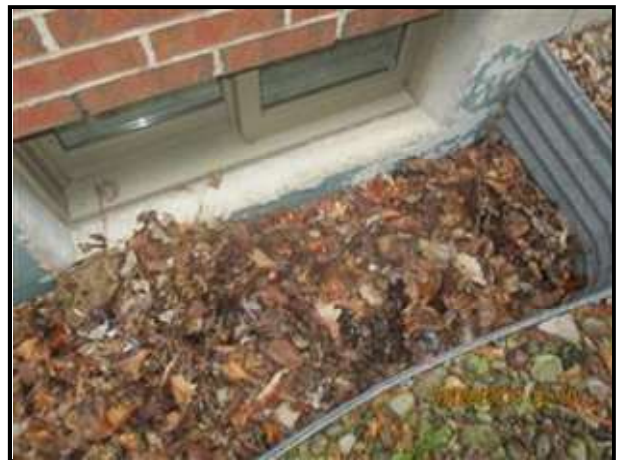
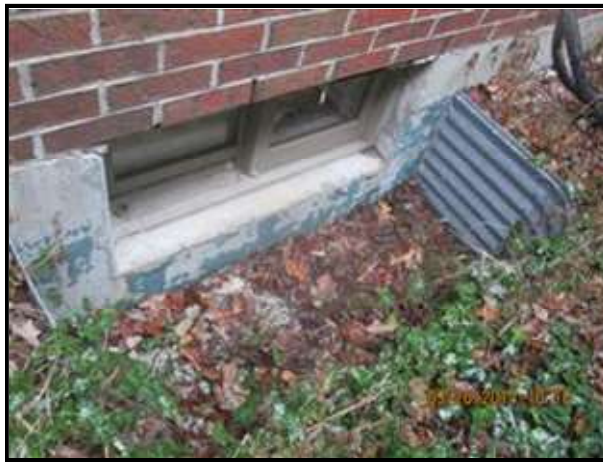
**3.5** Drainage tile below the surface was not verified. If water ponds inside the window well, alteration, such as adding a dome over the well, may be required to reduce the risk of seepage in this area.

See the comments on penetration (section 10). There was staining in the area of one of these window wells and improving these areas is highly recommended, although may not be full remedy to prevent further water seepage in the basement.

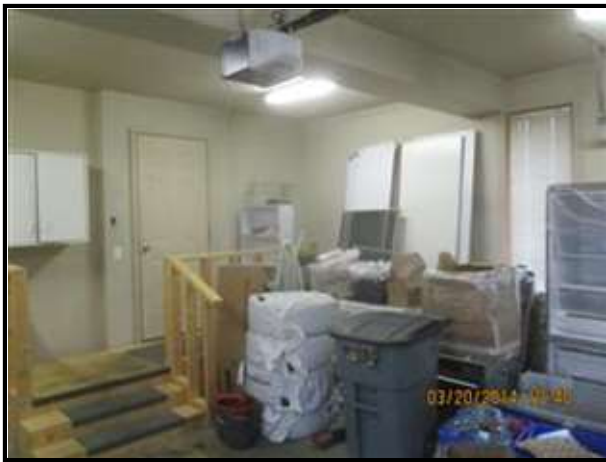
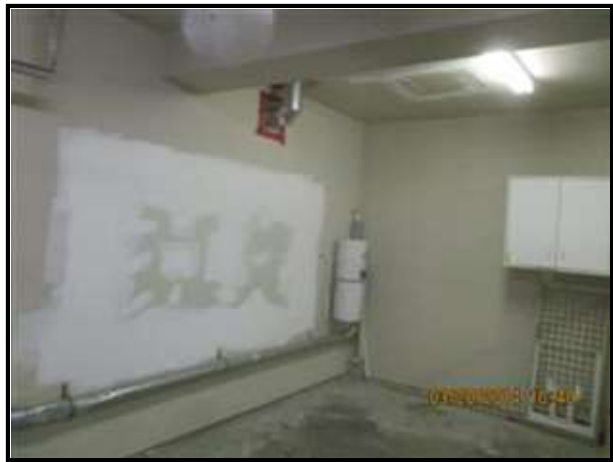
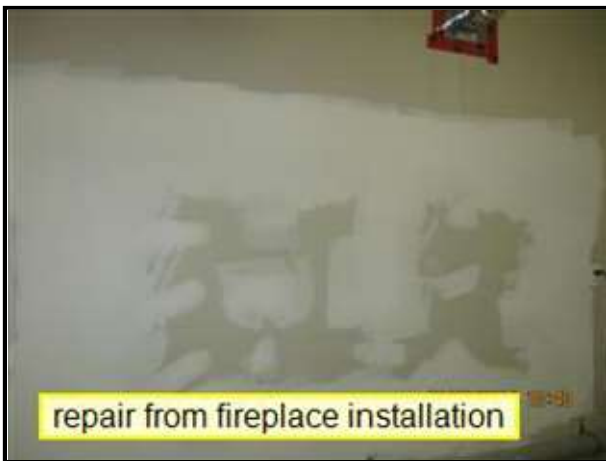
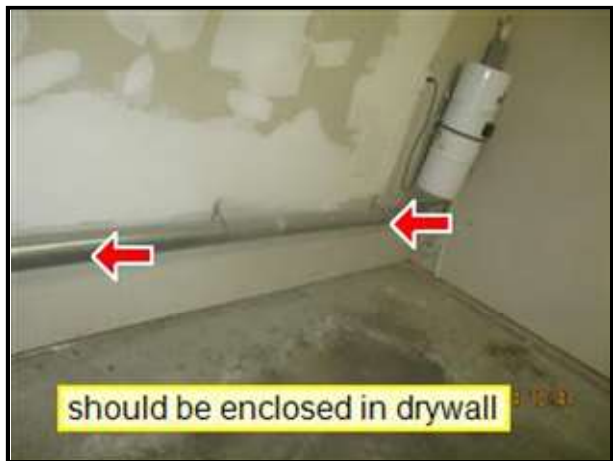
**4.5** Exposed dryer vent material noted in the garage. Normally, this material is required to be covered in non-combustible material (such as drywall) with seams sealed to prevent gasses in the garage from seeping through and possibly into the house.

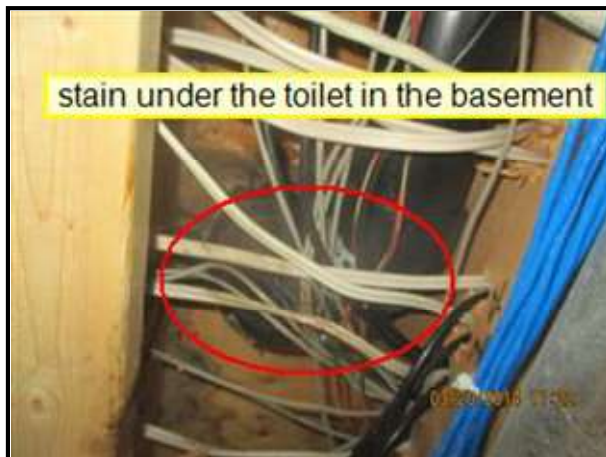
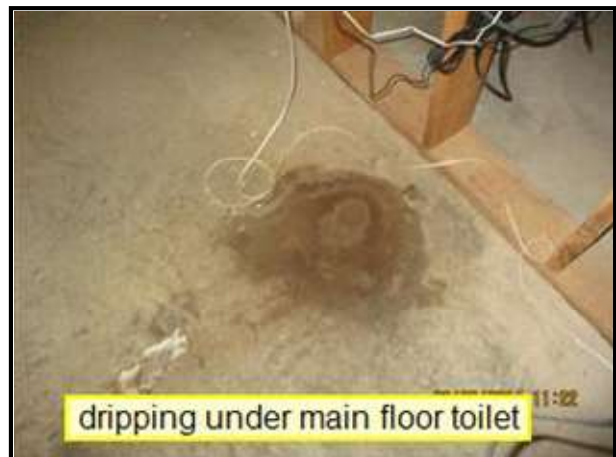
#### 6.1.B

Seepage at the base of the toilet dripping into the basement indicates a defective/leaking and requires immediate attention. Floor, flooring, and/or other damage may be uncovered when the toilet is lifted for repair. Have checked and corrected as required.

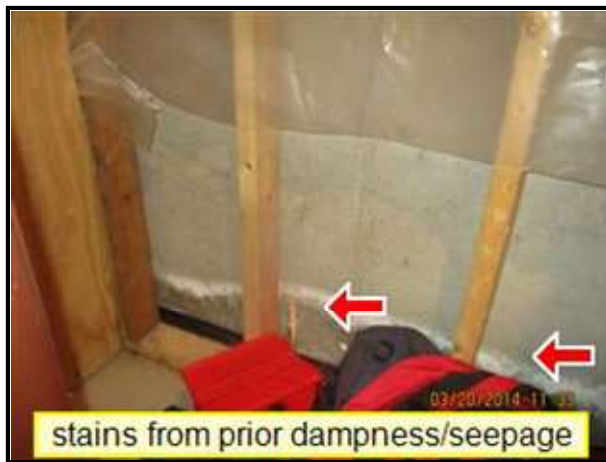
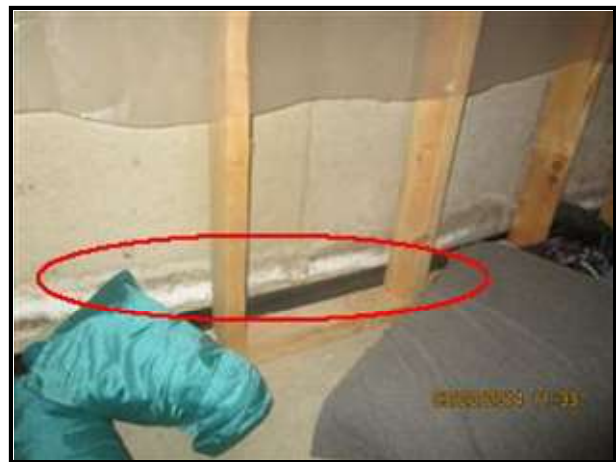
**10.1** (1) There was water staining and high moisture levels detected in the baseboard trim under the rear basement window on the south side. No other signs of ongoing leakage issues noted at time of inspection. At a minimum, a dome over the window well should be considered to prevent the window well from filling and leaking into the basement.

Water stains (efflorescence) noted in the unfinished walls in the utility room from prior water penetration; monitor for severity and correct as required. Note: It is not possible to determine when water penetration may have occurred. Sometimes the source of the original water leaks have been addressed. It is difficult to determine if future concerns will occur in the same areas as the water marks from previous leaks.

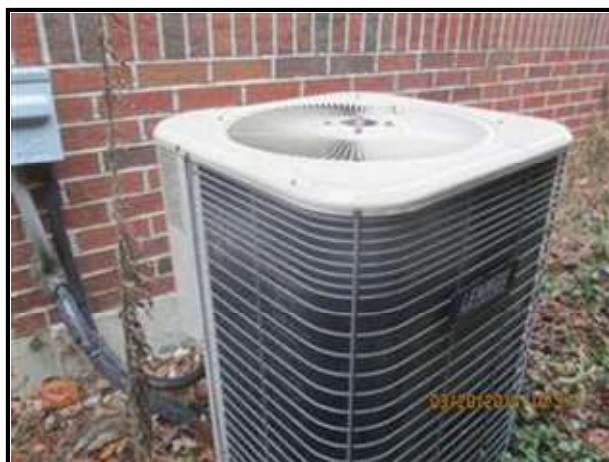
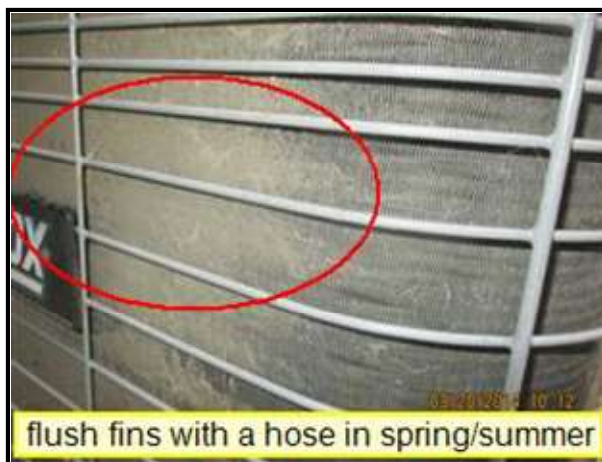
**12.1** Maintenance Tip: Fins need to be kept clean of dirt and debris for improved operation of the A/C unit. Periodically flush debris from fins.

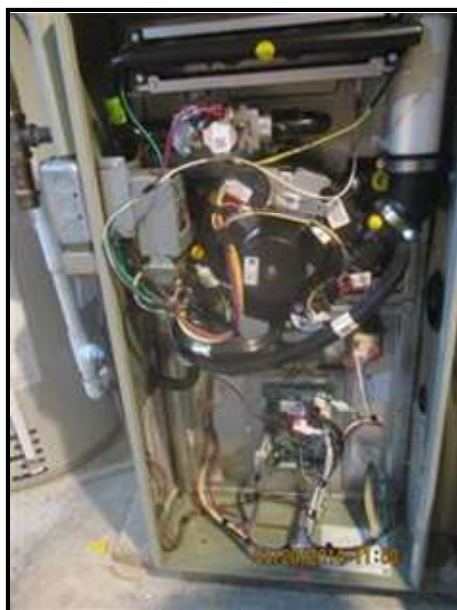
**13.0** This is a newer furnace and may still be under warranty. Be sure to get any paperwork from the home owner before closing.

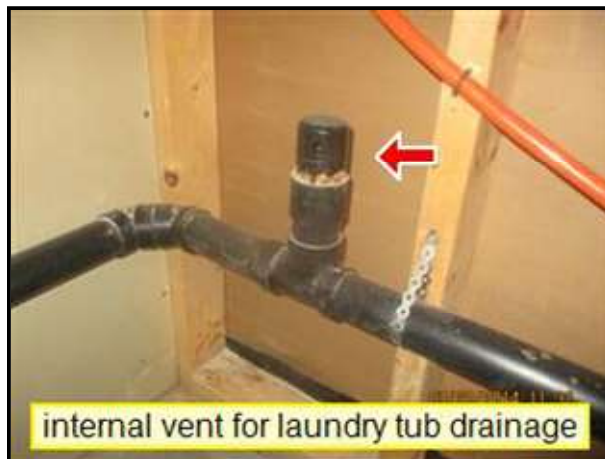
**14.4** An internal auto venting device installed. Auto venting devices are becoming more widely accepted although can be prone to failure and are not acceptable in all jurisdictions. Failure of these will allow sewer gasses to enter into the house. Newer Sure-Vents are more widely accepted.
