INSPECTION REPORT

For the Property at:
668 HAWLEY STREET
PETERBOROUGH, ON K9J 4C6

Prepared for: TEAM VANRAHAN
Inspection Date: Monday, August 14, 2023
Prepared by: David Sharman

RE: Report No. 4443
668 Hawley Street
Peterborough, ON
K9J 4C6

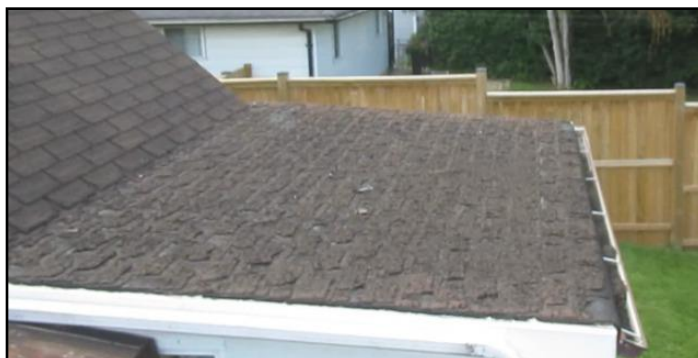
1. Condition: • Old, worn out

Implication(s): Chance of water damage to structure, finishes and contents

Location: Sun room

2. Old, worn out

Task: Replace

Time: As soon as is practicable

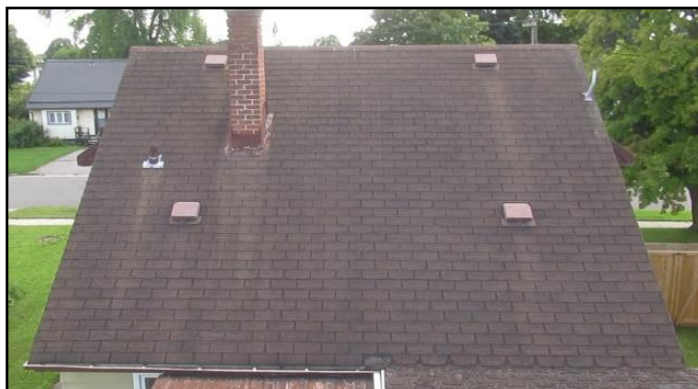
2. Condition: • Near end of life expectancy

Implication(s): Chance of water damage to structure, finishes and contents

Location: Rear elevation

3. Near end of life expectancy

Task: Replace

Time: Less than 2 years

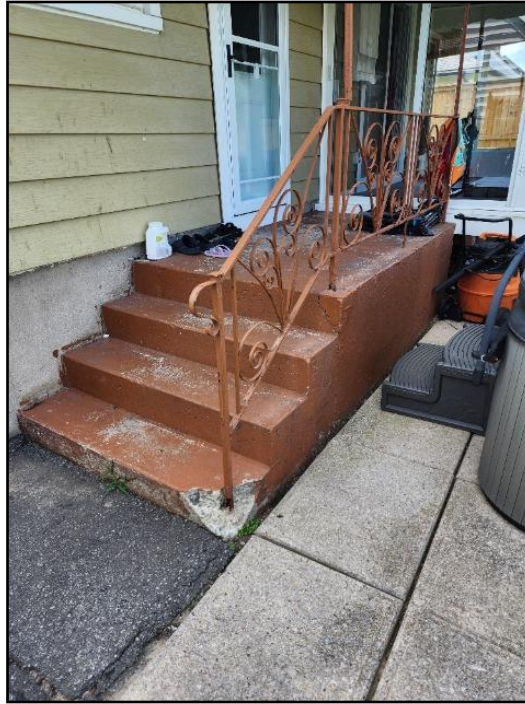
3. Condition: • Loose

Implication(s): Fall hazard

Location: Rear elevation

4. Loose

Task: Repair or replace

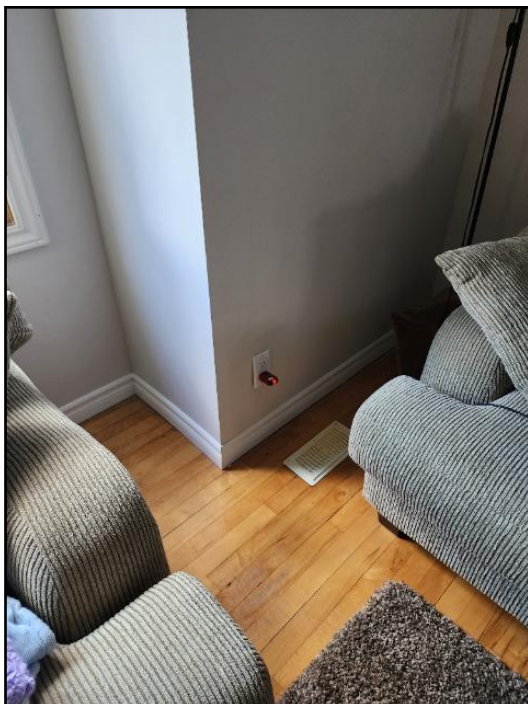
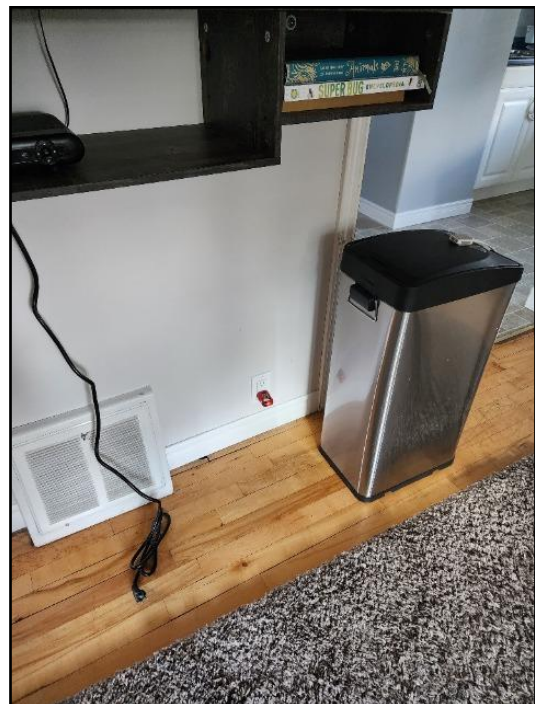
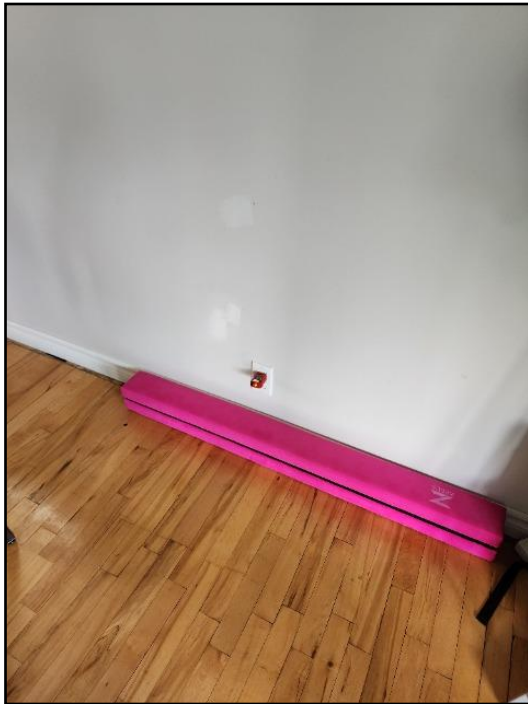
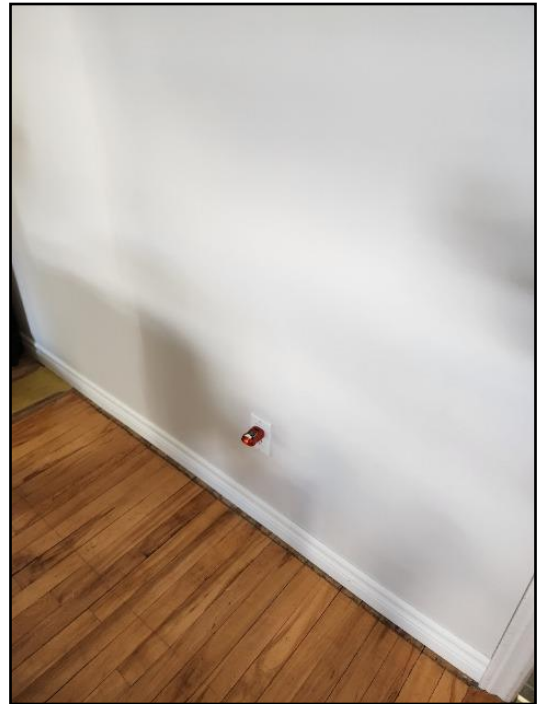
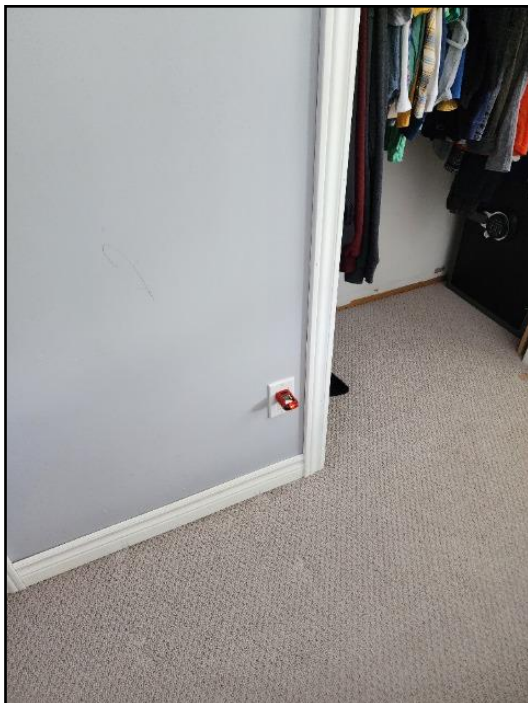
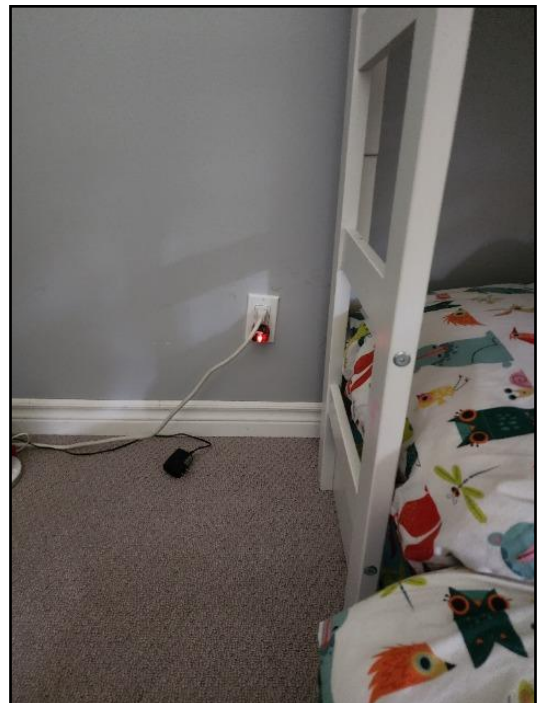
5. Condition: • Ungrounded

Although ungrounded service may be typical in a house of this age, safety may be improved by upgrading these receptacles.

Implication(s): Electric shock

Location: Various locations

7. Ungrounded

Task: Upgrade

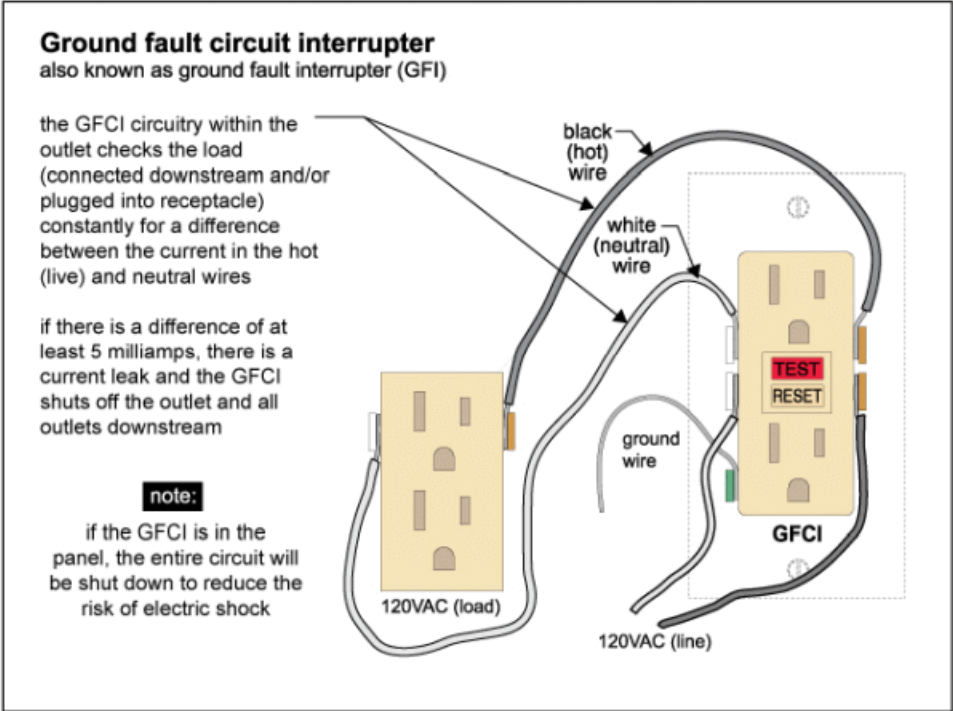
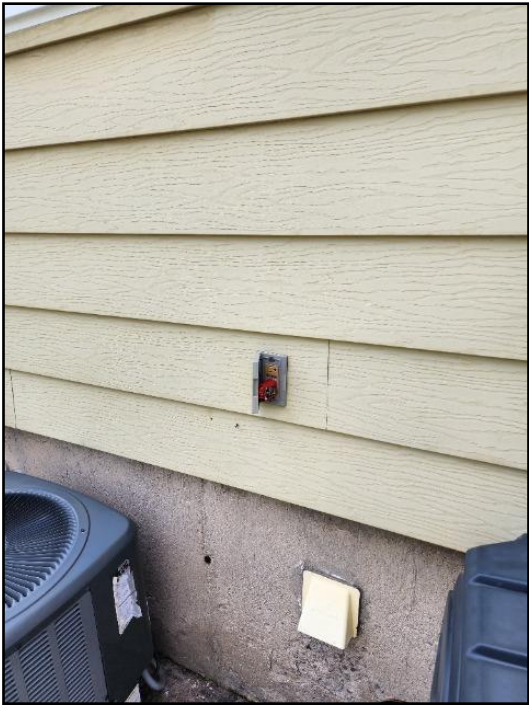
6. Condition: • Test faulty on GFCI/GFI (Ground Fault Circuit Interrupter)

Implication(s): Safety hazard

Location: Exterior wall

13. Test faulty on GFCI/GFI (Ground Fault...

Task: Replace
Time: As soon as is practicable
Cost: Minor

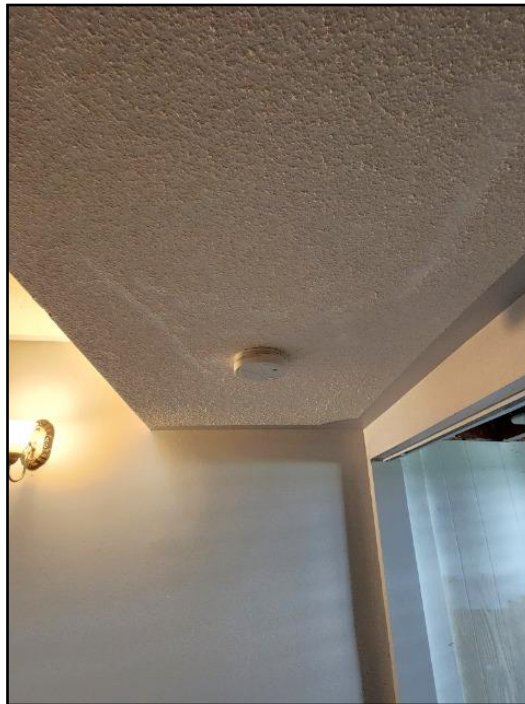
8. Condition: • Past life expectancy

Implication(s): Life safety hazard

Location: Basement

14. Past life expectancy

Task: Replace

Time: Immediate

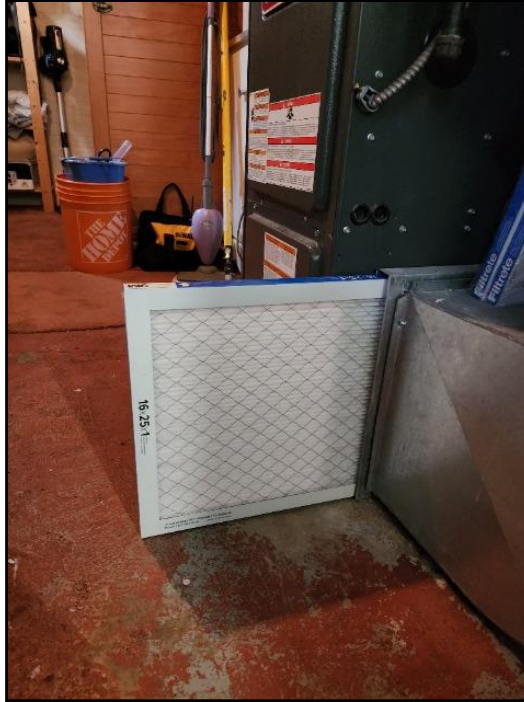
10. Condition: • Replace - regular maintenance

Implication(s): Increased heating & maintenance costs, Reduced comfort

Location: Cold air return

21. Replace - regular maintenance

Task: Replace

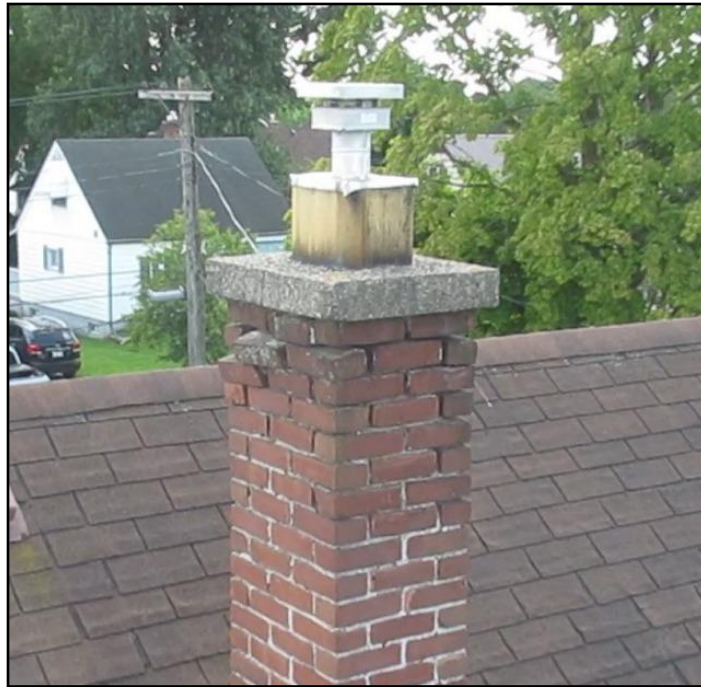
11. Condition: • Loose, missing or deteriorated masonry

Implication(s): Material deterioration

Location: Exterior

22. *Loose, missing or deteriorated masonry*

Task: Repair

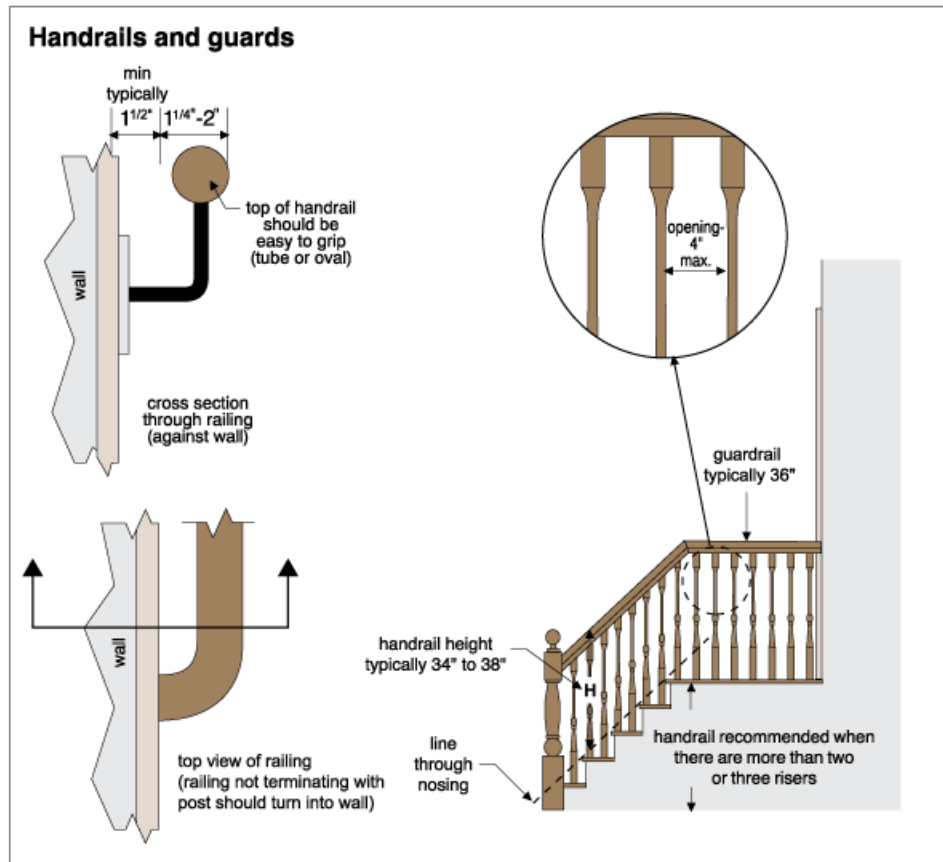
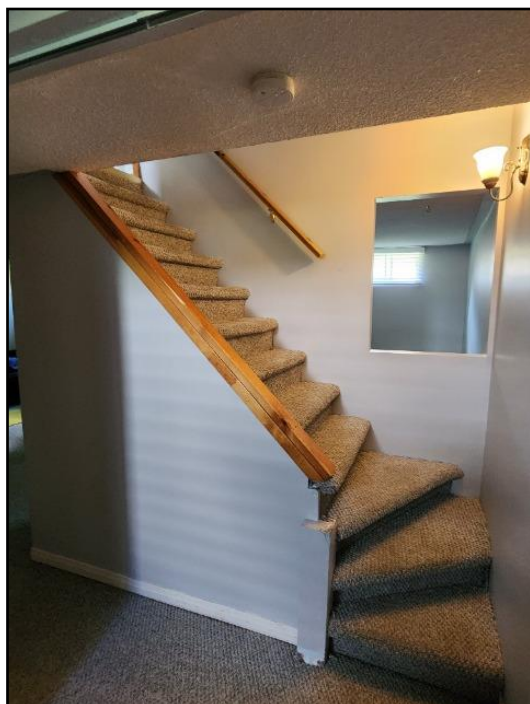
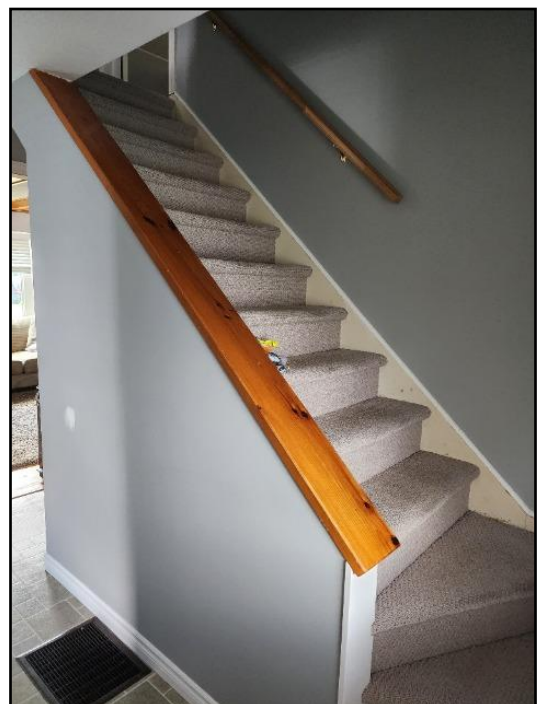
15. Condition: • Missing

Implication(s): Fall hazard

28. Missing
