HOME INSPECTION & PEST CONTROL

This Professional Inspection Report Has Been Prepared Exclusively For:

**Danielle Gumapac
6 Parkway Plaza
Lufkin, TX 75904
November 3, 2022**

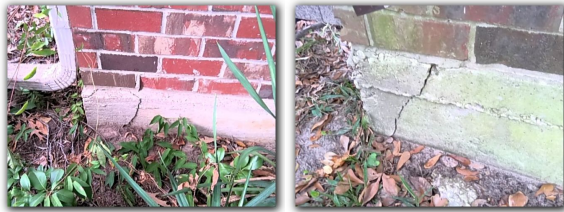
BN - Small cracks were detected on the corners of the concrete slab on grade foundation. These cracks are common in “post-tension” foundations or other type of slab foundations. Expansion properties in the brick veneer can also cause these cosmetic blemishes.

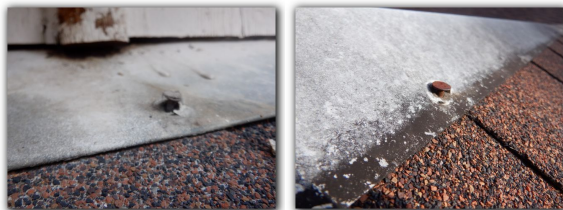
Nail pops and exposed nail heads should be properly fastened and sealed

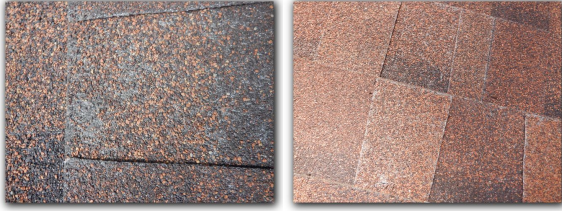
The composition roofing material has experienced some granular loss in various locations throughout the roof.

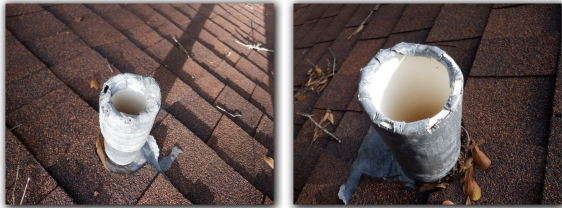
Damaged plumbing vents were observed in two or more areas. This could allow moisture to penetrate the structure.

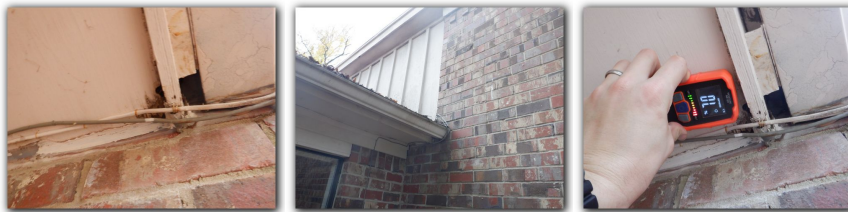
The soffit areas along the back side of the structure show evidence of active moisture and rot. Any wood rot and/or decayed wood should be replaced ,repaired, or treated. By replacing, repairing, or treating you prevent wood destroying insects from invading the wood and causing further damage.

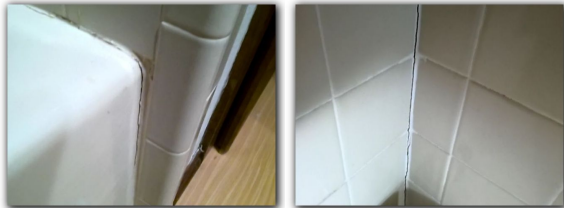
The wall was not properly sealed in the shower areas. This will allow water to penetrate under the tile. Hidden damage and fungal growth may exist that could not be seen at the time of inspection.

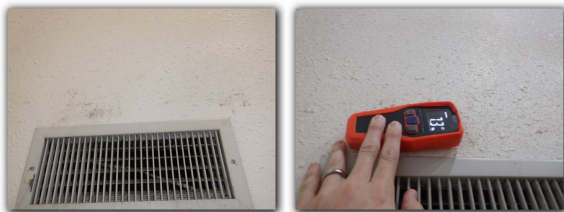
Discoloration was noted near the living room HVAC registers. These areas were tested and appeared to be inactive.

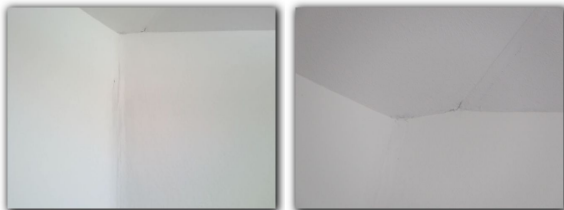
Detached drywall tape was noted in the dining room area.

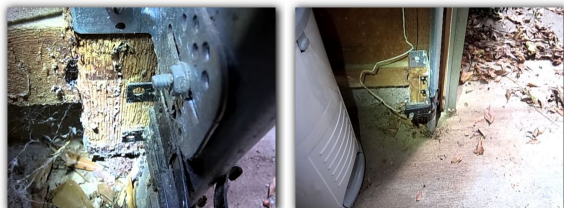
Evidence of previous activity and damage of wood destroying insects was detected on the garage walls near the bottom of the door frames in one or more areas. A full evaluation of the amount of damage caused by the insects cannot be detected within the walls, voids, or other hidden areas without defacing the property and cannot be address in this report. With the detection of previous activity of a wood destroying insect, it should be assumed that some degree of damage is present. Hidden damage, previous infestation, or active infestation may exist that could not be seen at the time of inspection. If this is a concern, I recommend that a more invasive inspection be conducted by a Qualified, Certified & Licensed Pest Control Company prior to closing.
