# INSPECTION REPORT

For the Property at:  
**14183 HIGHWAY 62**  
MADOC, ON

Prepared for: TEAM VANRAHAN  
Inspection Date: Tuesday, May 2, 2023  
Prepared by: David Sharman

RE: Report No. 4296  
14183 Highway 62  
Madoc, ON

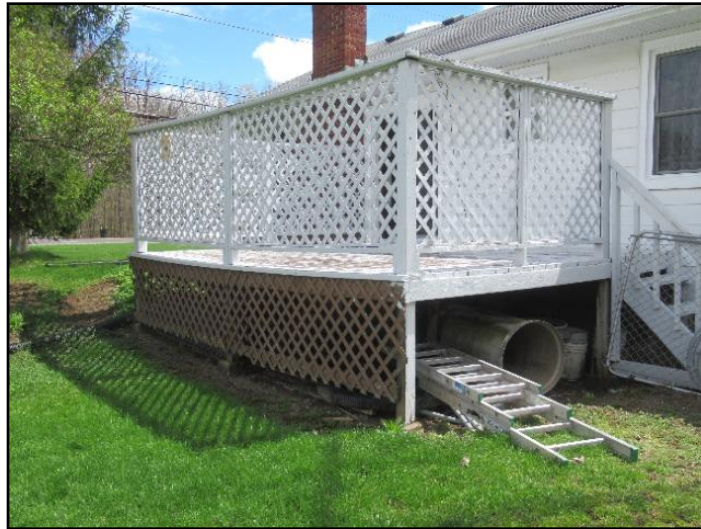
**2. Condition:** • Movement

**Implication(s):** Weakened structure | Chance of continued movement

**Location:** Raised decking

3. Movement

**Task:** Repair

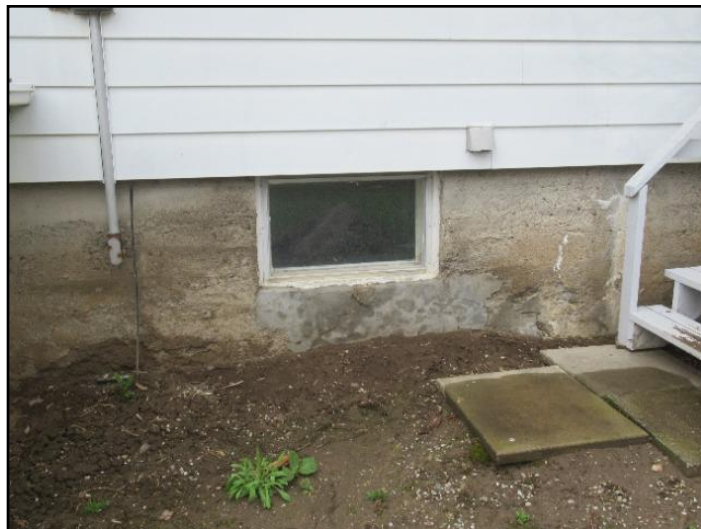
**4. Condition:** • Prior repairs

**Implication(s):** Weakened structure

**Location:** Rear elevation

5. *Prior repairs*

**Task:** Monitor

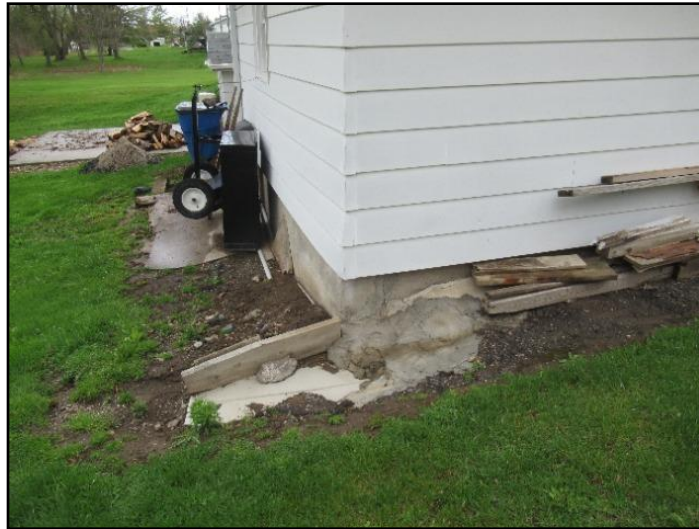
**5. Condition:** • Prior repairs

**Implication(s):** Weakened structure

**Location:** Garage

6. Prior repairs

**Task:** Monitor

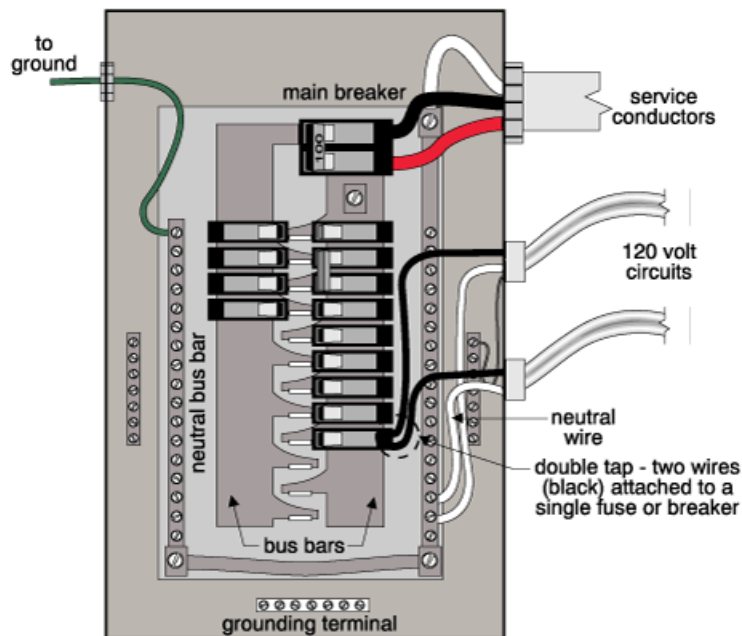
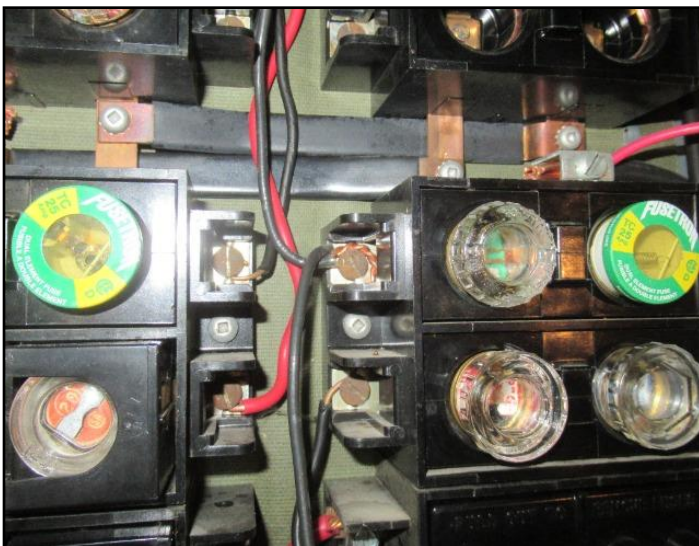
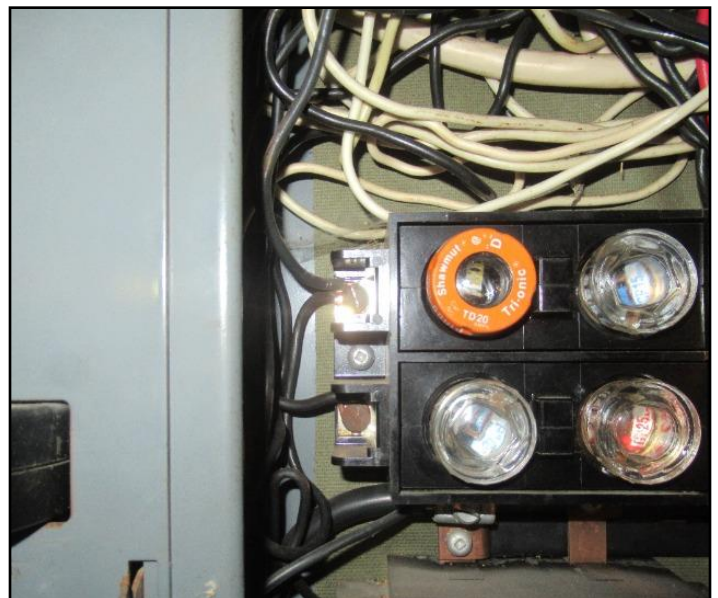
**SERVICE BOX, GROUNDING AND PANEL \ Panel wires****8. Condition:** • Double taps**Implication(s):** Fire hazard**Location:** Distribution panel**Task:** Correct**Time:** As soon as is practicable**Cost:** Minor**Double tapping (double lugging)**

**10. Double taps**

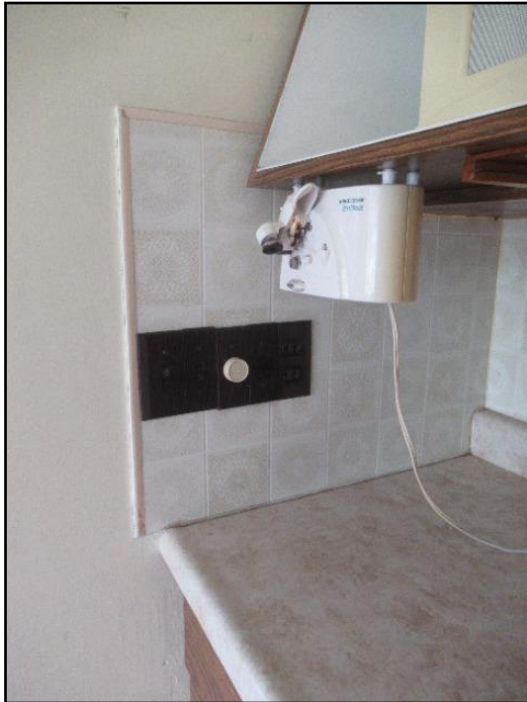
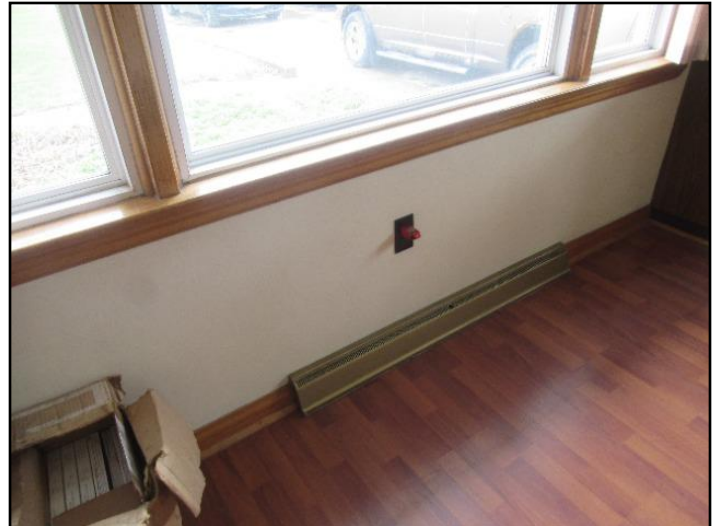
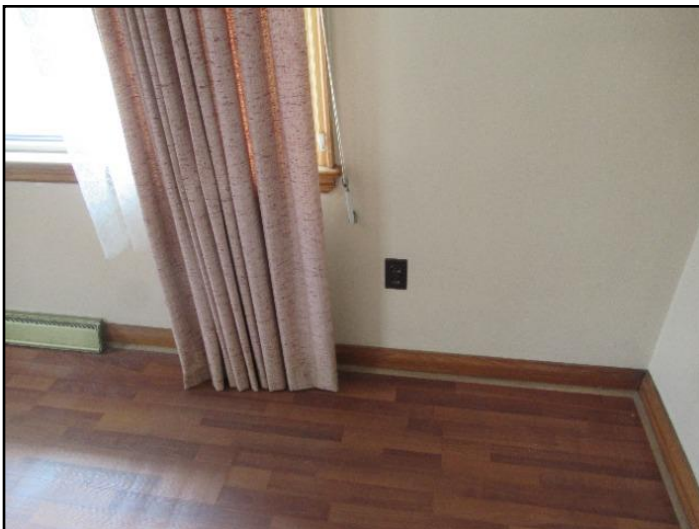
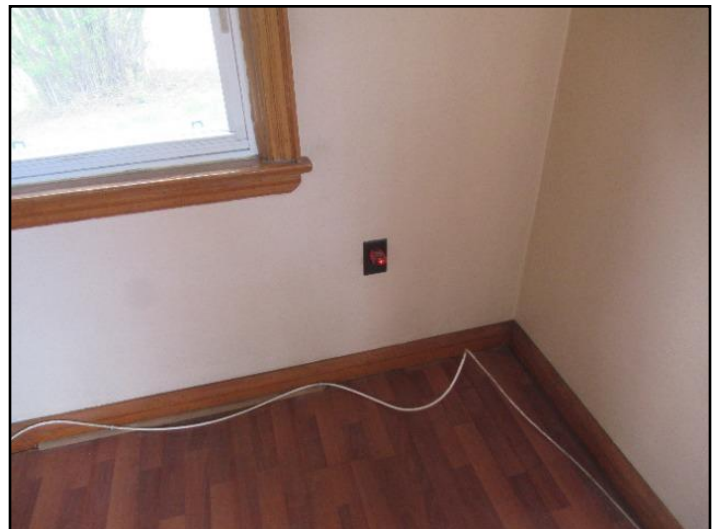
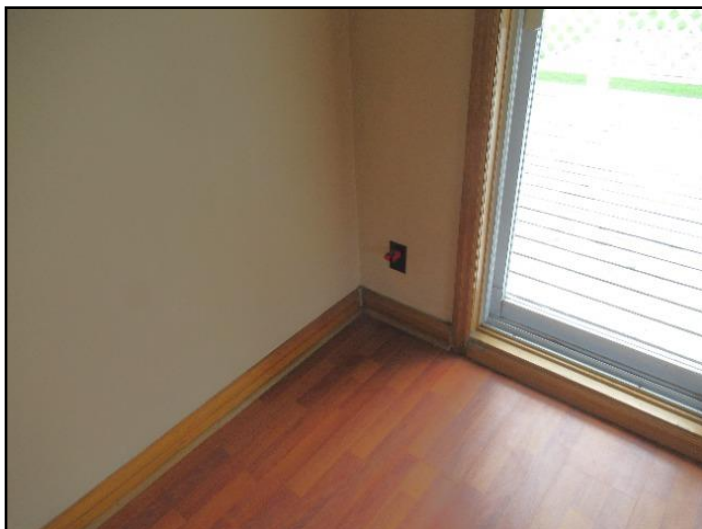
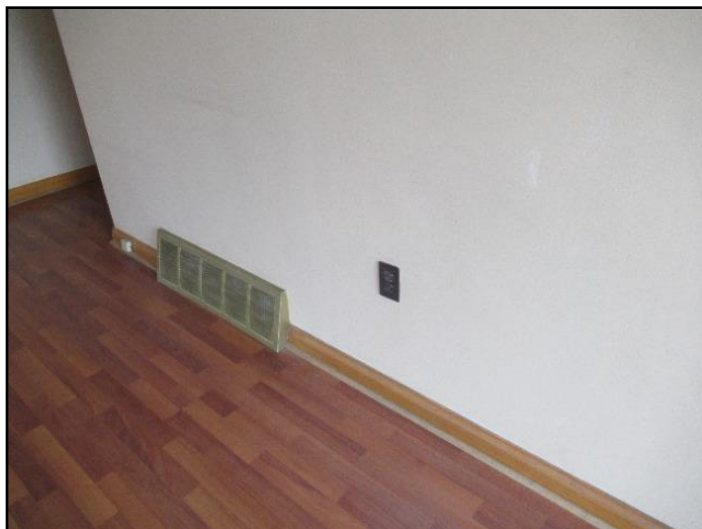
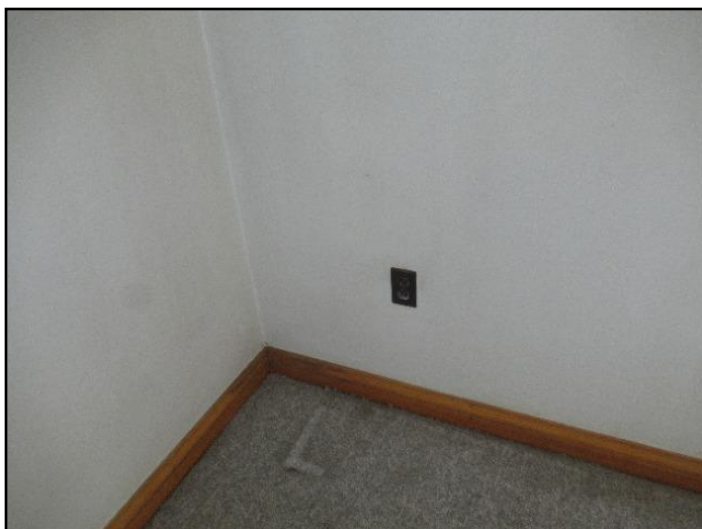
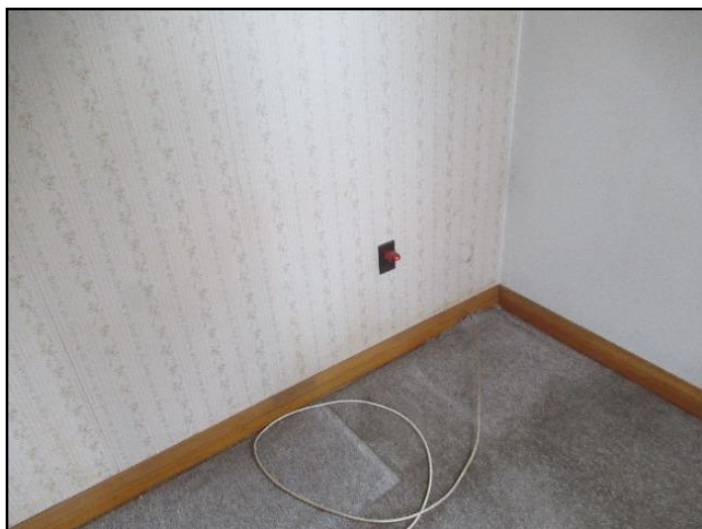
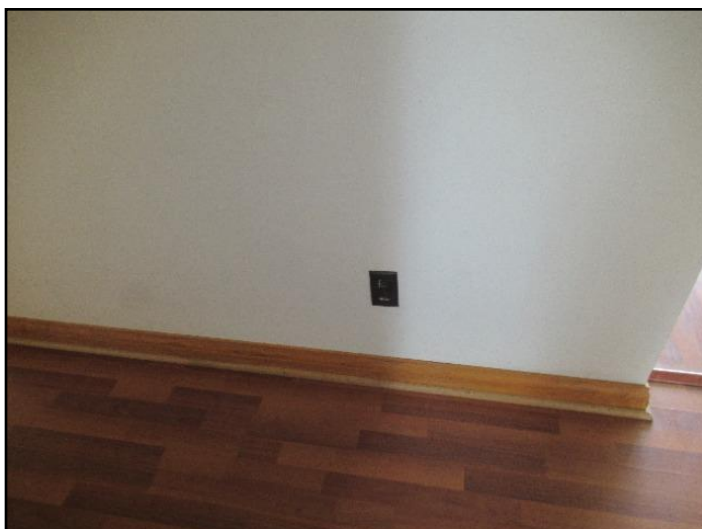
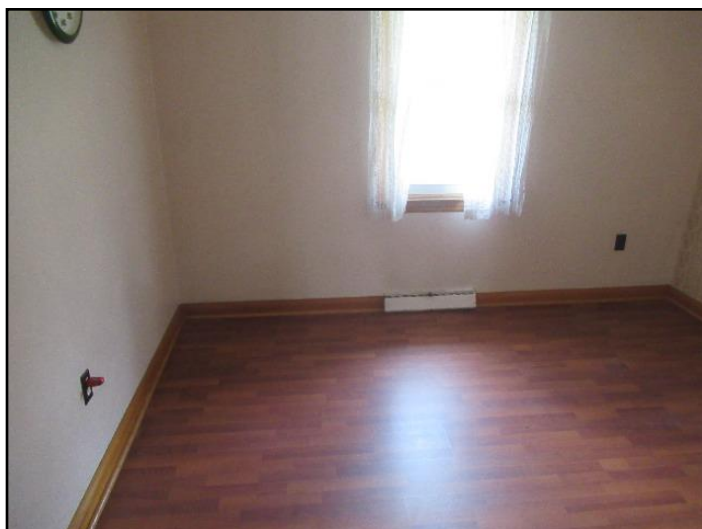
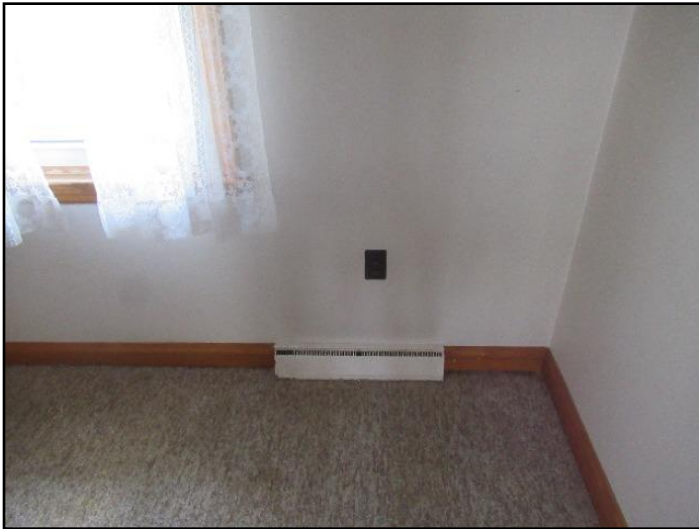
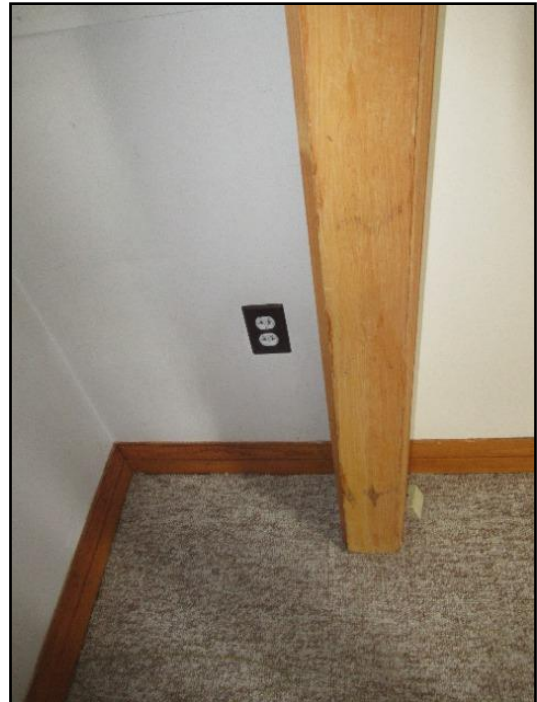
**9. Condition:** • Ungrounded

**Implication(s):** Electric shock

**Location:** Various locations

12. Ungrounded

**Task:** Upgrade

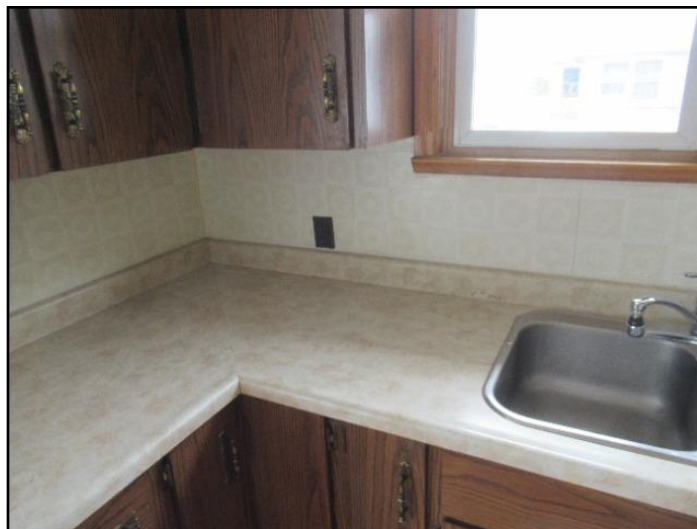
**10. Condition:** • No GFCI/GFI (Ground Fault Circuit Interrupter)

Although not a deficiency in a home of this age, safety may be improved by upgrading this receptacle.

**Implication(s):** Electric shock

**Location:** Kitchen

24. No GFCI/GFI (Ground Fault Circuit...

**Task:** Upgrade

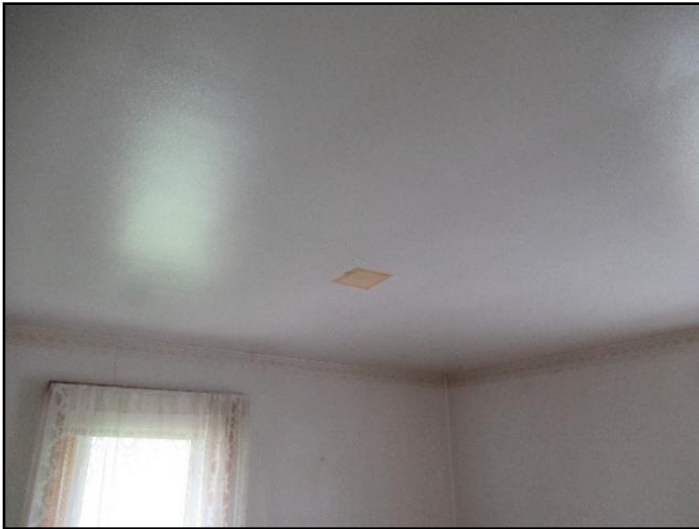
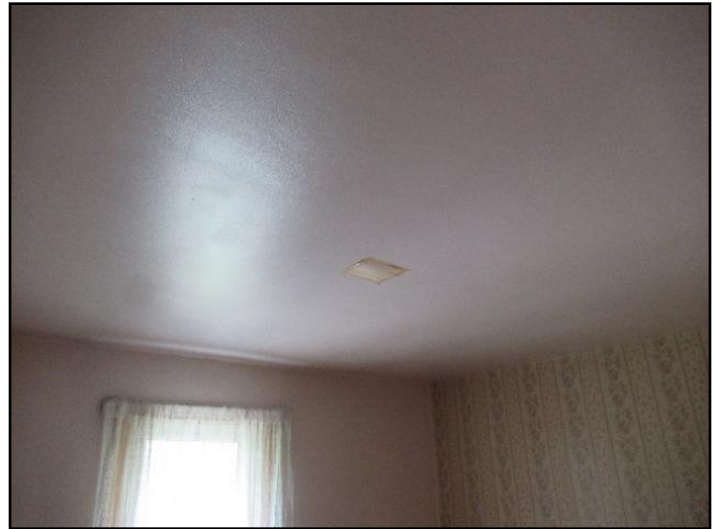
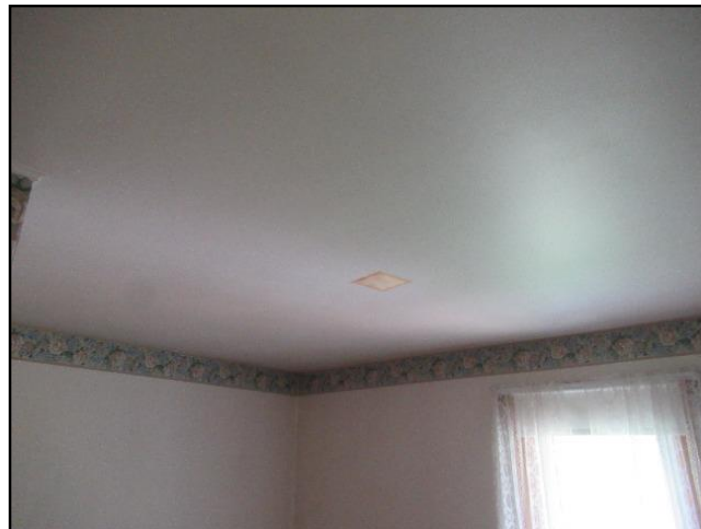
11. **Condition:** • Missing

**Implication(s):** Inadequate lighting

**Location:** Bedroom

25. Missing

**Task:** Replace

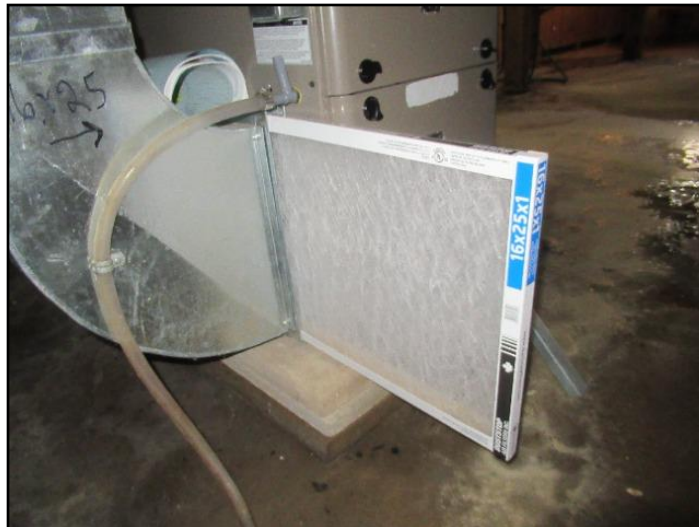
**12. Condition:** • Replace - regular maintenance

35. Replace - regular maintenance

**Task:** Replace

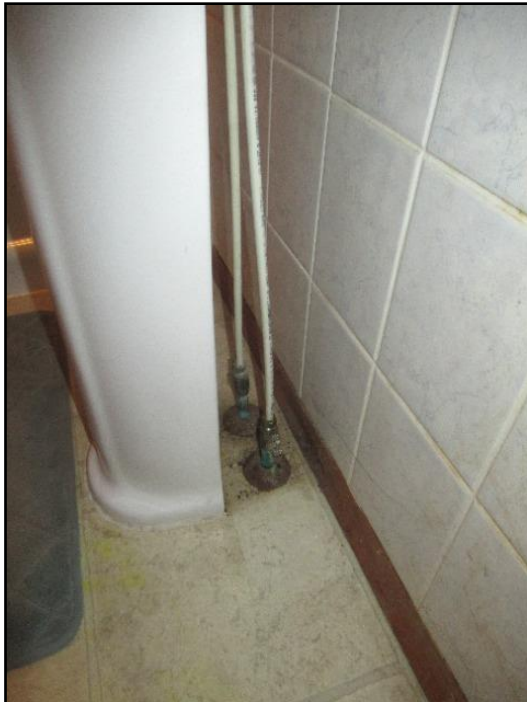
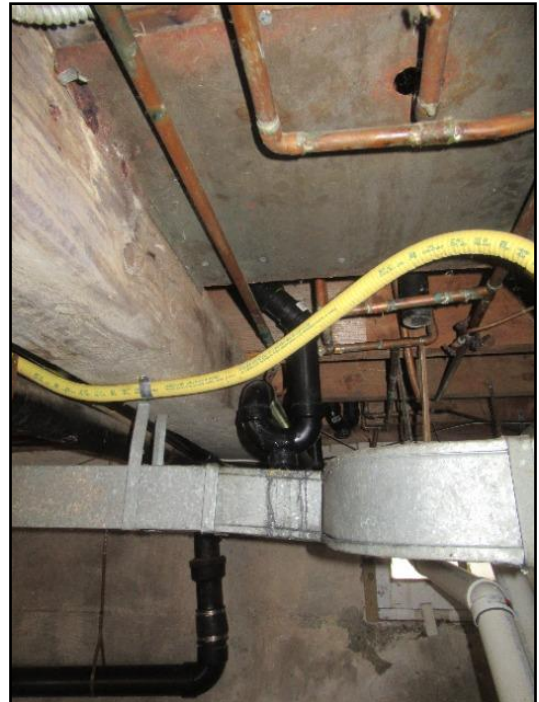
**14. Condition:** • Leak

**Implication(s):** Chance of water damage to structure, finishes and contents | System inoperative

42. Leak

**Task:** Repair

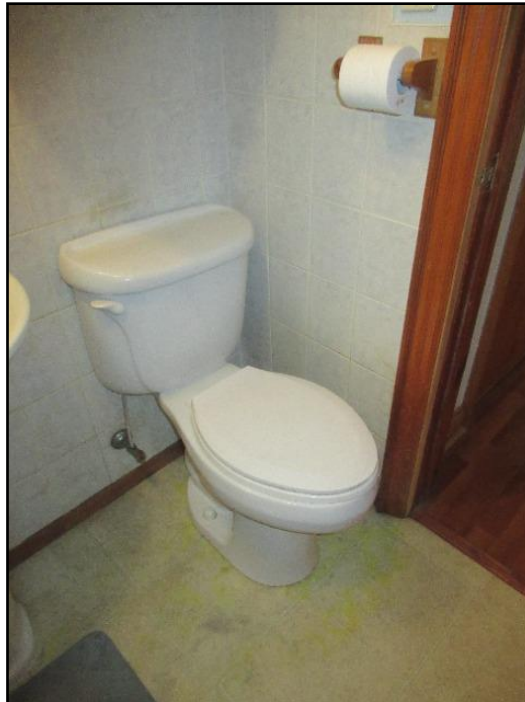
**15. Condition:** • Obstructed or weak flush

**Implication(s):** Chance of water damage to structure, finishes and contents | Sewage entering the building

**44.** *Obstructed or weak flush*

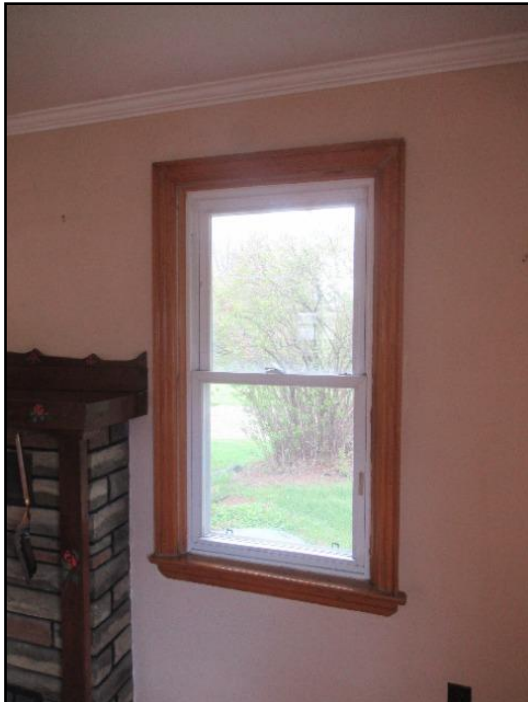
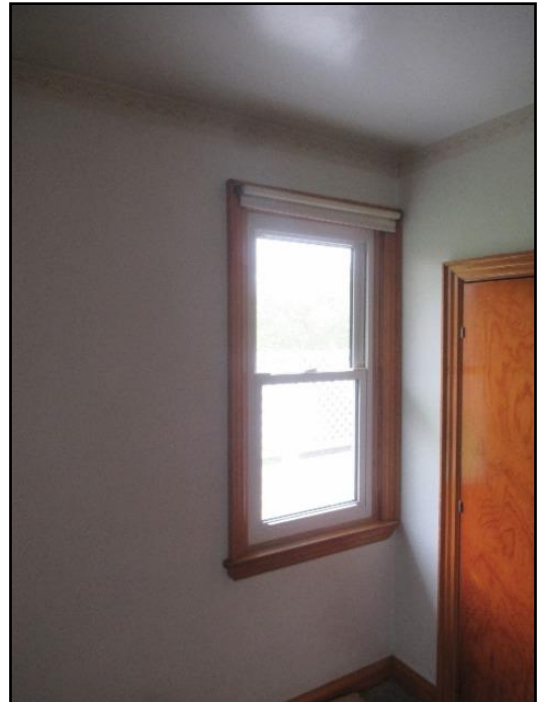
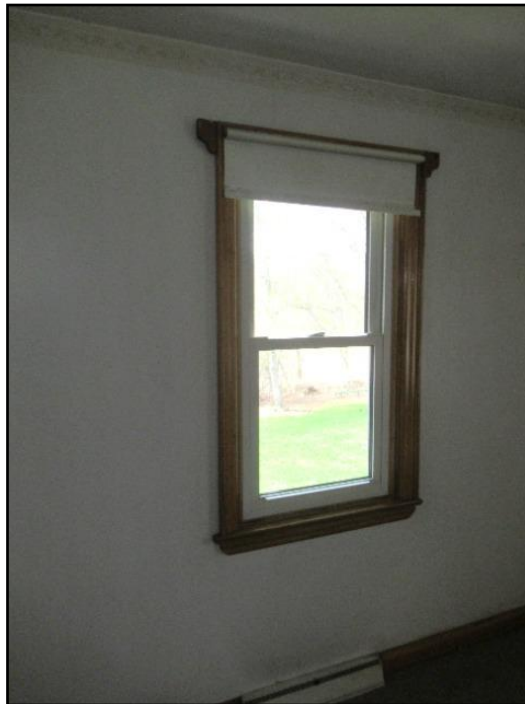
**16. Condition:** • Won't stay open

45. Won't stay open

**Task:** Repair

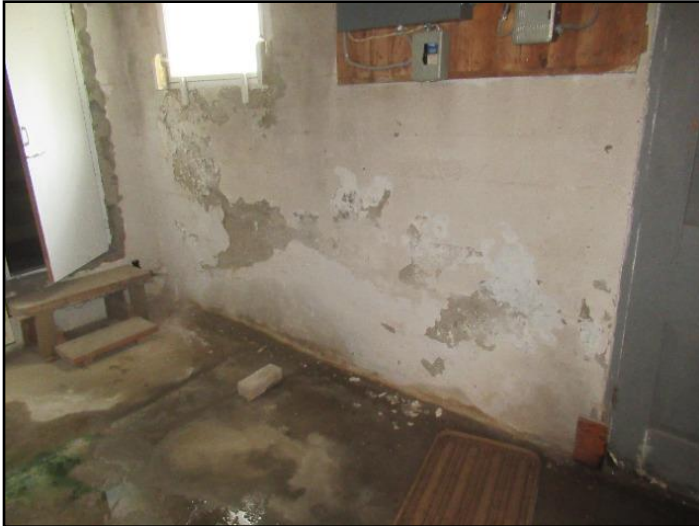
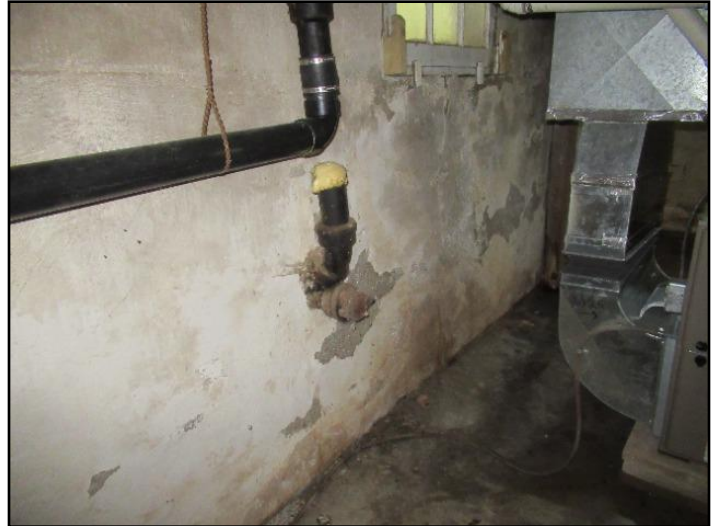
**17. Condition:** • Crumbling/spalling masonry, concrete or plaster

**Implication(s):** Chance of water damage to structure, finishes and contents | Material deterioration

48. Crumbling/spalling masonry, concrete or...

**Task:** Repair

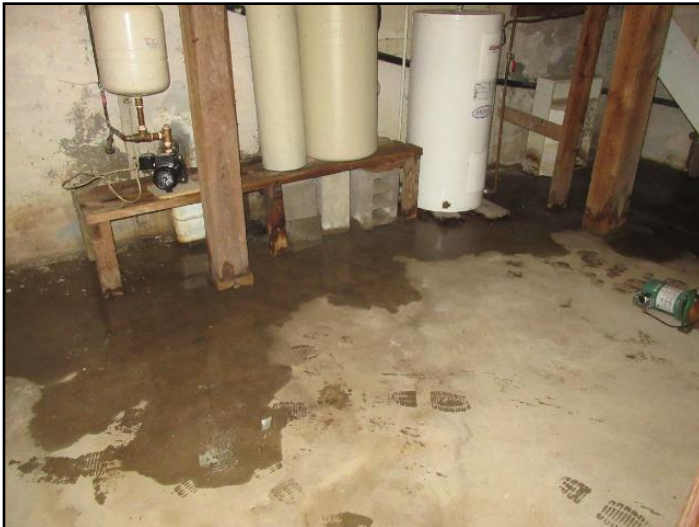
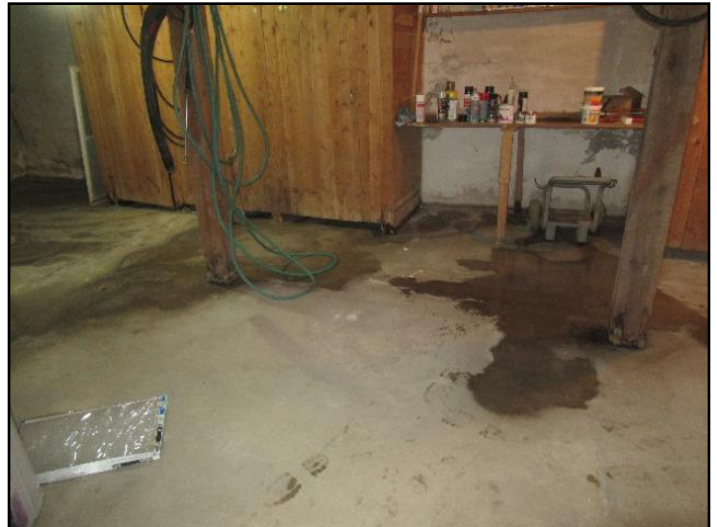
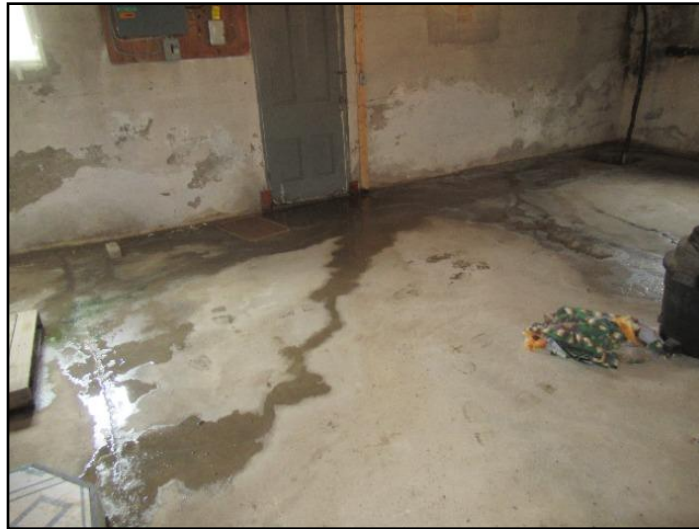
**18. Condition:** • Water on floor

**Implication(s):** Chance of water damage to structure, finishes and contents

50. Water on floor

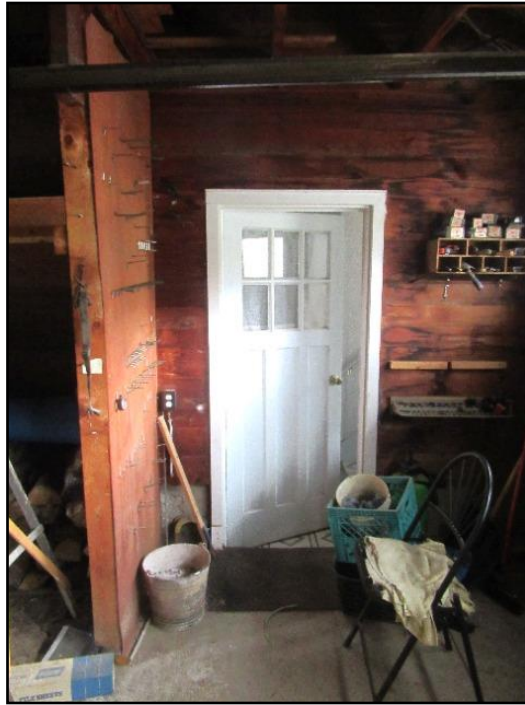
**20. Condition:** • Self closer missing, damaged or disconnected

**Implication(s):** Hazardous combustion products entering home

**Location:** Garage

**53.** *Self closer missing, damaged or disconnected*

**Task:** Provide
