# INSPECTION REPORT

For the Property at:  
**159 BOWEN DRIVE**  
PETERBOROUGH, ON K9H 0C1

Prepared for: TEAM VANRAHAN  
Inspection Date: Tuesday, April 11, 2023  
Prepared by: David Sharman

RE: Report No. 4253  
159 Bowen Drive  
Peterborough, ON  
K9H 0C1

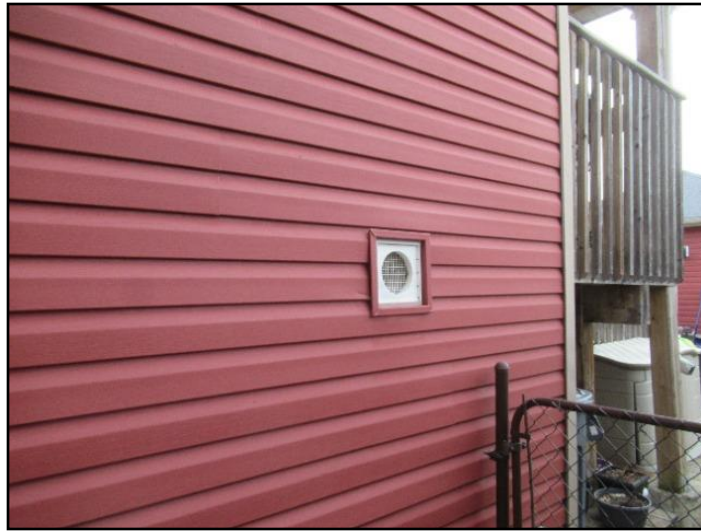
**2. Condition:** • Cover damaged

**Location:** Right elevation

3. Cover damaged

**Task:** Replace

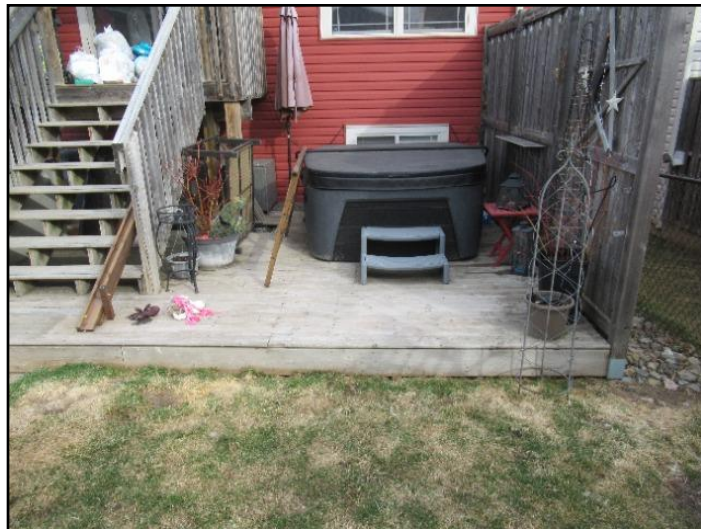
3. Condition: • Sag

Implication(s): Weakened structure | Chance of movement

Location: Rear decking

4. Sag

Task: Repair

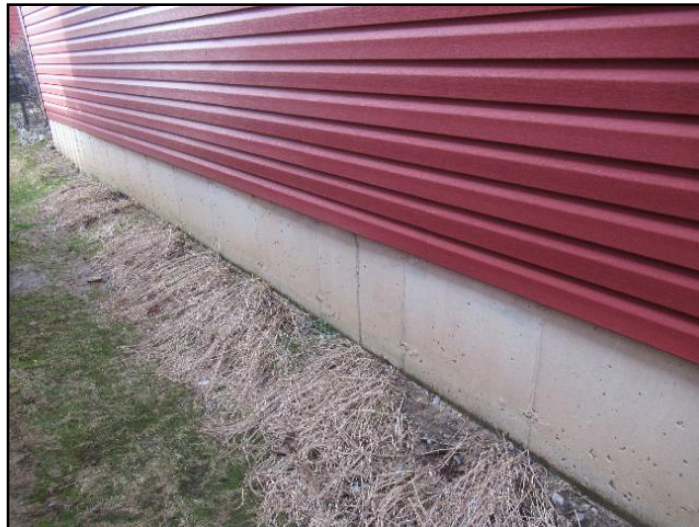
**4. Condition:** • Typical minor cracks

**Location:** Left elevation

5. Typical minor cracks

**Task:** Monitor

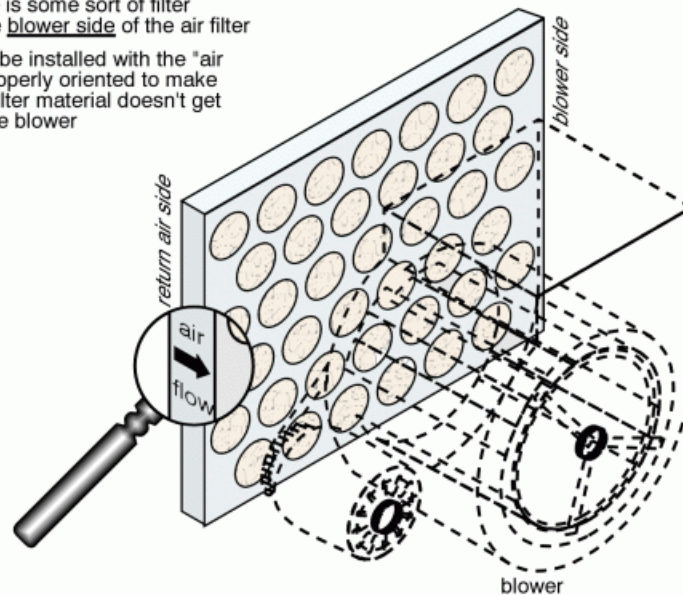
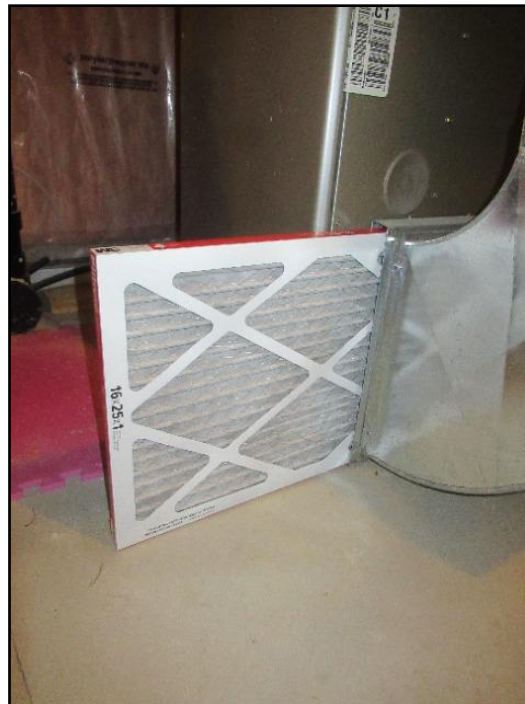
**7. Condition:** • Installed backwards

**Location:** Cold air return

typically, there is some sort of filter support on the blower side of the air filter

the filter must be installed with the "air flow" arrow properly oriented to make sure that the filter material doesn't get sucked into the blower

13. Installed backwards

**Task:** Replace

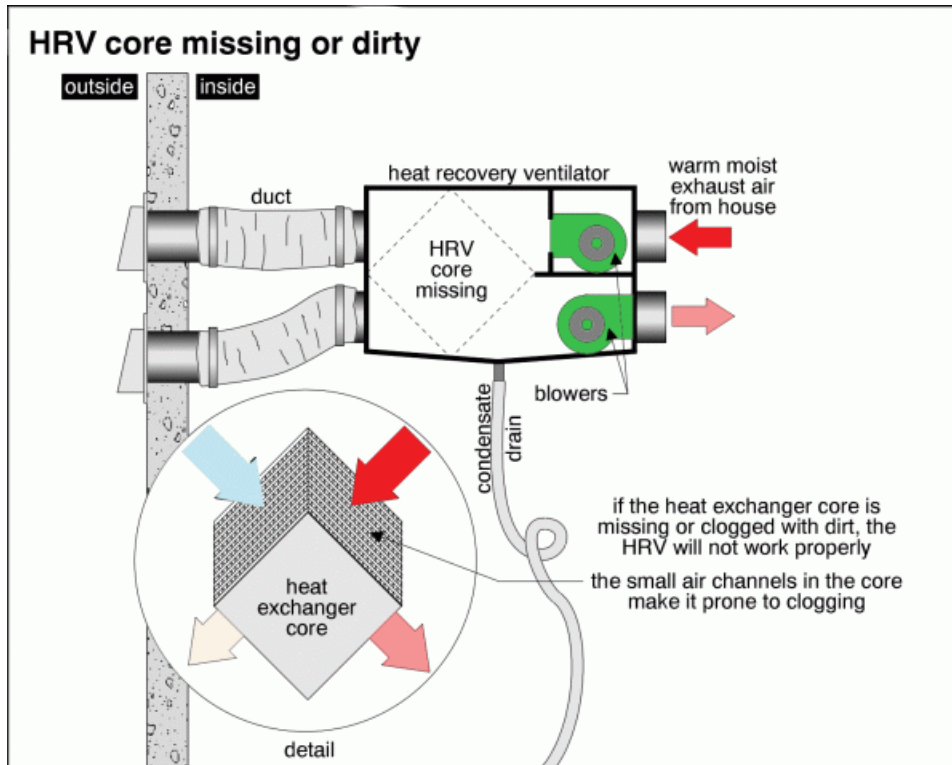
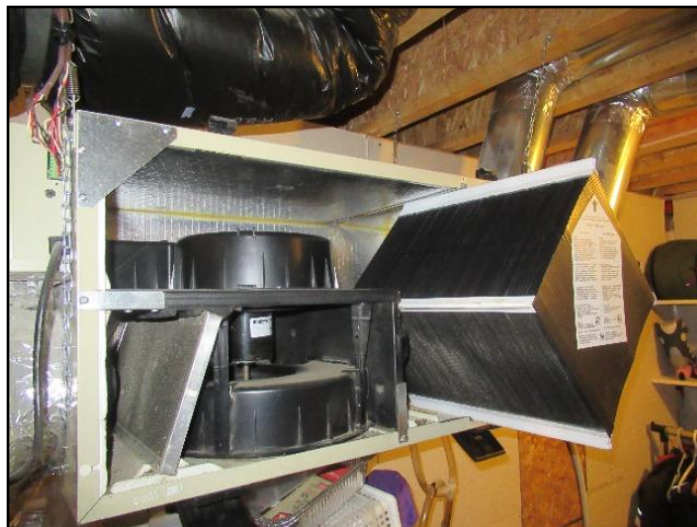
**8. Condition:** • Clean core - regular maintenance

**Location:** Unit interior

14. Clean core - regular maintenance

**Task:** Clean

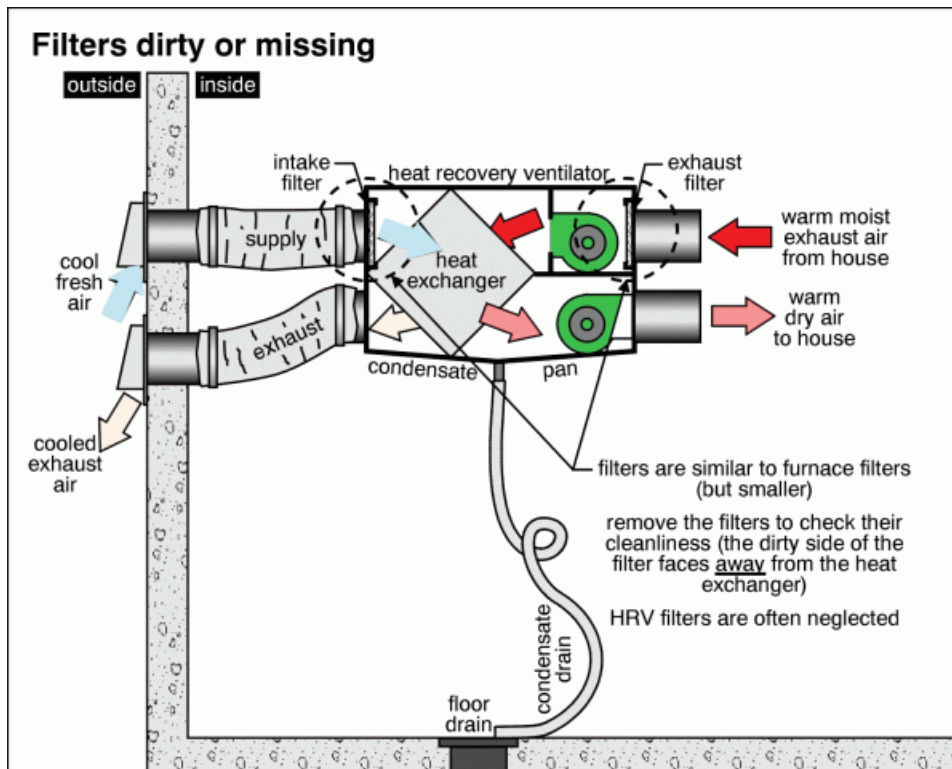
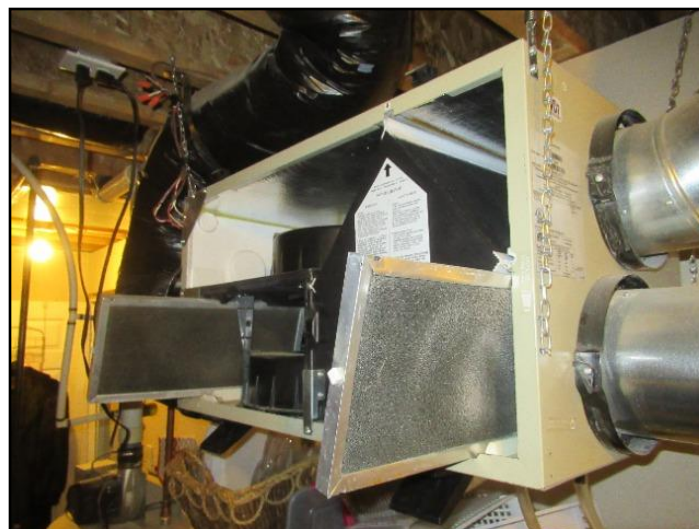
**9. Condition:** • Clean filters - regular maintenance

**Location:** Unit interior

15. Clean filters - regular maintenance

**Task:** Clean
