INSPECTION REPORT

For the Property at:
66 PINE GROVE ROAD
SPRINGBROOK, ON K0K 3C0

Prepared for: TEAM VANRAHAN
Inspection Date: Thursday, January 23, 2025
Prepared by: David Sharman

RE: Report No. 5135
66 Pine Grove Road
Springbrook, ON
K0K 3C0

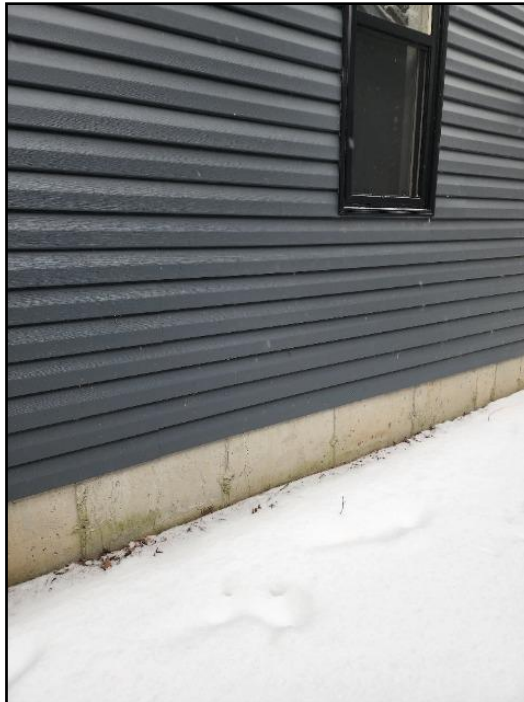
4. Condition: • Typical minor cracks

Implication(s): Material deterioration

Location: Rear elevation

1. *Typical minor cracks*

Task: Repair

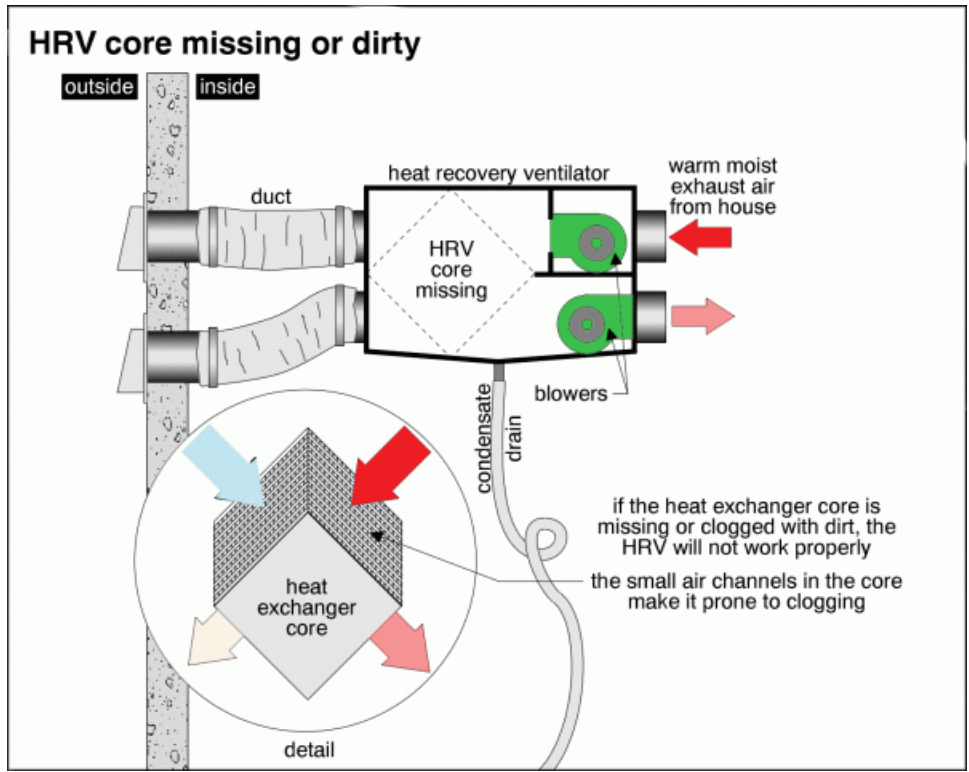
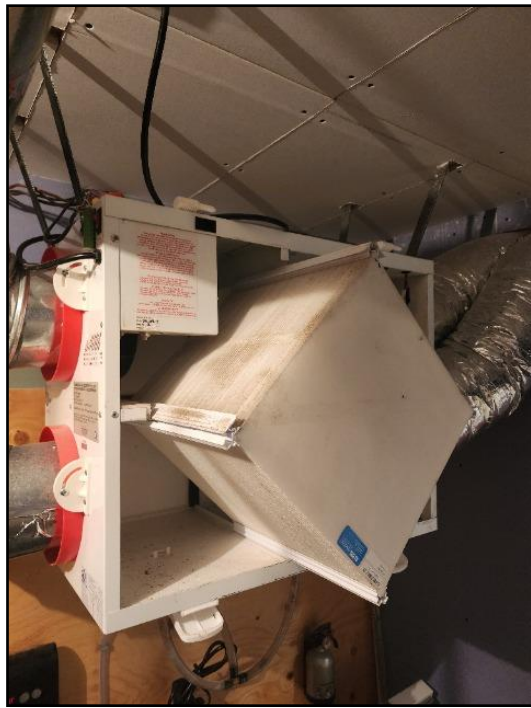
6. Condition: • Clean core - regular maintenance

Implication(s): Reduced operability & comfort

Location: Unit interior

13. Clean core - regular maintenance

Task: Clean - regular maintenance

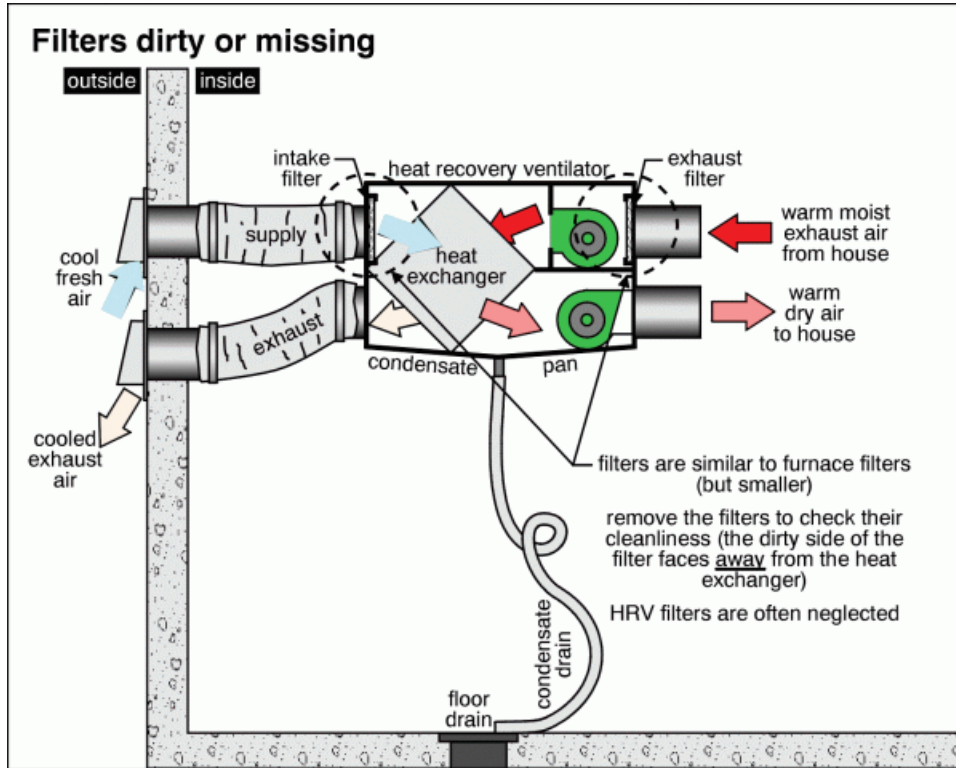
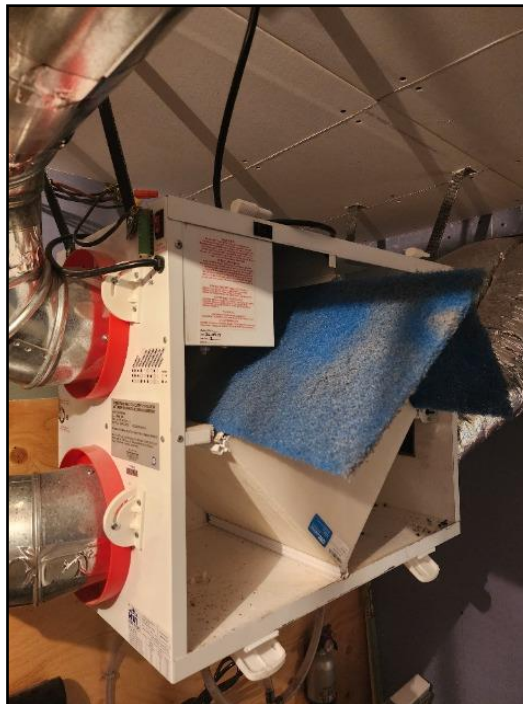
7. Condition: • Clean filters - regular maintenance

Implication(s): Reduced operability & comfort

Location: Unit interior

14. Clean filters - regular maintenance

Task: Clean - regular maintenance

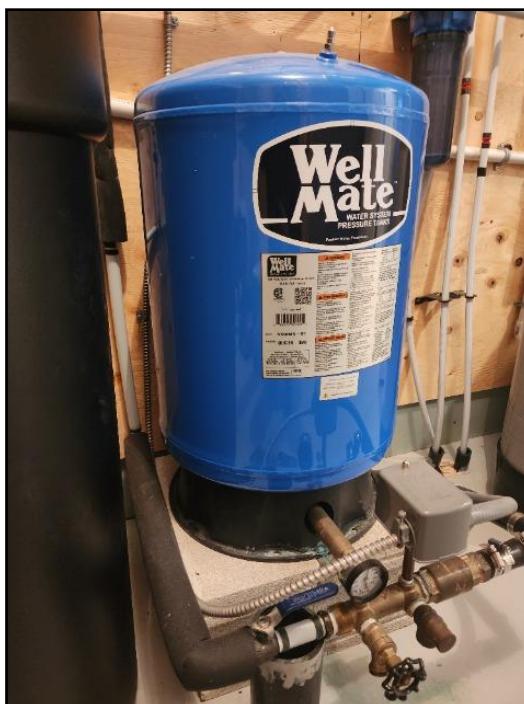
23.

9. Condition: • Short cycling **REMEDIED**

Implication(s): Premature equipment failure | Reduced water pressure and volume

Location: Utility room

Task: Correct

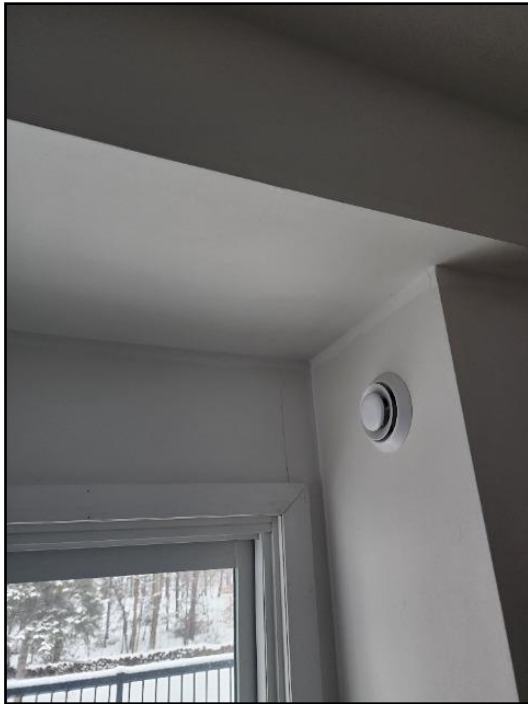
10. Condition: • Minor cracking

Implication(s): No implications exist for this condition

Location: Second floor bedroom

24. *Minor cracking*

Task: Repair
