Stucco Hard Coat Inspector: Lance Reid on 5/2/25

# Hard Coat Stucco Inspection

235 Foxley Way  
Roswell, Georgia 30075

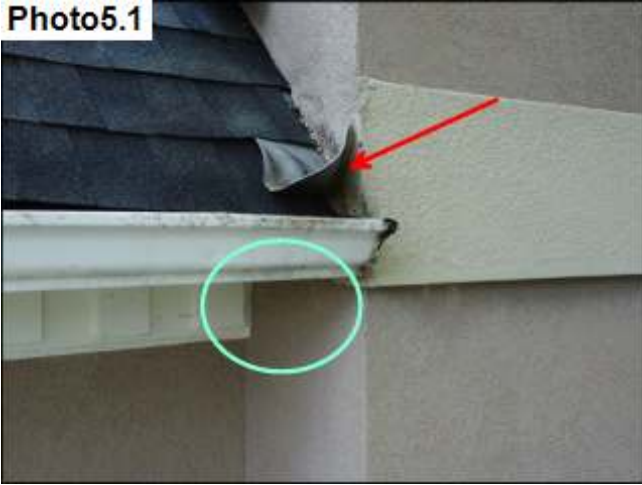
Photo5.1

A kick-out diverter is installed into the roofing terminations and the vertical soffit terminations below are sealed with a quality sealant.

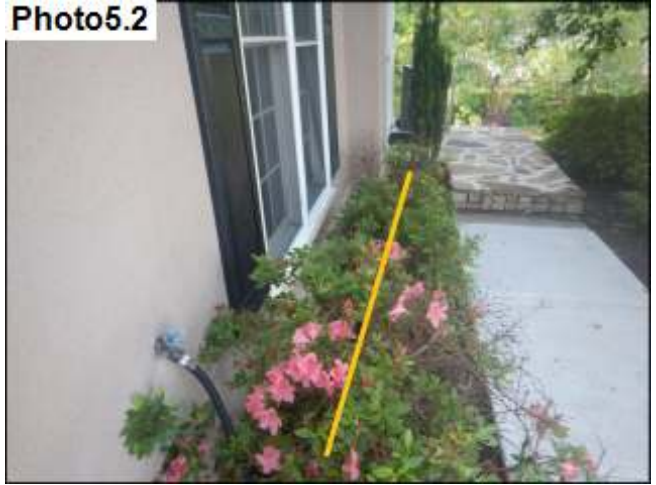
Photo5.2

Continue to manicure the landscaping to maintain a 18-24 inch barrier from the surface of the stucco to allow for adequate ventilation.

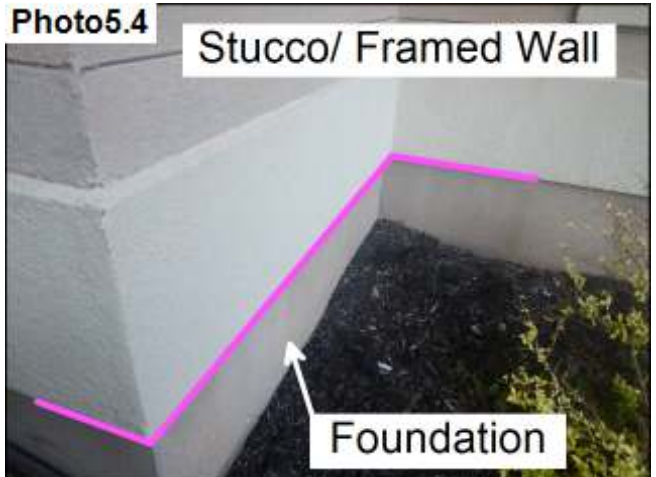
Photo5.4

The hard coat stucco system terminates on the poured foundation or slab with no insulation board, sheathing, metal lath or substrate framing exposed at grade.

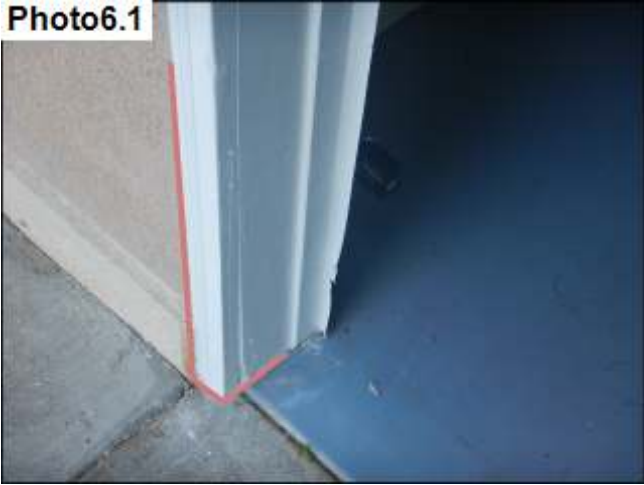
Photo6.1

The perimeters of the garage doors and the jamb terminations at the concrete are sealed with a quality sealant.

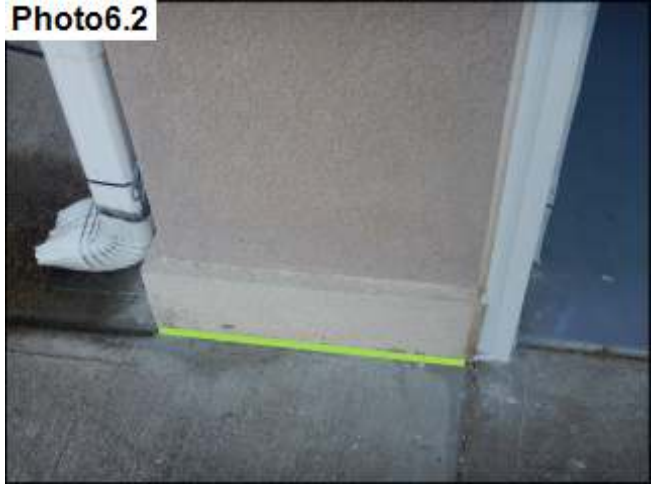
Photo6.2

The top edges of the driveway and front stoop are suggested to be sealed at the stucco with a Dow quality sealant.

1. Page 4 of the report - The top edges of the driveway, front stoop and vertical sides are suggested to be taped off and caulk sealed at the stucco with a quality sealant. \$110.00

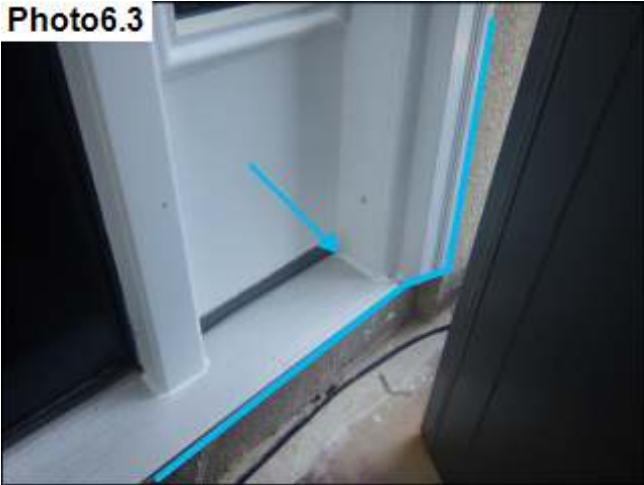
Photo6.3

The perimeter of the entry door and the threshold, including the bottom edge, are sealed with a quality sealant.

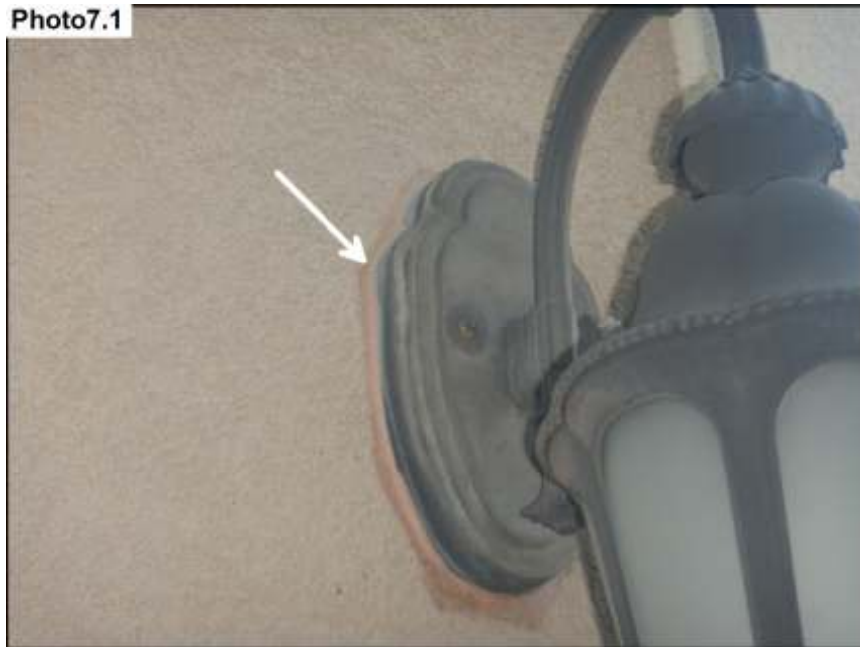
Light fixtures are classified as utility penetrations and all are sealed at the bases with a quality sealant.

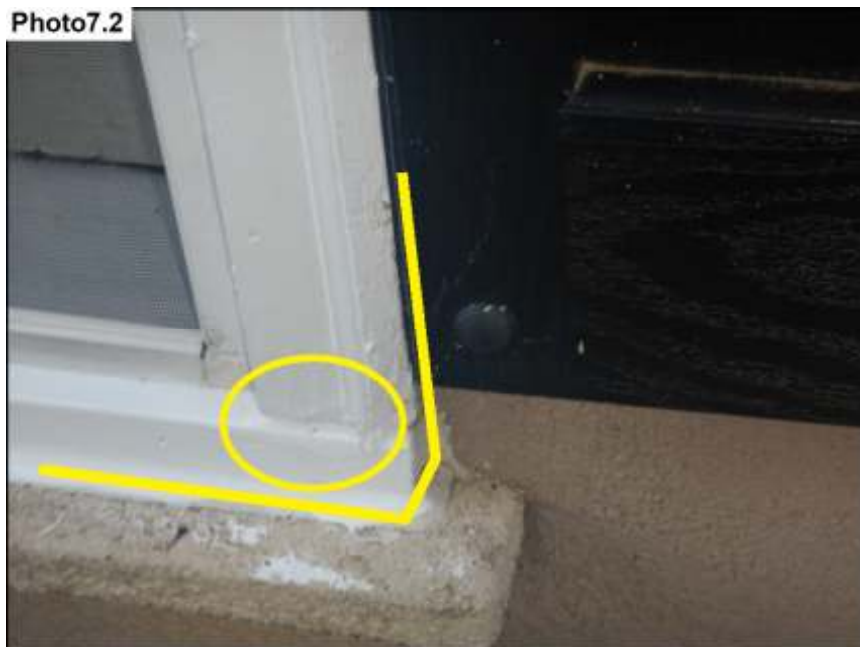
The perimeters of the windows (all four sides) and the mitered joints are sealed with a quality sealant.

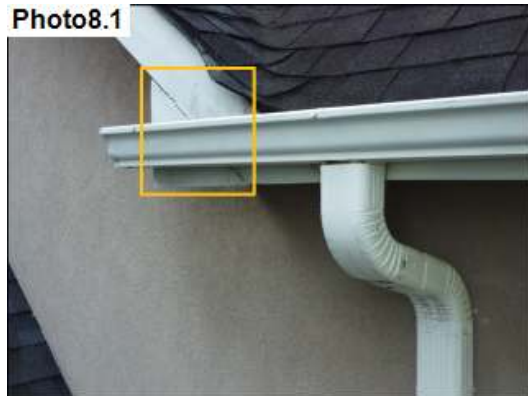
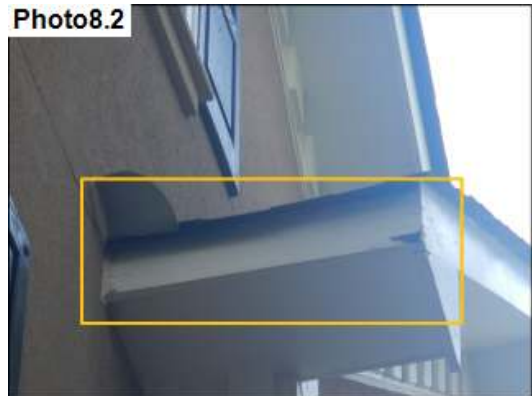
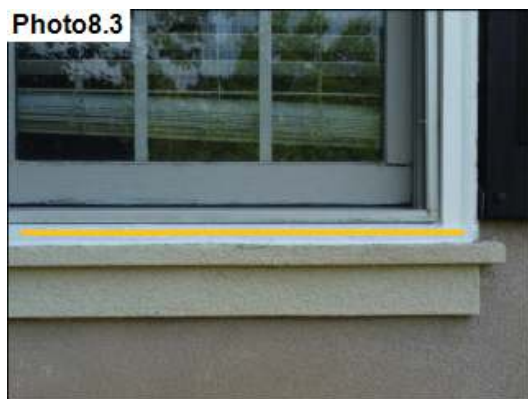
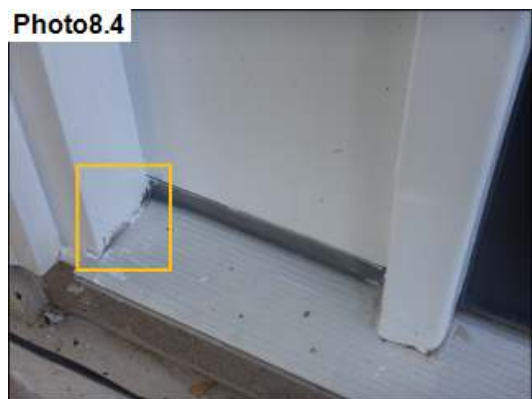
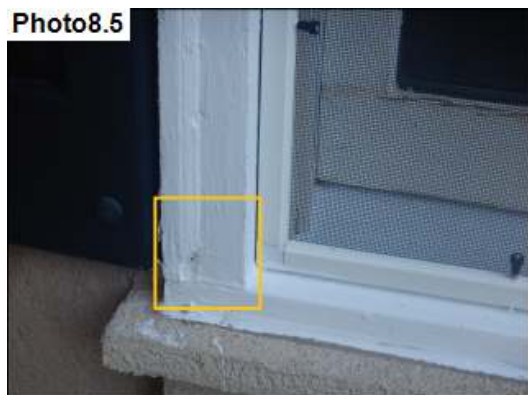
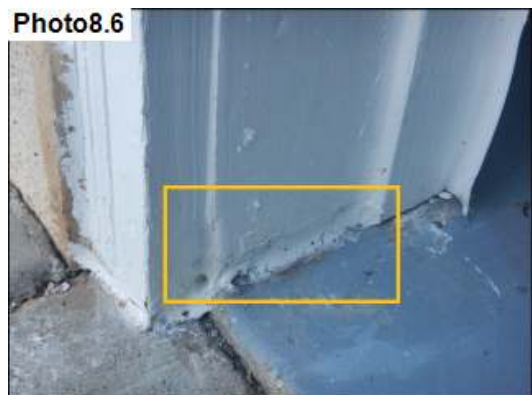
The identified compromised wood is suggested to be replaced by a stucco contractor using wood or PVC and then sealed with a Dow quality sealant.

2. Page 4 of the report - The front of the home has the following damaged wood trim areas in detailed photos outlined in yellow suggested to be replaced using treated wood or PVC then sealed and painted back if required. Page 8 - 8.1, 8.2, 8.3, 8.4, 8.5, 8.6. Page 9 - 9.1, 9.2, 9.3, 9.4. \$1595.00

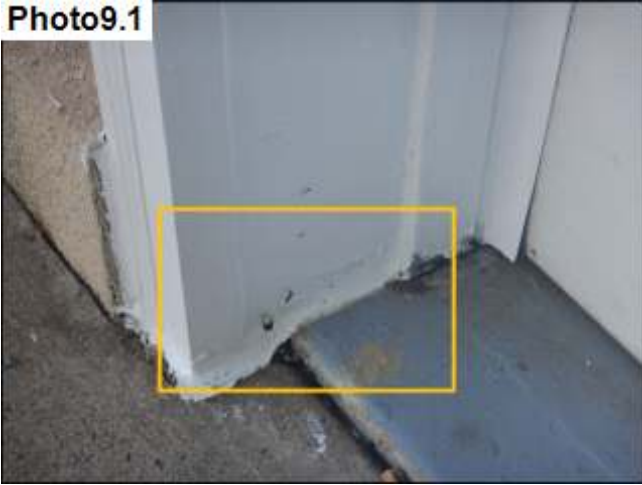
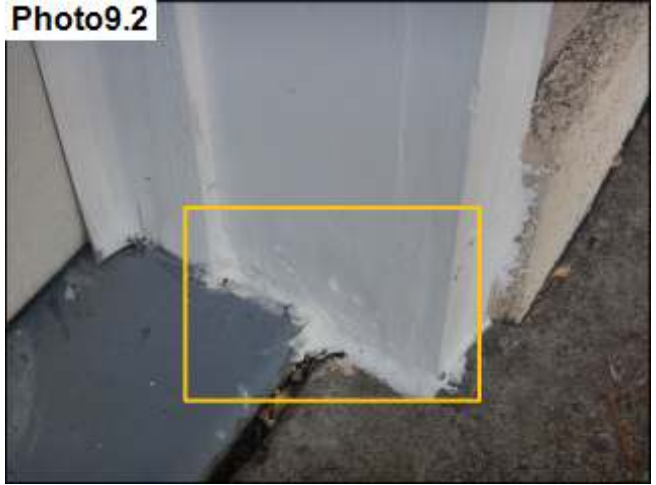
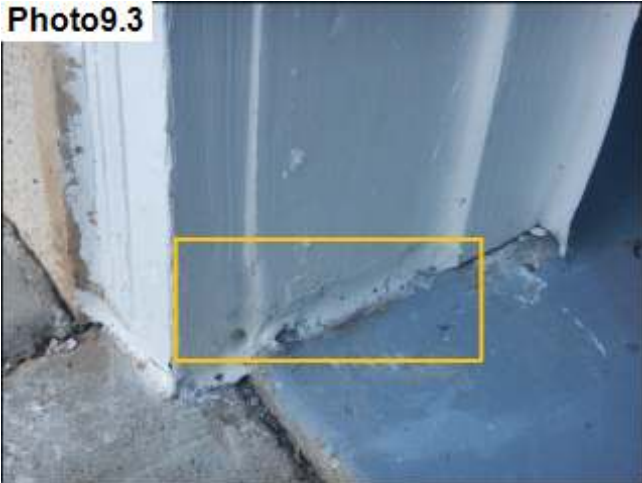
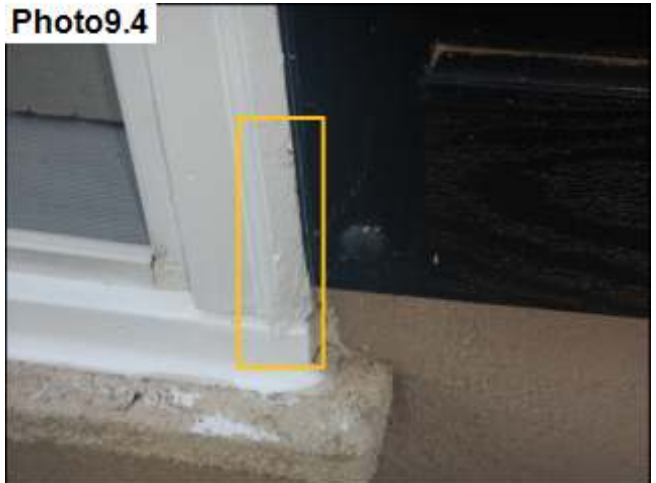
The identified compromised wood is suggested to be replaced by a stucco contractor using wood or PVC and then sealed with a Dow quality sealant.

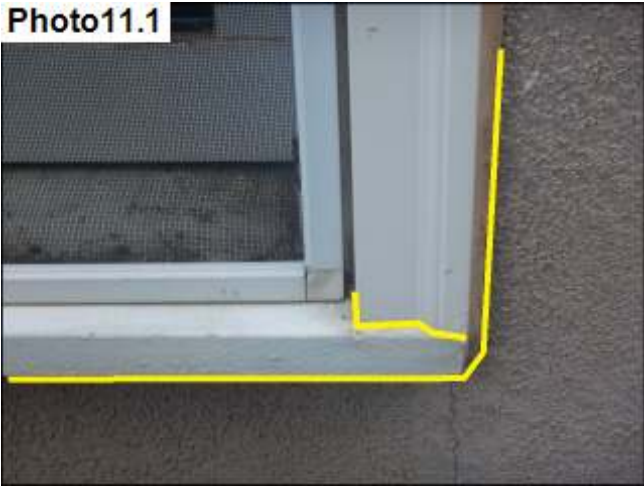
Photo11.1

The perimeters of the windows (all four sides) and the mitered joints are sealed with a quality sealant.

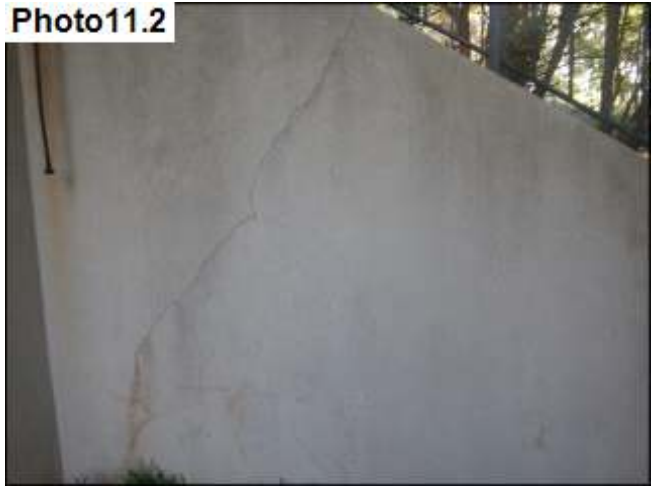
Photo11.2

The wing wall is masonry/concrete with a manufactured finish coat; not hard coat stucco. This wall does not impact the stucco on the dwelling and is not considered apart of this inspection report.

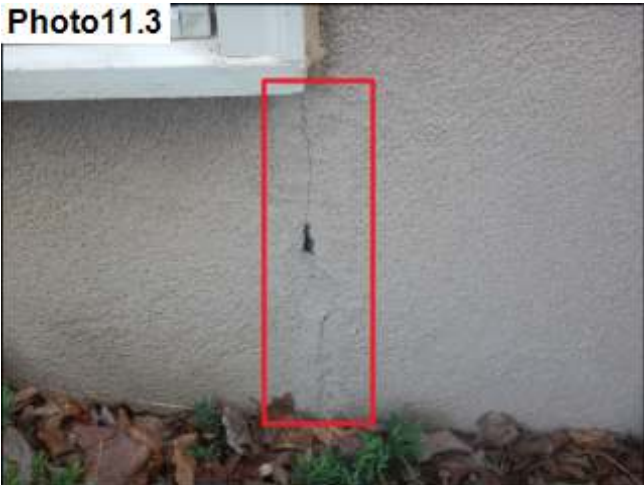
Photo11.3

The identified settlement crack is suggested to be repaired by a stucco contractor due to exposed metal components and base coat.

3. Page 10 of the report - The identified settlement crack is suggested to be repaired by a stucco contractor due to exposed metal components and base coat. See Detail Photo - Page 11 -11.3. Apply stucco base coat cement, reinforcement mesh, finish coat texture and paint back. \$150.00  
Note: Please have the current paint colors available to best match back replacements.

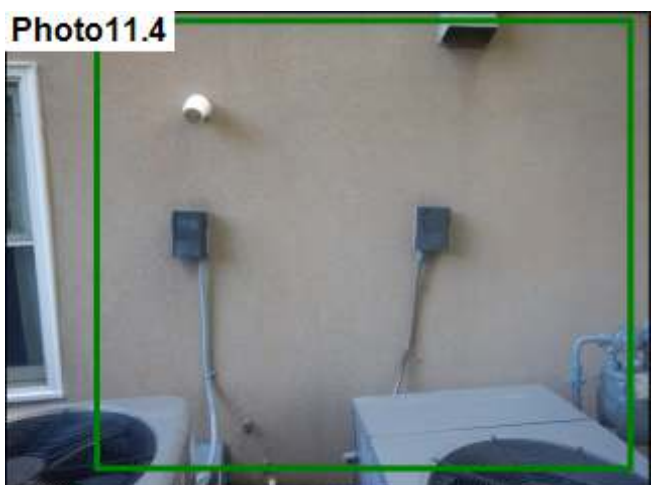
Photo11.4

The perimeters of the utility boxes, line penetrations and the conduit fastener penetrations into the stucco are sealed with a quality sealant.

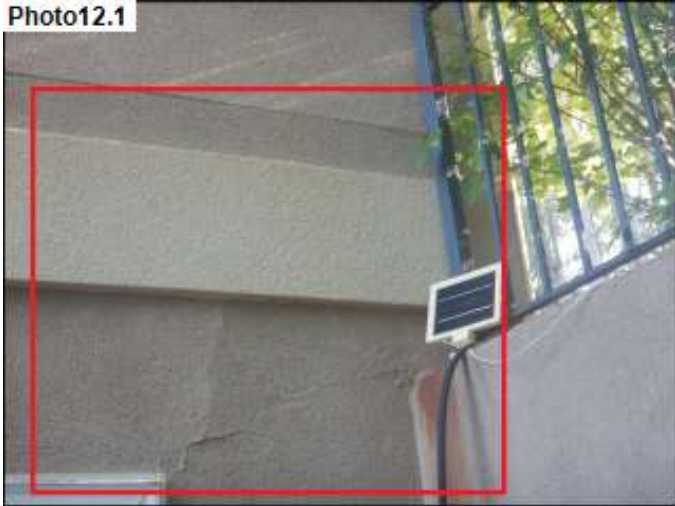
Photo12.1

Delamination of Stucco	X		X	The wall section identified in the right elevation detail photos is delaminated (lost adhesion from the framing of the structure) and is suggested to be reattached to the framing and then repaired by a stucco contractor.
Bird Holes Present		X		No recorded bird holes at the time of inspection.
Transition Joints (Stucco to Brick, etc.)		X		All four elevations of the house are stucco and do not have any transitions.
Termination Below Grade (Ground Level)	X	X		The hard coat stucco system terminates on the poured foundation or slab with no insulation board, sheathing, metal lath or substrate framing exposed at grade. Extermination companies have different requirements regarding the bottom edge of the system; it is suggested to ensure the current state of the system coincides with their standards of practice.
Termination Below or at Slab Level (Concrete)	X			The top edges of the driveway, stoop, patio and concrete pads are suggested to be sealed/resealed at the stucco with a Dow quality sealant.

The wall section identified is delaminated (lost adhesion from the framing of the structure) and is suggested to be reattached to the framing and then repaired by a stucco contractor.

4. Page 10 of the report - H6-I6 - Red Outline at large wall area -The wall section identified is delaminated (lost adhesion from the framing of the structure) and is suggested to be reattached to the framing and then repaired. See Detail Photo - Page 12 -12.1. Remove delaminating stucco and secure back substrate or add new duroc, not to exceed 12 sq. feet. Apply stucco base coat cement, reinforcement mesh, finish coat texture and paint back. \$960.00

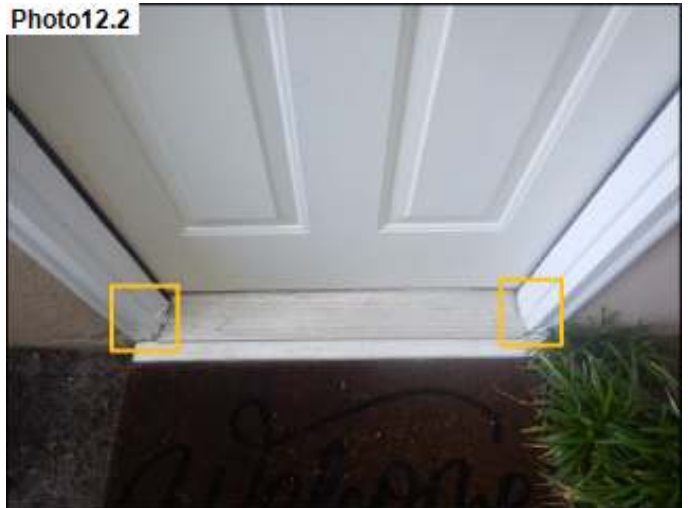
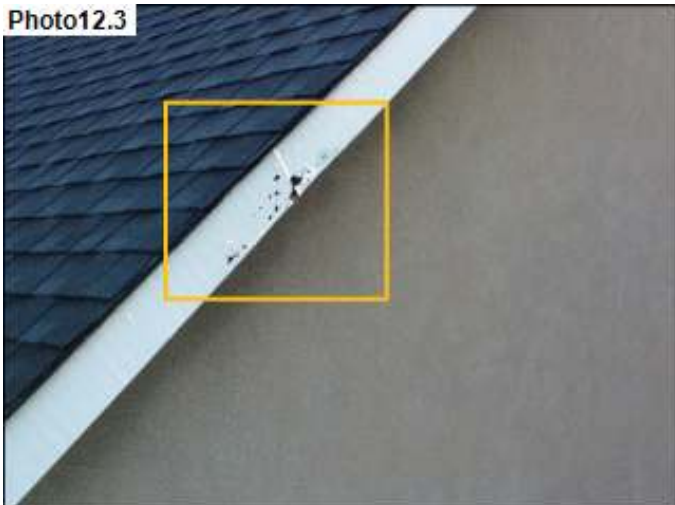
The identified compromised wood is suggested to be replaced by a stucco contractor using wood or PVC and then sealed with a Dow quality sealant.

5. Page 10 of the report - The right side of the home has the following damaged wood trim areas in detailed photos outlined in yellow suggested to be replaced using treated wood or PVC then sealed and painted back if required. Page 12, 12.2, 12.3. \$580.00

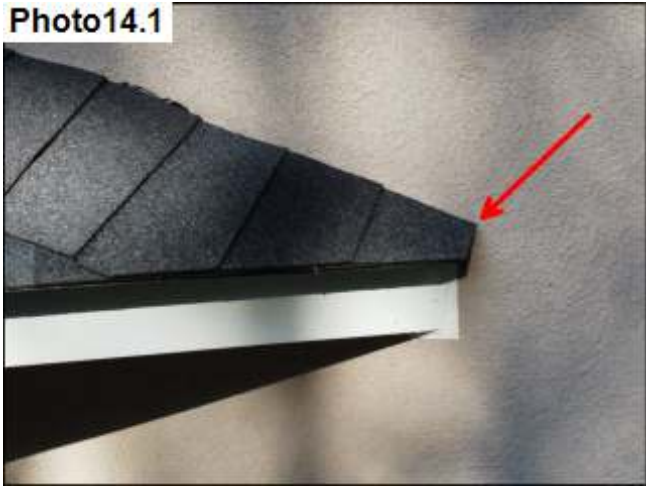
Photo14.1

A stucco contractor is suggested to install a Raintek kick-out diverter into the roofing termination. The vertical soffit termination below is sealed with a quality sealant.

6. Page 13 of the report - Red Arrow - Install (1) Raintek kick-out diverter into the roofing termination then seal the vertical soffit termination below. \$325.00

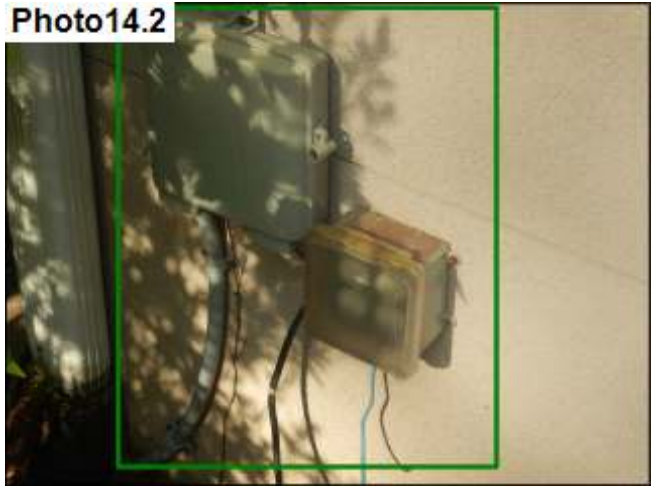
Photo14.2

The perimeters of the utility boxes, line penetrations and the conduit fastener penetrations into the stucco are suggested to be sealed by a stucco contractor using a Dow quality sealant.

7. Page 13 of the report - The perimeters of the utility boxes, line penetrations and the conduit fastener penetrations into the stucco are suggested to be sealed. See Detail Photo - Page 14, 14.2. \$55.00

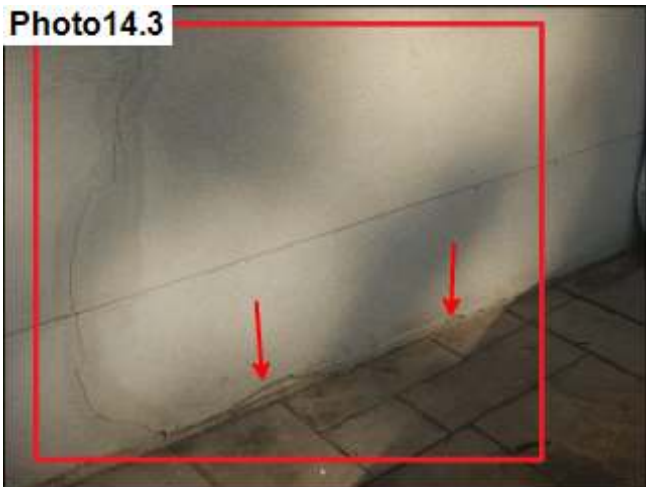
Photo14.3

The identified settlement crack is suggested to be repaired by a stucco contractor due to exposed metal components and base coat.

8. Page 13 of the report - The identified settlement crack is suggested to be repaired by a stucco contractor due to exposed metal components and base coat. See Detail Photo - Page 14, 14.3. Apply stucco base coat cement, reinforcement mesh, finish coat texture and paint back. \$150.00  
Note: Please have the current paint colors available to best match back replacements.

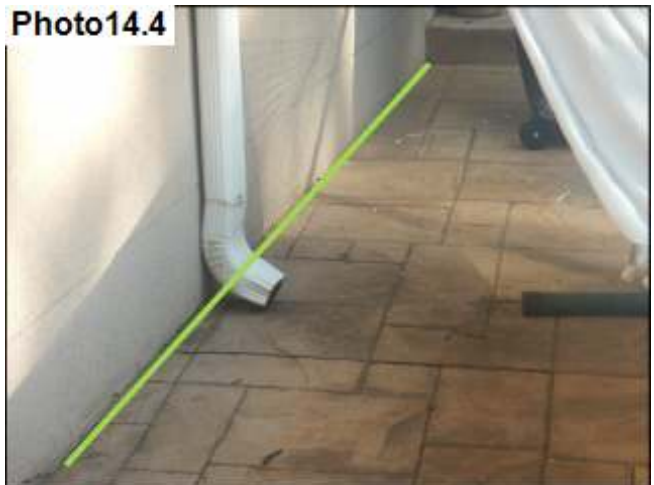
Photo14.4

The top edges of the patio are suggested to be sealed at the stucco with a Dow quality sealant.

9. Page 13 of the report - Green Line - The top edges of the patio are suggested to be taped off and caulk sealed at the stucco wall meetings and vertical ends. \$170.00

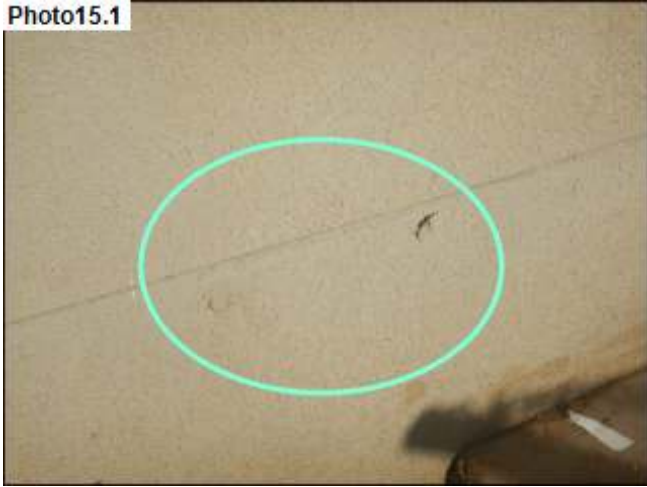
Photo15.1

Two fastener "pops" in the stucco were recorded and they are suggested to be touched-up by a stucco contractor due to exposed base coat.

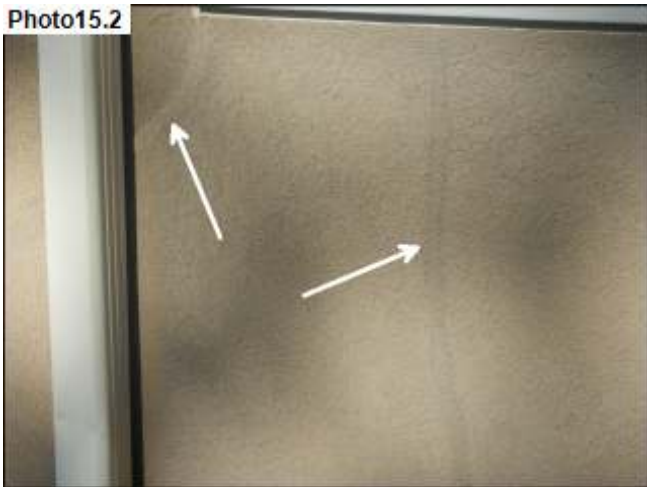
Photo15.2

The identified hairline cracks have been sealed/repared and as a result have altered the texture of the surface. Inconsistencies in texture will cause color differential and is strictly cosmetic.

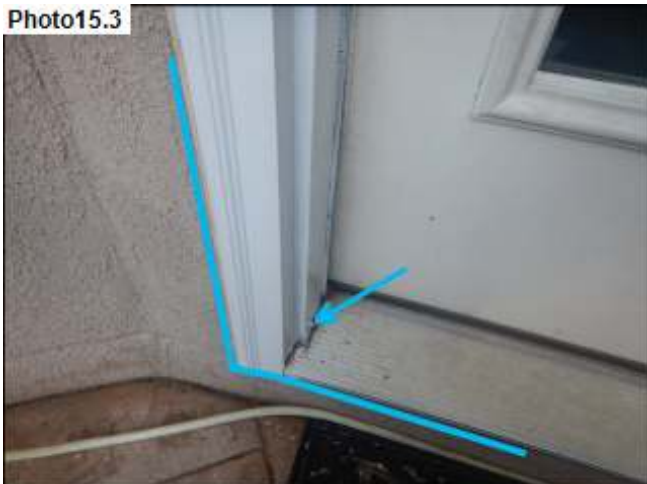
Photo15.3

The perimeter of the entry door and the threshold, including the bottom edge, are sealed with a quality sealant.

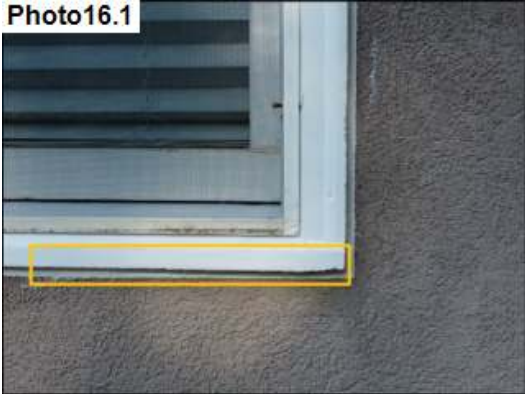
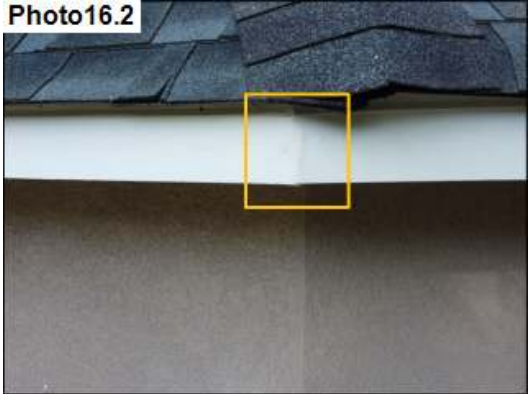
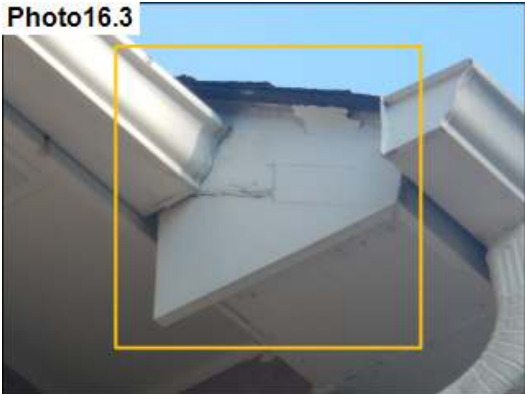
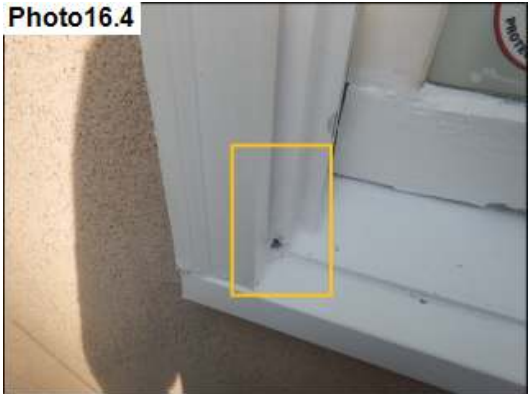
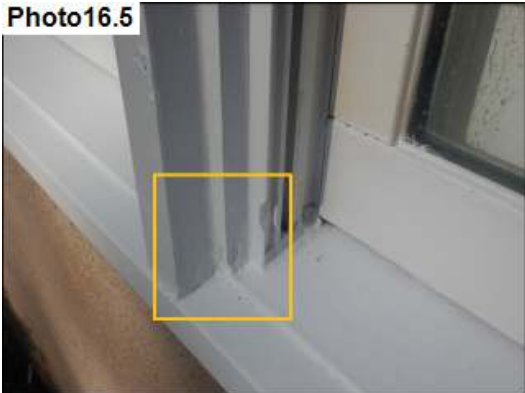
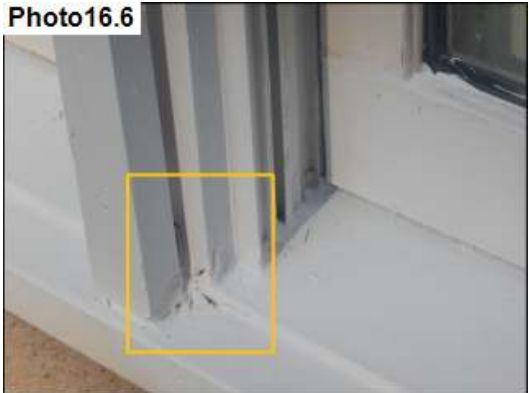
The identified compromised wood is suggested to be replaced by a stucco contractor using wood or PVC and then sealed with a Dow quality sealant.

10. Page 13 of the report - The rear of the home has the following damaged wood trim areas in detailed photos outlined in yellow suggested to be replaced using treated wood or PVC then sealed and painted back if required. Page 16 - 16.1, 16.2, 16.3, 16.4, 16.5, 16.6. Page 17 - 17.1, 17.2, 17.3, 17.4, 17.5. \$1885.00

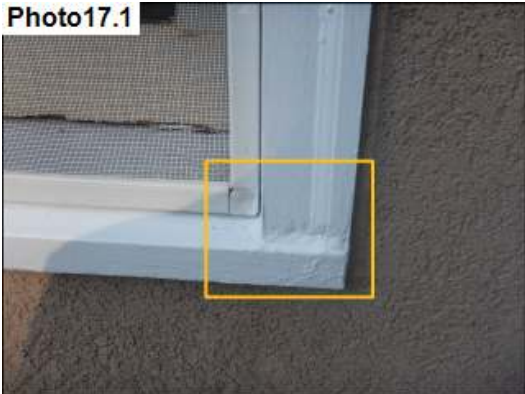
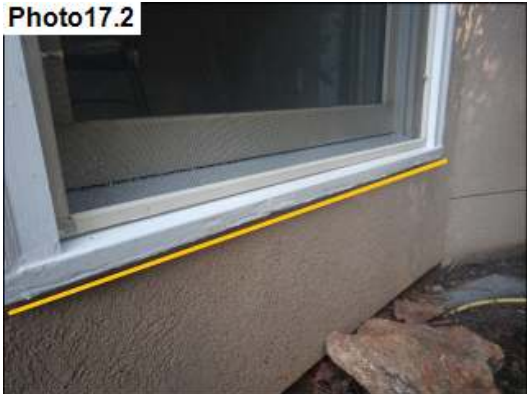
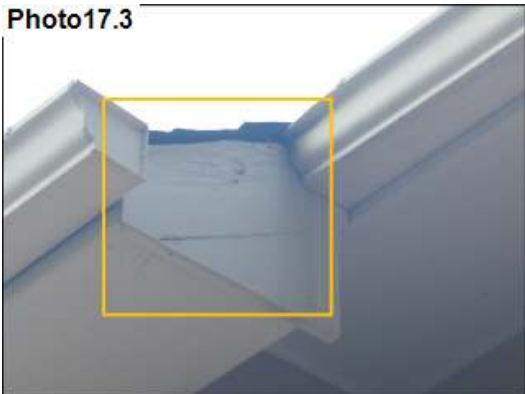
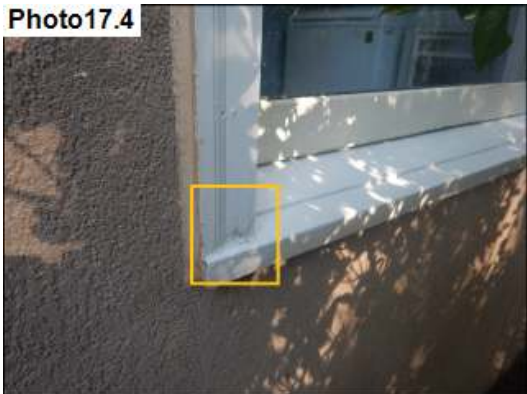
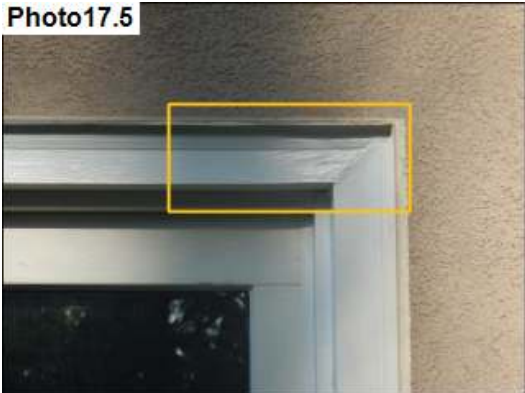
The identified compromised wood is suggested to be replaced by a stucco contractor using wood or PVC and then sealed with a Dow quality sealant.

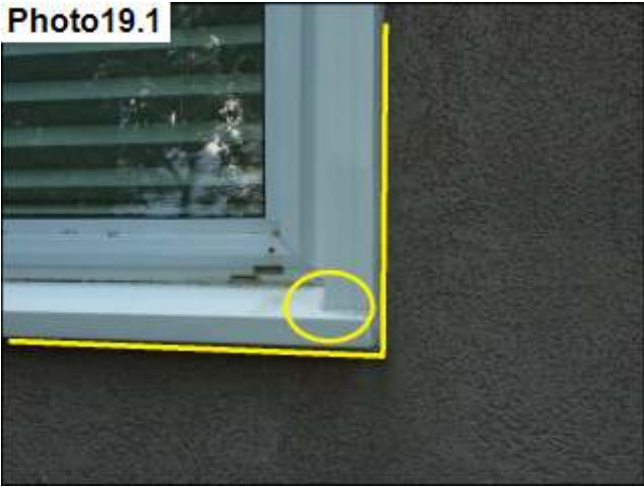
Photo19.1

The perimeter of the window (all four sides) and the mitered joints are sealed with a quality sealant.

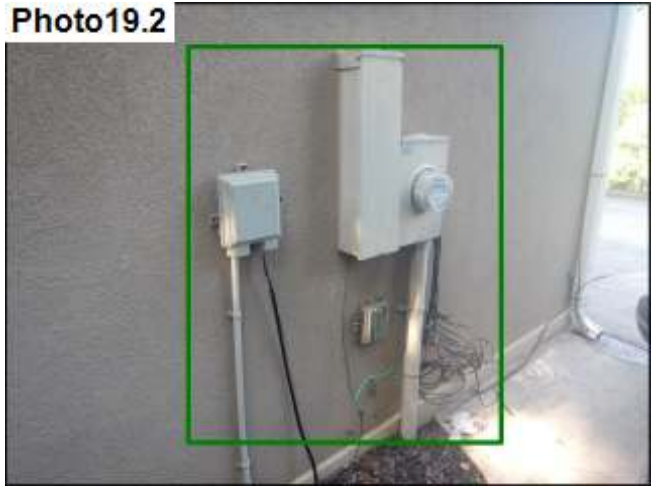
Photo19.2

The perimeters of the utility boxes, line penetrations and the conduit fastener penetrations into the stucco are sealed with a quality sealant.

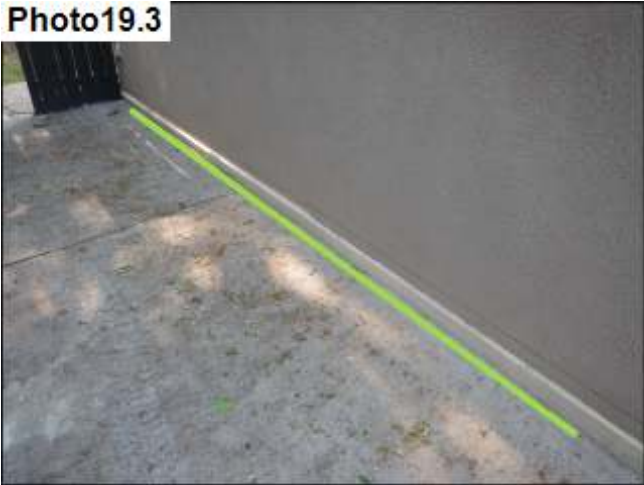
Photo19.3

The top edges of the driveway are suggested to be sealed at the stucco with a Dow quality sealant.

**11. Page 18 of the report - The top edges of the driveway are suggested to be taped off and caulk sealed at the stucco wall meetings and vertical ends. \$220.00**

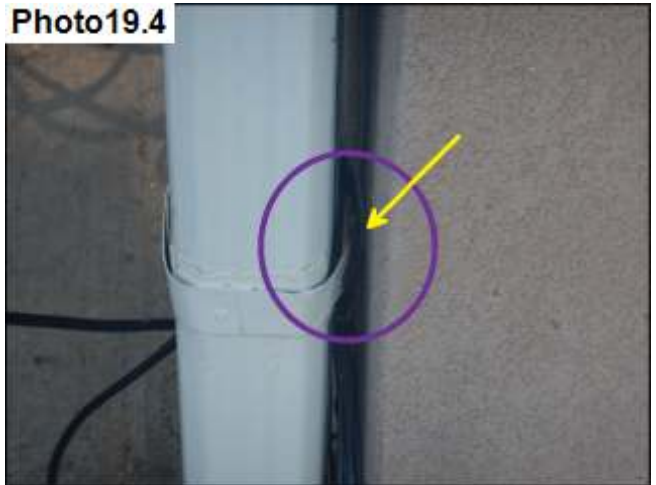
Photo19.4

The gutter down-spouts are securely fastened to the house but the strap penetrations are not sealed and suggested to be sealed with a Dow quality sealant.

**12. Page 18 of the report - The downspouts strap anchor penetrations into the stucco system are not sealed and suggested to be sealed where entering stucco around the home. \$384.00**

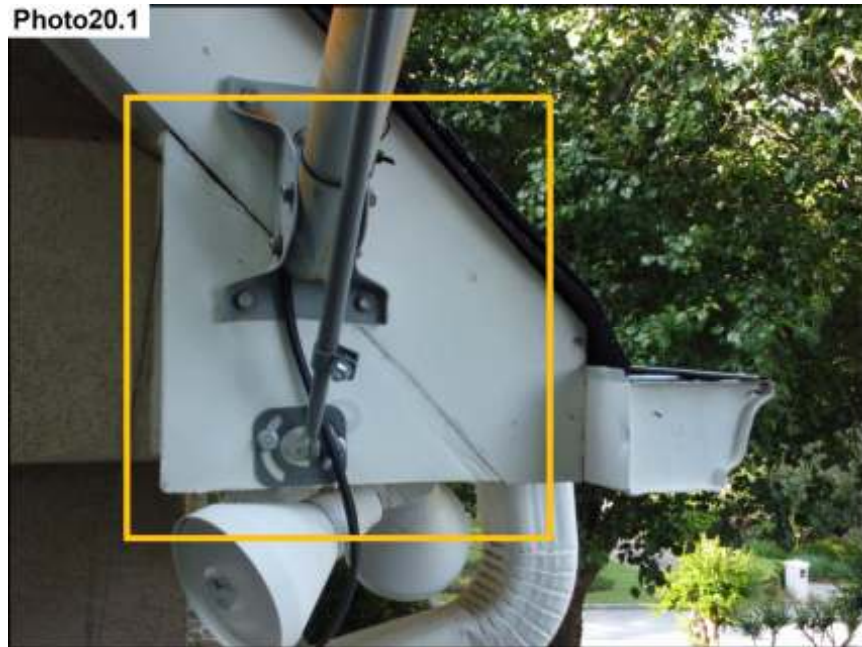
The identified compromised wood is suggested to be replaced by a stucco contractor using wood or PVC and then sealed with a Dow quality sealant.
