# V.I. Inspections

111 N 97th St

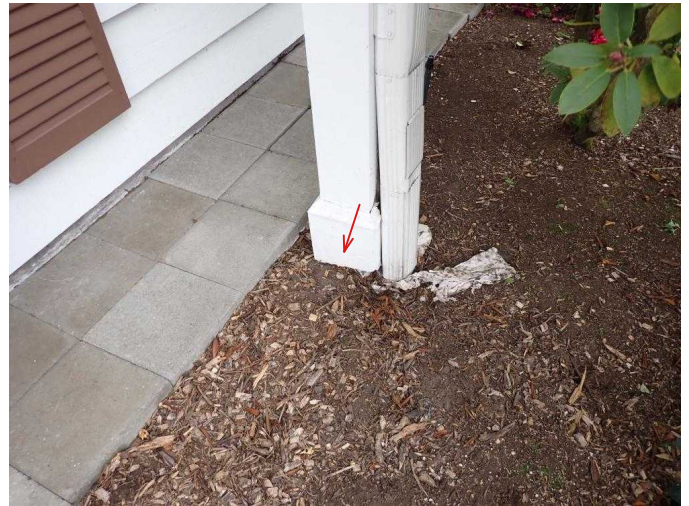
#2 W front porch roof support pillar is no longer attached to footing.

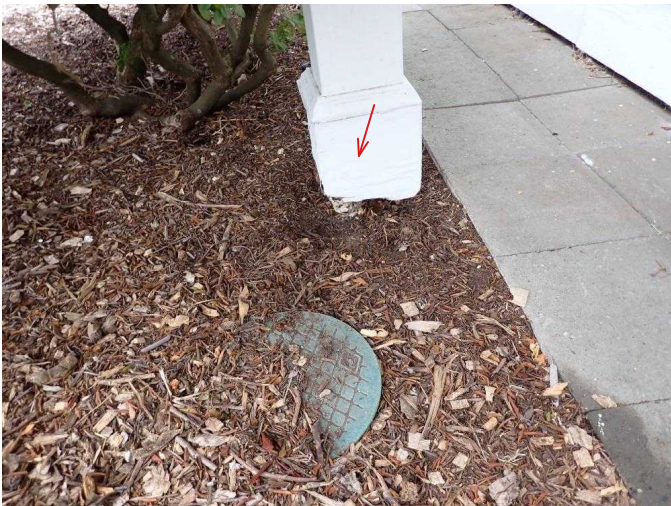
#3 Rot occurring in lower ends of E and W front porch roof support pillars.

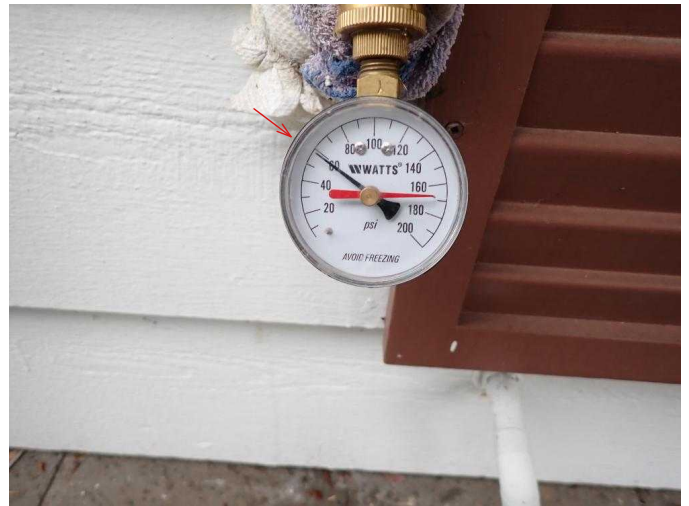
#4 Water pressure 60 psi, acceptable.

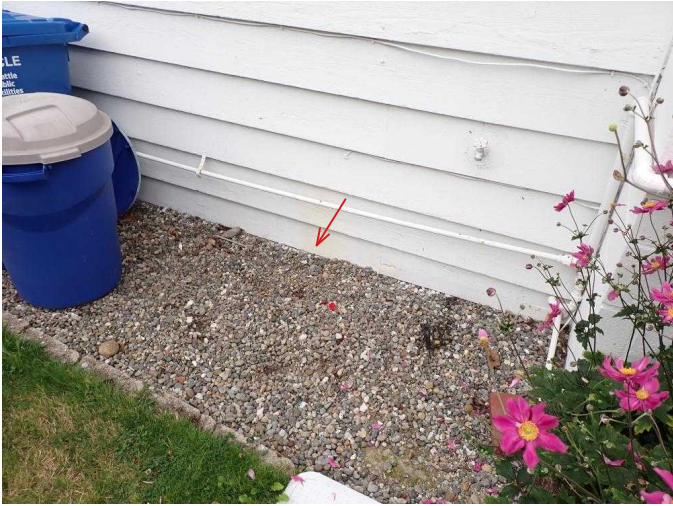
#7 Soil in contact with siding along E side of house, higher potential for rot to occur, soil needs to be removed.

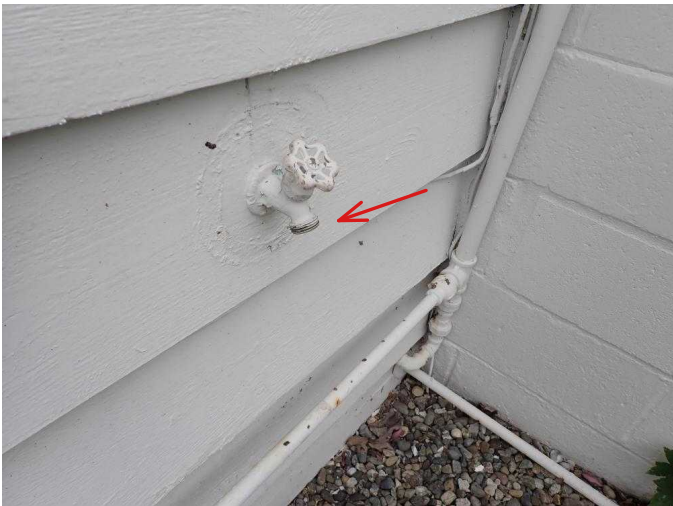
#9 Vacuum breakers are not installed, should be installed to prevent back flow.

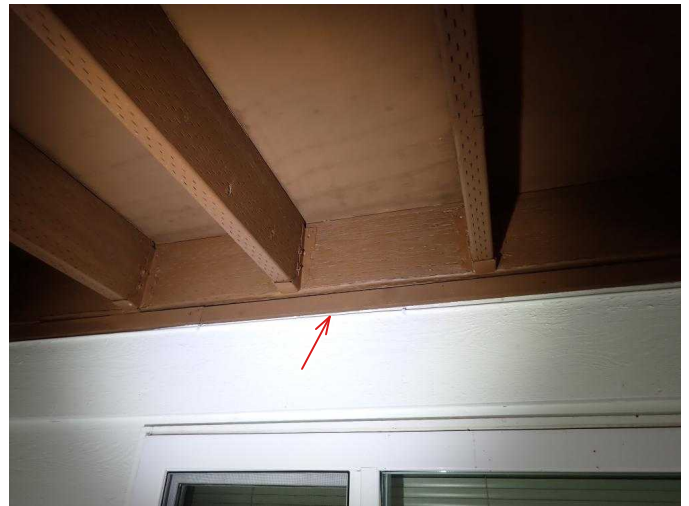
#10 Deck is not bolted to house (safety).

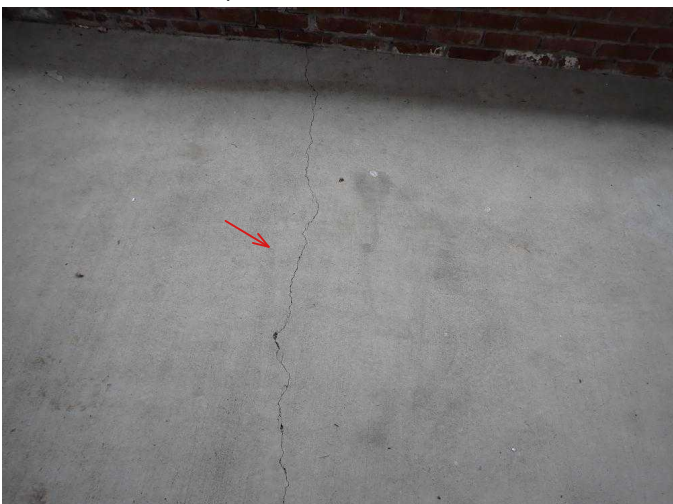
#11 Cosmetic cracks present in patio surface.

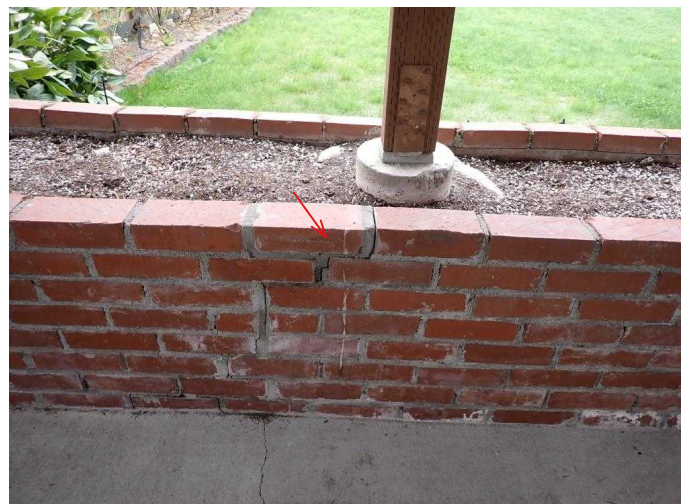
#12 Moderate staggered settling crack in patio flower bed.

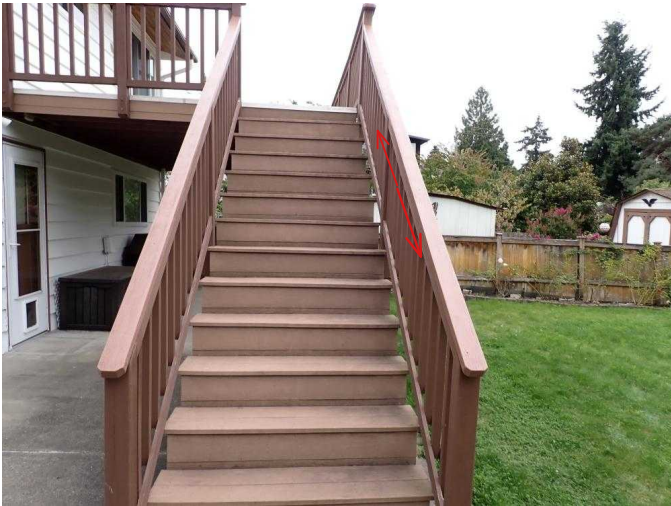
#13 No graspable handrails present for deck access steps (safety).

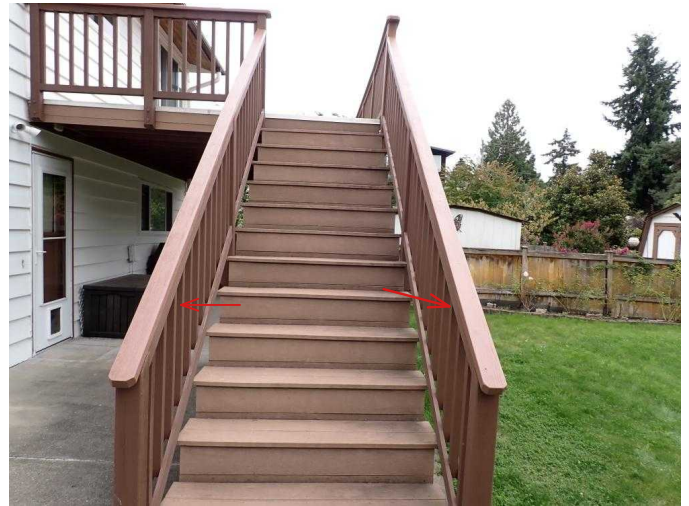
#14 Railings on deck access steps are loose on install.

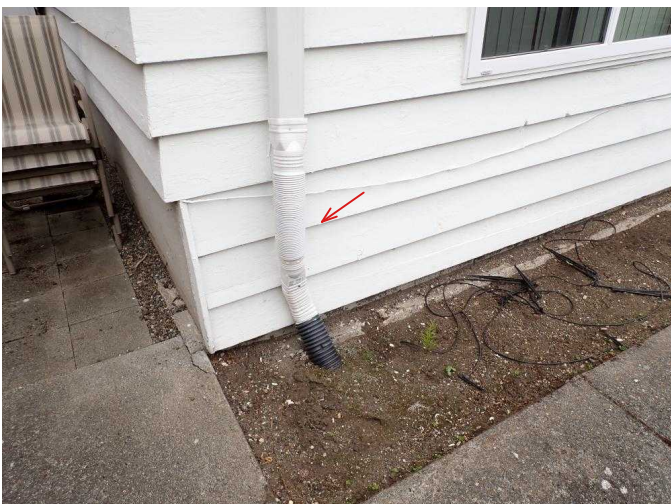
#17 Corrugated leader pipes will have a higher potential for clogging and will need to be maintained.

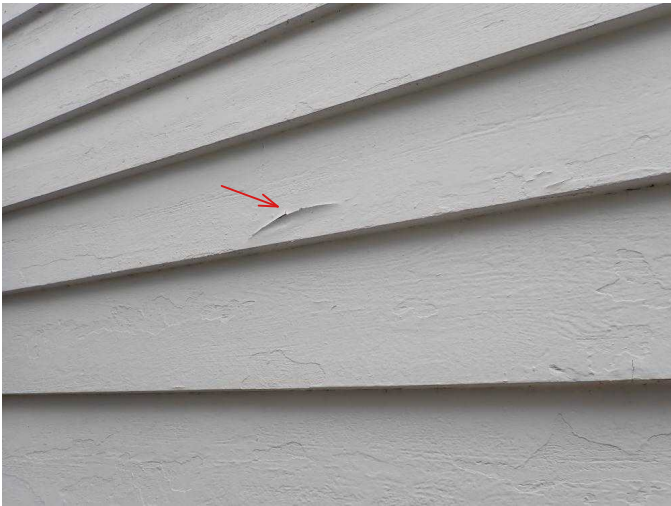
#19 Minor paint peeling in sections of siding system, needs to be resealed against moisture intrusion.

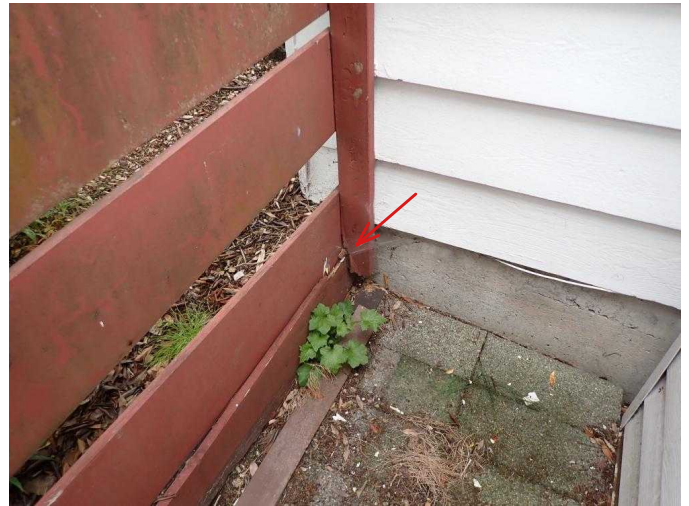
#20 Rot in sections of fence system.

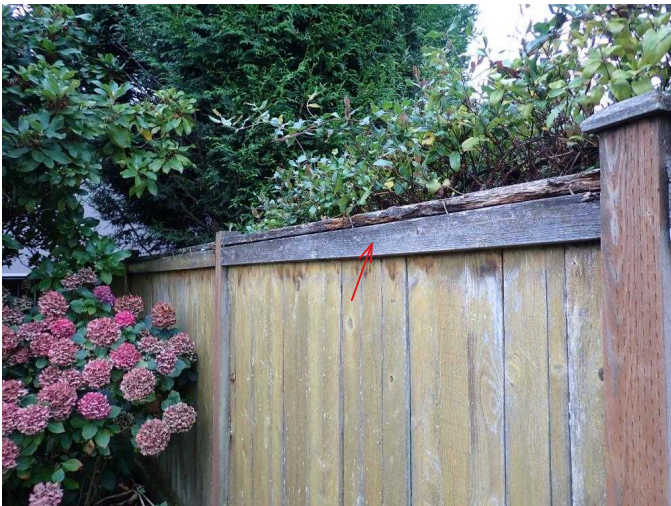
#21 Rot occurring in sections of fence system. Fence system moderately weathered.

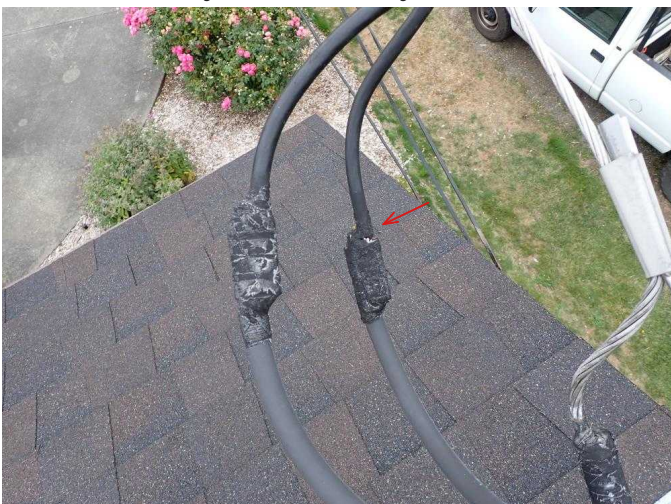
#23 Wire wrap at service line connections to mast head wiring has worn out, exposed live wiring (safety).

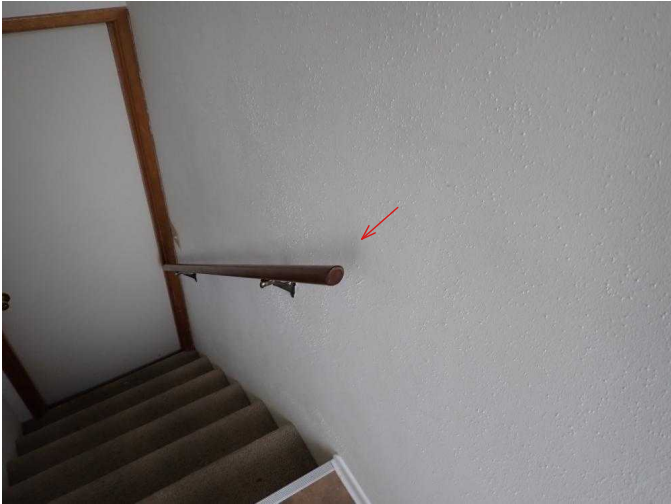
#25 No return on handrails, higher potential for articles of clothing to catch at the top end of the stairwell handrail

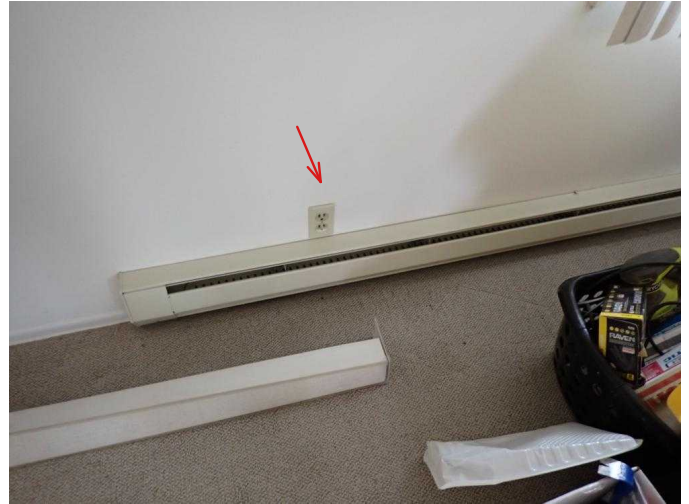
#26 Outlets over baseboard heaters need to be removed or relocated (safety).

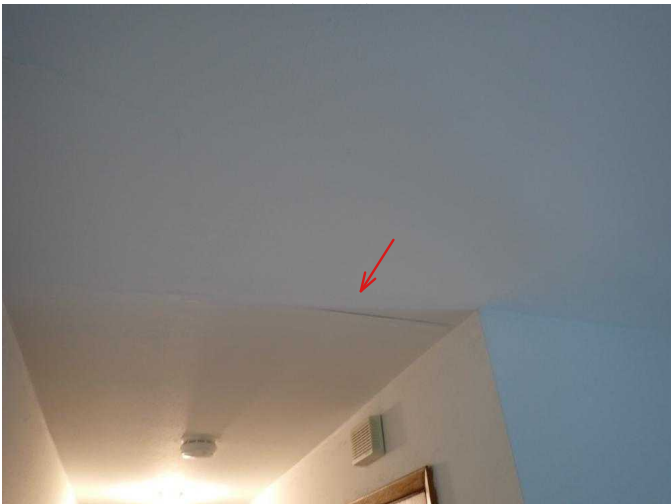
#27 Minor age crack in upper hall ceiling junction with stairwell.

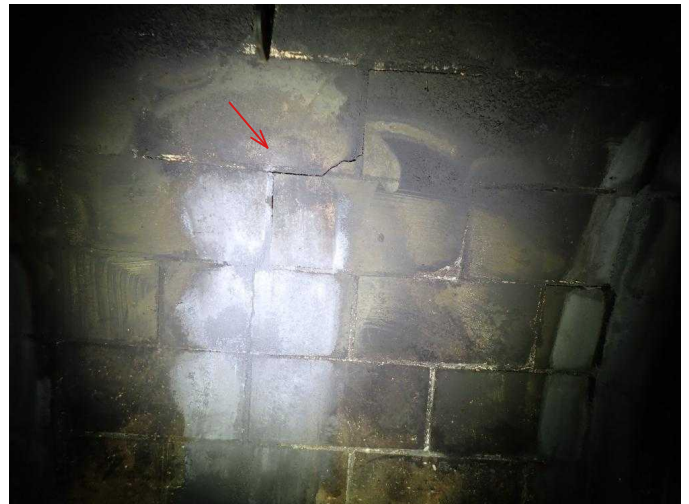
#28 Minor cracks in firebrick in back of living room firebox, needs to be sealed prior to use.

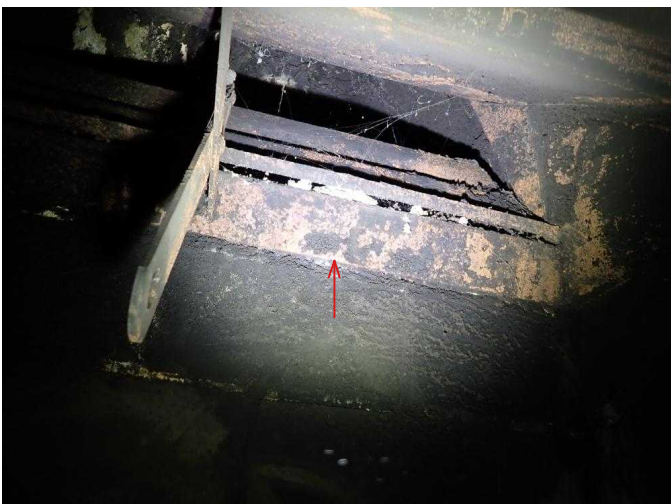
#29 Minor creosote build up in living room smoke chamber, needs to be cleaned before use.

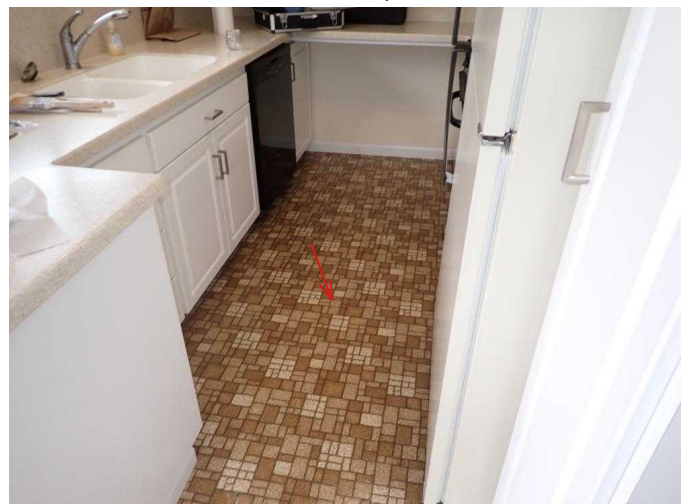
#30 Test kitchen flooring for asbestos prior to working with, altering or removing.

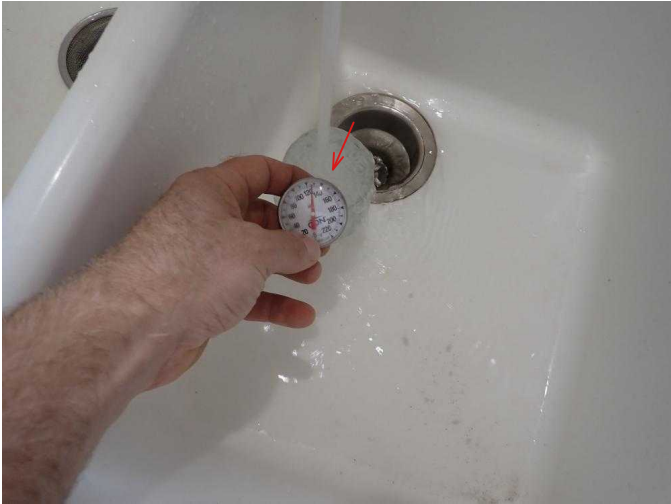
#31 Water temperature is 130 deg F, should be lowered to 120 deg F to reduce the risk of scalding.

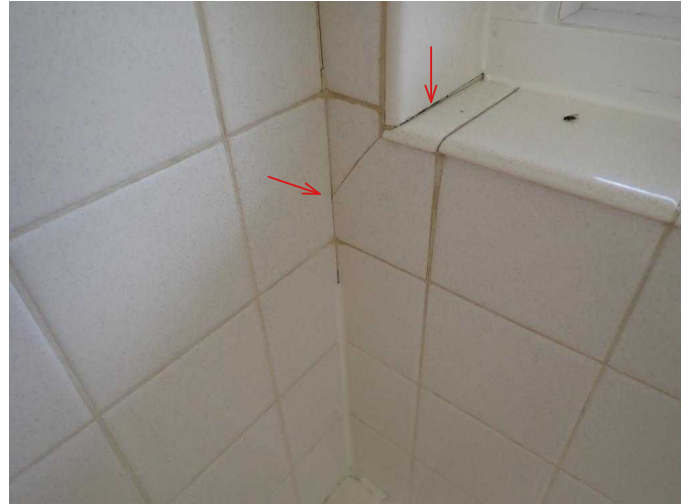
#32 Minor cracks in first floor bath surround grout at corner junctions, water intrusion spots, need to be sealed.

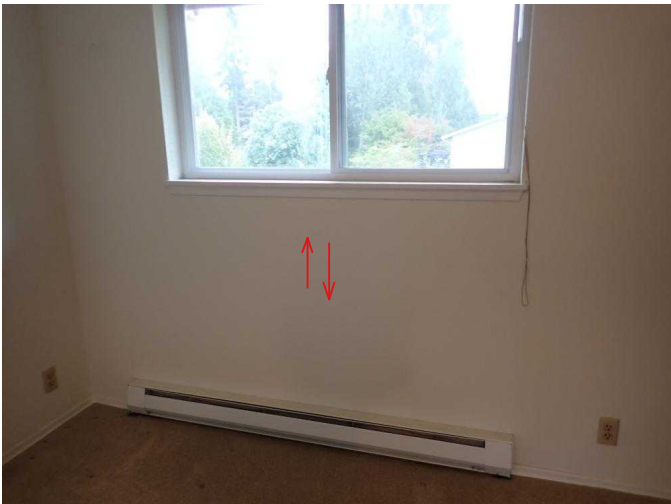
#33 Windows in S and SW bedrooms not of legal egress due to height, normal for age of house (safety).

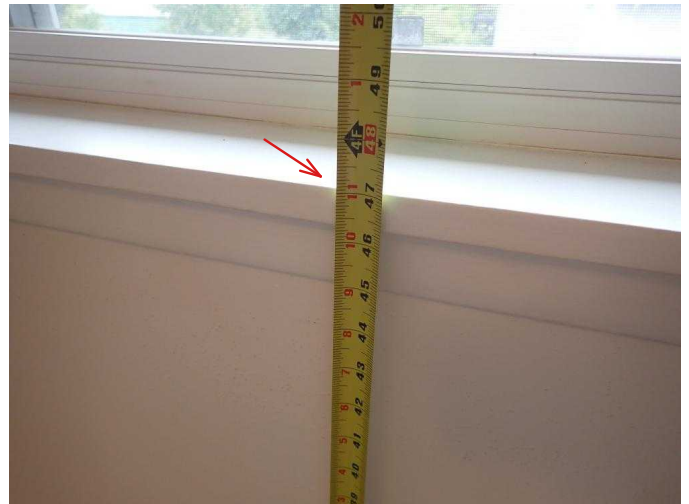
#34 Windows in S and SW bedrooms not of legal egress due to height, normal for age of house (safety).

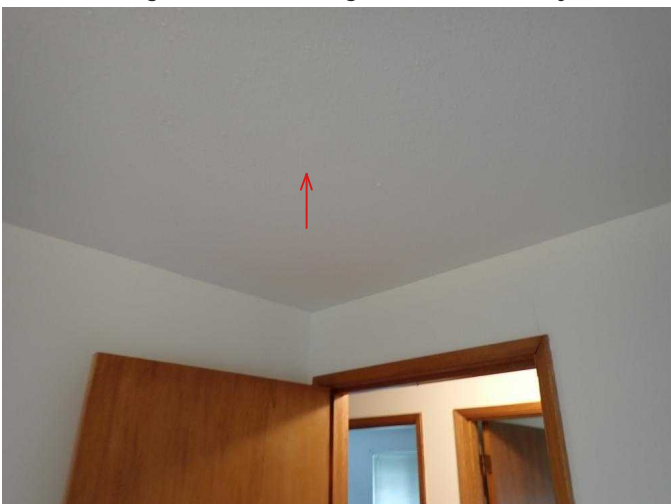
#35 Smoke detectors need to be installed in all bedrooms.

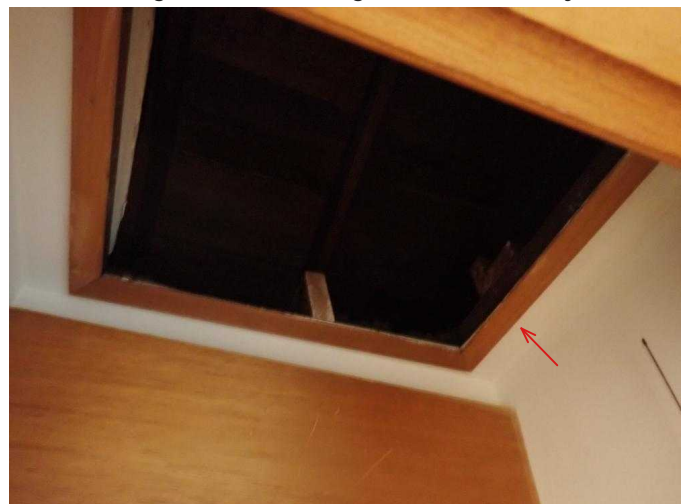
#36 No air seal present for attic access hatch. Access located in first floor hall closet.

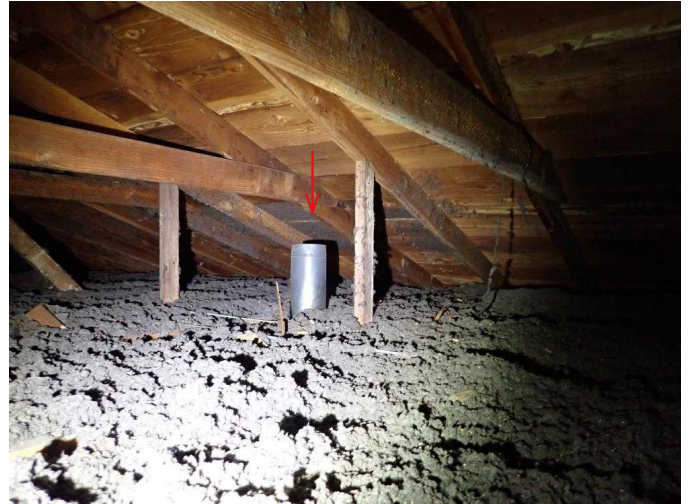
#38 Kitchen fan vents directly into attic, needs to be sealed transition to exterior.

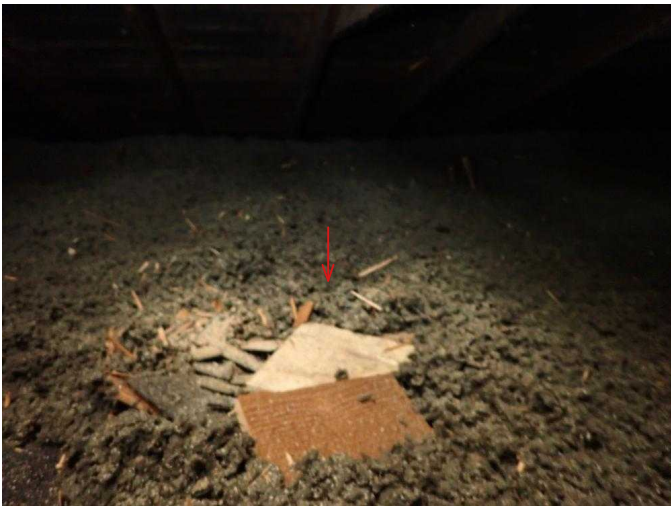
#39 Light amount of roof debris noted in attic.

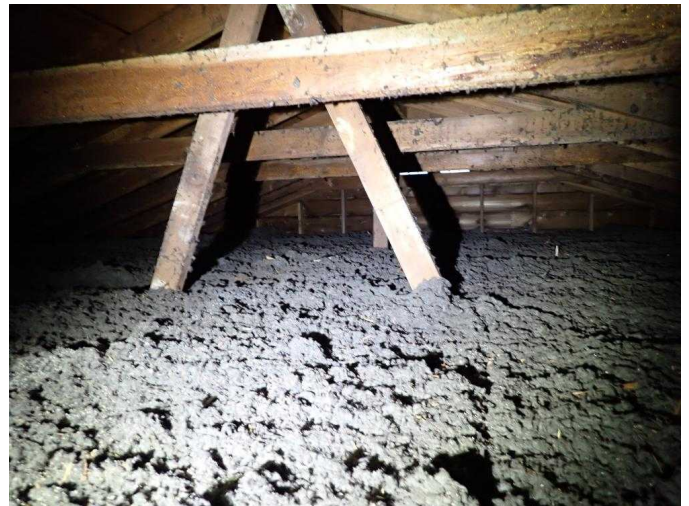
#40 No lower intake ventilation present, reduced air flow in attic space, normal for age of house.

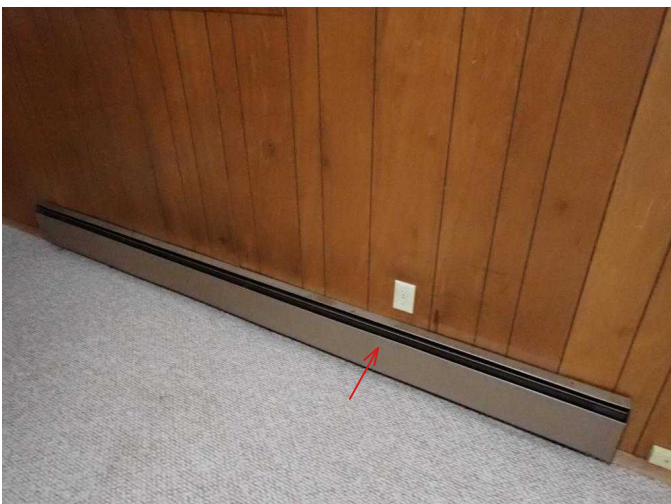
#41 Outlet over baseboard heater needs to be removed or relocated (safety).

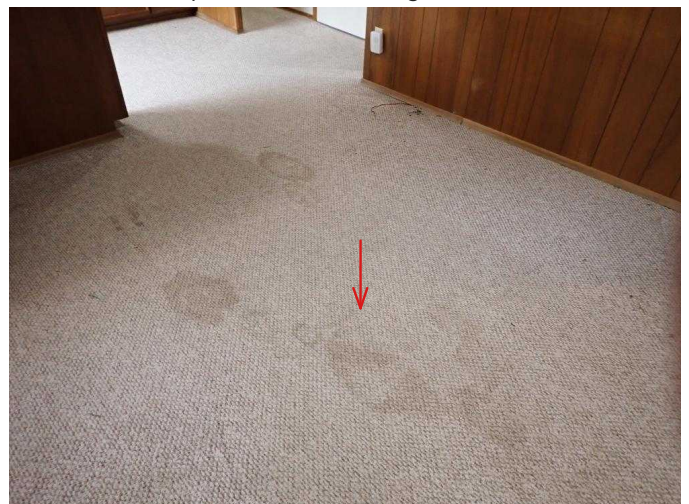
#42 Family room carpet stained/soiled.

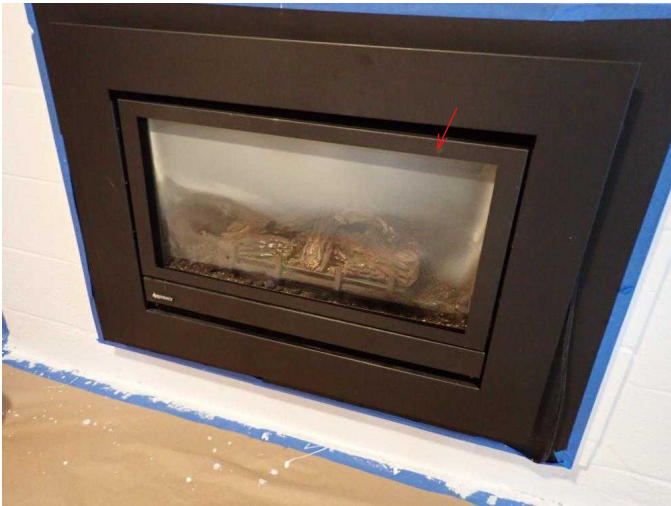
#43 Glass needs cleaning, only use fireplace glass cleaner.

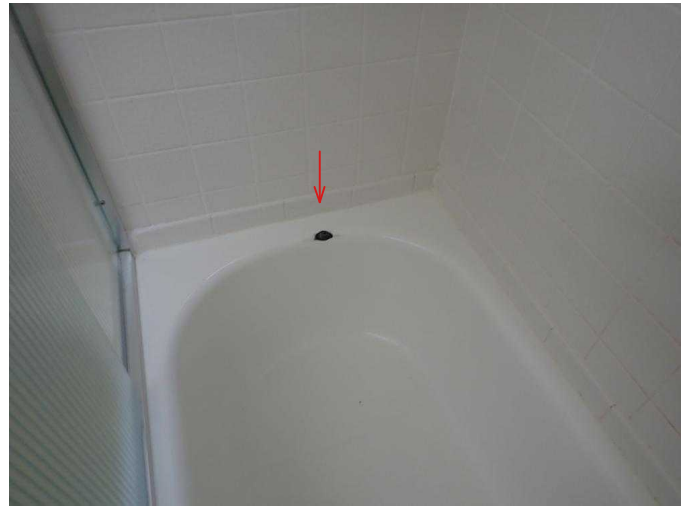
#44 Moderate chip in lower level bath enamel.

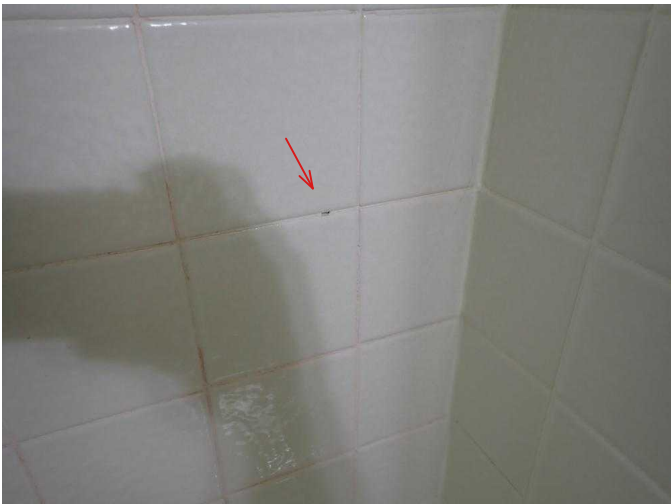
#45 Small sections of grout missing from lower level bath surround, water intrusion spots, need to be sealed.

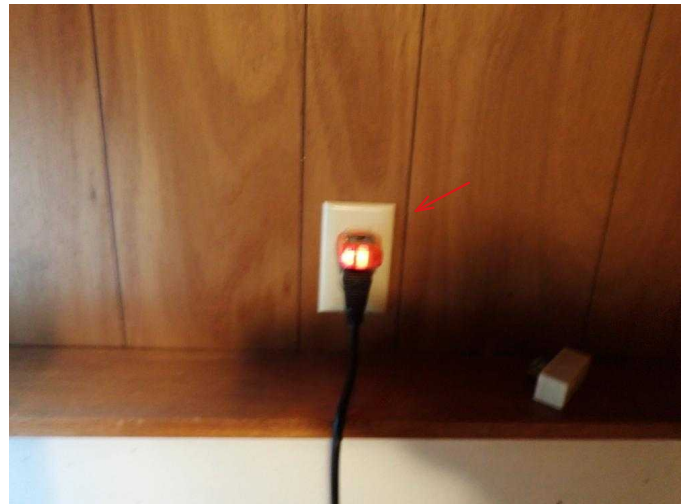
#46 N outlet in lower level office wired incorrectly, reversed polarity.

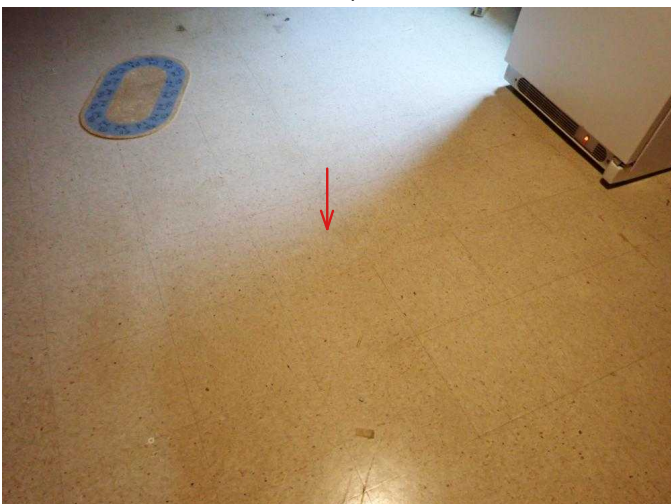
#47 Test linoleum tile for asbestos prior to working with, altering or removing linoleum tile.

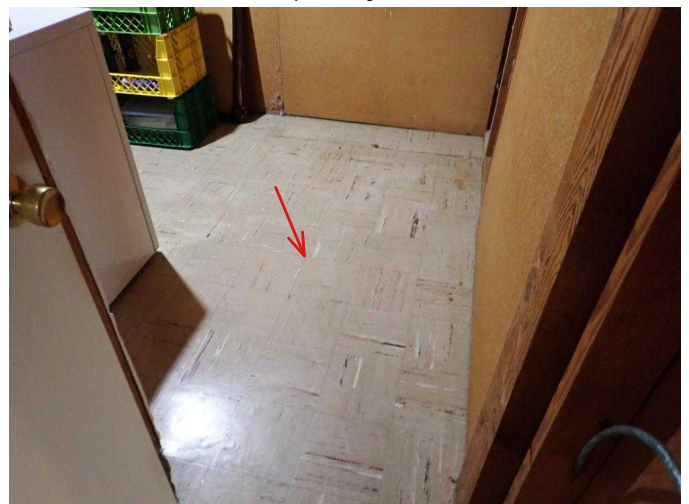
#48 Test linoleum tile for asbestos prior to working with, altering or removing linoleum tile.

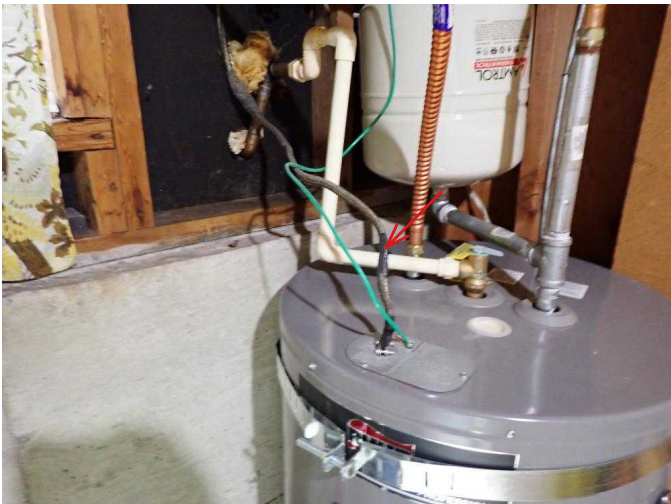
#51 Exposed wiring to water heater needs to be in conduit.
