INSPECTION REPORT

For the Property at:
1217 KENNETH AVENUE
PETERBOROUGH, ON K9J 5P8

Prepared for: TEAM VANRAHAN
Inspection Date: Thursday, May 23, 2024
Prepared by: David Sharman

RE: Report No. 4815
1217 Kenneth Avenue
Peterborough, ON
K9J 5P8

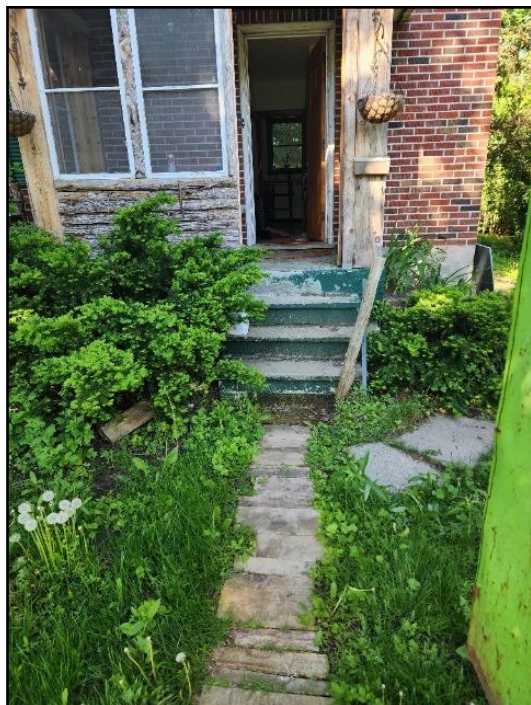
4. Condition: • Stair rise too big or not uniform

Implication(s): Trip or fall hazard

3. Stair rise too big or not uniform

Task: Improve

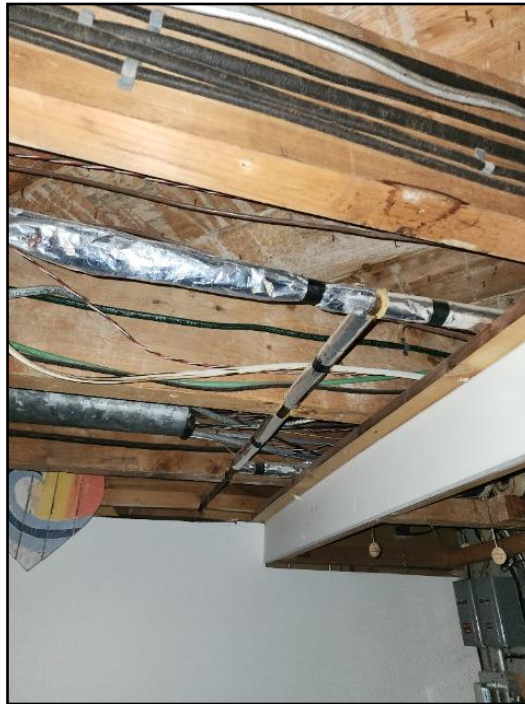
6. Condition: • Notches or holes

Implication(s): Weakened structure

Location: Utility room

4. Notches or holes

Task: Monitor

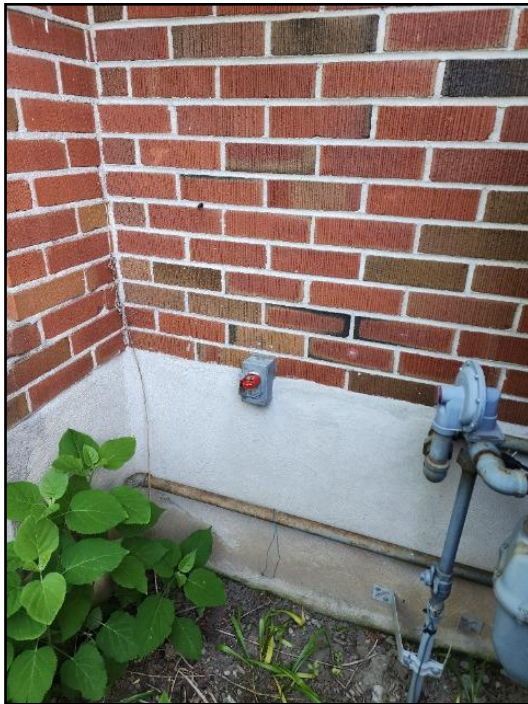
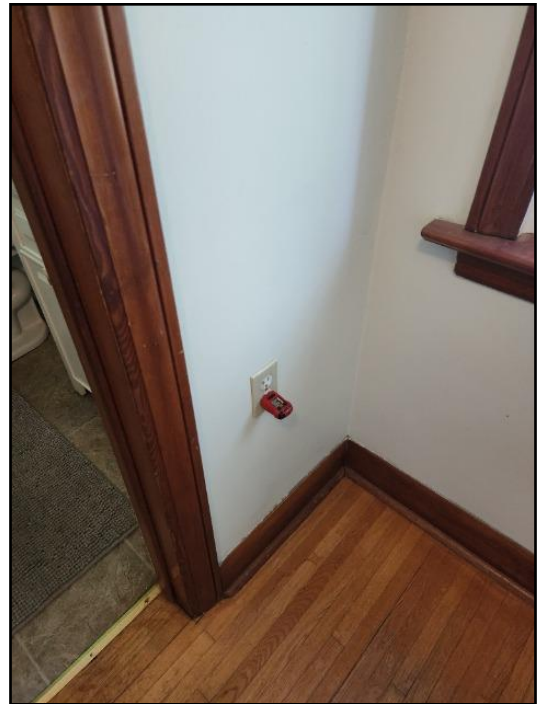
7. Condition: • Inoperative

Implication(s): Equipment inoperative

Location: Exterior wall & second floor

11. Inoperative

Task: Repair or replace

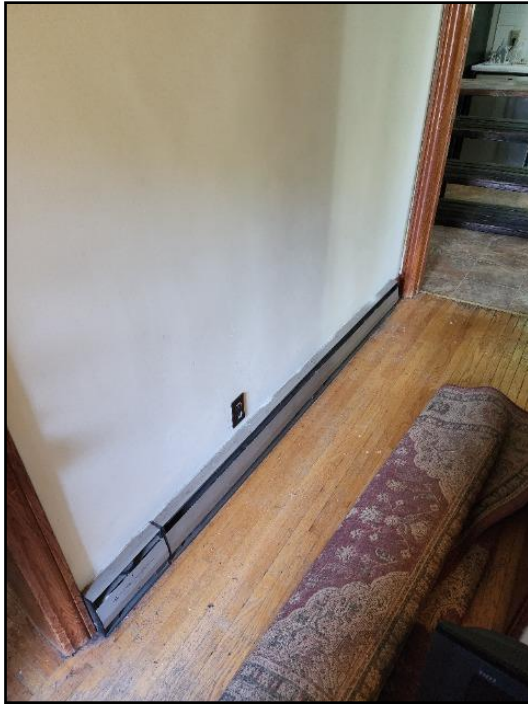
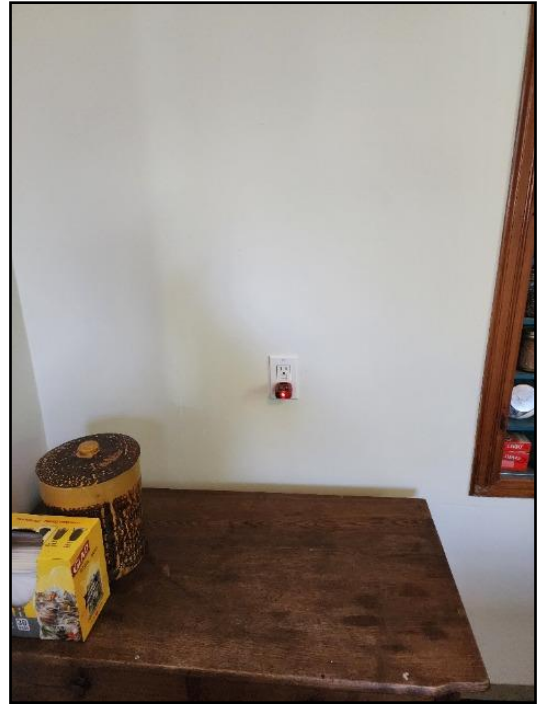
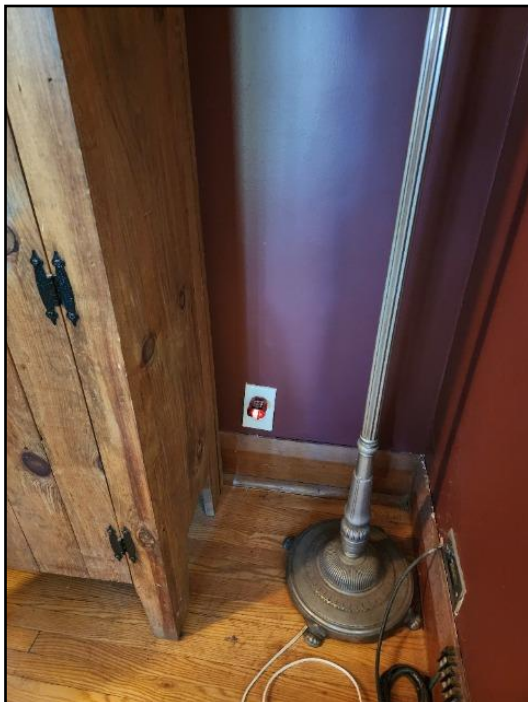
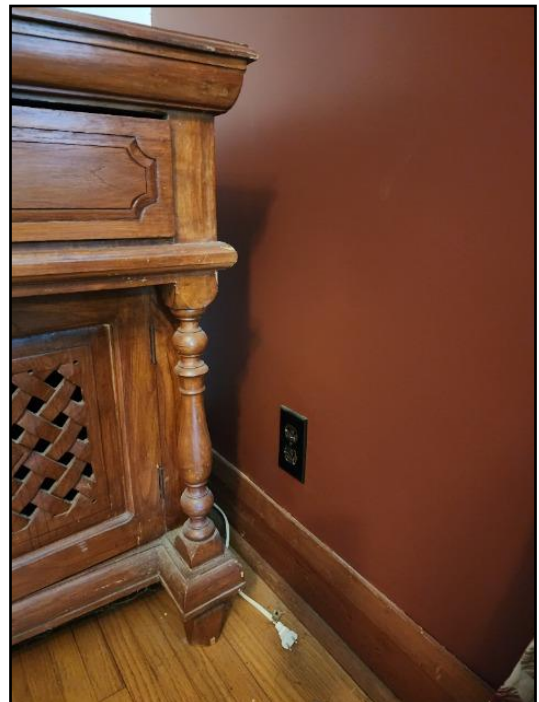
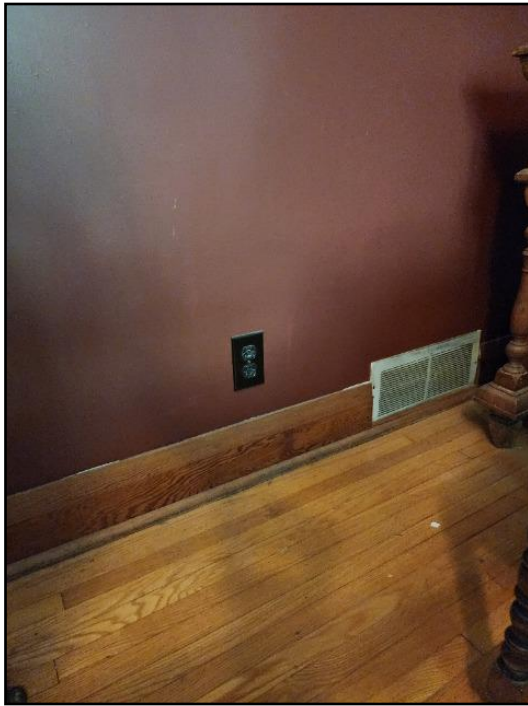
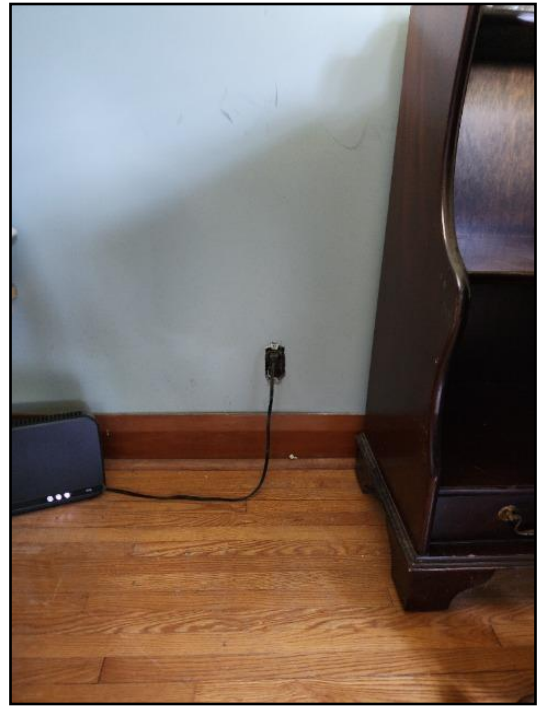
8. Condition: • Ungrounded

Although ungrounded service may be typical in a house of this age, safety may be improved by upgrading these receptacles.

Implication(s): Electric shock

13. Ungrounded

Task: Upgrade

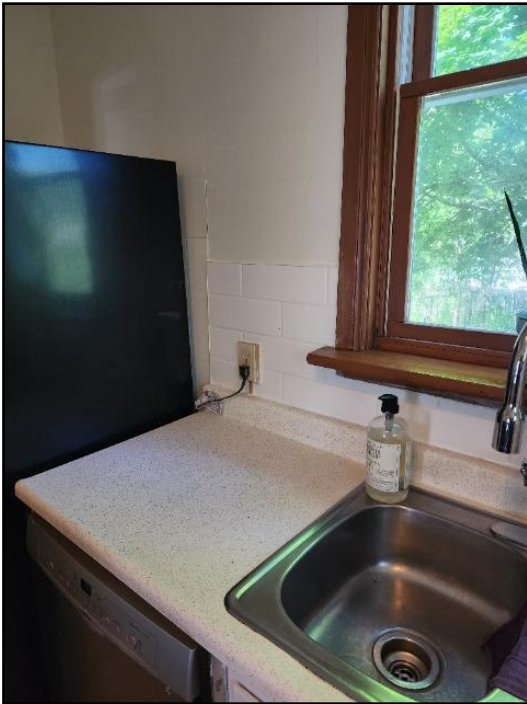
9. Condition: • No GFCI/GFI (Ground Fault Circuit Interrupter)

Although not a deficiency in a home of this age safety may be improved by upgrading this receptacle.

26. No GFCI/GFI (Ground Fault Circuit...

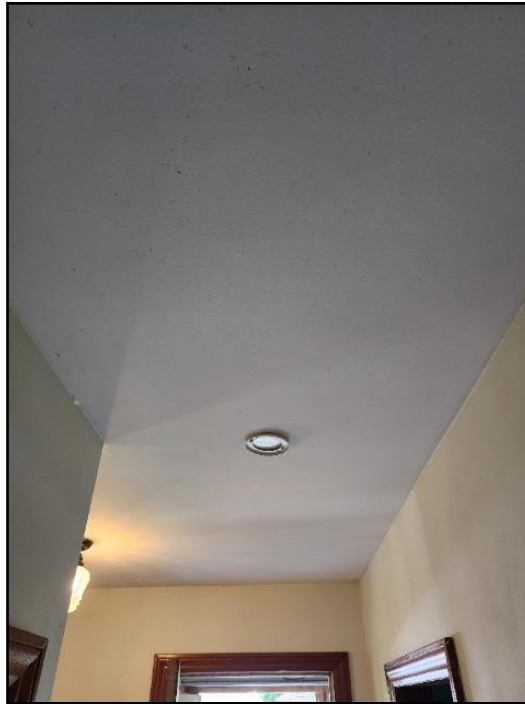
10. Condition: • Missing

27. Missing

Location: Hall
Task: Replace
Time: Immediate
Cost: Minor

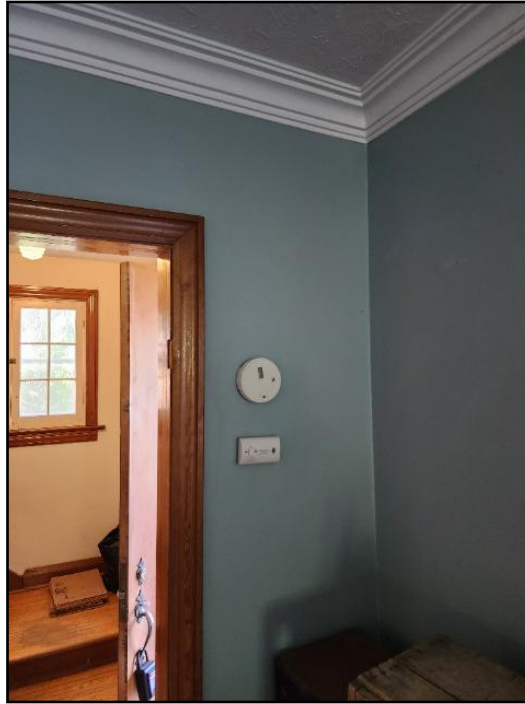
11. Condition: • More than 10 years old
Implication(s): Life safety hazard
Location: First floor
Task: Replace
Time: Immediate
Cost: Minor

28. *More than 10 years old*

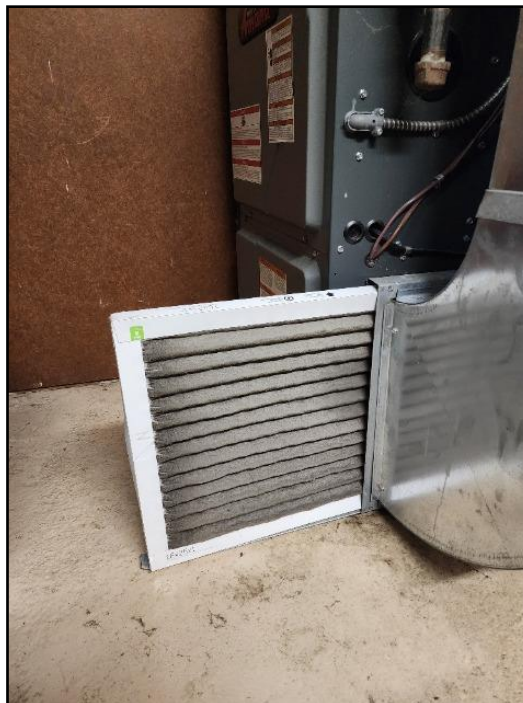
12. Condition: • Replace - regular maintenance

35. Replace - regular maintenance

Task: Replace - regular maintenance

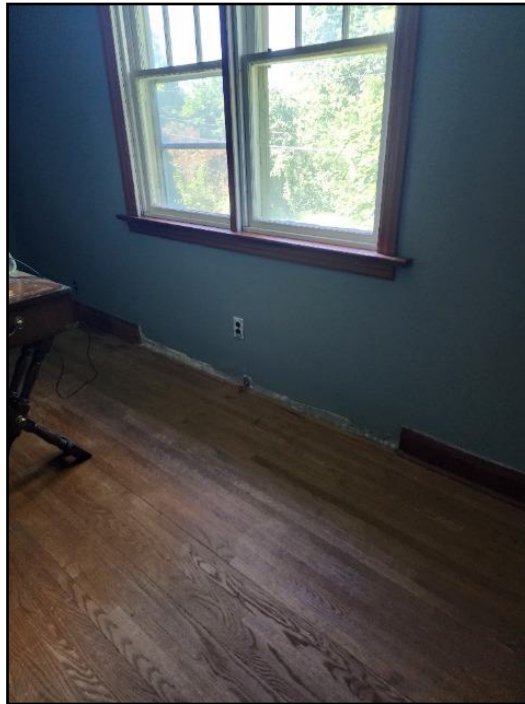
13. Condition: • Missing or too few heaters

36. *Missing or too few heaters*

Task: Replace

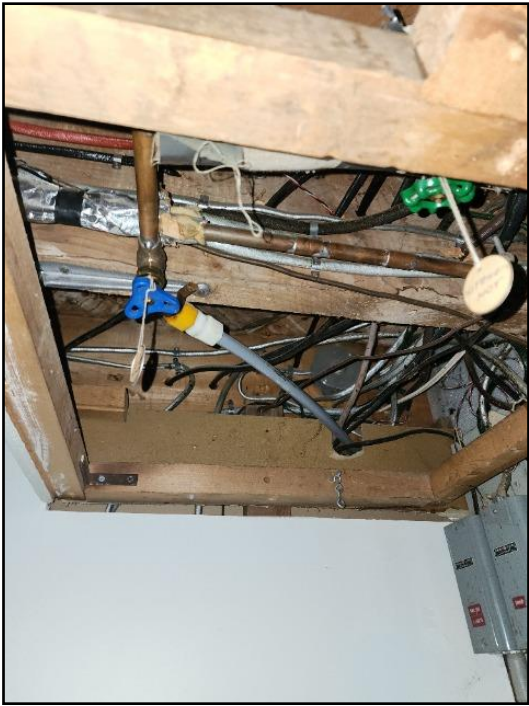
16. Condition: • Polybutylene

Implication(s): Chance of water damage to structure, finishes and contents | Leakage

43. Polybutylene

Task: Monitor

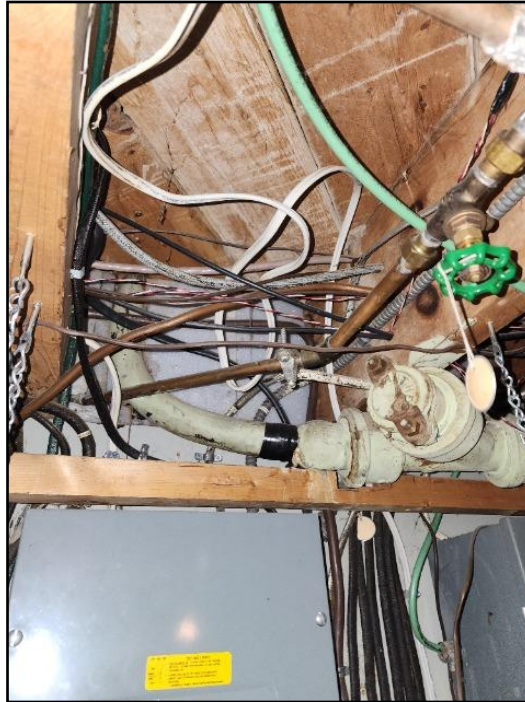
17. Condition: • Leak

44. Leak

Task: Repair

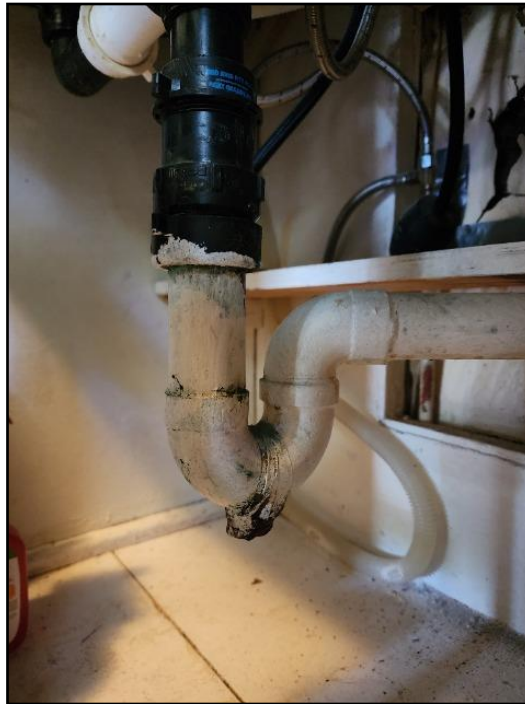
18. Condition: • Leak

Implication(s): Chance of water damage to structure, finishes and contents

45. Leak

Task: Repair or replace

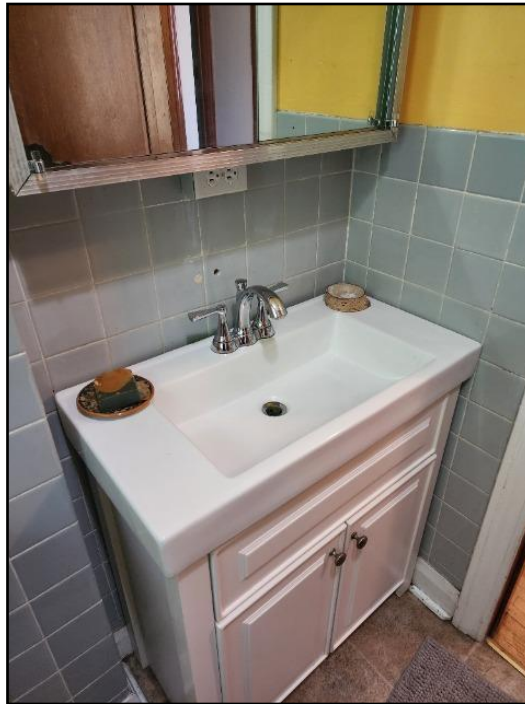
19. Condition: • Loose

Implication(s): Chance of water damage to structure, finishes and contents | Damage or physical injury due to falling materials | Sewage entering the building

46. Loose

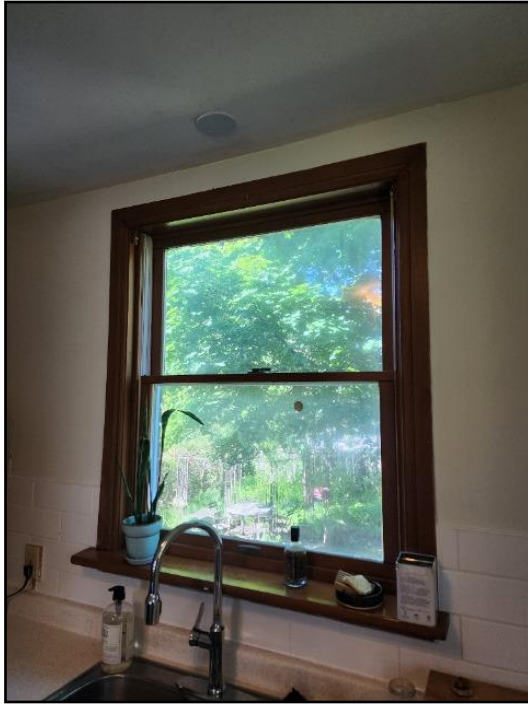
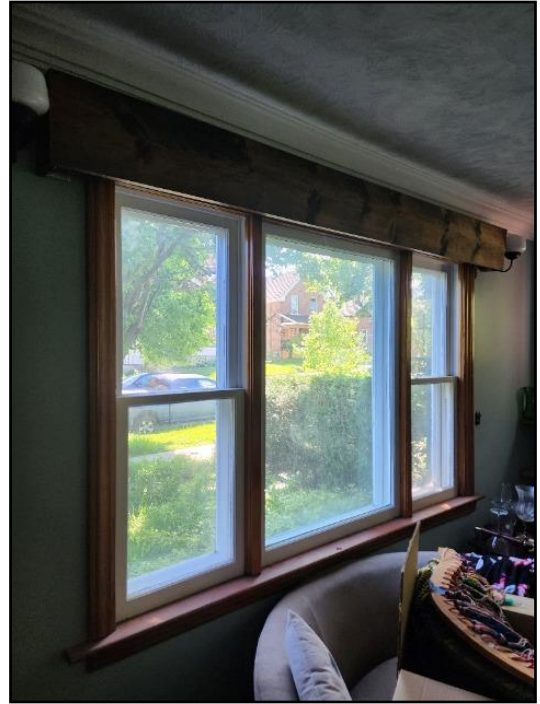
20. Condition: • Inoperative

48. Inoperative

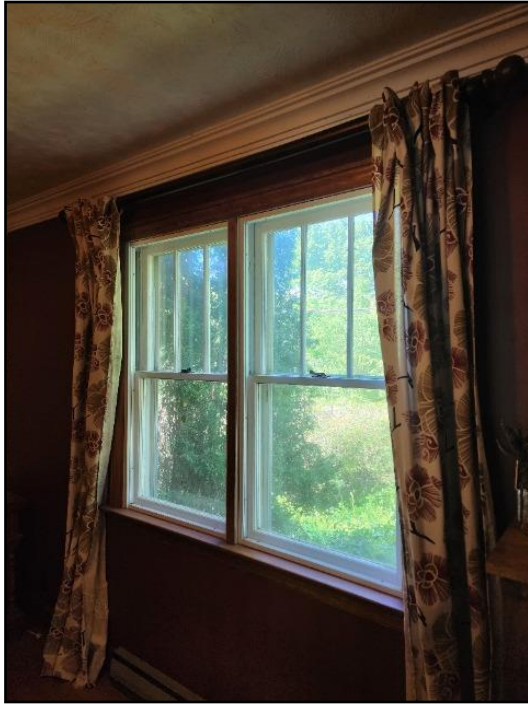
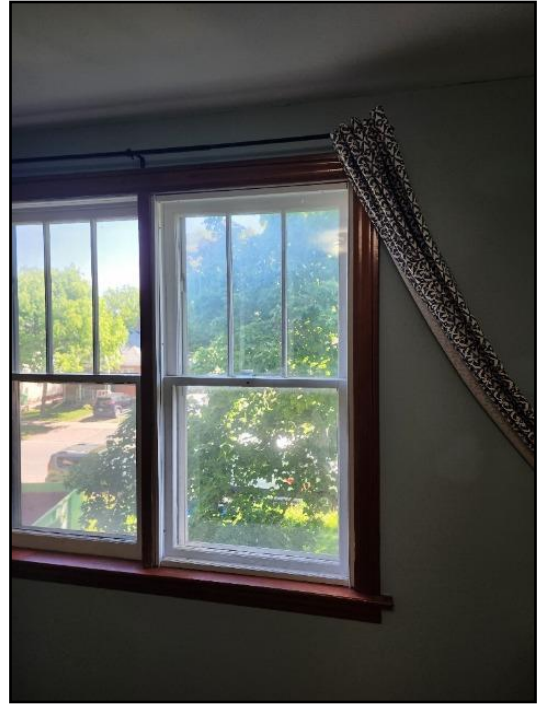
21. Condition: • Air leaks
Implication(s): Leakage
Location: Various locations
Task: Improve
Time: Discretionary
Cost: Minor

50. Air leaks

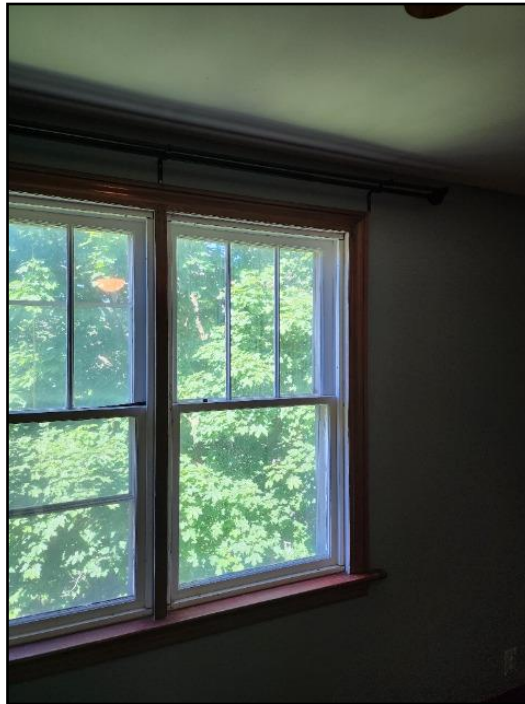
23. Condition: • Won't stay open

52. *Won't stay open*

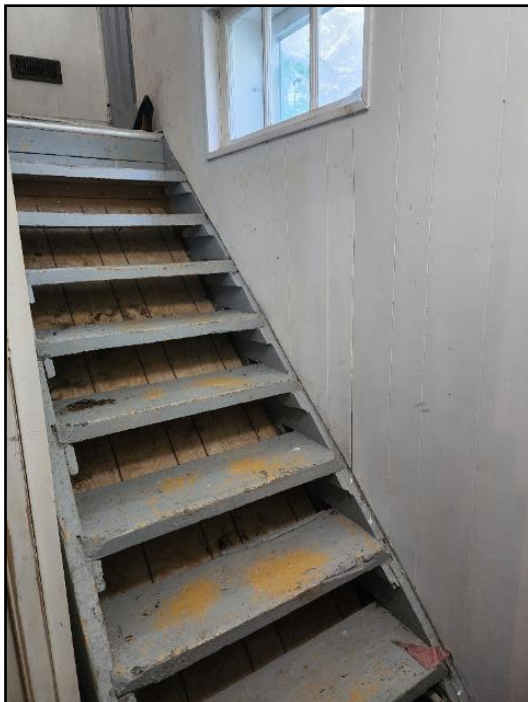
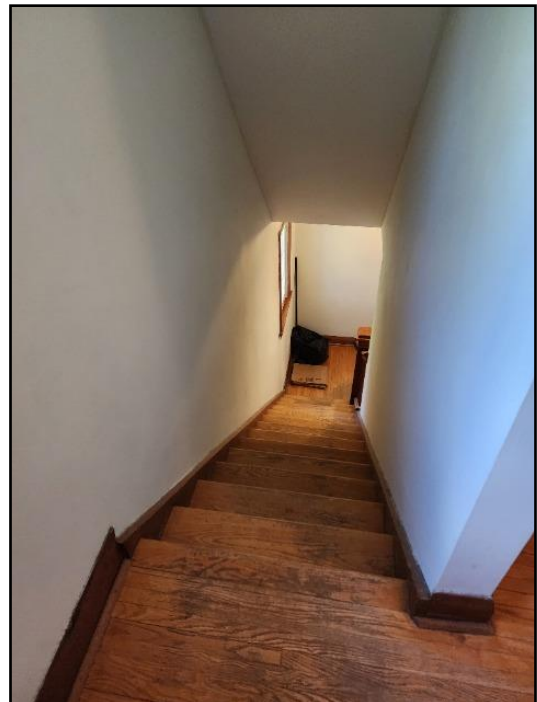
24. Condition: • Missing

Implication(s): Fall hazard

53. Missing

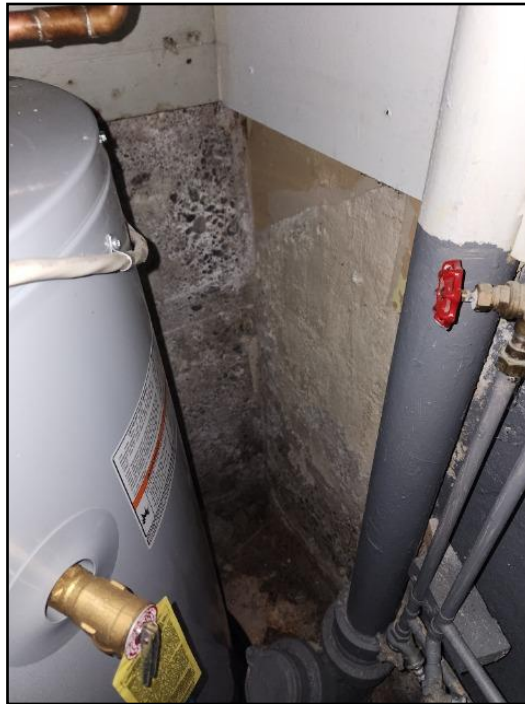
25. Condition: • Efflorescence

Implication(s): Chance of water damage to structure, finishes and contents

55. Efflorescence

Task: Monitor
