Siena del Lago  
Seattle, WA

Report #: 26109-4  
Beginning: January 1, 2024  
Expires: December 31, 2024

RESERVE STUDY  
Update "With-Site-Visit"

June 30, 2023

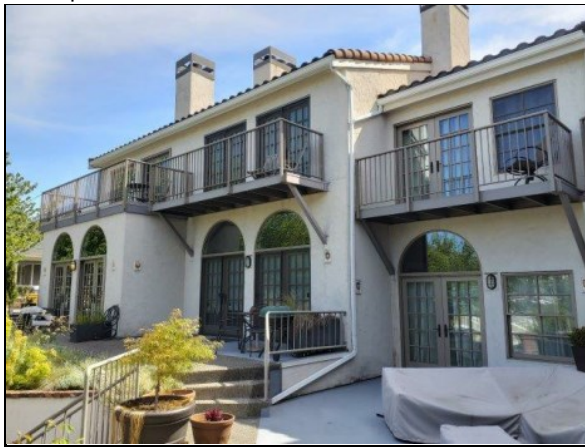
History: Repairs 2013.
