LIGHTHOUSE ENGINEERING, L.L.C.

RE: Engineering Evaluation – Distress Inventory Report and Structural Performance
Express Limited Major Structural Defect Warranty

Homeowner - Jacqueline Yoo (Current Homeowner)
Subject Address: 2001 Faro Drive (Unit 13), Austin, TX 78741
Work Order # - W10054
Certificate # - 760931
Enrollment Date - 07/26/12
Case # - G75476

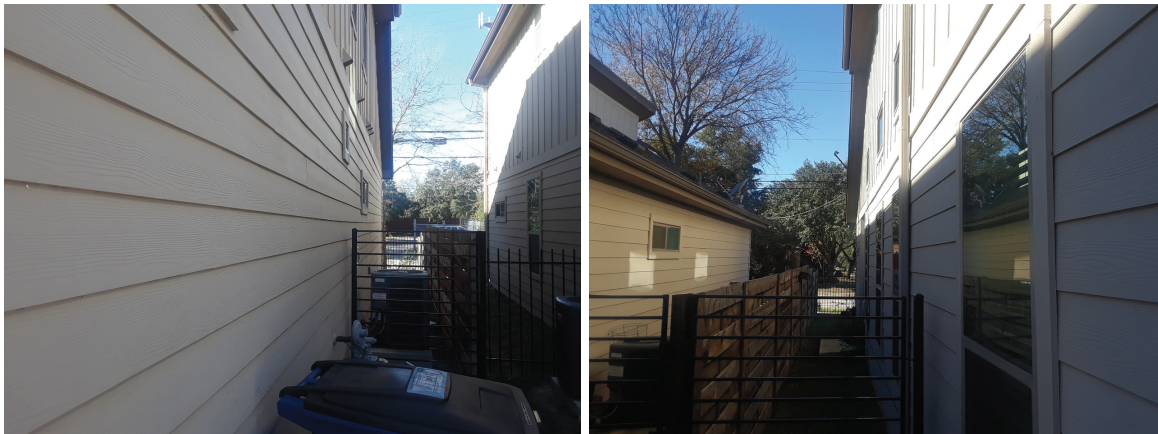
Pictures E1 - E2: Sight down the siding lines along the left and right sides showed siding line deflections.

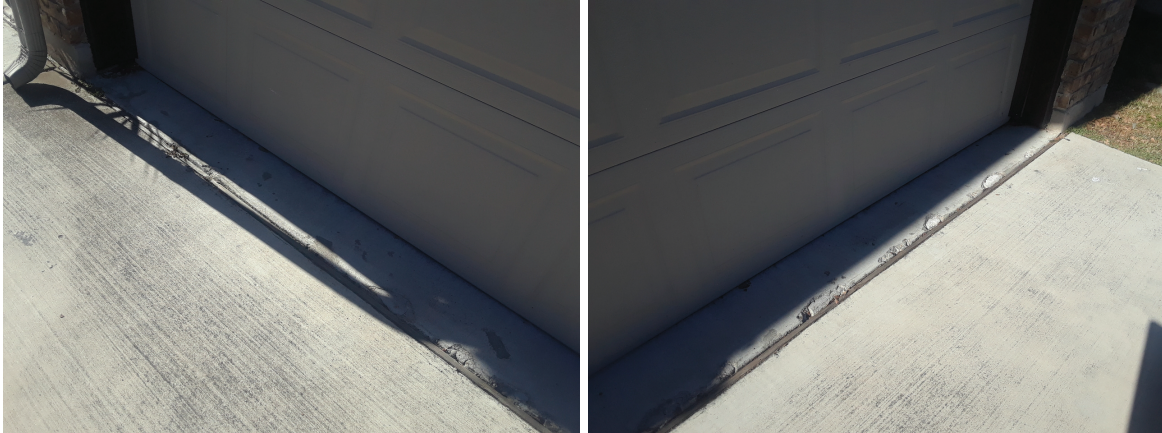
Pictures E3 - E4: No vertical driveway/garage displacement.

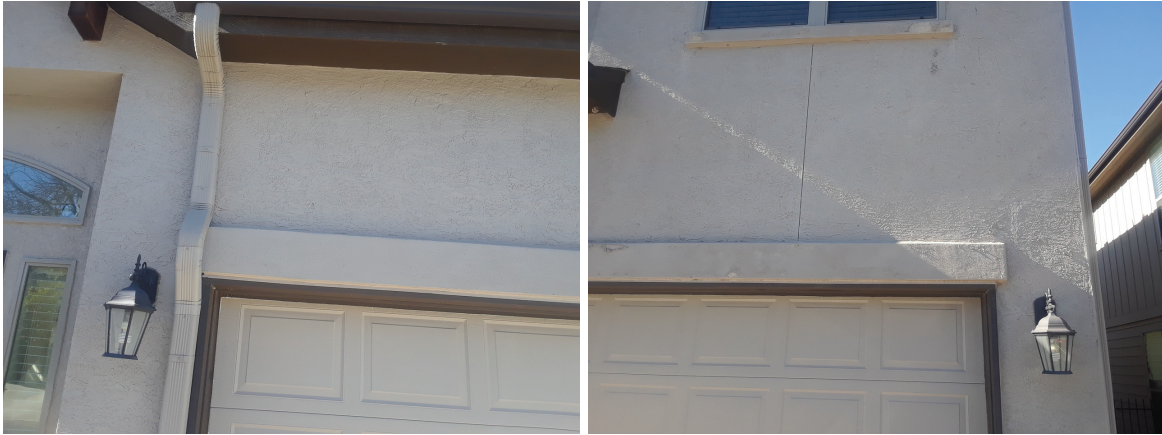
Pictures E5 - E6: Minor stucco and trim separations in various locations.

1. Make cosmetic repairs to seasonal distress such as, exterior cladding cracks, trim separations, sheetrock cracks, out-of-square or binding doors and striker plates. It is recommended to adjust doors, windows and striker plates to accommodate for seasonal movements.
2. There are no practical engineering methods to help prevent continued movement.
3. Monitor the foundation for indications of reoccurring or active movement.

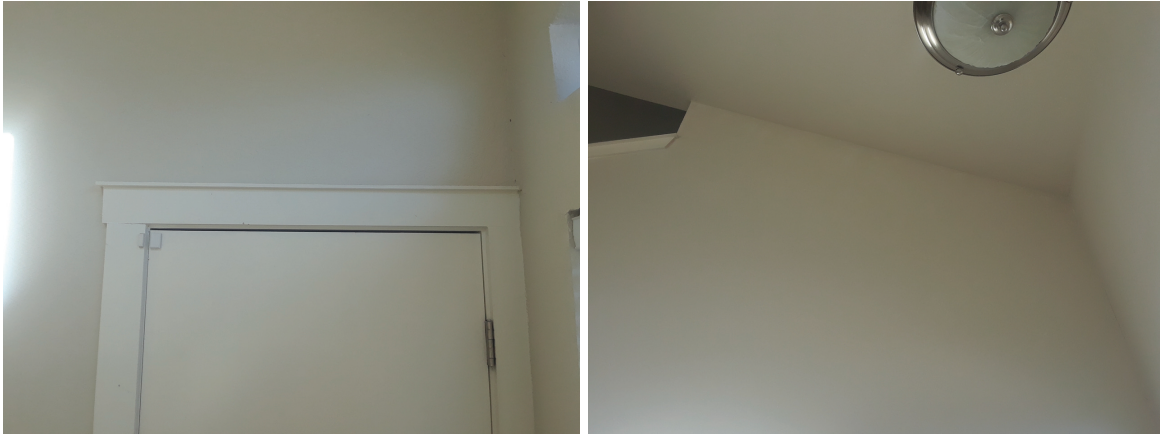
Pictures I1 - I2: Minor out-of-square door at the front entry. Interior doors opened, closed and latched within reasonable expectations. Minor sheetrock cracking various locations.

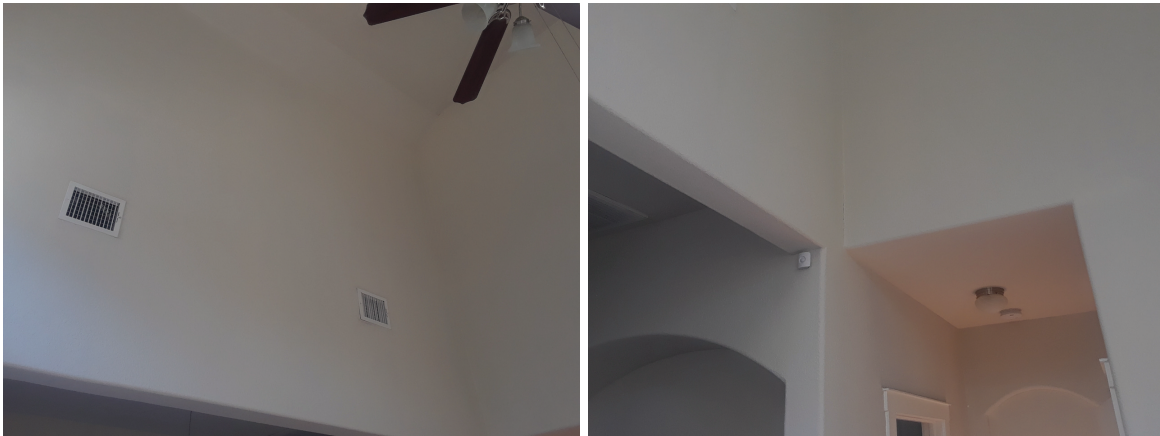
Pictures I3- I4: Minor sheetrock cracking various locations.

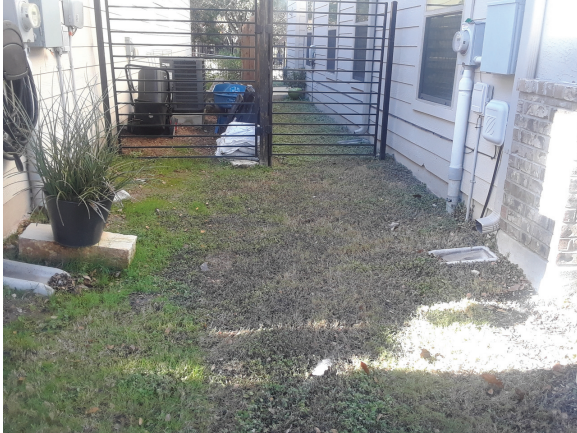
Left Side

1. Drainage around the perimeter is positive away from the foundation.
2. Surface drainage was concluded to not be a contributing factor to the overall foundation performance.

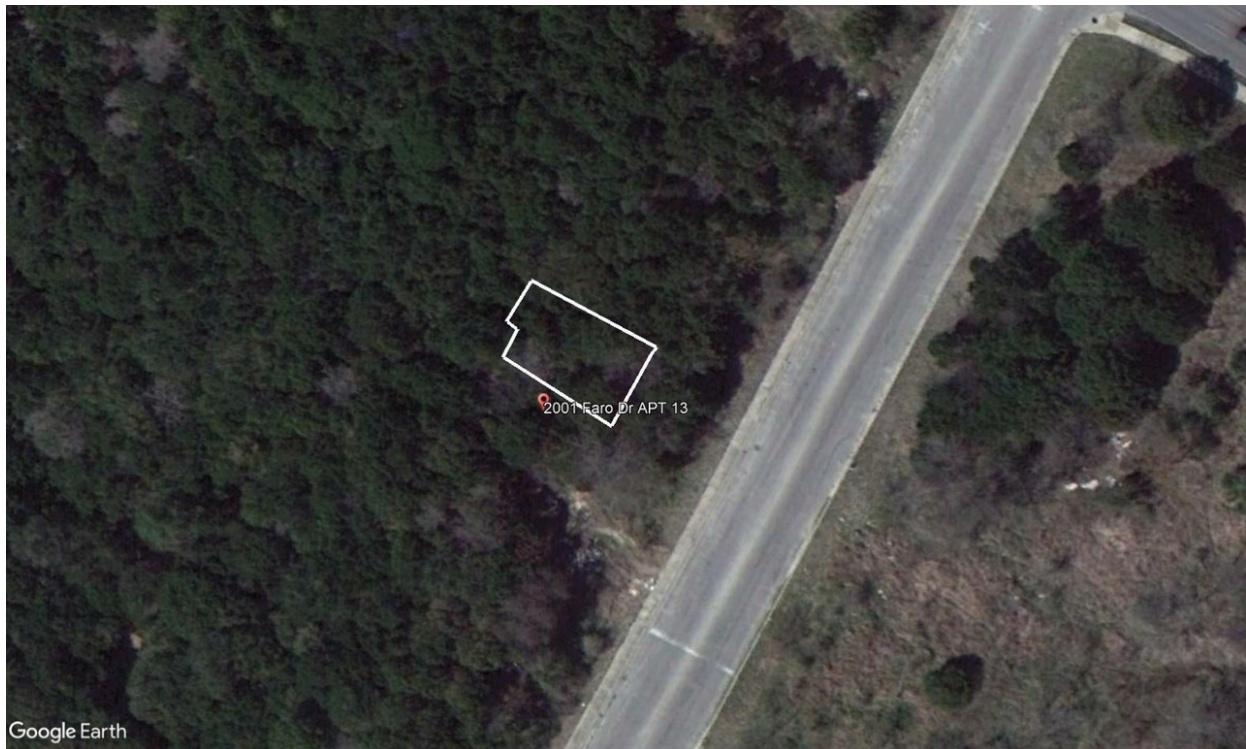
1. There were no obvious negative contributing factors to the lot development prior to construction. This photo was taken 03/2011 prior to the development of the lot.
2. The subject Home is constructed on the Houston Black Clay soil group. These soil properties were reviewed pertinent to the subject property. (WebSoilSurvey)

Picture 1: Pre lot development prior to construction.

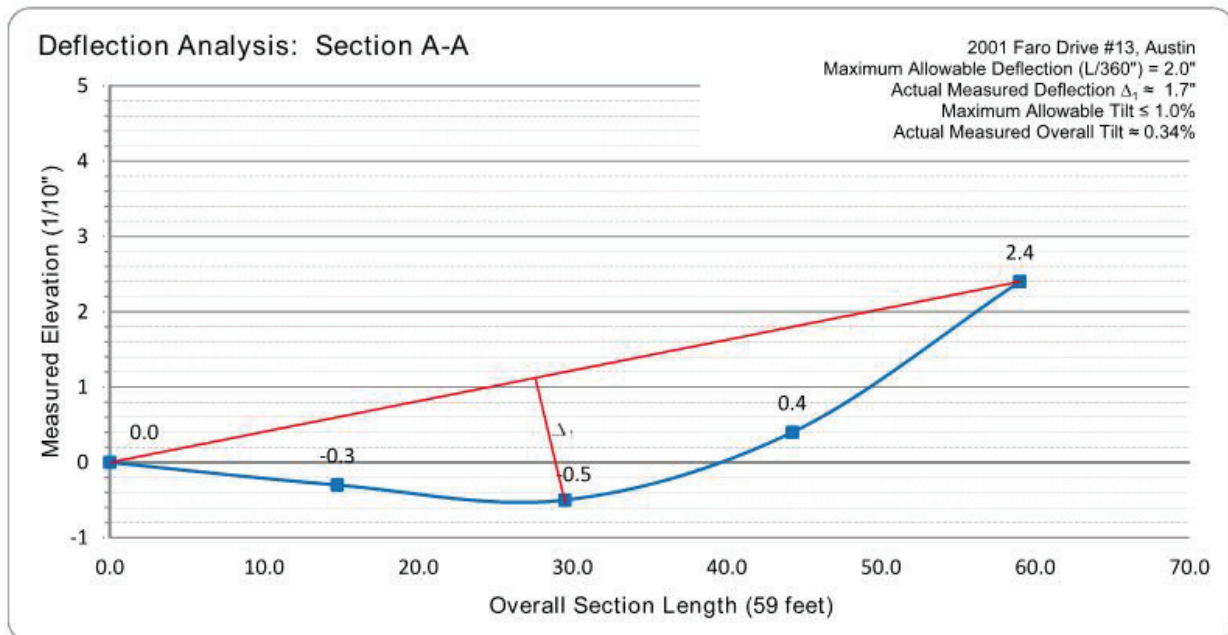
Figure 1: Deflection Analysis Across Section A-A

- The allowable edge-to-edge deflection is $\Delta_1 = L/360" = 708"/360" = 2.0"$.
The actual edge-to-edge deflection measured is $\Delta_1 \approx 1.7"$.
This is within the ASCE guideline tolerance of L/360 for foundation deflection.
- The actual edge-to-edge tilt measured is $\approx 0.34\%$.
This is within the ASCE guideline tolerance of 1.0% for foundation tilt.

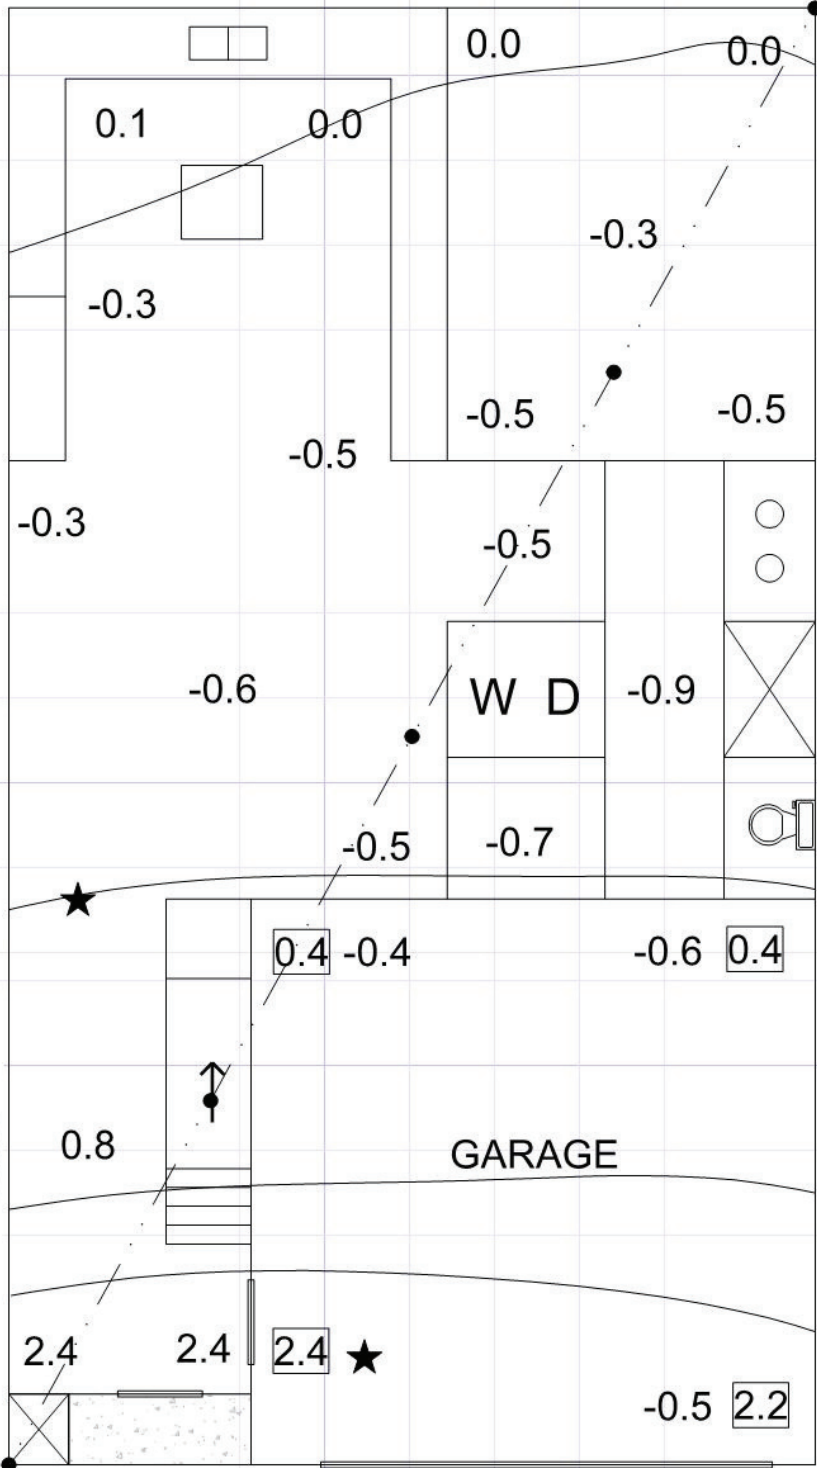
DRAWING NO. 1001

Interior floor elevations were taken with a Technidea Pro-2000 Zipllevel. Elevations were recorded to the nearest 0.1-inch throughout the home. A benchmark of 0.0 was established within the footprint of the home and is shown on Drawing No. 1001 with a star. An adjustment was made for floor coverings if they were a different elevation than the floor covering at the benchmark location. Elevation differentials varied by a maximum of 2.9" vertical inches in 30' horizontal feet. It should be noted that the elevation measurements include effects of elevation variation in the original construction which normally are 0.6 inches to 1.0 inches.
