YOUR INSPECTION REPORT

1297 Canterbury Road
Mississauga, ON L5G 4A8

Friday, February 7, 2025

RE: Report No. 2216
1297 Canterbury Road
Mississauga, ON
L5G 4A8

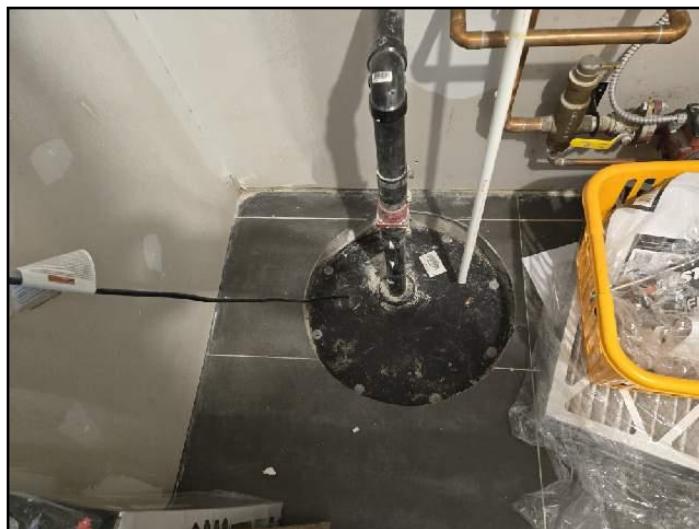
17. Sump pump

5. Condition: • Sump pump could not be evaluated - sealed lid

Location: Basement

4. Condition: • Recommend adding battery backup system for the sump pump

Task: Further evaluation

Time: As soon as possible

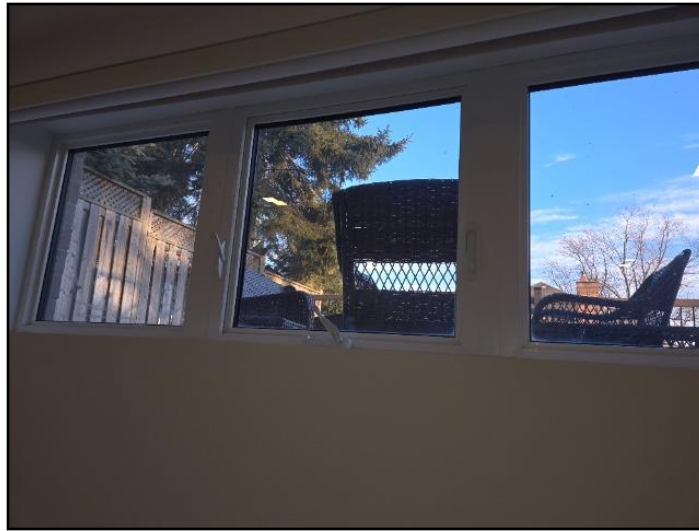
6. Condition: • [Missing](#)

Location: Basement, bedroom

18. Missing screen

Task: Install screen

Time: As soon as possible
