INSPECTION REPORT

For the Property at:
658 BROWN STREET
PETERBOROUGH, ON K9J 4K5

Prepared for: TEAM VANRAHAN
Inspection Date: Friday, August 16, 2024
Prepared by: David Sharman

RE: Report No. 4940, v.3
658 Brown Street
Peterborough, ON
K9J 4K5

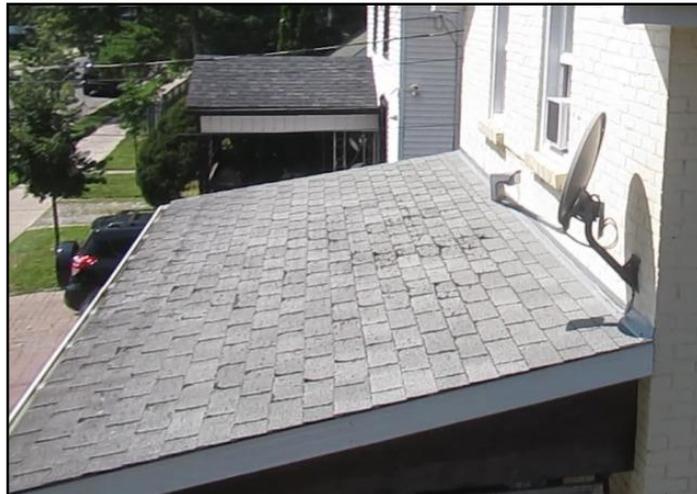
1. Condition: • Aging

Location: Porch

4. Aging

Task: Replace

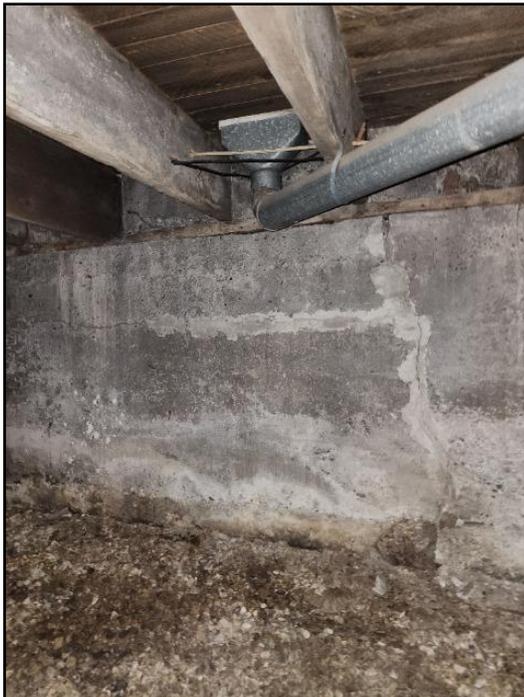
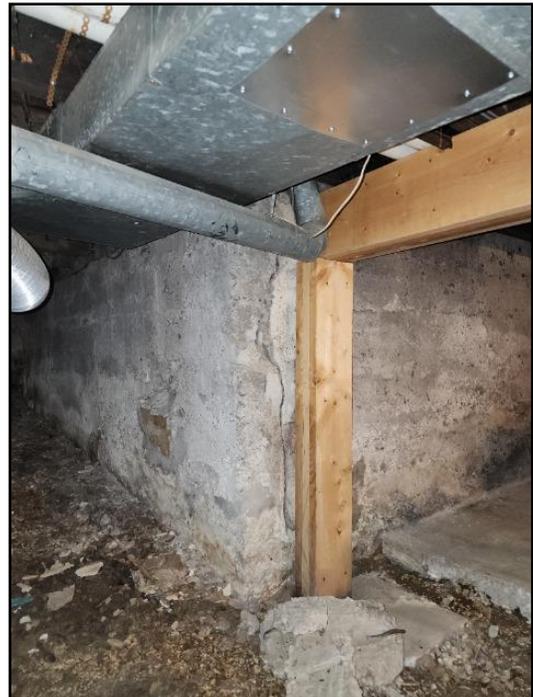
3. Condition: • Cracked

Implication(s): Chance of water damage to structure, finishes and contents | Weakened structure

Location: Rear right elevation

5. Cracked

Task: Monitor

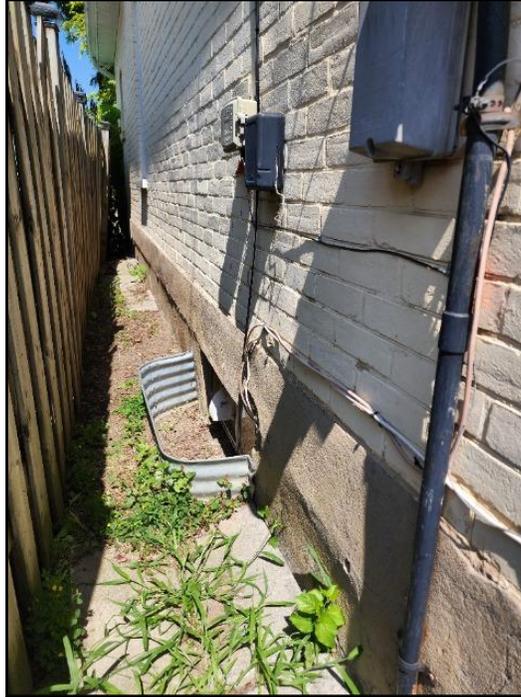
4. Condition: • Cracked horizontally

Implication(s): Chance of structural movement

Location: Left elevation

7. Cracked horizontally

Task: Further evaluation

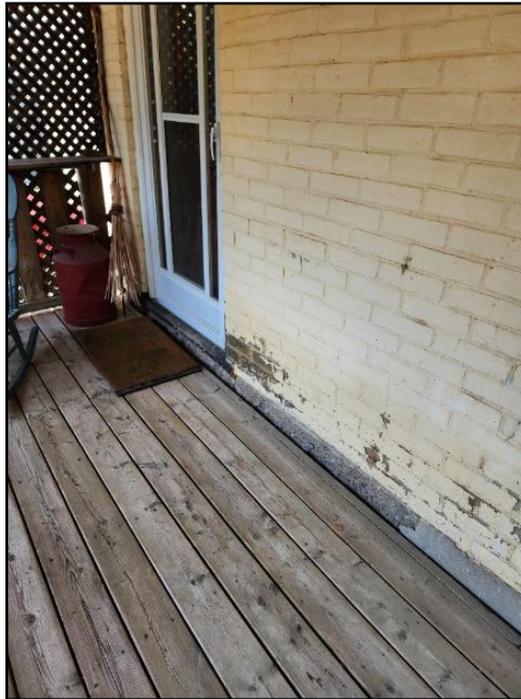
5. Condition: • Spalling, crumbling or broken material

Implication(s): Continued material deterioration, Weakened structure

Location: Exterior

8. *Spalling, crumbling or broken material*

Task: Repair

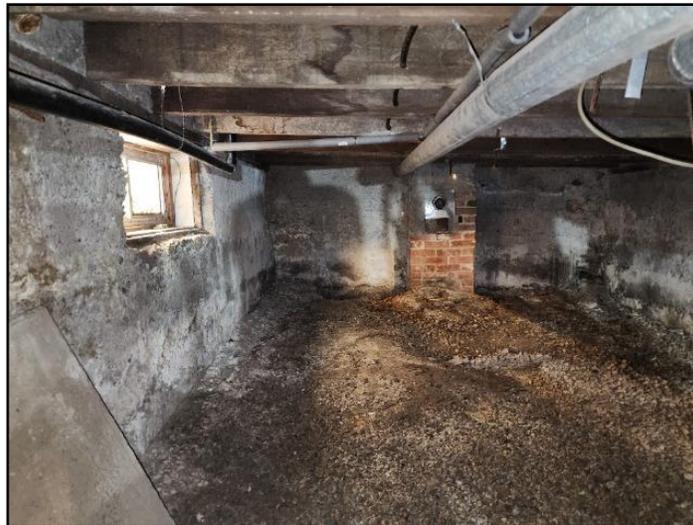
6. Condition: • Spalling, crumbling or broken material

Implication(s): Continued material deterioration, Weakened structure

Location: Throughout basement

9. *Spalling, crumbling or broken material*

Task: Monitor

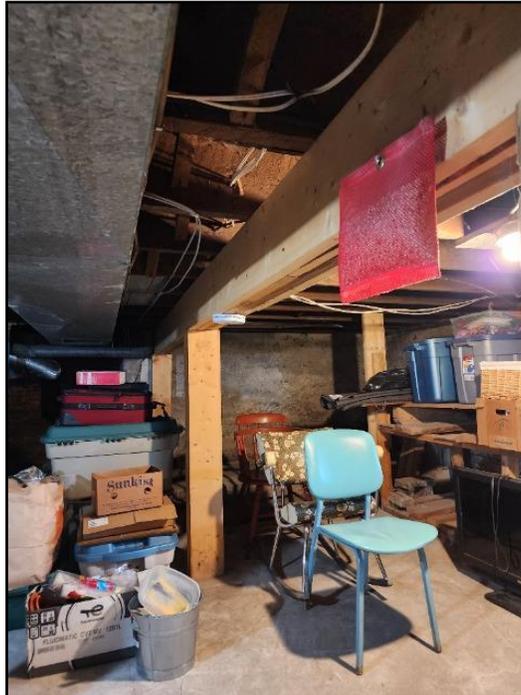
8. Condition: • Repaired/replaced

Location: Basement

10. *Repaired/replaced*

Task: Monitor

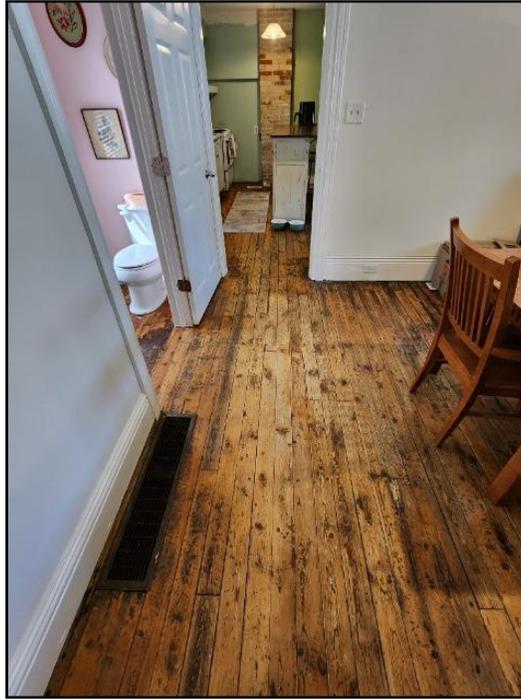
9. Condition: • Slope

Implication(s): Weakend structure, chance of continued movement

Location: Various locations

11. Slope

Task: Monitor

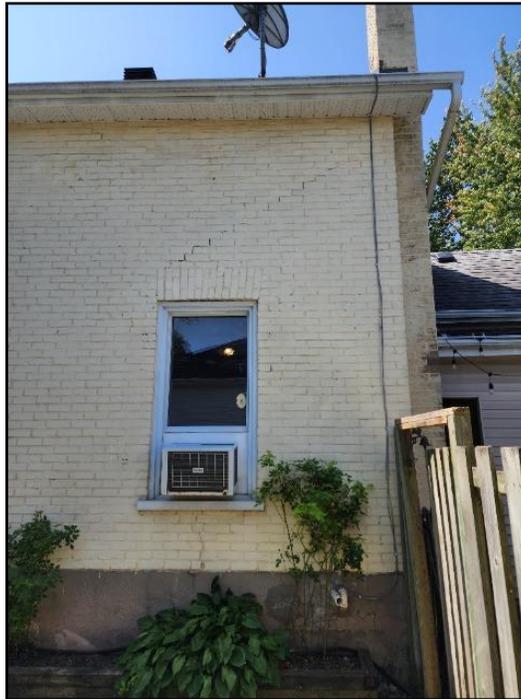
10. Condition: • Cracked

Implication(s): Weakened structure, material deterioration

Location: Rear right corner

12. Cracked

Task: Repair

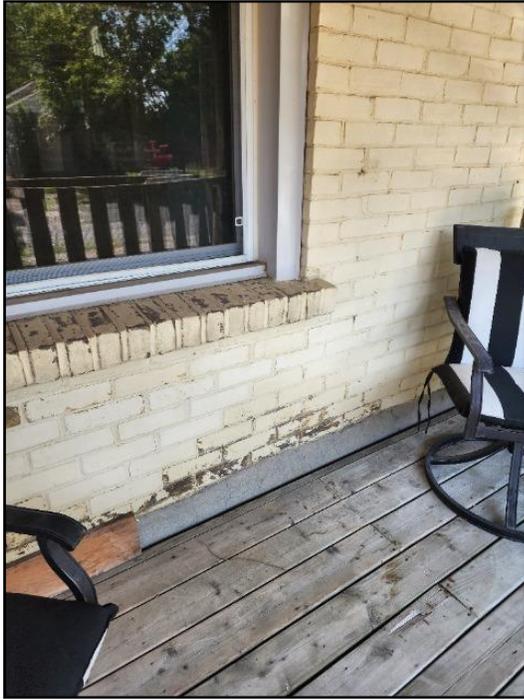
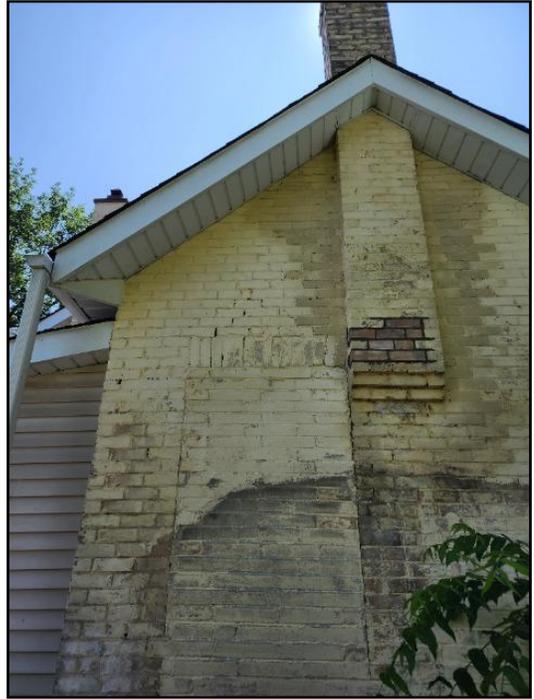
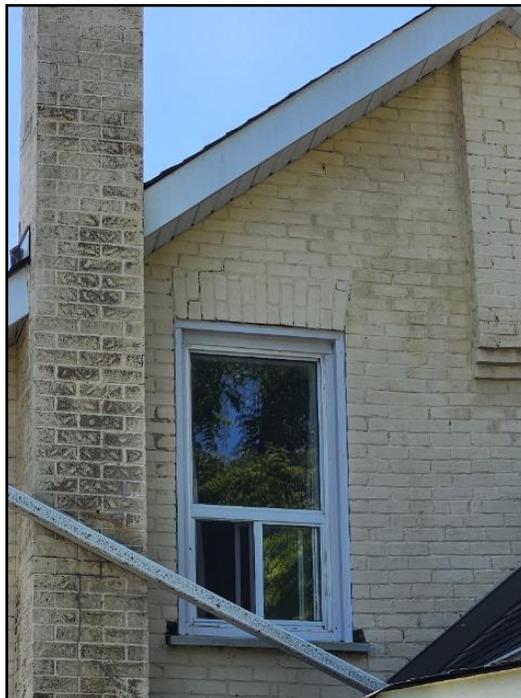
11. Condition: • Typical minor cracking

Implication(s): Material deterioration

Location: Various locations

13. Typical minor cracking

Task: Repair

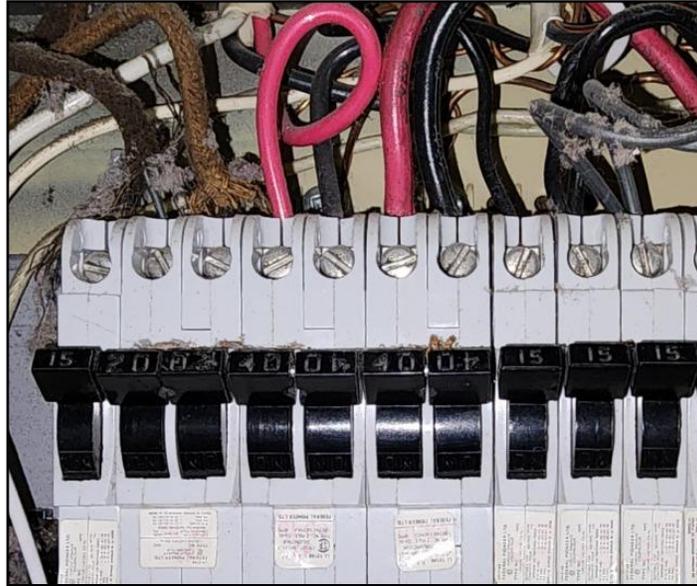
12. Condition: • Breakers too big

40 Amp breakers on a 10 gauge branch circuit wire. Although not a deficiency in a panel of this age, safety may be improved by replacing this breaker.

Implication(s): Equipment overheating | Fire hazard

18. Breakers too big

Task: Correct

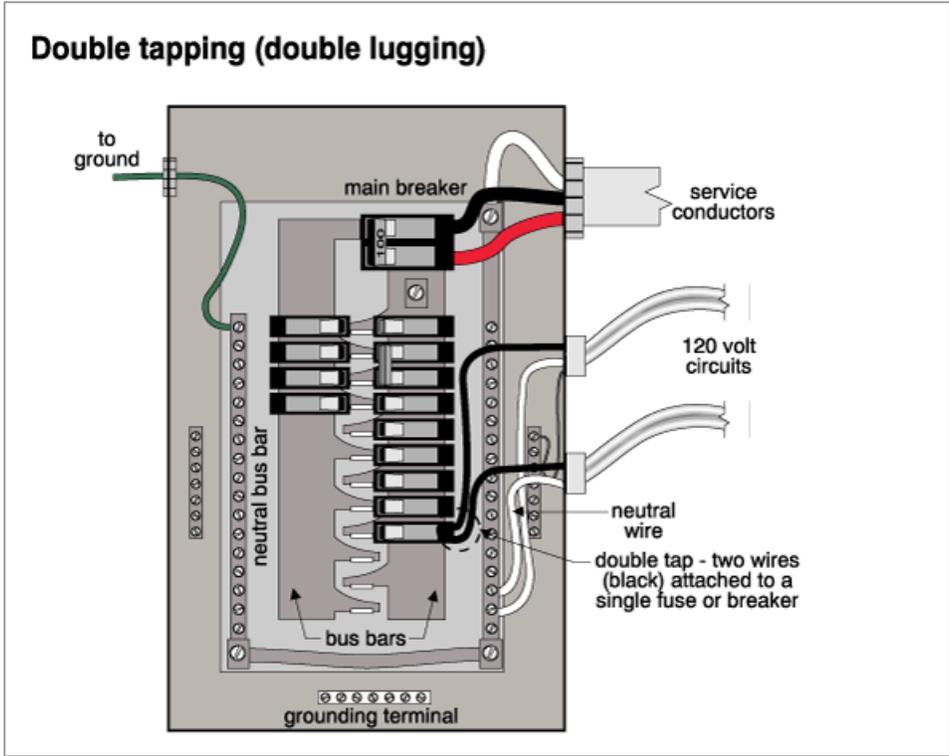
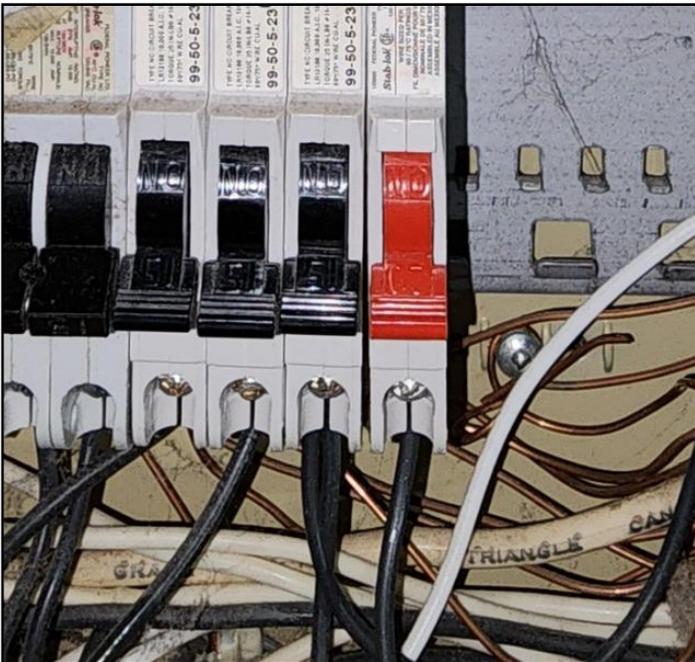
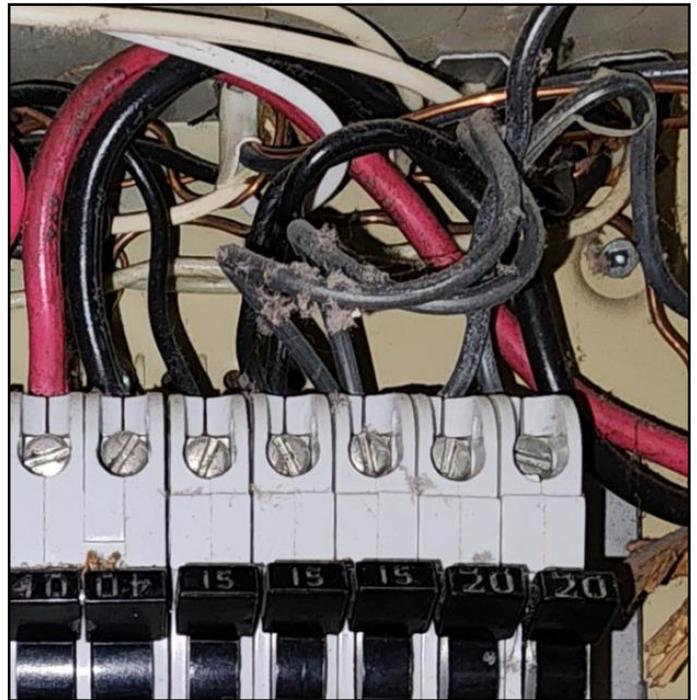
13. Condition: • Double taps

Implication(s): Fire hazard

Location: Distribution panel

19. Double taps

Task: Correct

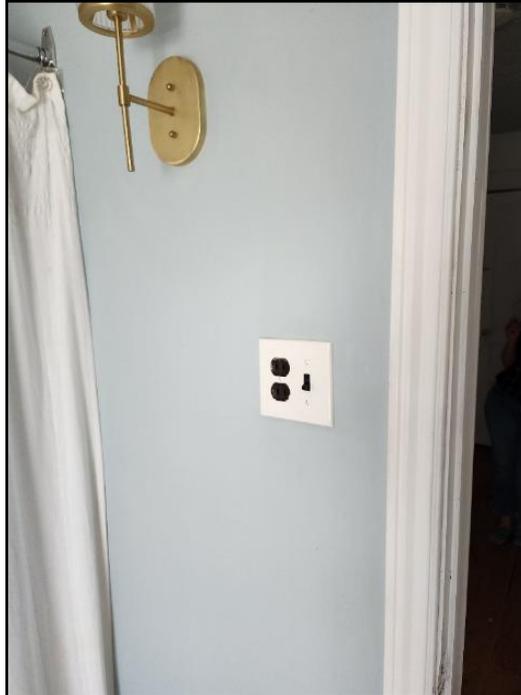
14. Condition: • Ungrounded

Although ungrounded service may be typical in a house of this age, safety may be improved by upgrading these receptacles.

Implication(s): Electric shock

21. Ungrounded

Task: Upgrade or repair

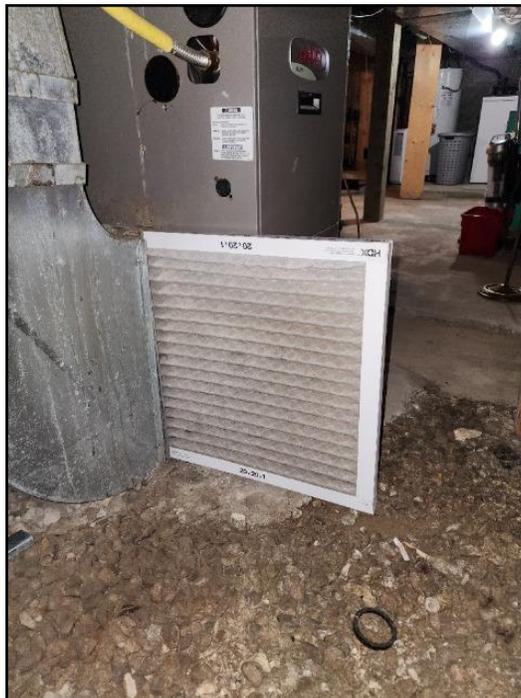
16. Condition: • Replace - regular maintenance
Implication(s): Increased heating & maintenance costs, Reduced comfort
Location: Cold air return
Task: Replace - regular maintenance
Time: Regular maintenance
Cost: Minor

32. *Replace - regular maintenance*

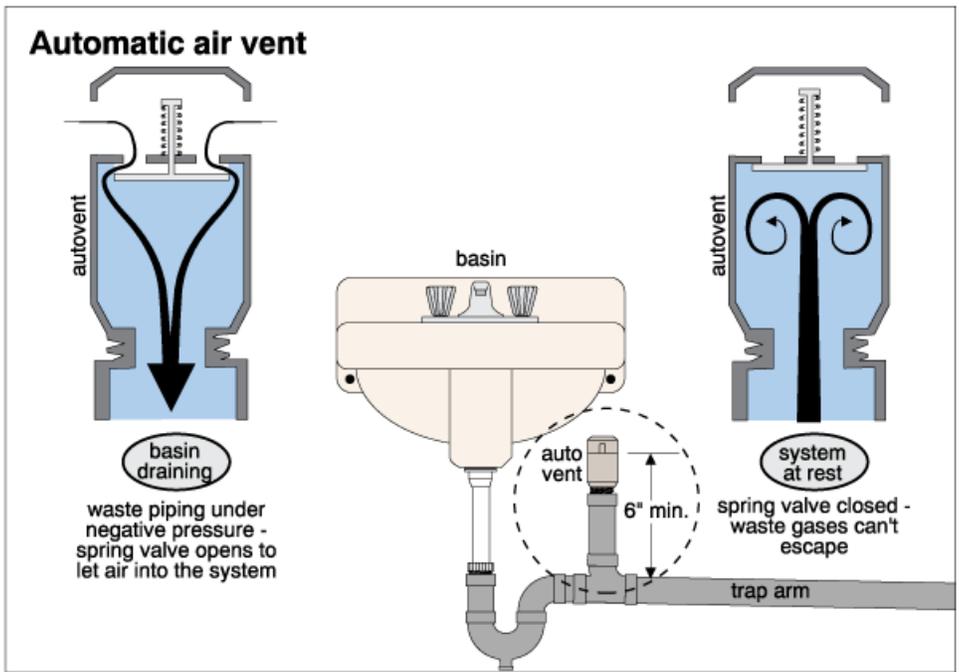
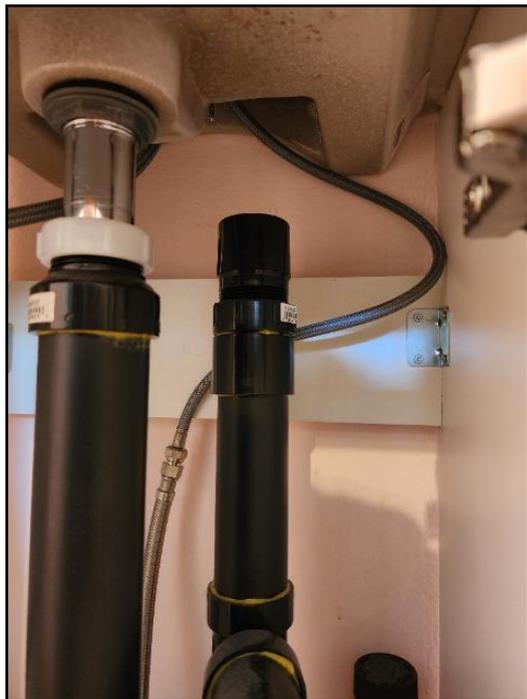
- WASTE PLUMBING \ Venting system**
- 19. Condition:** • Automatic air vents
- Implication(s):** Failure may allow sewer gasses to enter building
- Location:** Washroom
- Task:** Monitor
- Time:** Ongoing

38. Automatic air vents

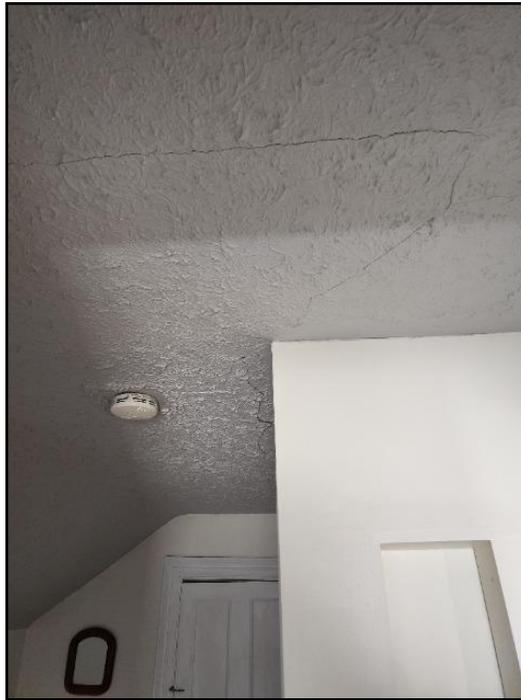
20. Condition: • Damage

Implication(s): Damage due to falling materials

39. *Damage*

Task: Repair or replace

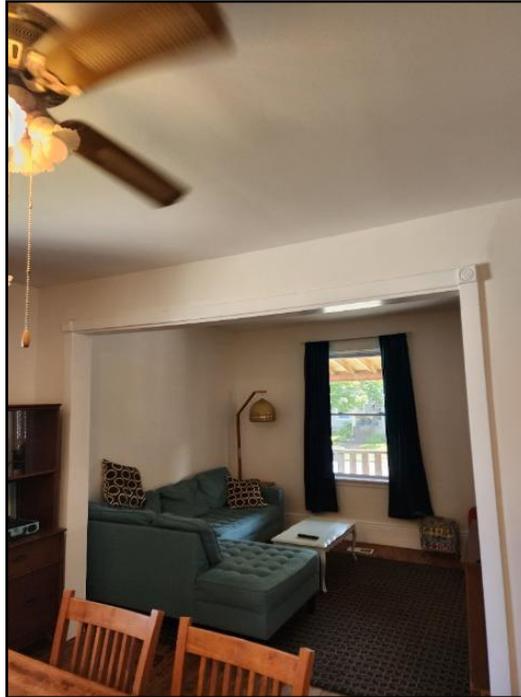
21. Condition: • Door opening sagging

Implication(s): Damage to interior finishes

40. *Sagging*

Task: Monitor

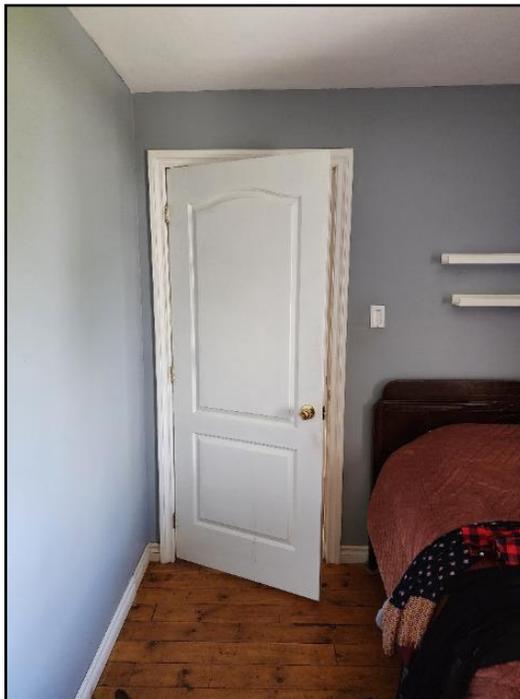
22. Condition: • Binds

41. *Binds*
