Report #: 071025WO2.

Date of inspection: 07/10/2025.

Address of inspection: 211 Meadow Ridge Drive. , Tallahassee, FL 32312.

The following summary is provided as a courtesy for quick access to the information within the attached inspection report. It is not intended as a substitute for reading the entire inspection report.

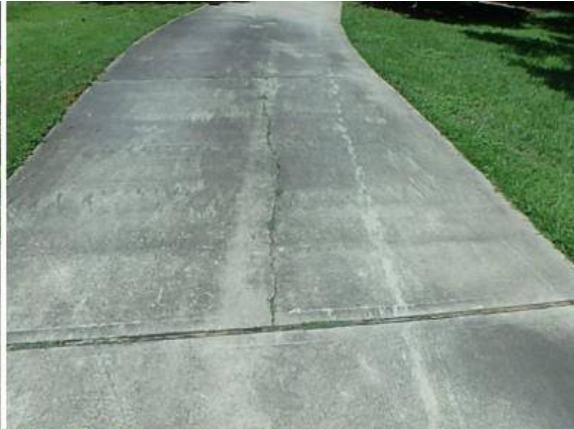
1. Driveway has various areas of cracking and settlement.

Pressure Washed
July 2025

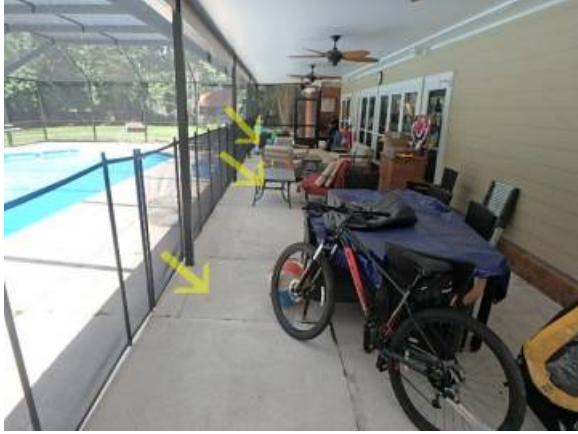
2. The rear patio area appears to trap / hold water during heavy rain events. This area does not appear to have proper drains / slope to evacuate water.

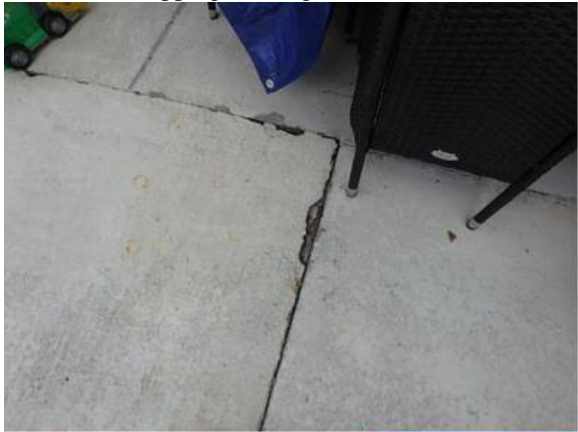
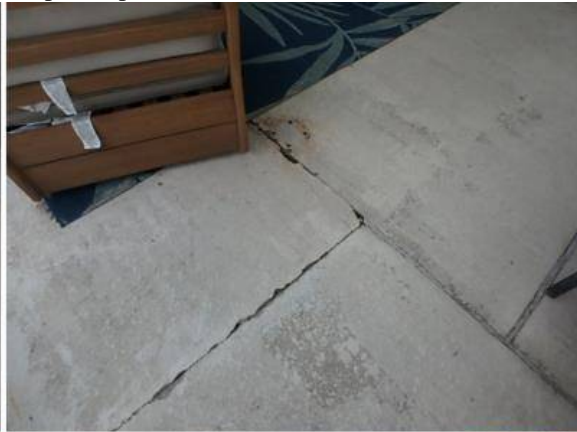
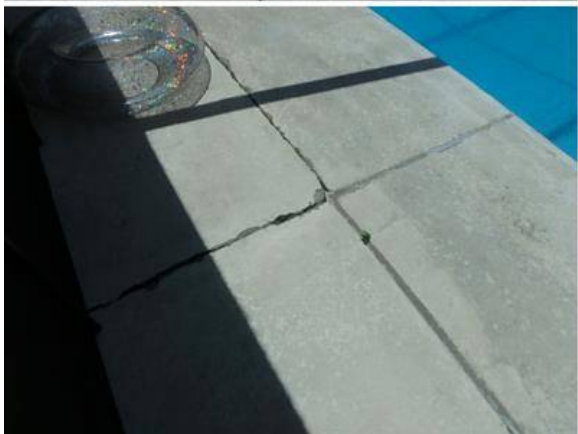
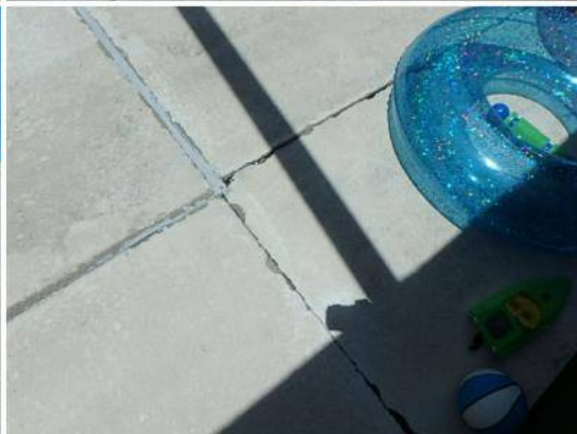
3. Areas of chipping / damaged concrete noted at the rear patio / porch.

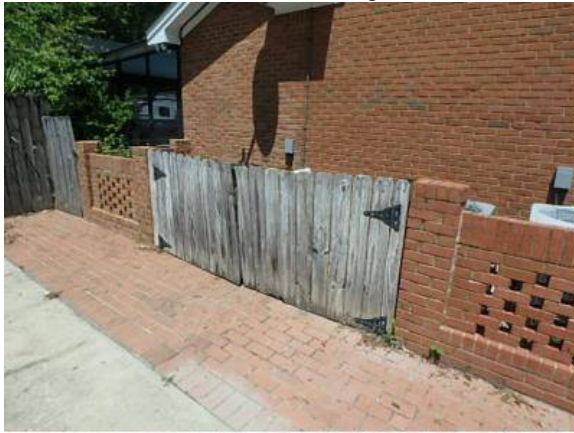
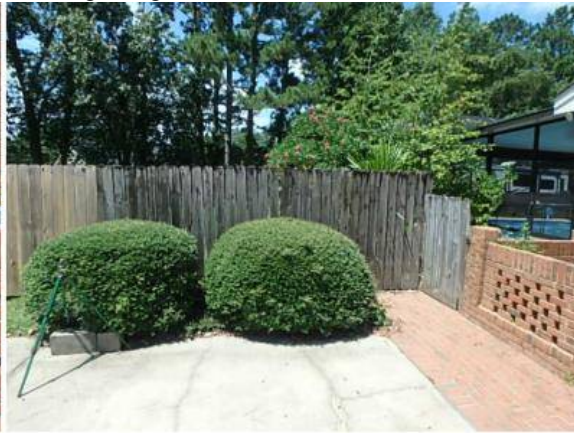
4. General deterioration and damage noted at the wood fencing and gates.

washed July 2025

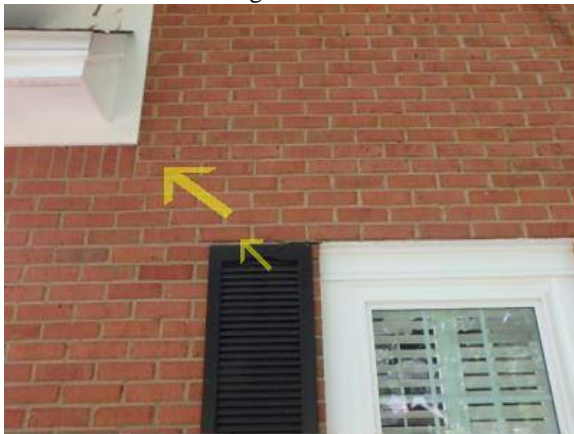
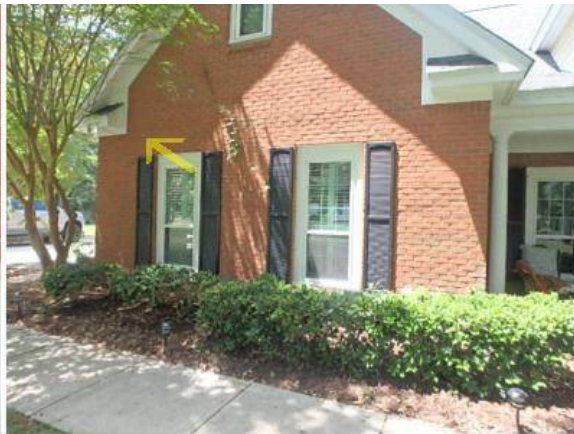
5. Cracking noted at the brick mortar above the front garage window here. No structural damage noted at this time. Recommend monitoring.

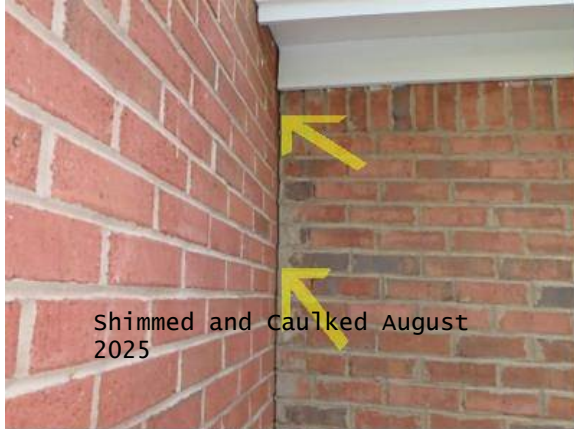
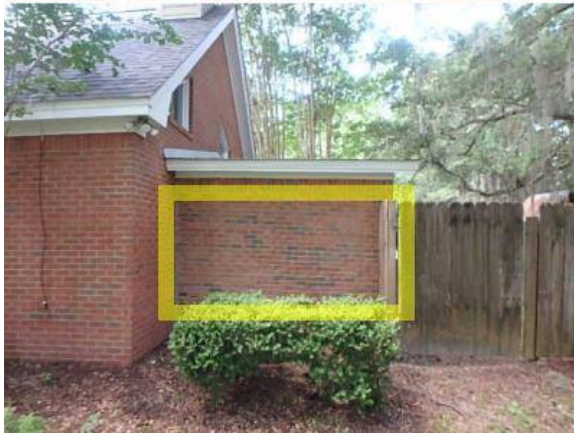
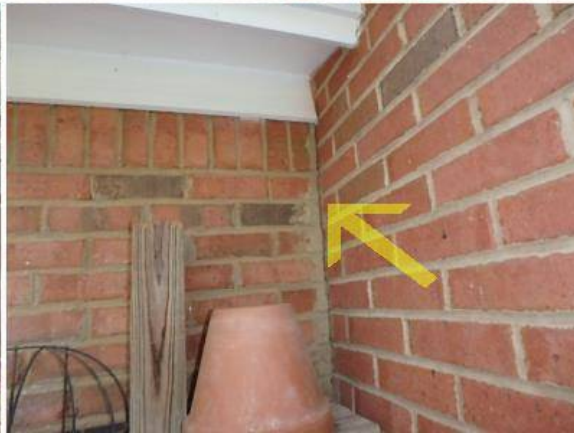
6. Separation and evidence of settlement noted at the right side exterior shed addition. Separation noted at the brick mortar at the transition to the house. Brick coursing does not appear level at the front facing wall.

Shimmed and Caulked August 2025

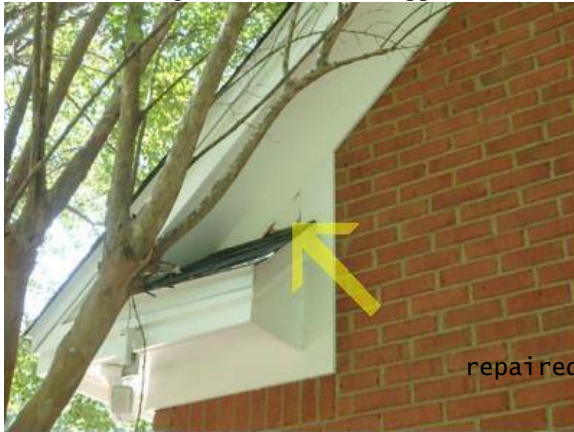
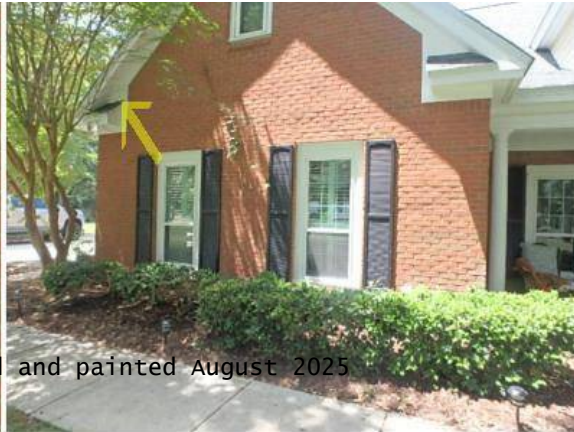
7. Rodent damage noted at the front upper trim here.

repaired and painted August 2025

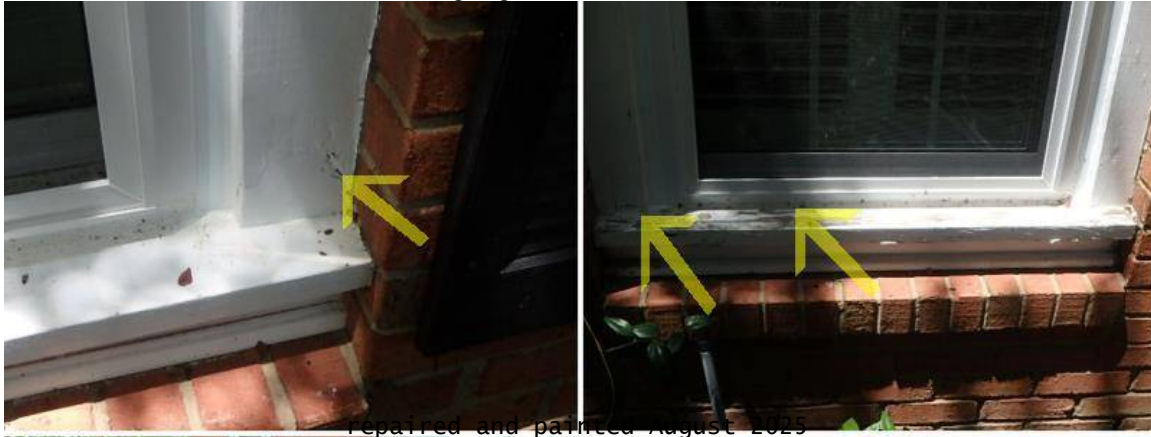
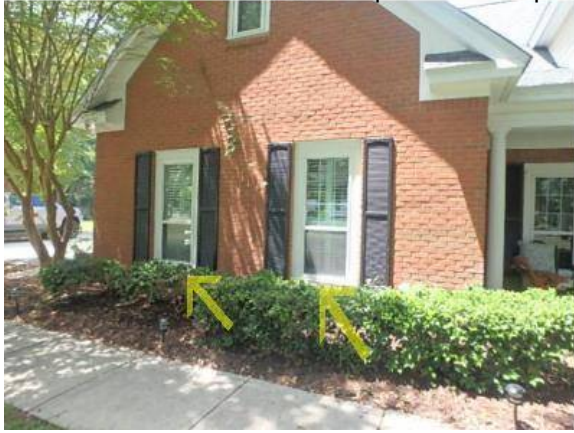
8. Rot and deterioration noted at the front garage window trims here.

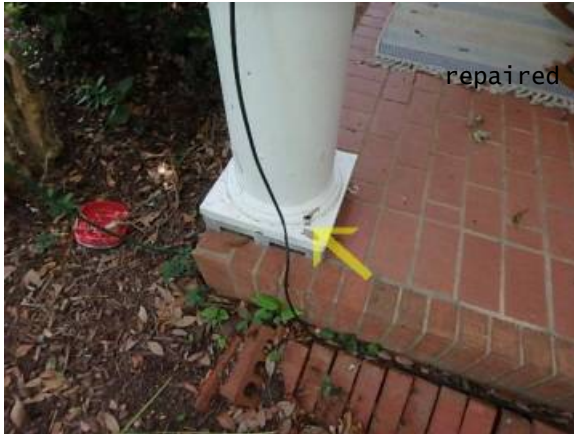
9. Deterioration / rot noted at the base of the front right porch column.

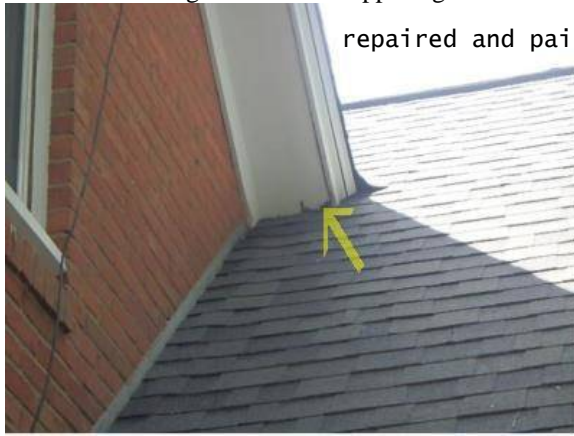
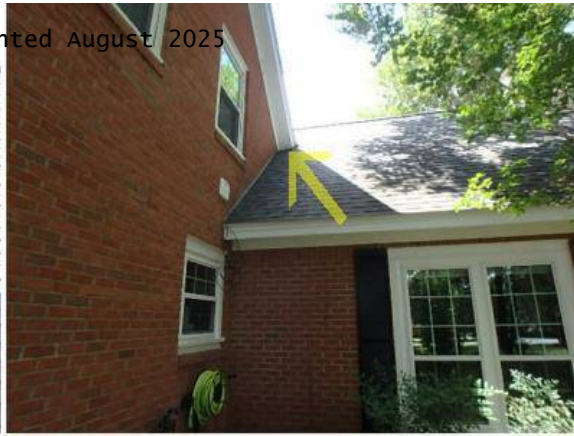
10. Rodent damage noted at the upper right side soffit trim here.

repaired and painted August 2025

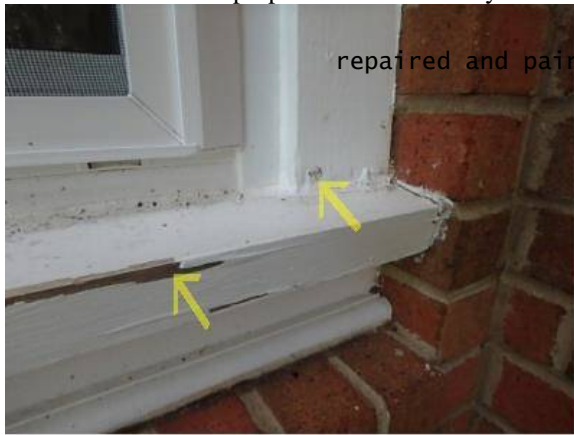
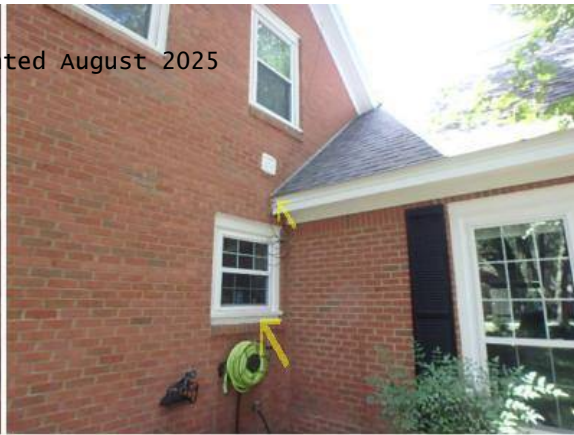
11. Rot and deterioration noted at the kitchen window trim here. Consider installation of proper diverter flashing at the intersection above to proper divert water away from the wall and window below.

repaired and painted August 2025

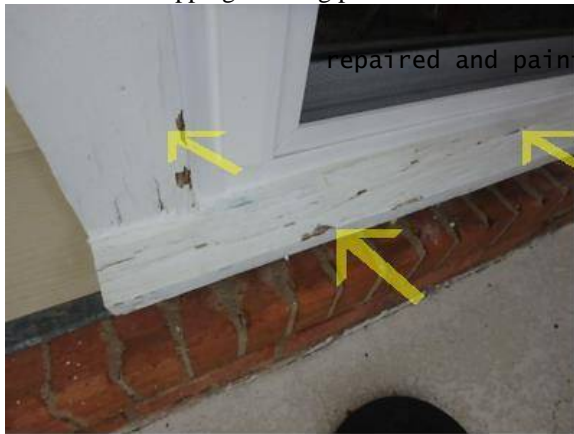
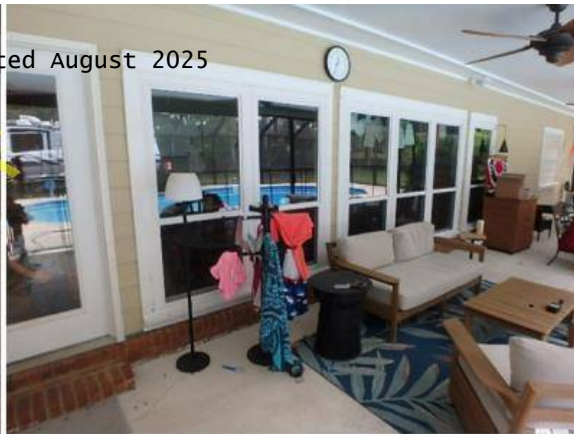
12. Areas of chipping / flaking paint noted at the rear window trims here.

repaired and painted August 2025

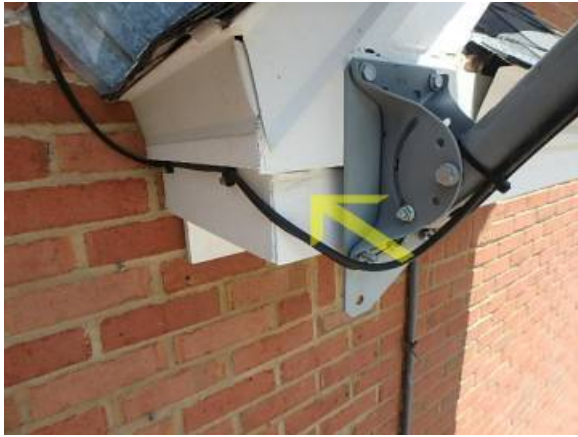
13. Wood rot noted at the right side fascia trim adjacent to the satellite dish attachment.

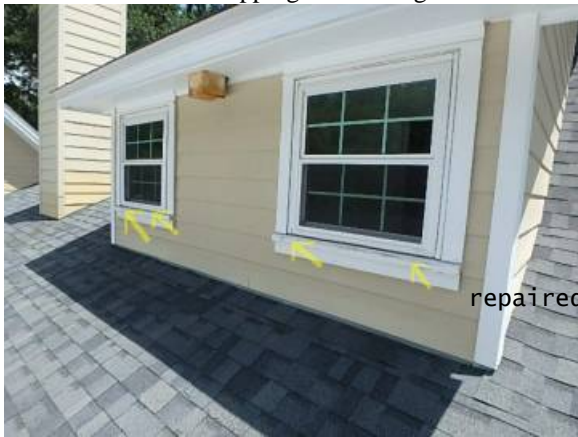
14. Deterioration / chipping and flaking noted at the rear upper window trims.

repaired and painted August 2025

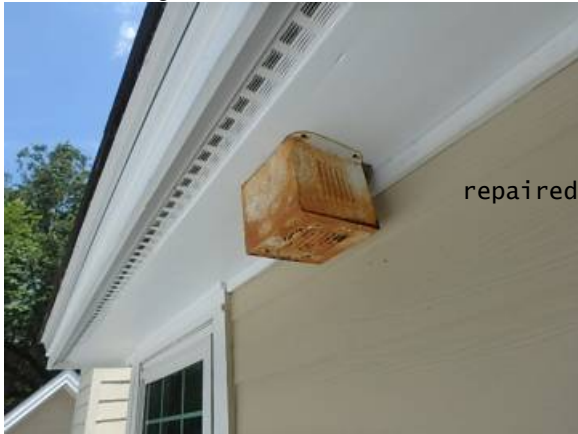
15. Rust damage noted at the exterior eave vent boxes. Representative picture.

repaired and painted August 2025

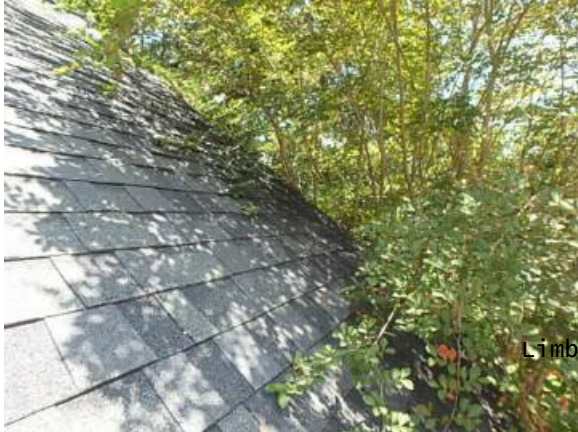
16. Recommend removing tree limbs from the roof to prevent damage.

Limbs trimmed August 2025

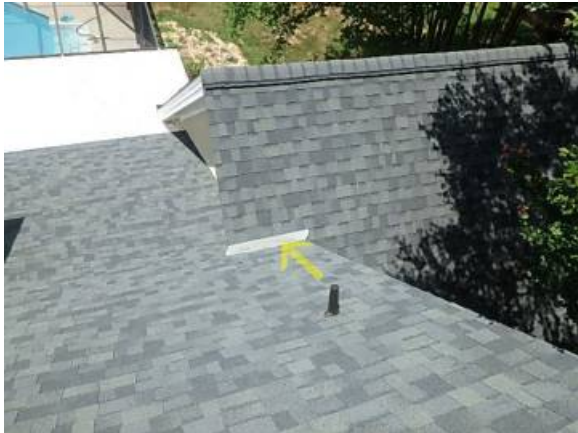
17. Recommend closely monitoring and maintaining the transition at the roof between the main house roof and the right side addition roof.

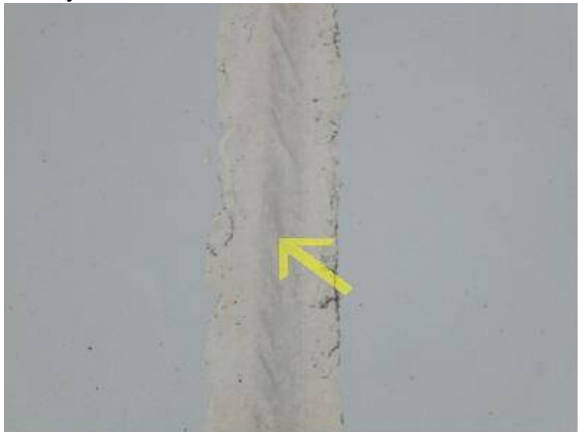
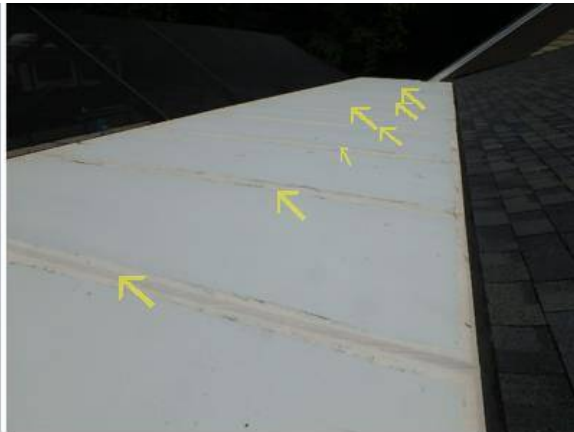
18. Raised areas of tape noted at the rear roof panel transitions. Transitions have sealant over the tape, however should be closely monitored and maintained.

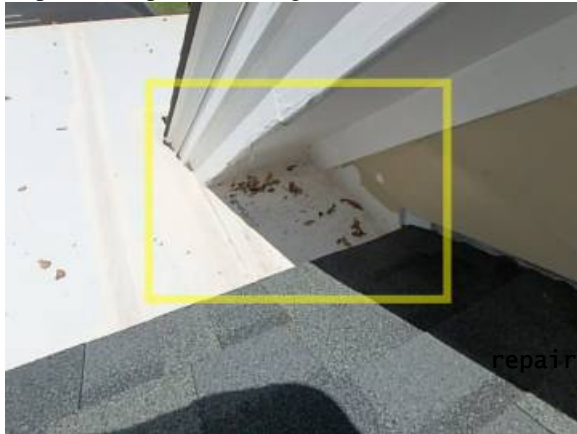
19. Recommend closely monitoring and maintaining the transition from the main roof and house wall to the rear porch low slope roof to prevent leakage.

repaired and painted August 2025

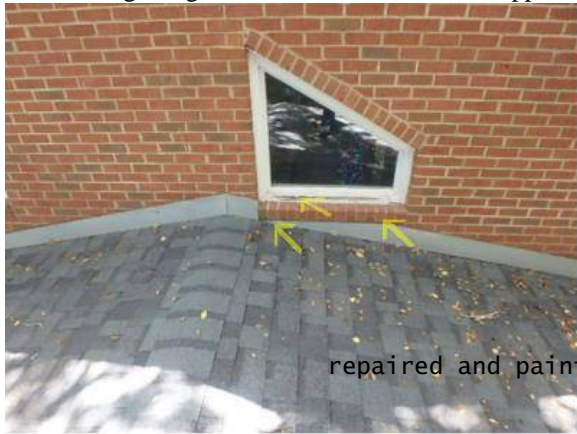
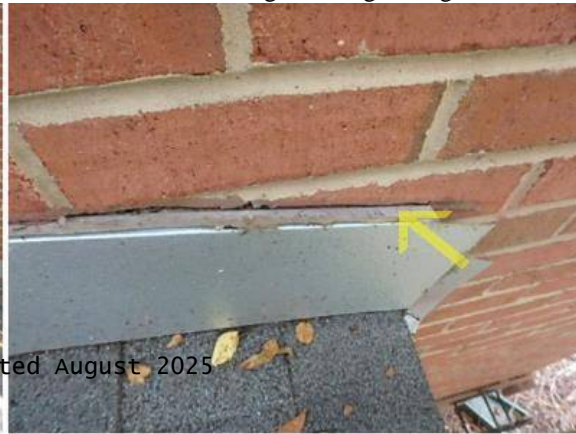
20. Flashing at right side shed roof transitions appears to be loose and/or failing allowing leakage to the roof decking below.

repaired and painted August 2025

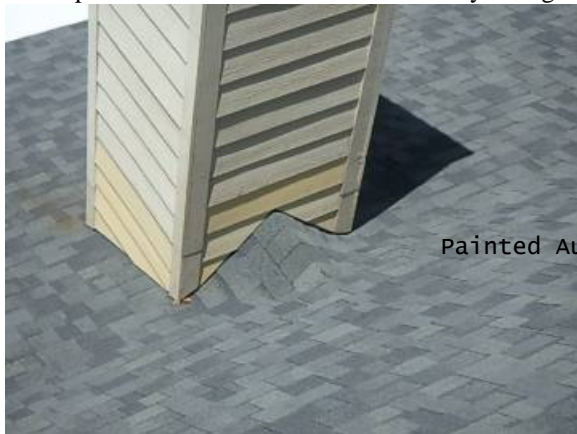
21. Repairs noted at the main house chimney siding and trim. Siding and trim has not been painted.

Painted August 2025

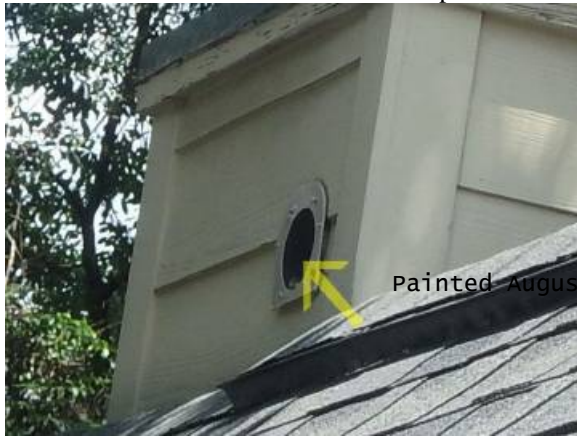
22. The fresh air return vent termination piece is missing at the right side chimney above the roof level.

Painted August 2025

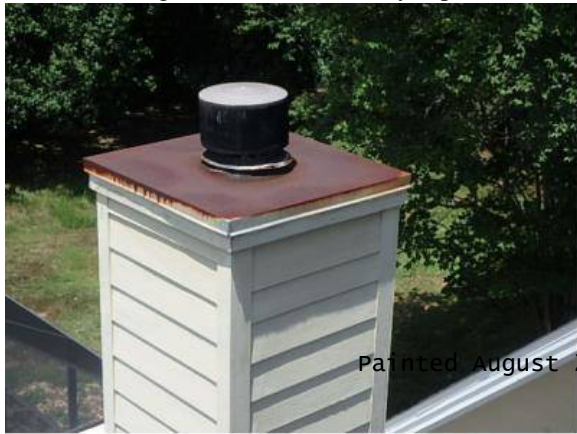
23. Rust damage noted at the chimney caps of both chimneys.

Painted August 2025

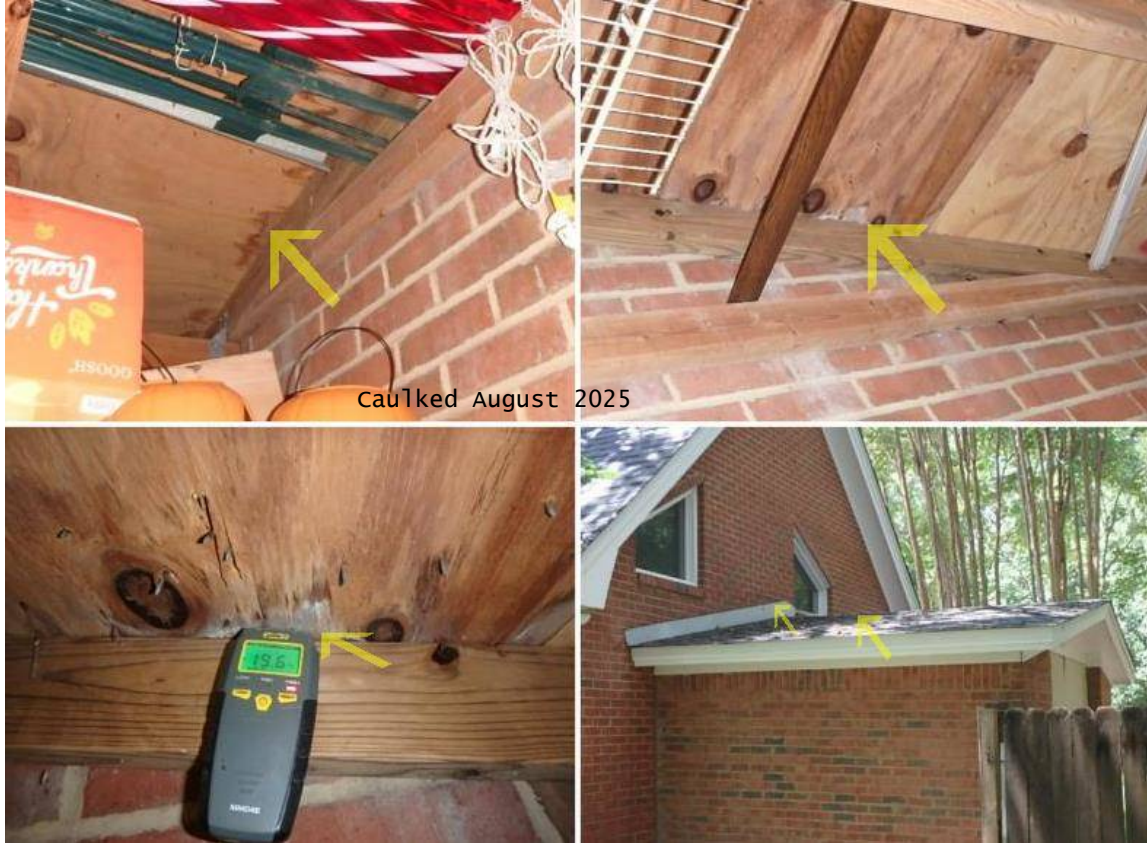
24. Moisture staining and evidence of leakage noted at the roof decking in the right side shed addition area. Flashing at roof to wall intersection appears to be failing allowing leakage. Stains tested for elevated moisture at time of inspection.

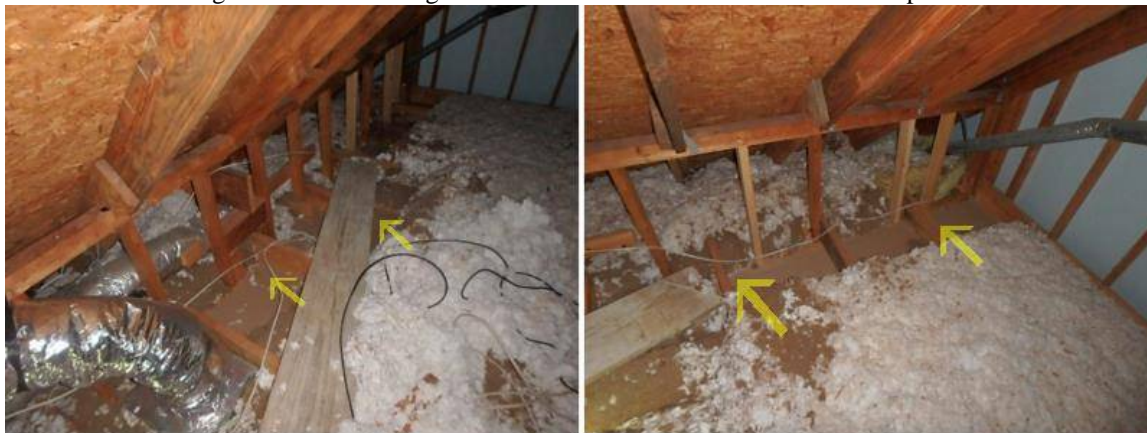
25. Areas of missing or disturbed ceiling insulation noted in the Attic area over the upstairs.

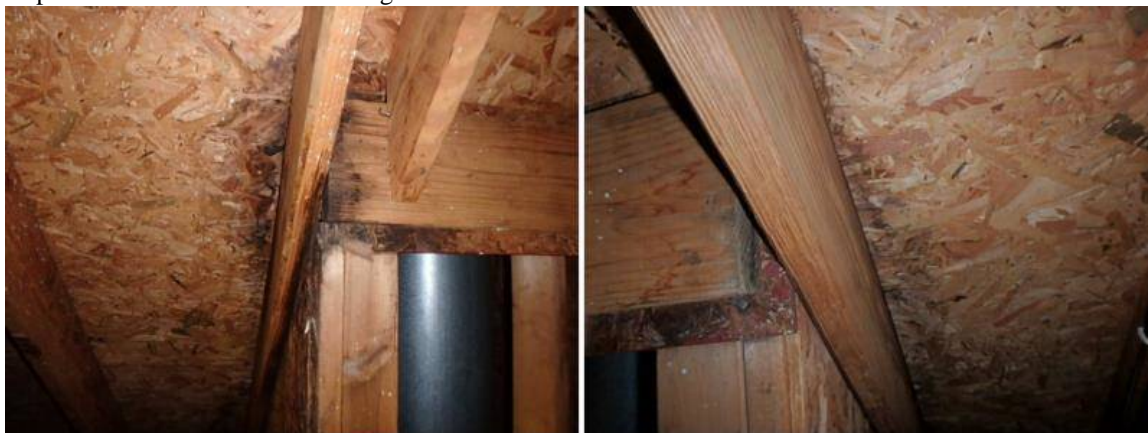
26. Moisture staining / rot noted at the roof decking around the main house chimney. Damaged areas tested dry at time of inspection. Recommend monitoring.

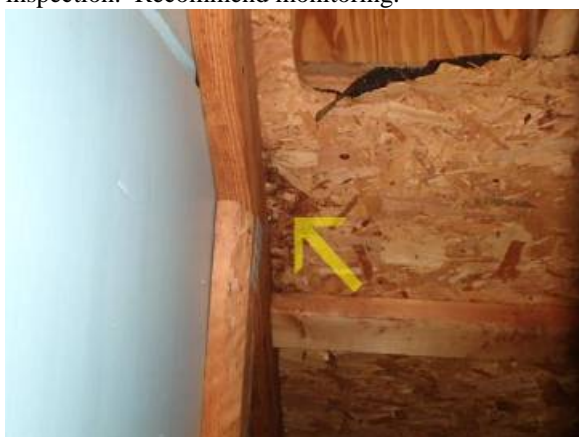
27. Moisture staining / rot noted at the roof decking around the addition area chimney. Damaged areas tested dry at time of inspection. Recommend monitoring.

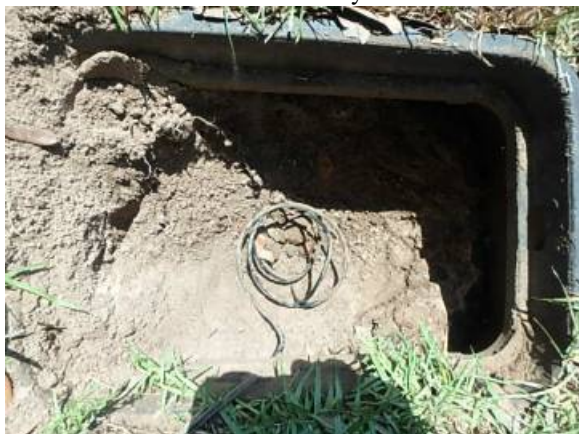
28. The water meter in the front yard should be cleaned of all debris to expose the main water shut off valve to the house.

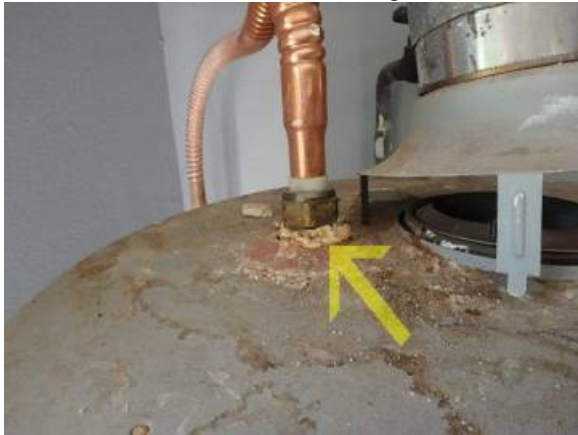
30. Corrosion and evidence of leakage noted at the hot water supply connection at the top of the water heater.

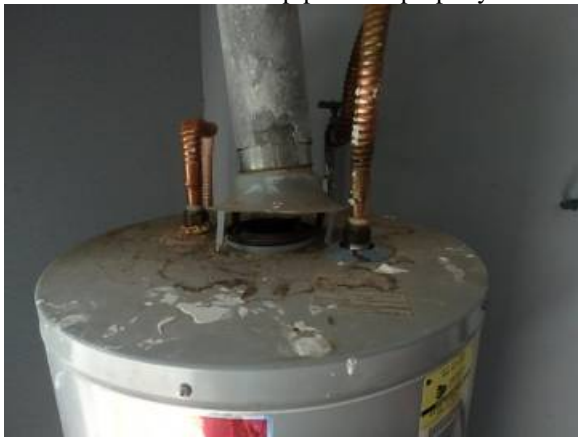
31. The water heater vent pipe is not properly secured at the top of the tank.

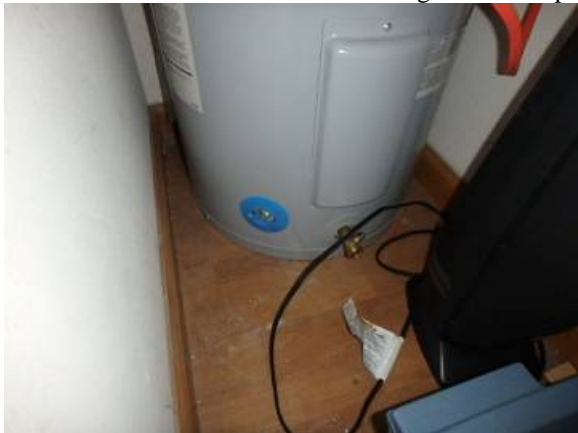
32. FYI: The water heater is not resting inside of a pan. A pan under the unit is recommended.

Completed July 2025

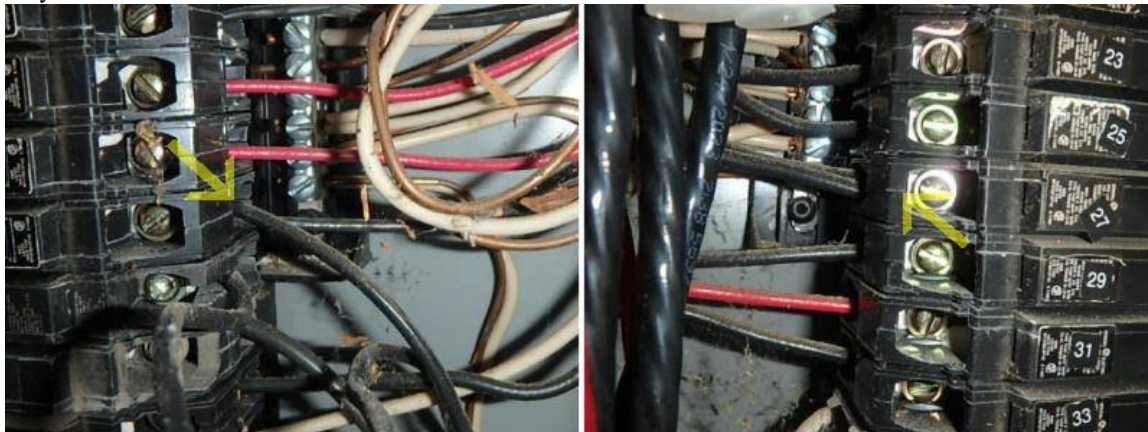
36. Multiple wires are connected to a single lug on a circuit breaker (2 locations in right side panel) in the electrical panel where only one wire should be connected.

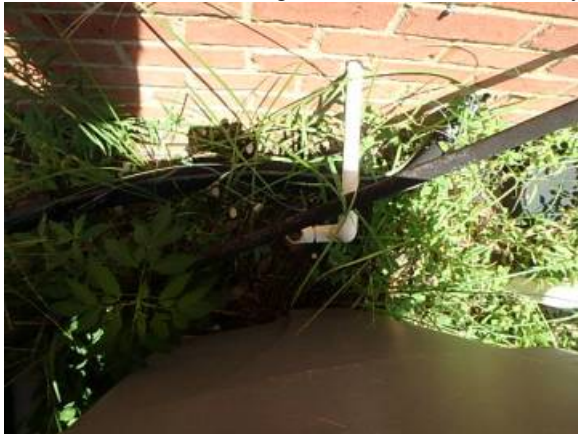
39. Recommend extending the condensation line away from the foundation.

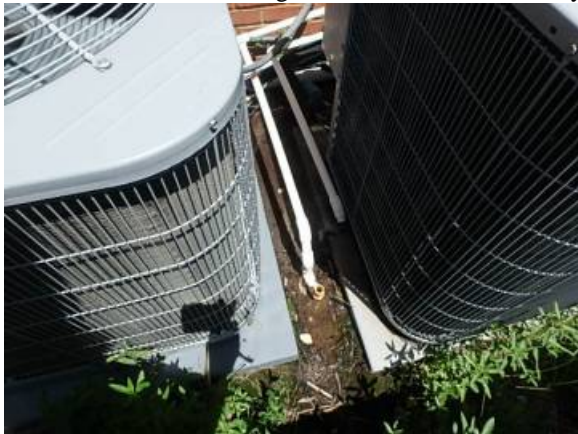
40. Recommend extending the condensation line away from the foundation.

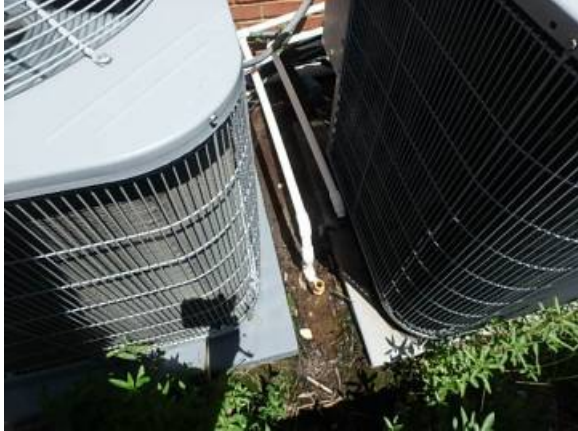
41. Recommend extending the condensation line away from the foundation.

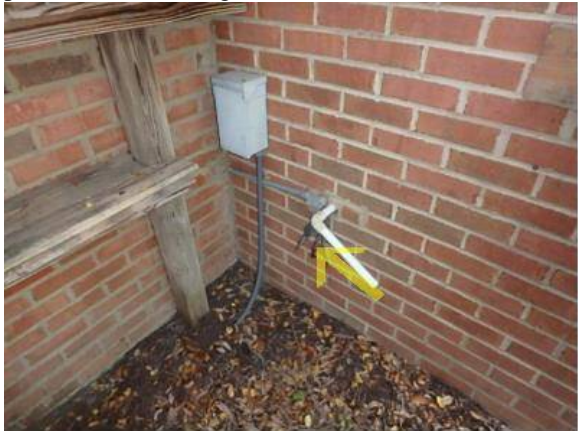
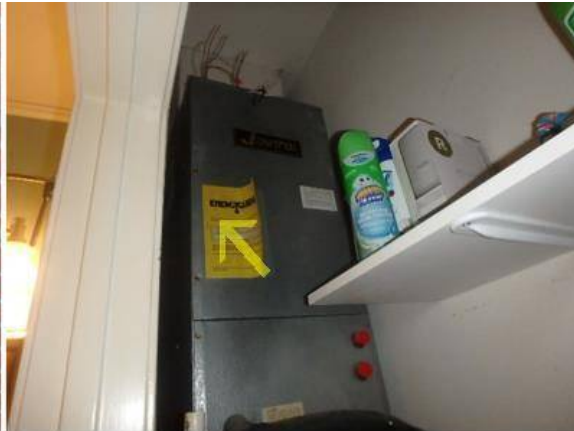
42. This system is not active / operational. The compressor unit for this system has been removed. No conditioned air supply present to the rear right addition area.

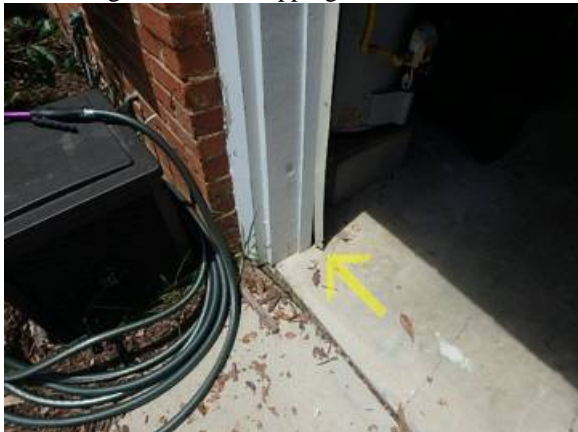
43. Damaged weather stripping noted at the base of the garage door.

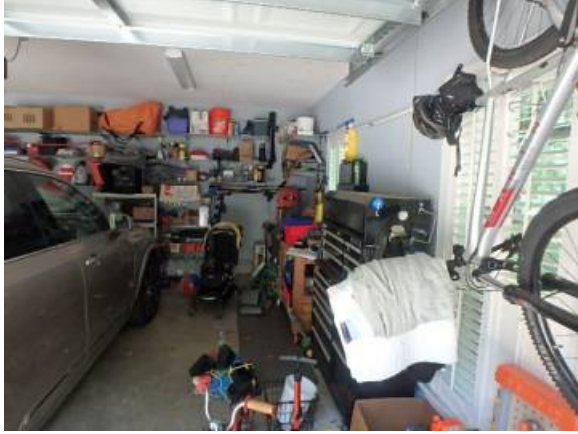
44. Stored items restrict viewing of the garage area; recommend performing a careful walk through inspection prior to closing.

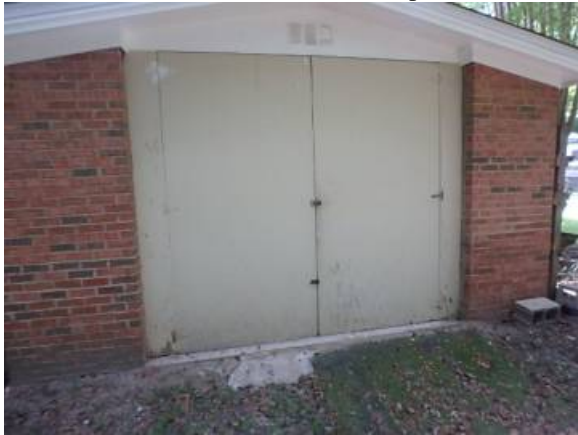
45. General deterioration noted at the paint / finish of the right side exterior shed door.

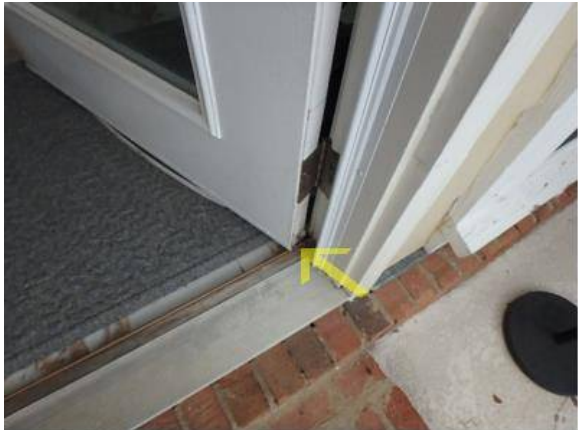
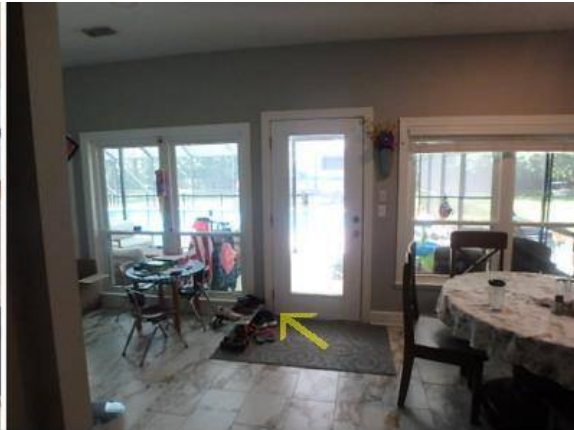
46. Rot noted at the base of the rear exterior door core.

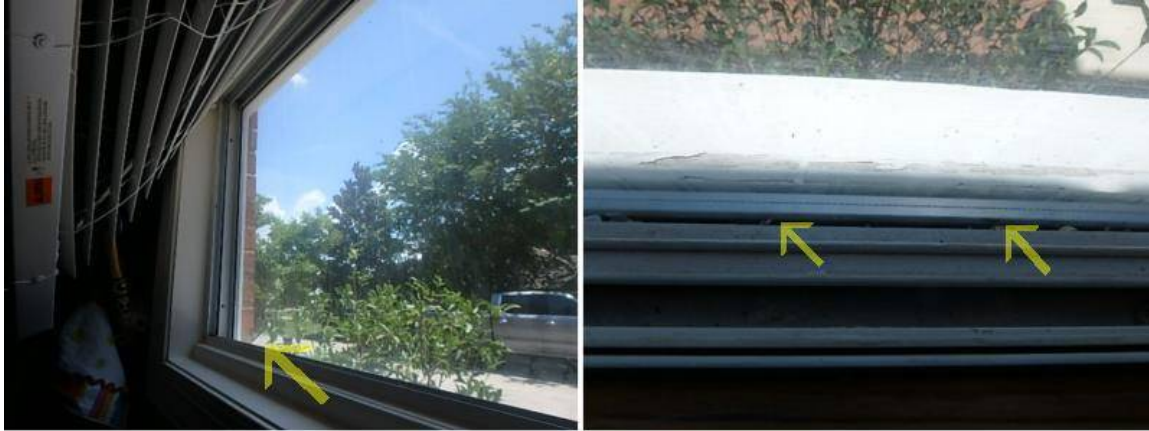
47. Improper type window or installation noted in the downstairs left side bedroom closet. Openings visible from the inside to the exterior at the bottom of the window track / weep holes.

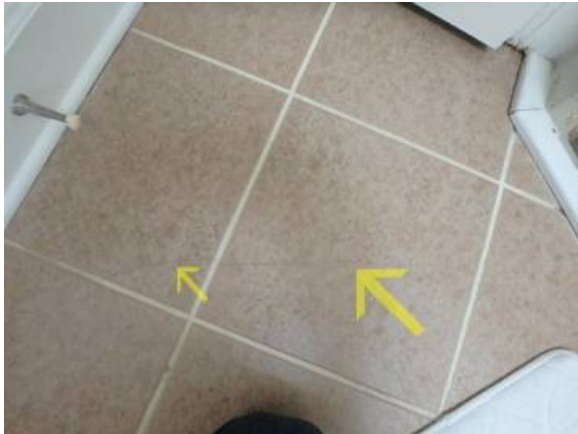
49. Cracked tiles noted in the downstairs left side bedroom bathroom.

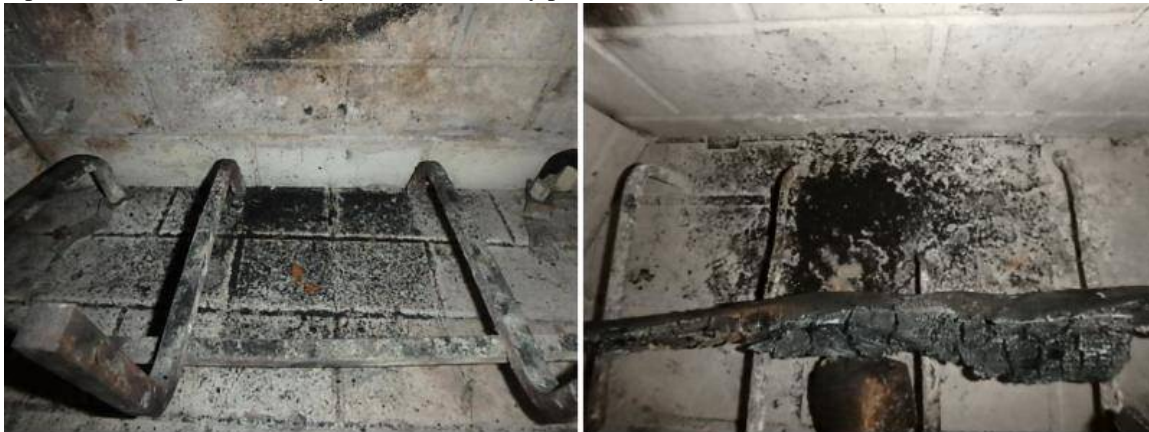
50. Both fireplaces have damaged / cracked fire brick panels. Chimneys appear "dirty". Recommend further evaluation and repairs / cleaning as needed by a licensed chimney professional.

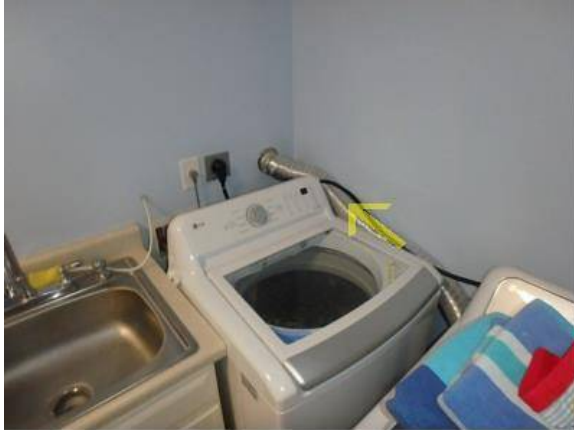
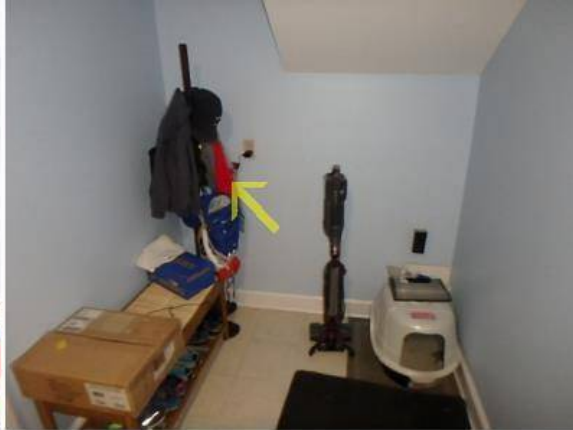
52. The laundry equipment plumbing locations causes a conflict with the vent pipe in relation to the washing machine. The original laundry location is across the room, however the plumbing lines do not appear to be active.

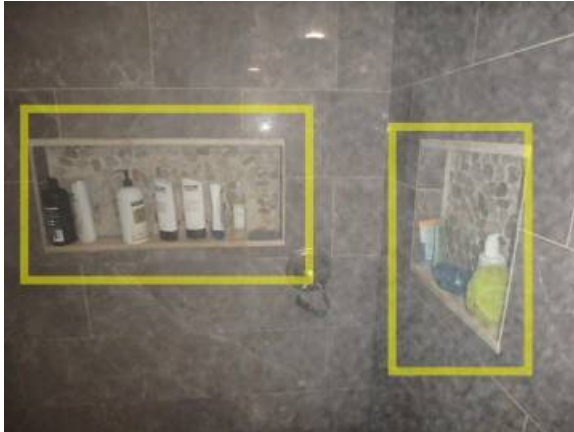
53. Recommend regular maintenance and sealing of soap shelf transitions in shower area to prevent moisture intrusion behind the tile into the wall cavity.

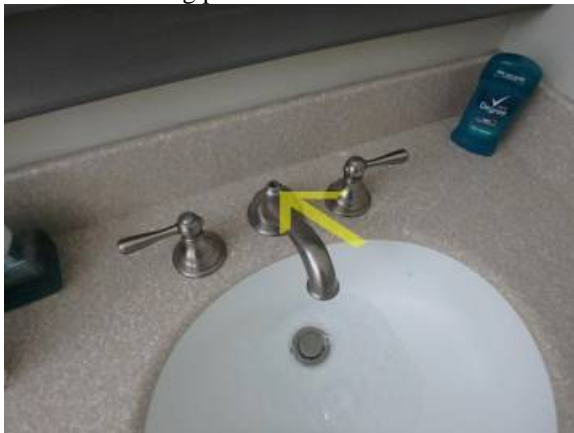
55. The following problems were noted at the sink: drain stopper is inoperable at sink.

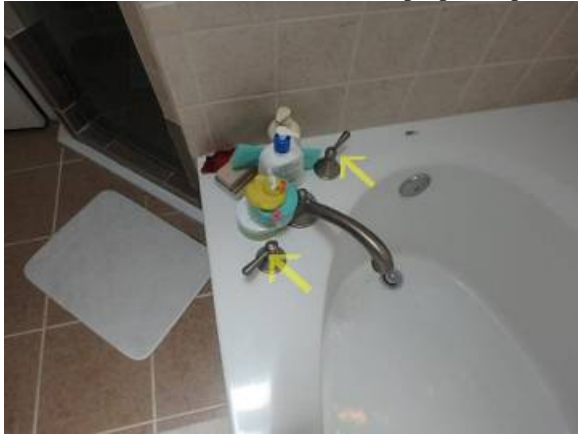
56. Tub faucet handles do not have a proper stop and will spend 360°.

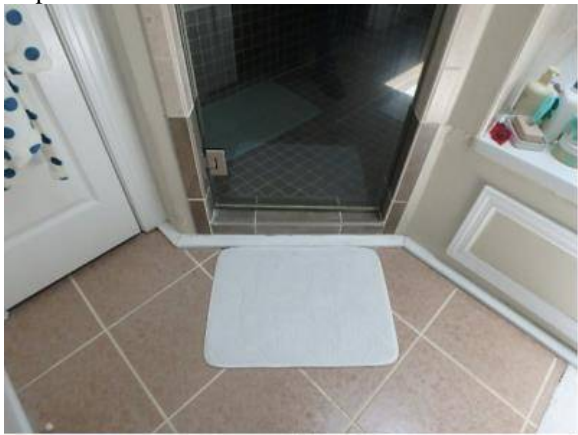
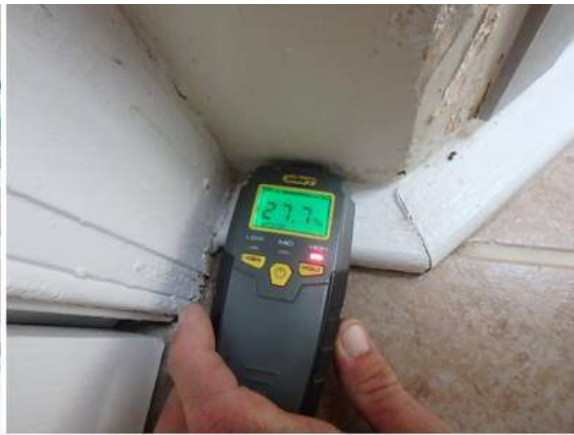
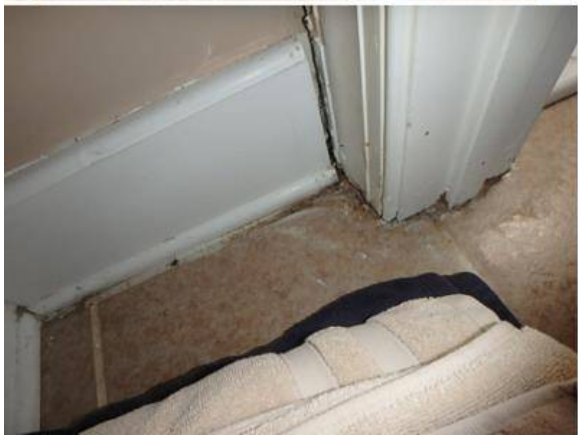
57. Moisture staining and damage noted at the base of the walls adjacent to the shower. Areas tested high in moisture at time of inspection.

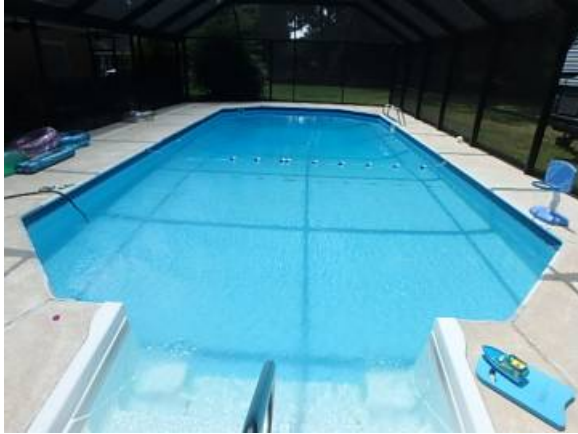
58. Appearance is marginal. Vinyl liner appears to be faded. Liner appears to be nearing the end of its life expectancy.

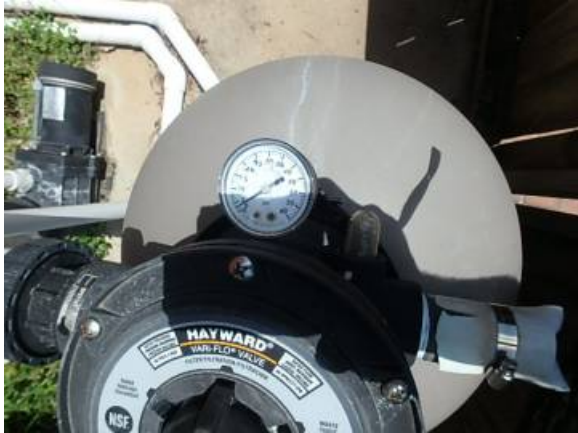
59. Pool pressure gauge is inoperative and needs replacement.

Not broken. Requested Letter.
