# INSPECTION REPORT

For the Property at:  
**12 TYLER DRIVE, SHADY ACRES**  
KEENE, ON

RE: Report No. 4561  
12 Tyler Drive, Shady Acres  
Keene, ON

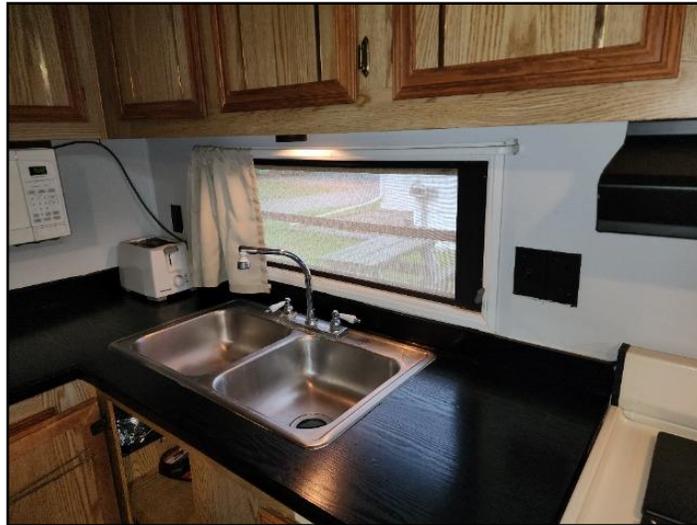
**4. Condition:** • No GFCI/GFI (Ground Fault Circuit Interrupter)

Although not a deficiency in a home of this age, safety may be improved by upgrading these receptacles.

**Implication(s):** Electric shock

**Location:** Kitchen

5. No GFCI/GFI (Ground Fault Circuit...

Although not a deficiency in a home of this age, safety may be improved by upgrading these receptacles.

**Task:** Upgrade

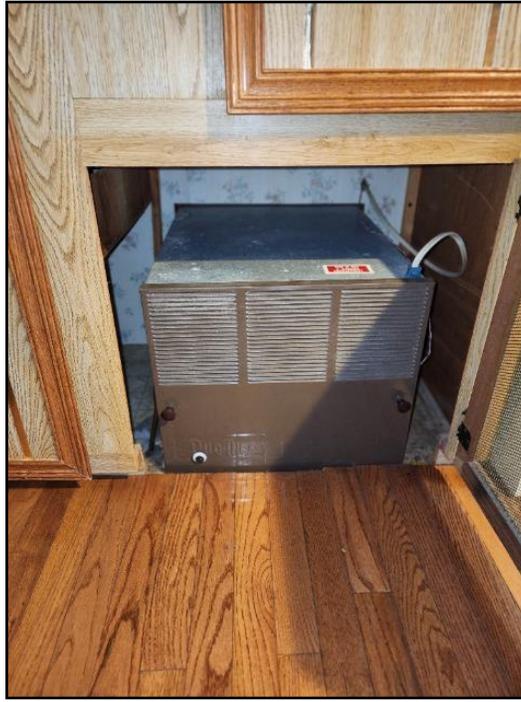
6. Furnace

**Approximate age:** • 36 years

**Typical life expectancy:** • Furnace (conventional or mid-efficiency) 18 to 25 years

**Failure probability:** • High

**5. Condition:** • Past life expectancy

**Implication(s):** Equipment failure | No heat for building

**Task:** Monitor

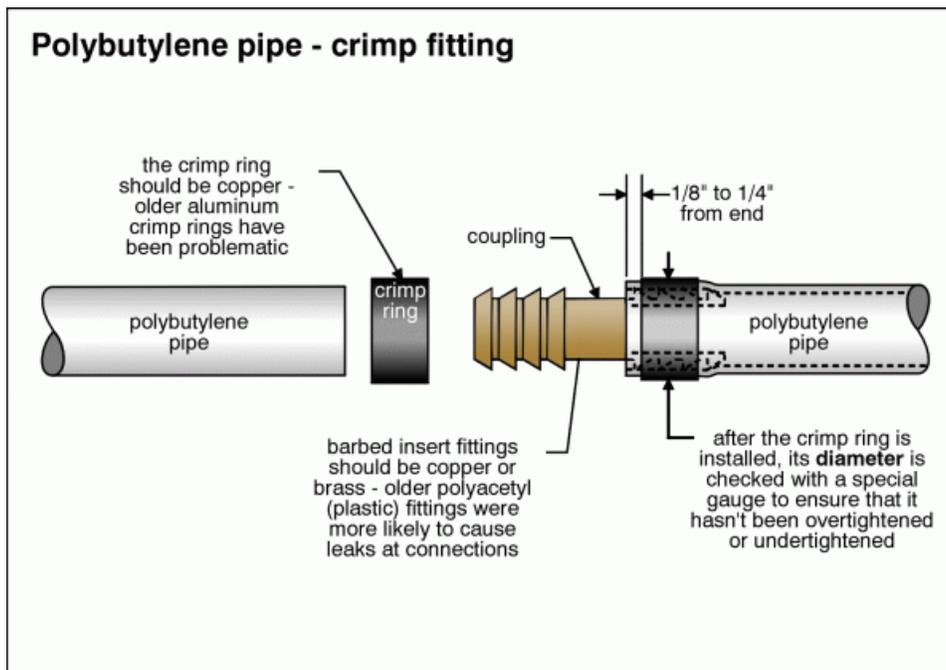
**7. Condition:** • Polybutylene

**Implication(s):** Chance of water damage to structure, finishes and contents | Leakage

**Task:** Monitor

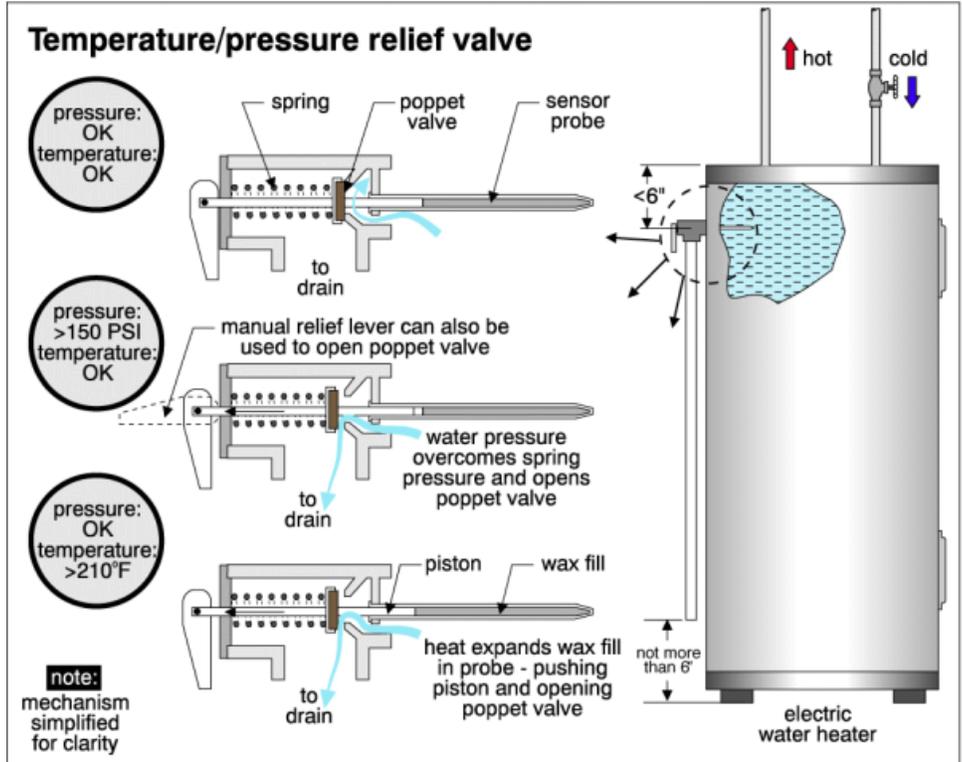
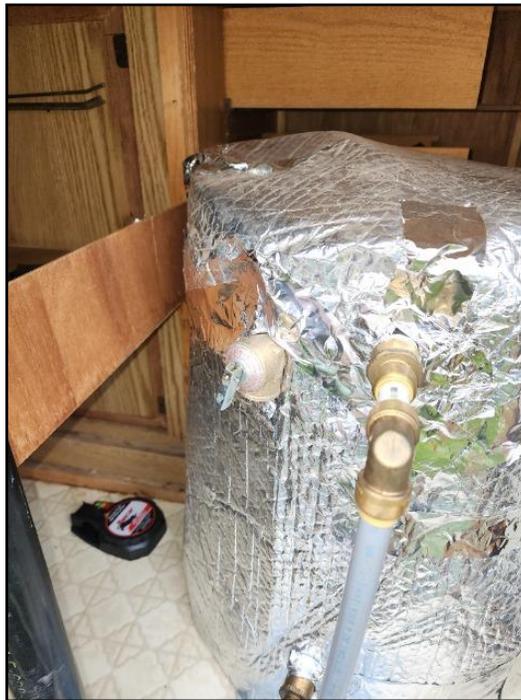
**8. Condition:** • Discharge tube missing

**Implication(s):** Scalding. Possible water damage to finishes, storage and structure

9. Discharge tube missing

**Task:** Provide

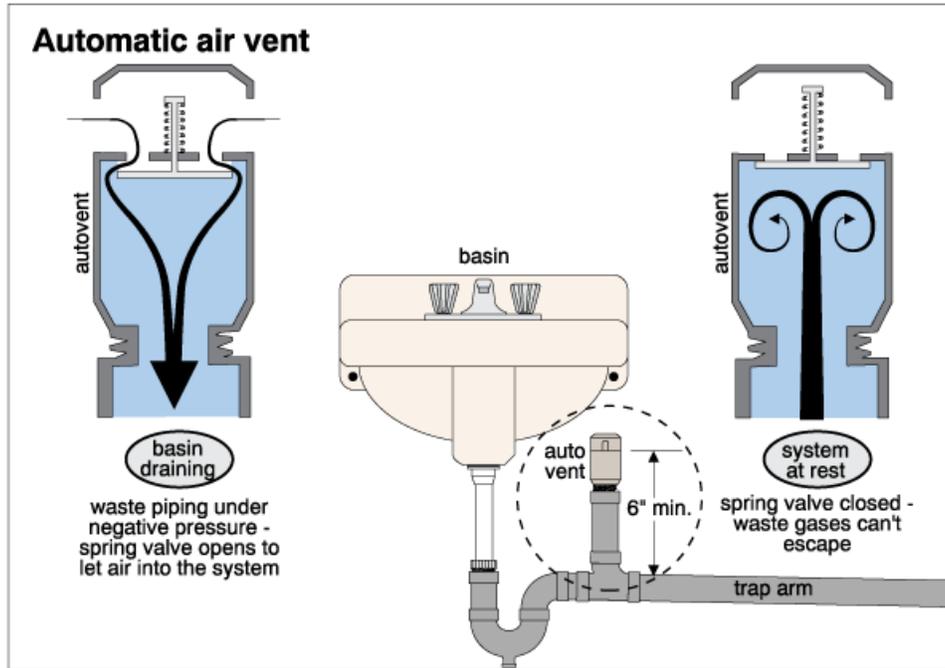
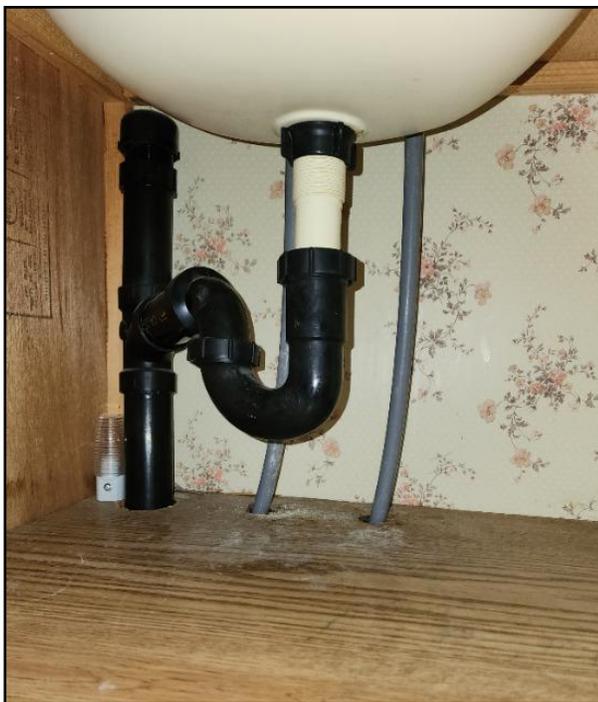
9. Condition: • Automatic air vents

**Implication(s):** Failure may allow sewer gasses to enter building

10. Automatic air vents

**Task:** Monitor
