Hanna Home Inspection

Home Inspection Report

935 Langlois, Windsor, ON

Inspection prepared for: Alfonso Teshuba
Date of Inspection: 9/8/2024

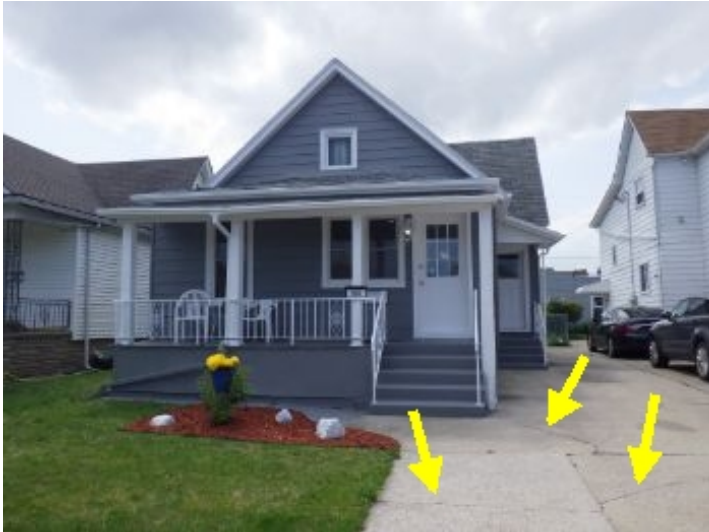
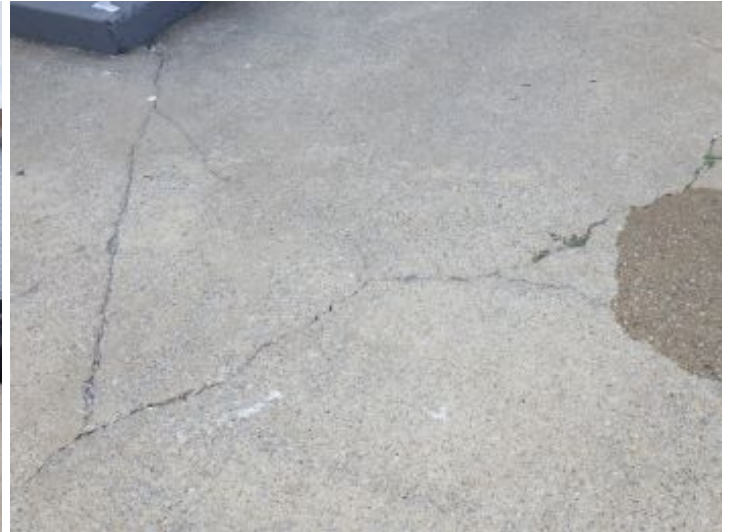
1. Driveway Condition

- Common cracks noted.

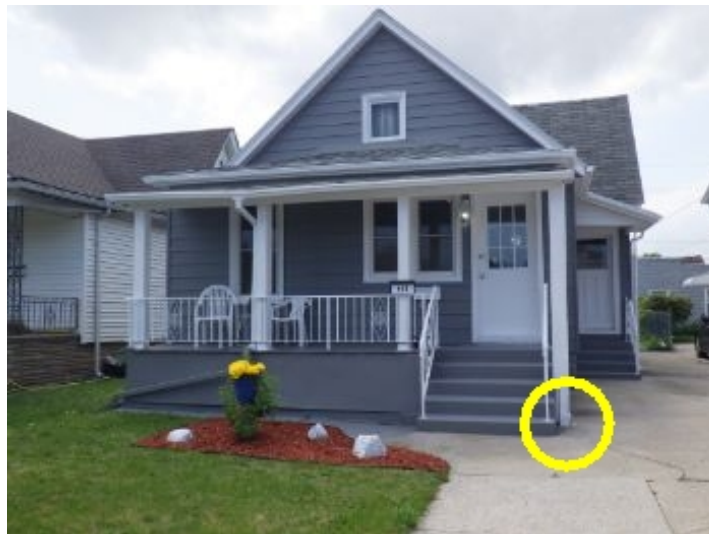
13. Porch Condition

- Suggest protecting the wood post from rain water and snow to prevent premature rot.

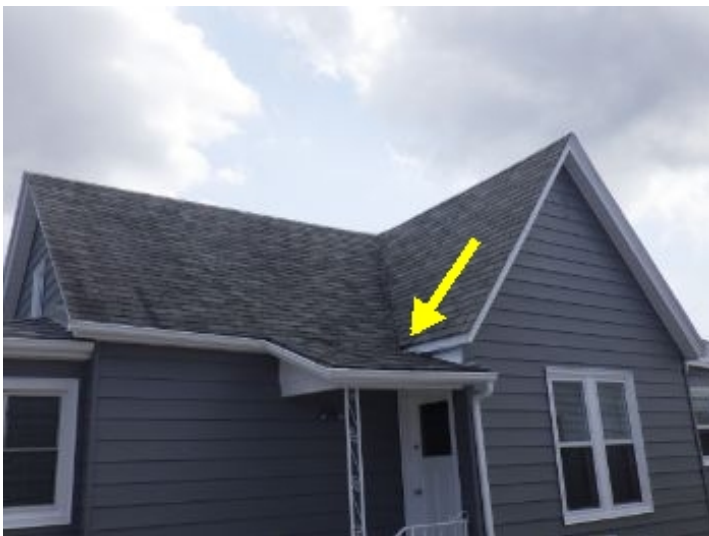
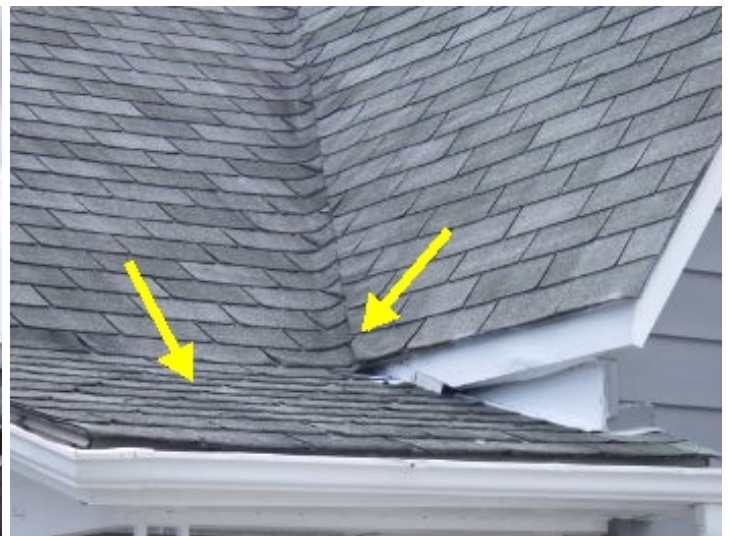
3. Roof Surface Conditions

- Curling seams.(Front section only)
- Roof shows normal wear for its age and type. No damaged, deteriorated, or missing roofing materials were observed; it appears to be in serviceable condition.

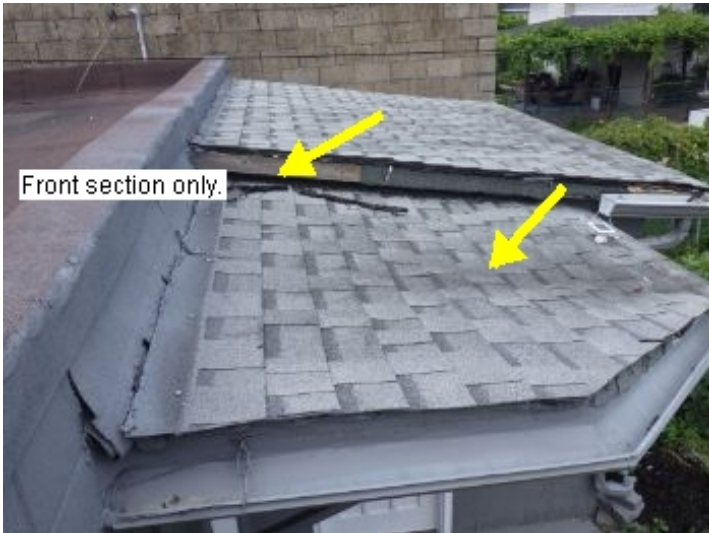
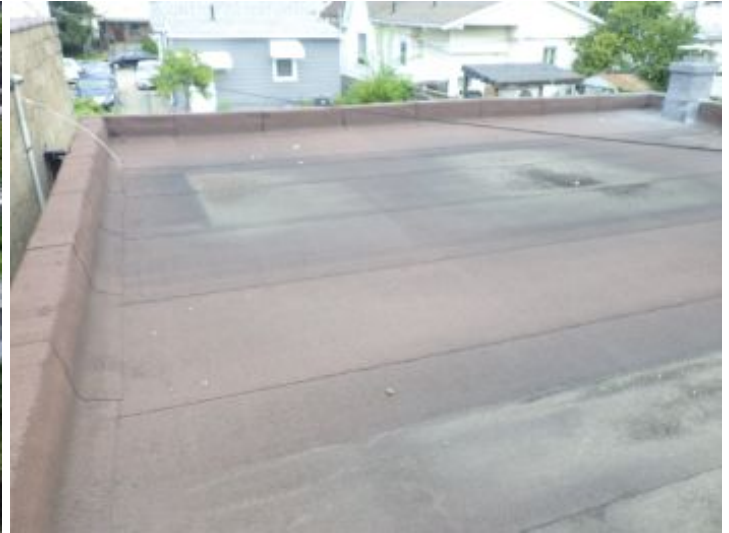
1. Garage Roof Condition

- Roof shows normal wear for its age and type.
- Surface cracking observed.
- **The roof is statistically at or near the end of its useful life.**

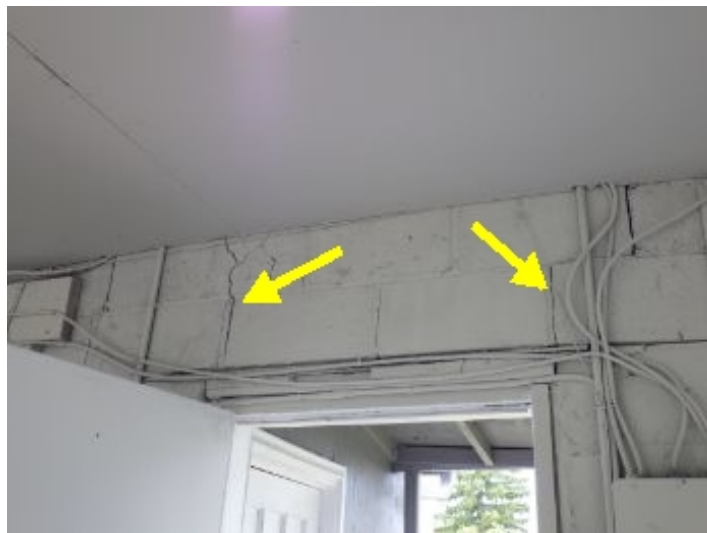
2. Garage Wall Condition

- Dry at the time of the inspection.
- Common cracks noted.

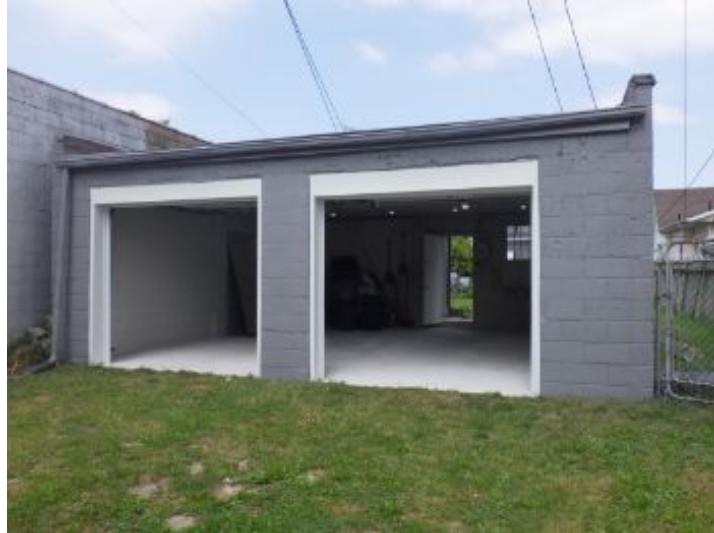
3. Garage Comments

- Limited inspection due to storage of personal property.

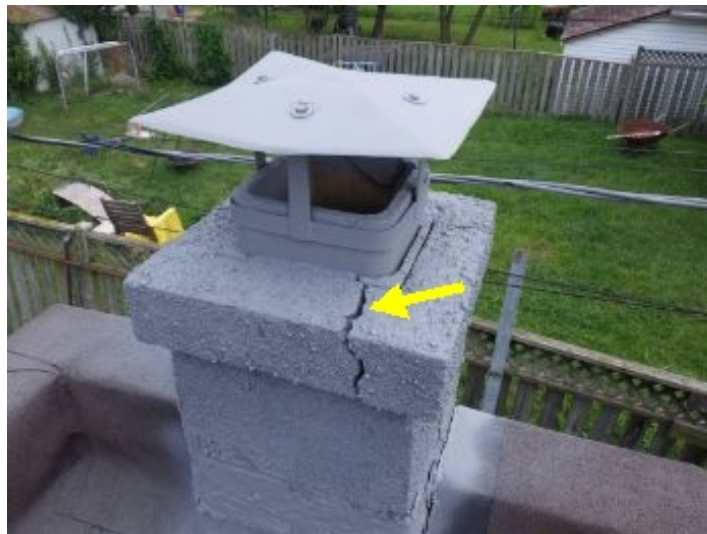
1. Chimney Condition

- Brick and mortar deterioration observed; repair advised.

- Suggest rebuilding weather cap (chimney crown) to reduce opportunity for water infiltration and damage. This is a common maintenance item that is often neglected by homeowners; you should make a crown inspection part of your routine seasonal maintenance checklist.

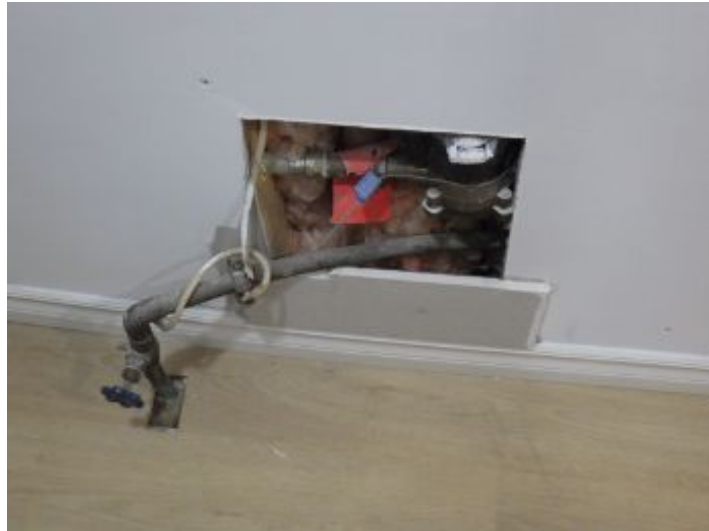
1. Main Shutoff Location

- Basement front area. Ground wire in place. Compliant 3/4" copper supply line.
- Since main shutoff valves are operated infrequently, it is not unusual for them to become frozen over time. They often leak or break when operated after a period of inactivity. For this reason main shutoff valves are not tested during a home inspection. We suggest caution when operating shutoffs that have not been turned for a long period of time. All shutoff valves and angle stops should be turned regularly to ensure free movement in case of emergency.
- Basement closet.

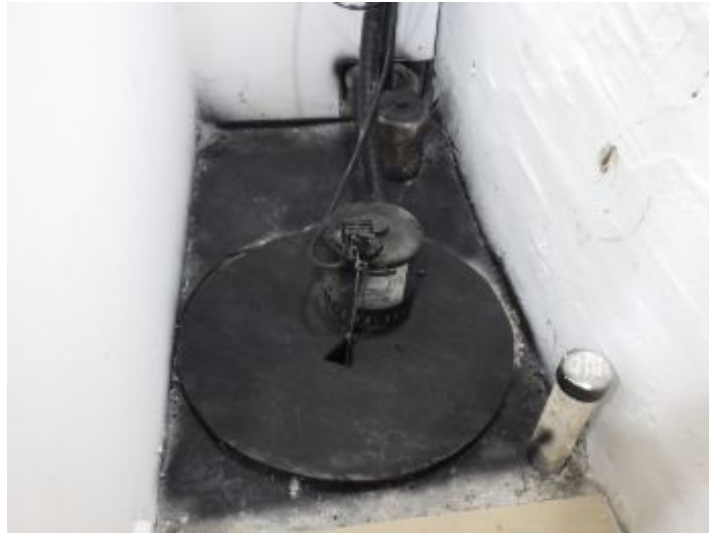
6. Sump Pump Plumbing

- Check valve present

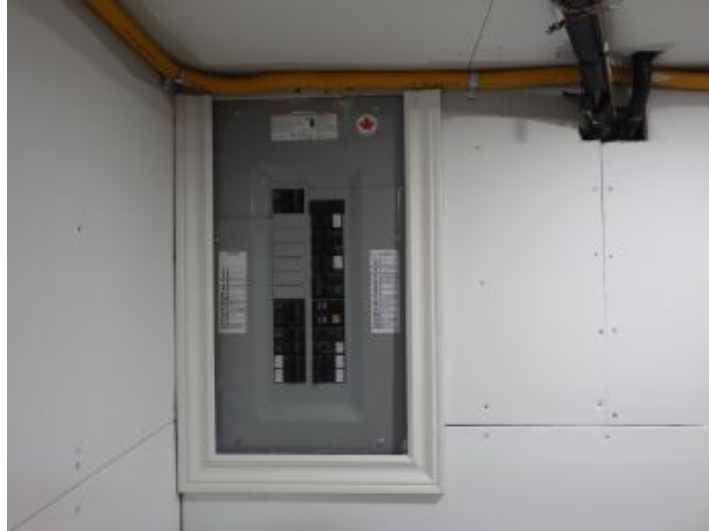
1. Electrical panel Condition

- Overload protection provided by breakers.
- The main service is approximately 100 amps, 240 volts.

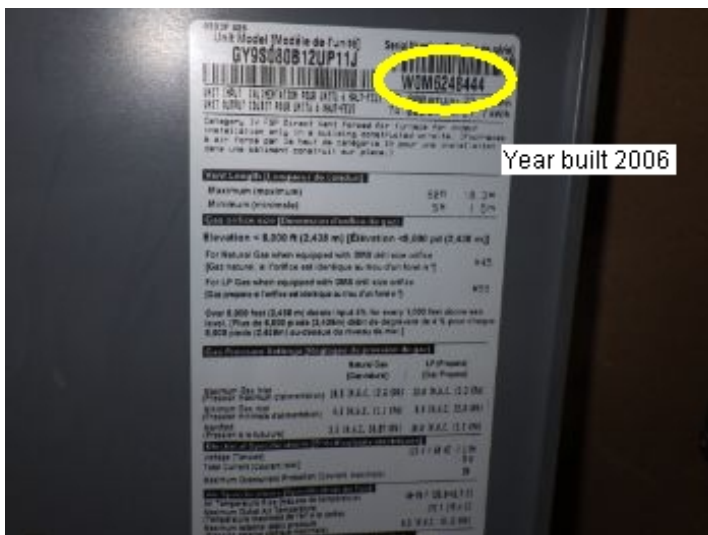
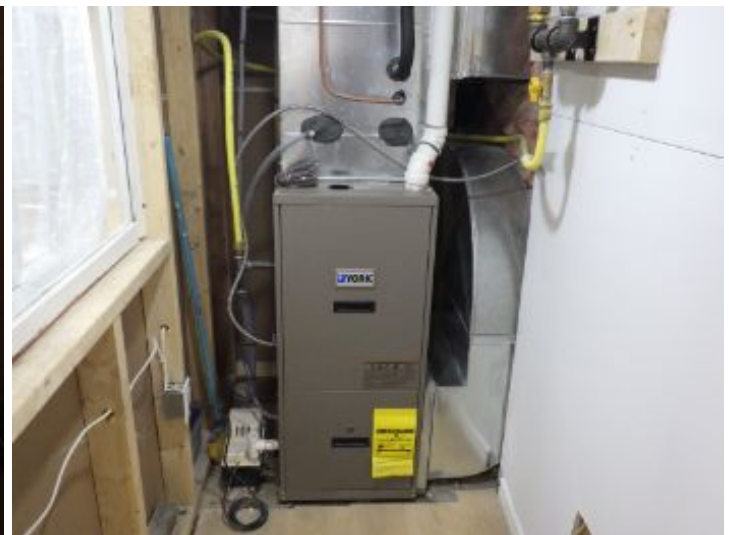
3. Heating Comments

- Relatively new high efficiency furnace in place.
- Due to the higher efficiency of this unit, this review is limited. Most areas are sealed and inaccessible. We suggest review by a licensed heating contractor if a more detailed review is desired.

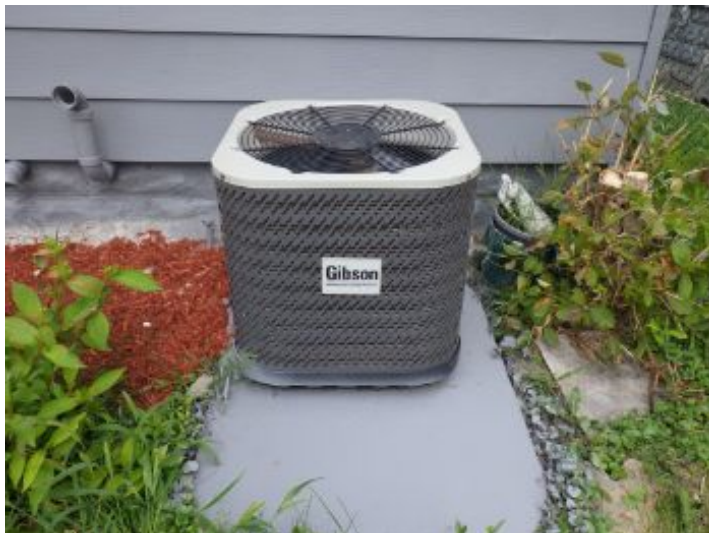
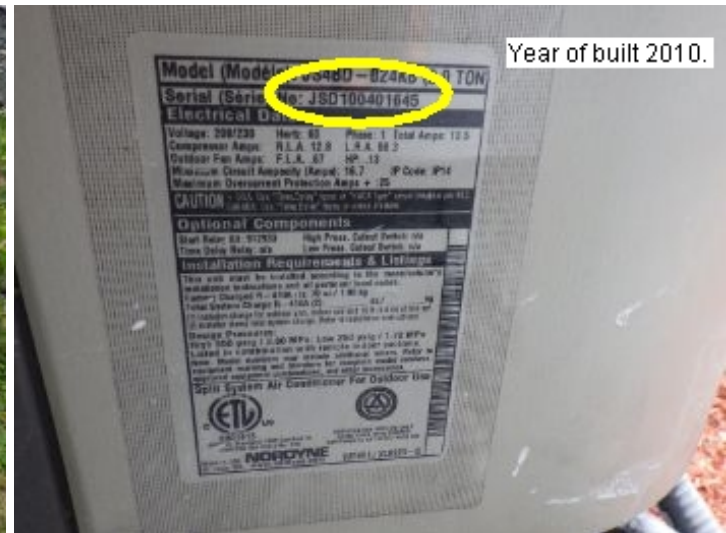
1. Air Conditioning Comments

- Air conditioning operational during inspection and appeared to be performing satisfactorily. Buyer is advised to verify satisfactory operation prior to close.
- Vegetation should be trimmed from around the condenser unit to allow adequate ventilation for proper cooling.
- **Coils are dirty or full of debris, suggest cleaning coils regularly for proper operation.**

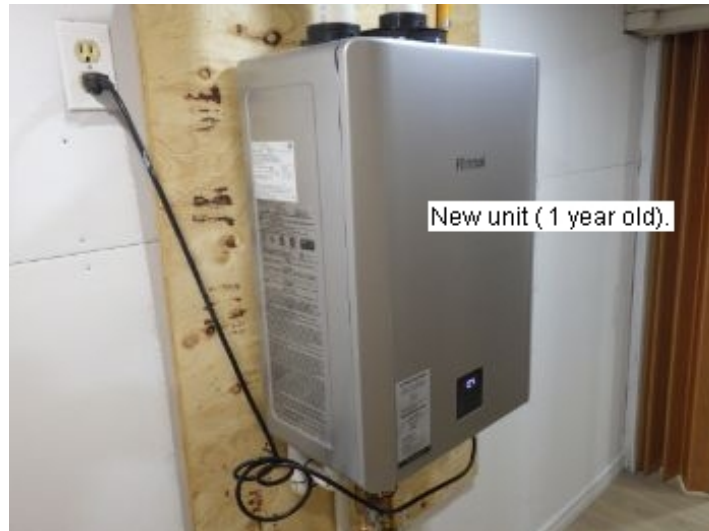
4. Water Heater Comments

- Children should be kept away from water heater as the high pressure release valve, if disturbed, can cause scalding.
- Serviceable at time of inspection. No warranties can be offered on this or any other appliance.
