STRUCTURAL CONDOMINIUM EVALUATION

**946 BAY ROAD, UNIT #2
HAMILTON, MA 01982**

November 14, 2016

Re: 946 Bay Road, Unit #2
Hamilton, MA 01982

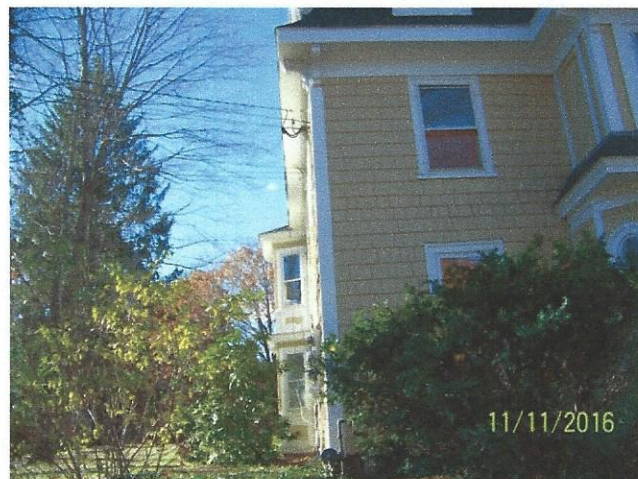
Because of its age, the home appears to be slightly out of plumb vertically at the left front exterior corner as one views the building from the front yard.

The apparent lack of vertical "plum" at the front left exterior corner of the dwelling and the apparent bulge in the second floor sidewall on the right side of the dwelling are both deficiencies, however not surprising for a dwelling of the vintage.

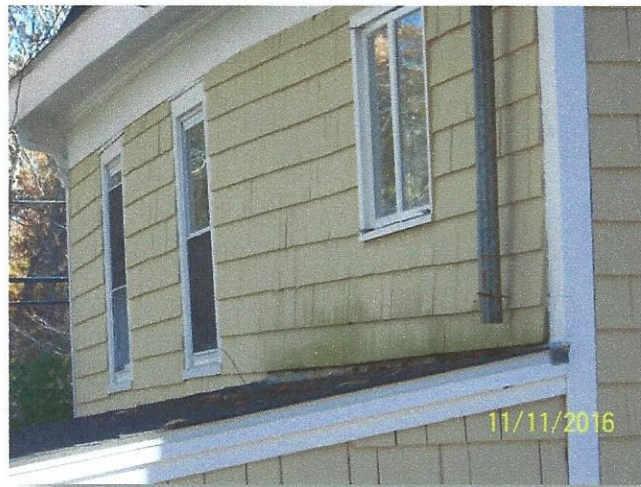
Additionally, there appears to be slight bulge on the right elevation wall at the lower portion of the second floor. Both of these issues are neither unusual nor unexpected for a three (3) story wood framed dwelling that is 176 years old.

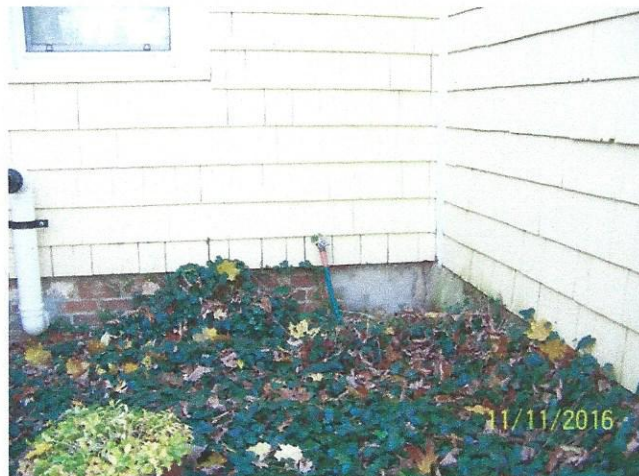
The exterior foundation where visible, consists of brick which is attached to the top of a stone foundation wall that is visible in the basement of the dwelling. It has been patched in one area along the right side of the dwelling near the gas vents.

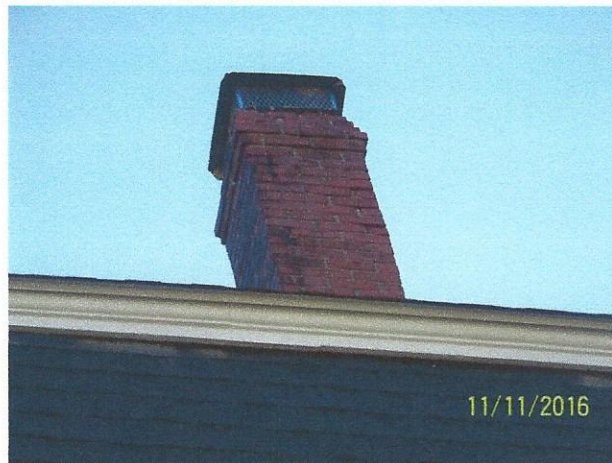
There are two (2) chimneys on the dwelling one of which requires some attention. The severe climatic conditions in New England cause deterioration of masonry and mortar over time. Cyclic freeze thaw activity cause moisture to freeze during the winter months. As the moisture freezes it expands which expands cracks in the mortar and brick masonry. Over time, the bricks become dislodged and occasional fall away. This is a very common occurrence in New England. There appears to be the beginning of mortar joint washout which will eventually require that each chimney be pointed in the near future in order to preclude further weather deterioration.

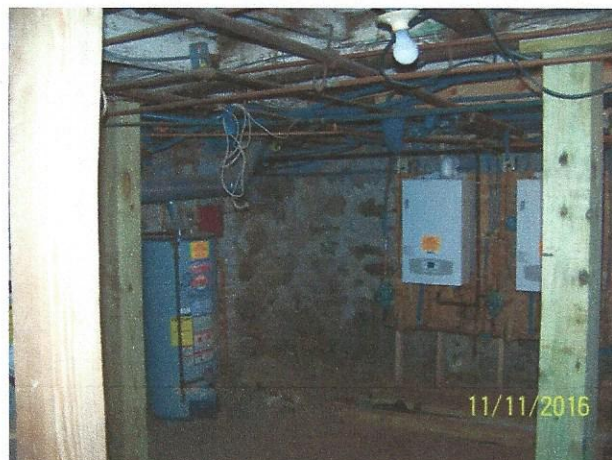
The accessible portion of the basement of the dwelling is located in the front of the structure. The rear portion consists of an almost inaccessible crawl space that I did not enter. The open area of the basement contains various building utilities and the first floor structural framing is also visible in this area. The area was dry and Mr. Pulver indicated that he has never experienced any water infiltration in the basement of this residence.

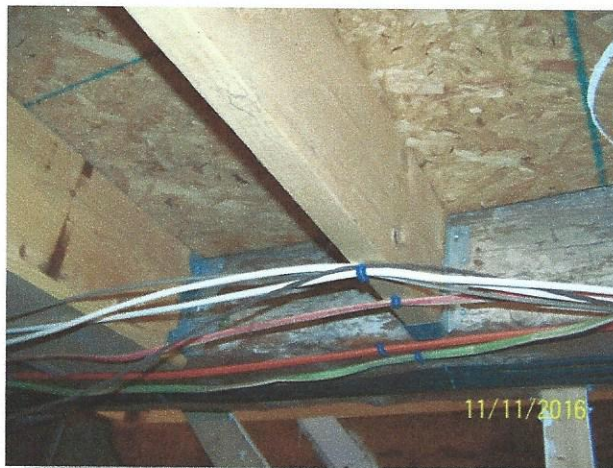
He mentioned that he had damage to the building framing from termites which he addressed. The dwelling was treated as was evidenced by the round caps in the ground around the exterior of the structure indicating where termite repellent had been injected into the ground around the dwelling. New wooden floor framing had been added to a section of the first floor to replace that which was compromised by the termites.

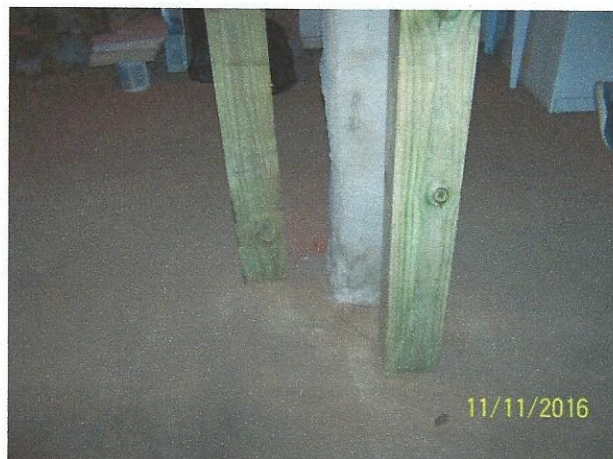
Additionally, there were temporary screw jack columns supporting the first floor in this area that were replaced with new 6 x 6 wooden columns. The existence of "screw jack" supports was mentioned in the home inspection report. These new columns were nailed into the existing first floor framing above and were resting on the existing concrete floor below without a mechanical connection. I recommended to Mr. Pulver that he should provide a mechanical connection at the base of the column screwed into the column and expansion bolted into the concrete floor.

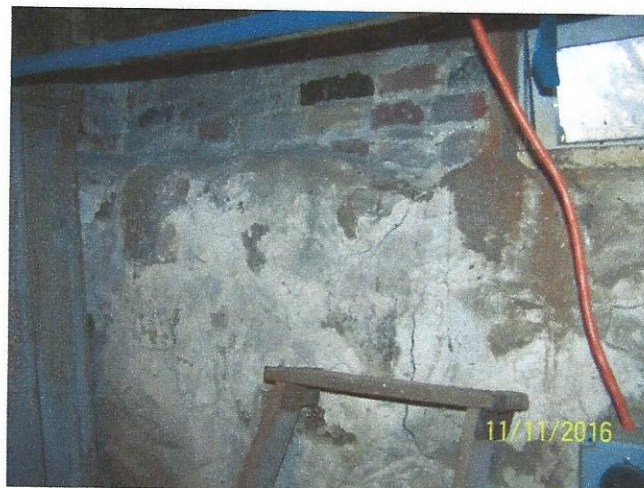
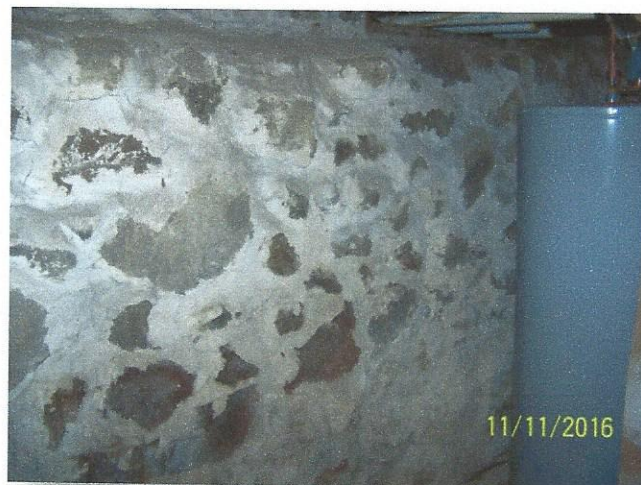
The stone foundation of the dwelling was visible in the basement. It had been repaired in the past by pointing and the addition of mortar between and around the stones. I did not observe any obvious structural deficiencies with the exception of some mortar cracking in a number of locations. Mr. Pulver indicated that he did not contract to have this work done and was in place prior to him owning the property.

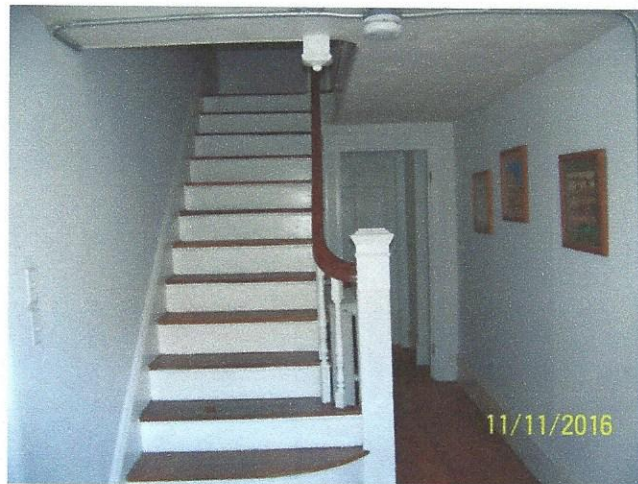
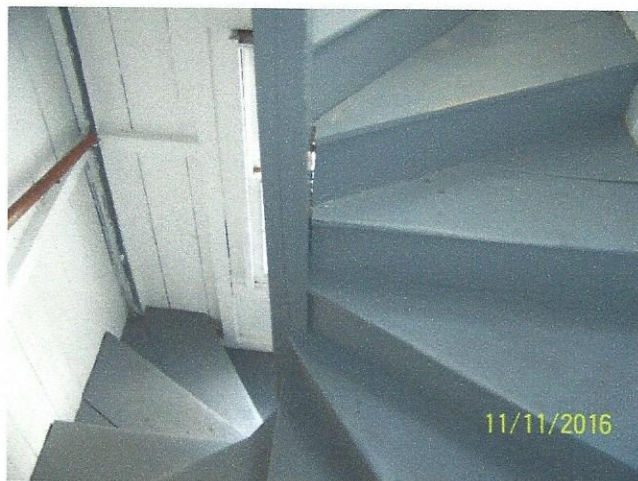
The second means of egress from the unit consisted of a rear spiral stair that Mr. Pulver mentioned was "grandfathered" from current Massachusetts State Building Code requirements. Care must be exercised when using this stair since it very steep and without adequate handrails.

The second means of egress spiral stair in the rear of the building also serves the third floor of the structure. It is a dangerous stair in an emergency and not much can be done to improve its existing configuration. Since the current owner indicated that it is "grandfathered", it is a viable yet dangerous means of egress in an emergency.

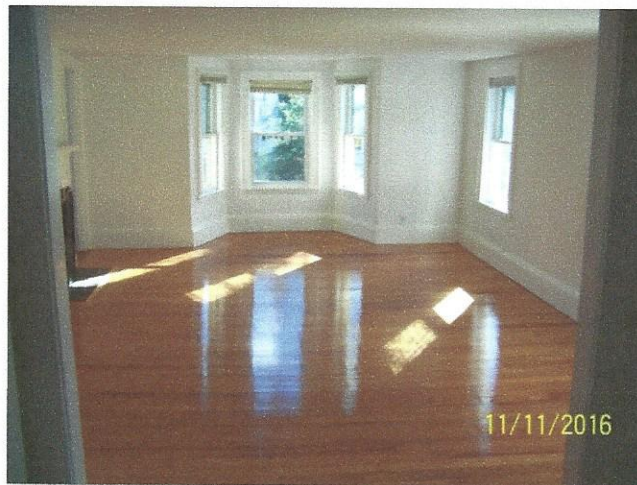
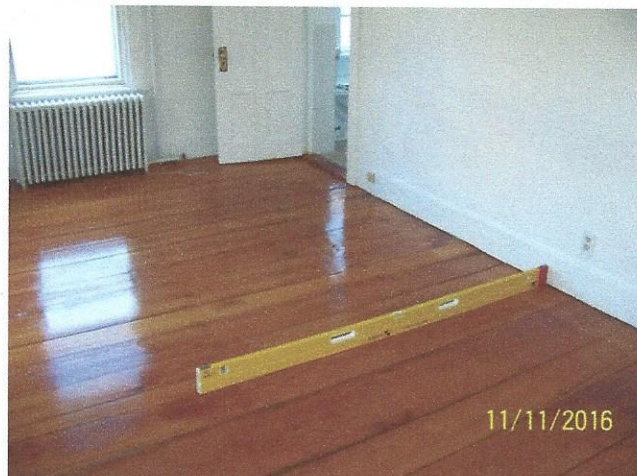
I observed all the rooms within the unit and saw no obvious structural deficiencies. I observed no cracks in the walls and ceilings. The ceilings were low in all rooms and the floors were significantly sloped. The slope in the right front room is in excess of one (1) inch in six (6) feet.

The sloped floors in Unit #2 are noticeable but again not unexpected for a building on this age.
