INSPECTION REPORT

For the Property at:
12 GEORGE STREET EAST
HAVELOCK, ON K0L 1Z0

Prepared for: TEAM VANRAHAN
Inspection Date: Friday, June 30, 2023
Prepared by: David Sharman

RE: Report No. 4386
12 George Street East
Havelock, ON
K0L 1Z0

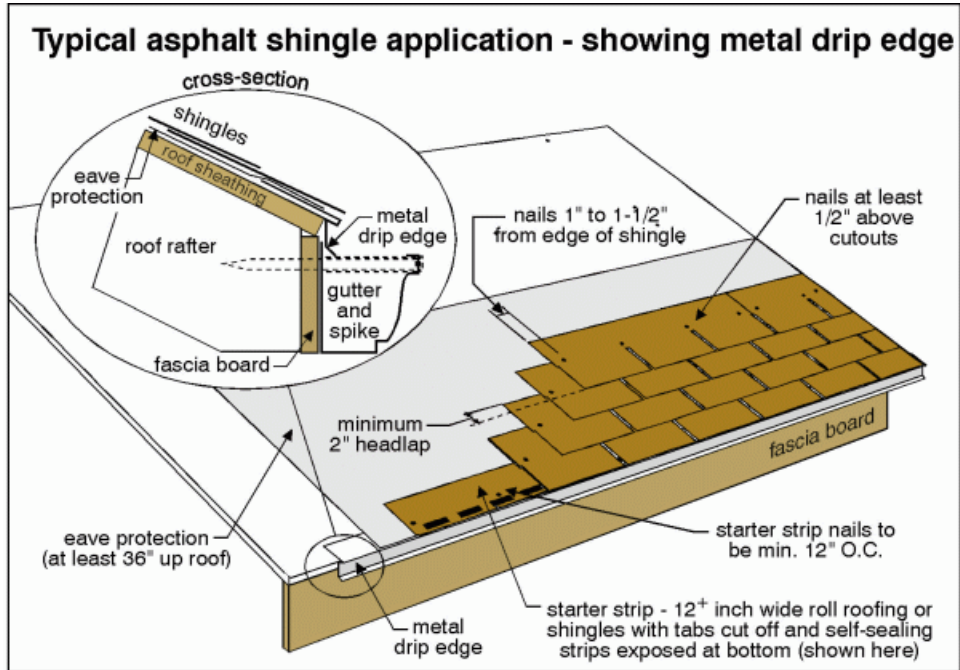
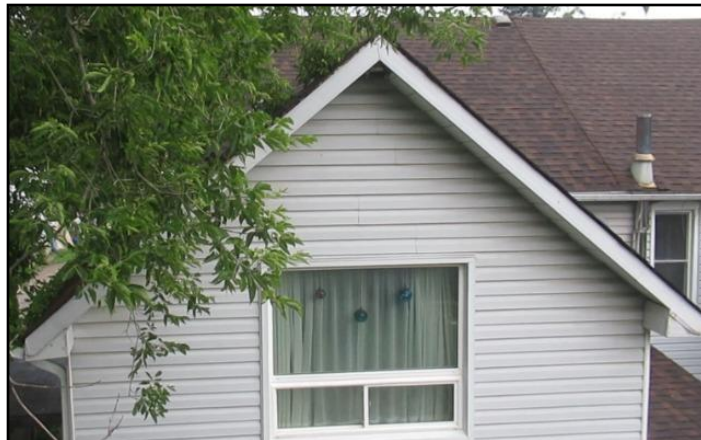
1. Condition: • Missing

Implication(s): Chance of water damage to structure, finishes and contents

Location: Rear gable end

3. Missing

Task: Provide

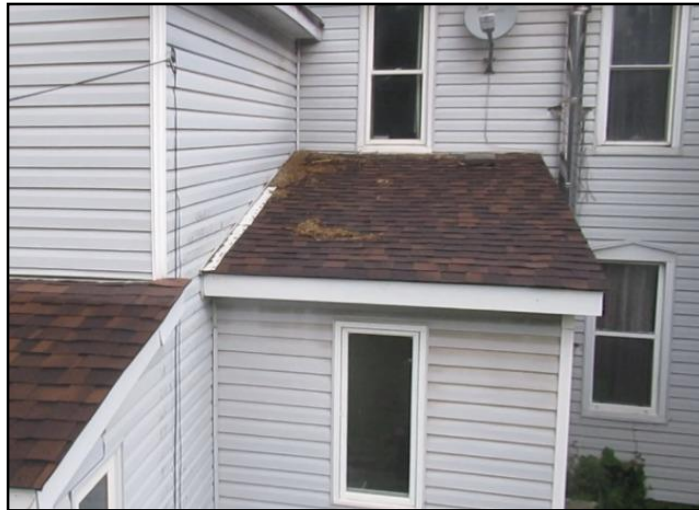
2. Condition: • Missing

Implication(s): Chance of water damage to structure, finishes and contents

Location: Rear elevation

4. *Missing*

Task: Provide

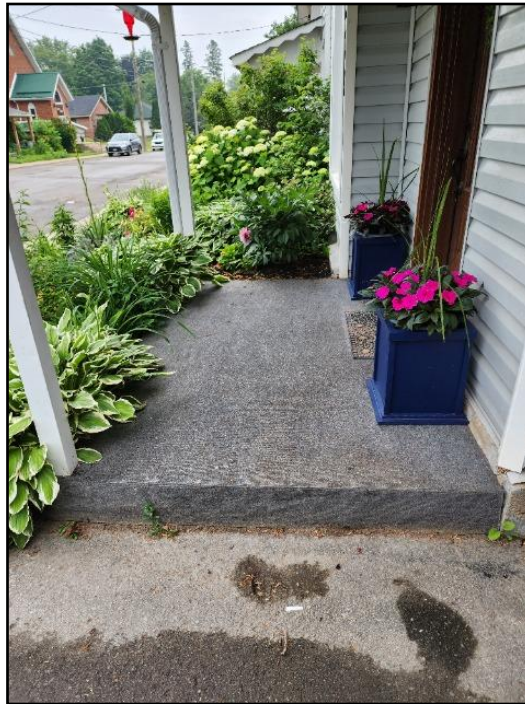
4. Condition: • Carpet

Implication(s): Shortened life expectancy of material | Material deterioration

Location: Porch

5. Carpet

Task: Improve

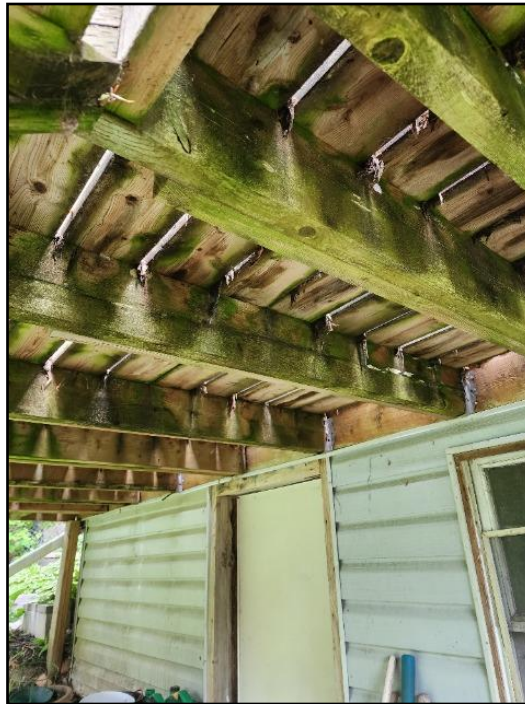
5. Condition: • Prior repair

Implication(s): Weekend structure

Location: Raised decking

6. *Prior repairs*

Task: Monitor

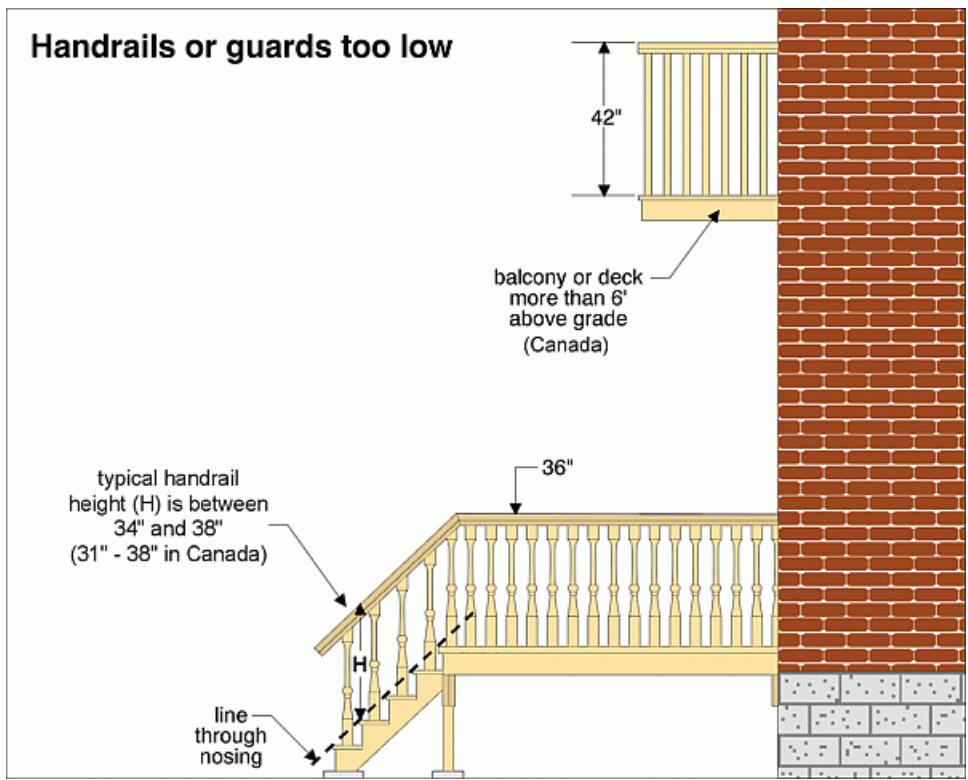
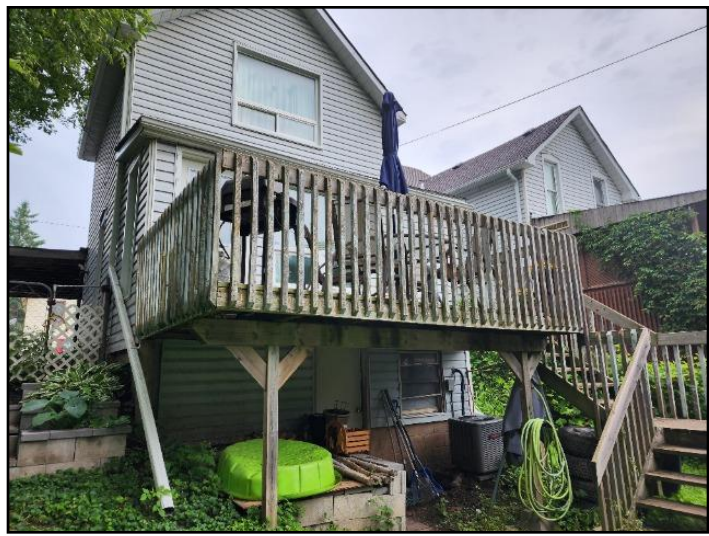
6. Condition: • Too low

Implication(s): Fall hazard

Location: Raised decking

7. Too low

Task: Improve

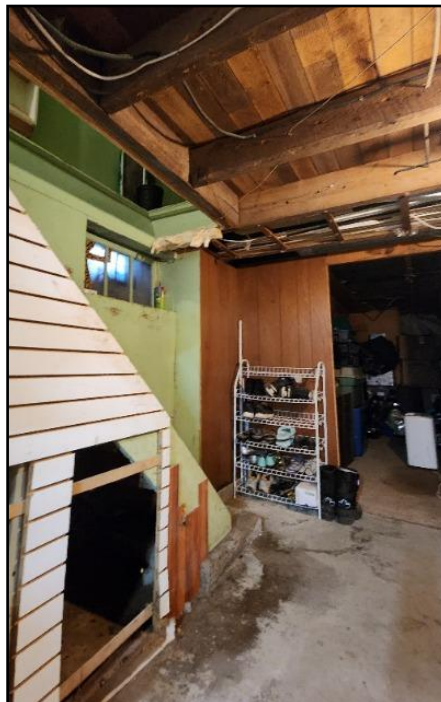
7. Condition: • Missing

Implication(s): Chance of structural movement

Location: Basement

8. Missing

Task: Provide

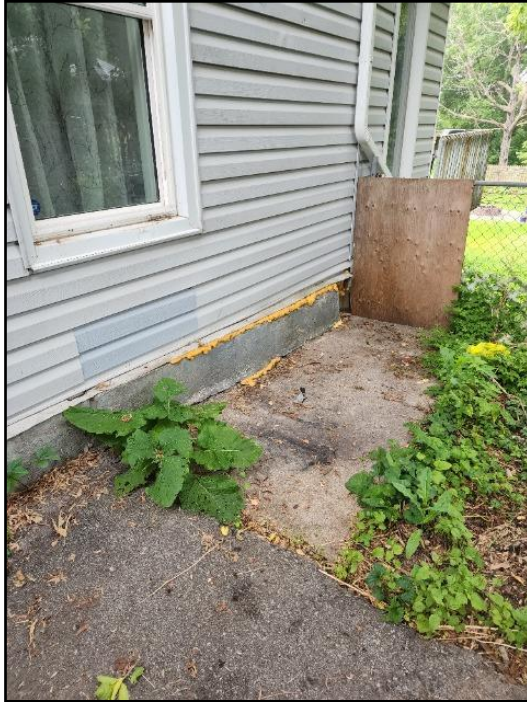
8. Condition: • Typical minor cracks

Implication(s): Material deterioration

Location: Right elevation

9. Typical minor cracks

Task: Repair

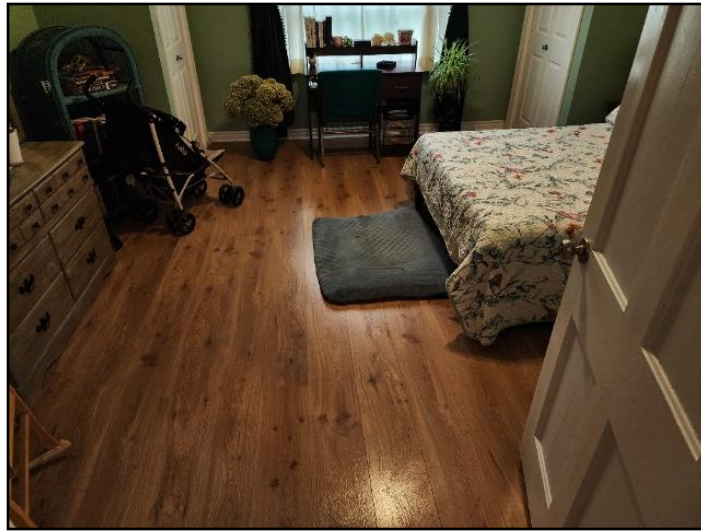
10. Condition: • Slope

Implication(s): Weekend structure, chance of continued movement

Location: Second floor master bedroom

11. Slope

Task: Monitor

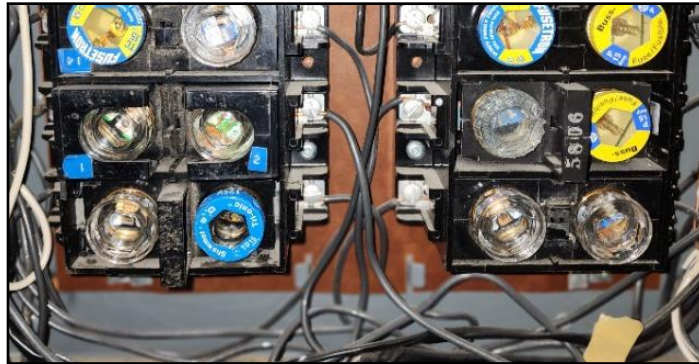
11. Condition: • Damaged

Implication(s): Fire/ electric shock hazard

Location: Distribution panel

15. *Damaged*

Task: Replace

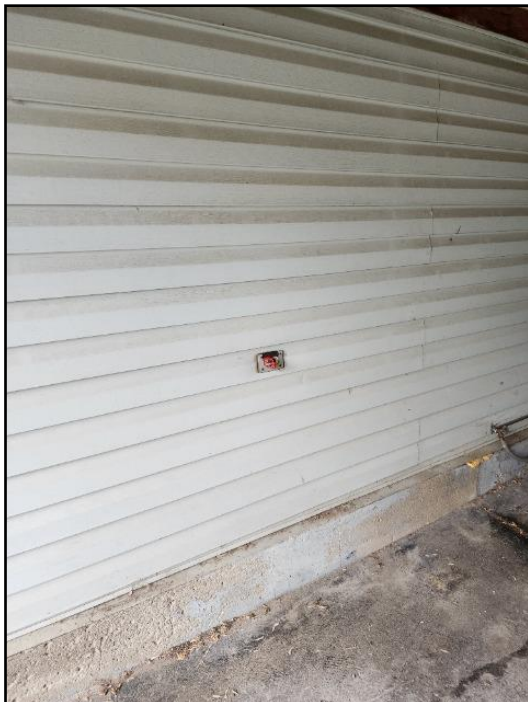
12. Condition: • No GFCI/GFI (Ground Fault Circuit Interrupter)

Although not a deficiency in a building of this age, safety may be improved by upgrading these receptacles

Implication(s): Electric shock

16. No GFCI/GFI (Ground Fault Circuit...

Task: Upgrade

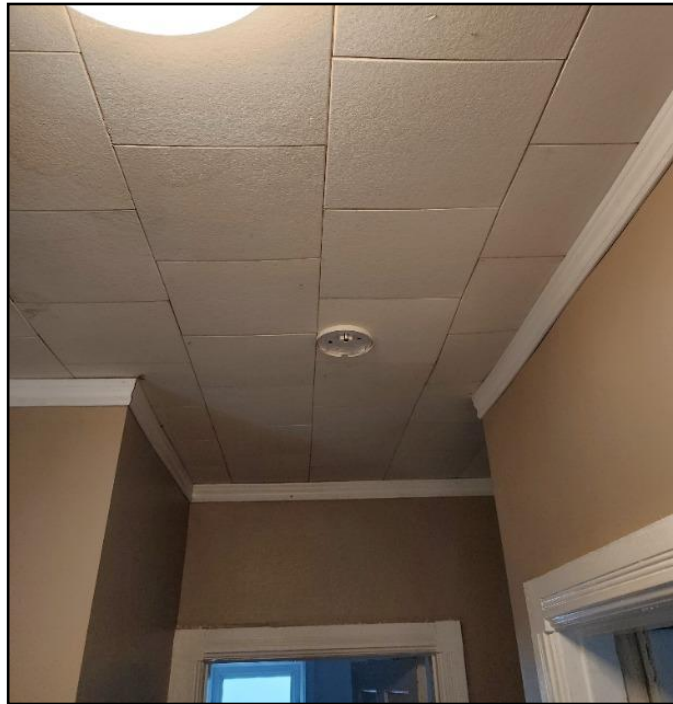
13. Condition: • Missing

Implication(s): Safety issue

Location: Second floor

20. *Missing*

Task: Replace

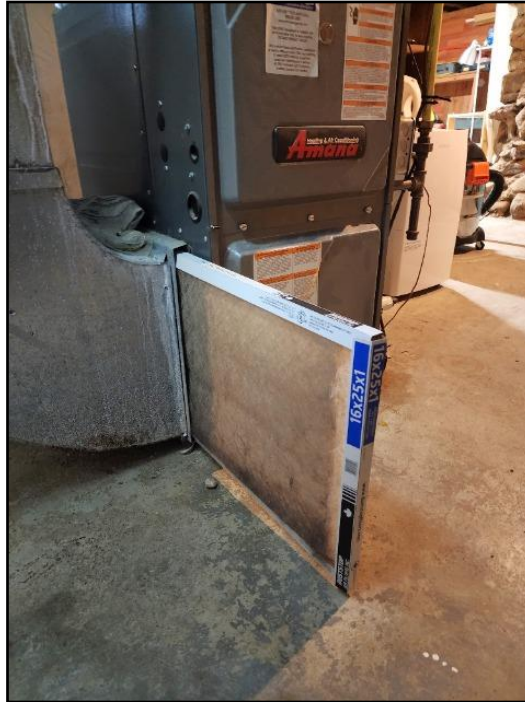
14. Condition: • Dirty

26. Dirty

Task: Replace

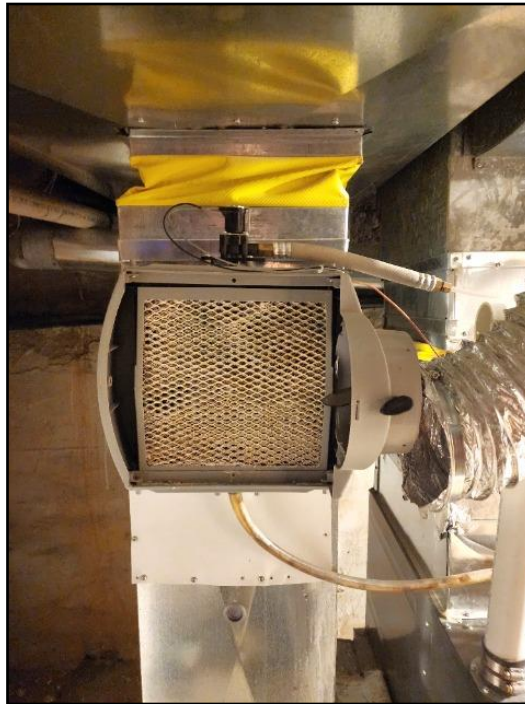
15. Condition: • Clean pad/mesh - regular maintenance

27. Clean pad/mesh - regular maintenance

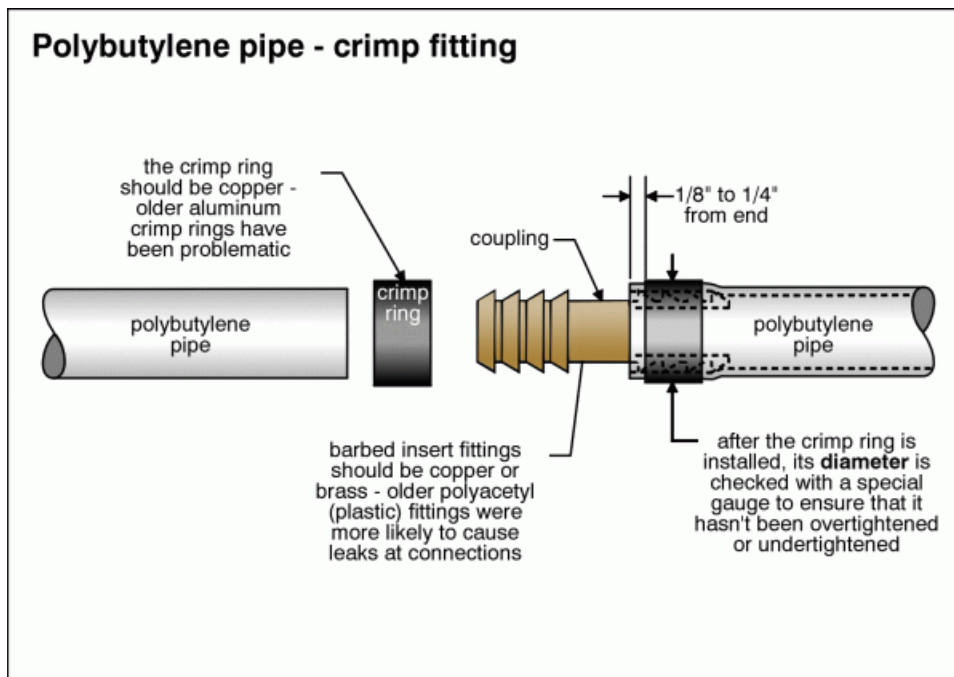
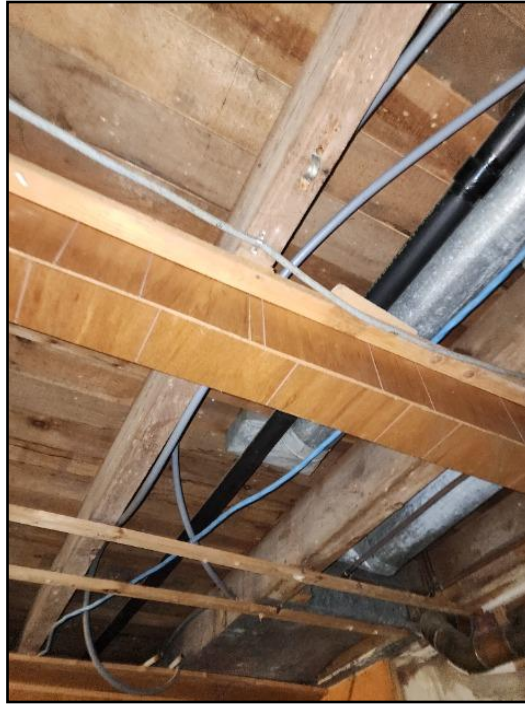
18. Condition: • Polybutylene

Implication(s): Chance of water damage to structure, finishes and contents | Leakage

35. Polybutylene Polybutylene has been replaced

Task: Monitor

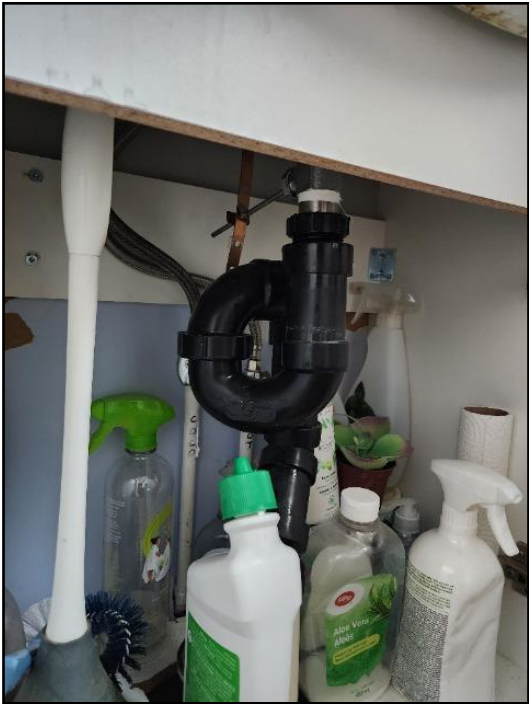
19. Condition: • Wrong type

36. Wrong type

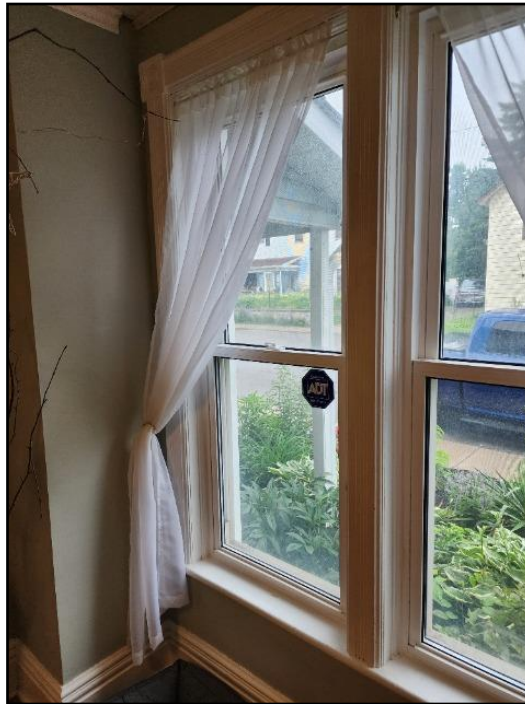
21. Condition: • Won't stay open

37. Won't stay open

Task: Repair

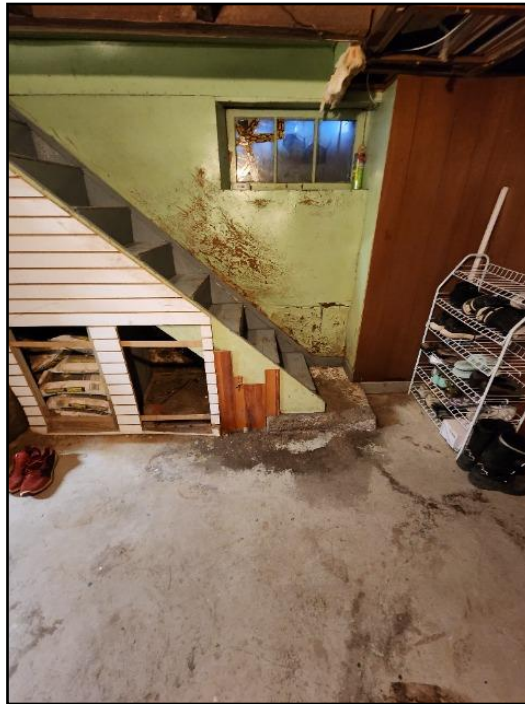
22. Condition: • Dampness on floor or walls

Implication(s): Chance of water damage to structure, finishes and contents | Material deterioration

38. Dampness on floor or walls

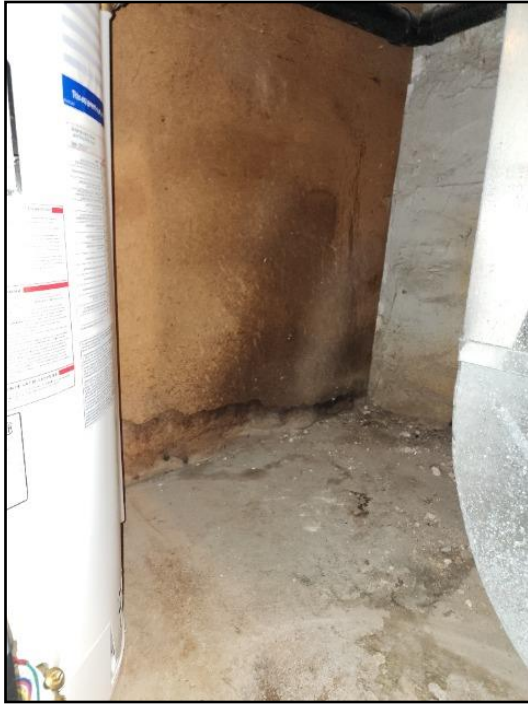
23. Condition: • Stains

Implication(s): Chance of water damage to structure, finishes and contents

39. Stains
