Inspection Report

G2 Home Inspections

Property Address 3063 S Dawes Pl Kennewick Wa

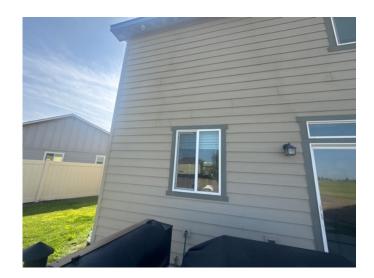
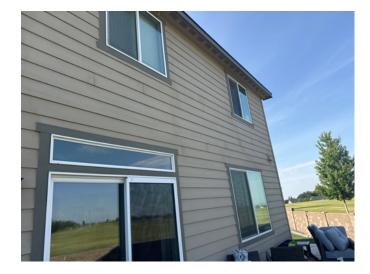
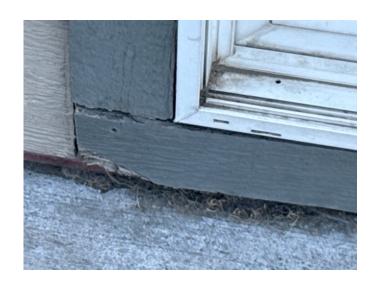
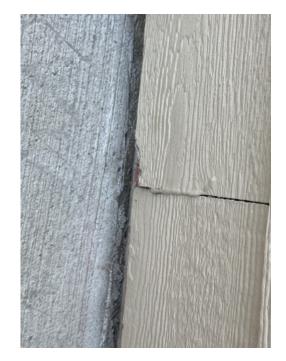
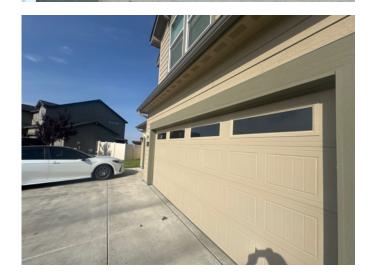
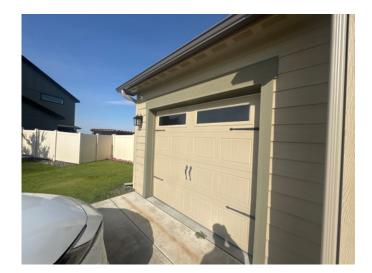
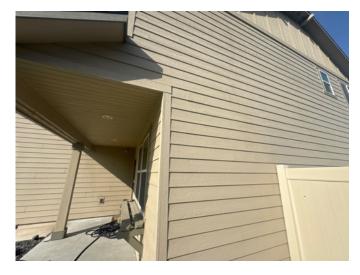
2.1) Exterior Wall Conditions

There was evidence of moisture exposure and damage observed at the trim below the sliding glass door and at the bottom edge of siding at the back patio area. Recommend repair. Installing a gutter above this area would help prevent future damage

There was a small area of damaged corner trim near the ground to the right of the garage door. Recommend repair as needed.

There was cracked caulking, observed at siding and trim joints in several areas around the home. Recommend maintenance/recaulking.

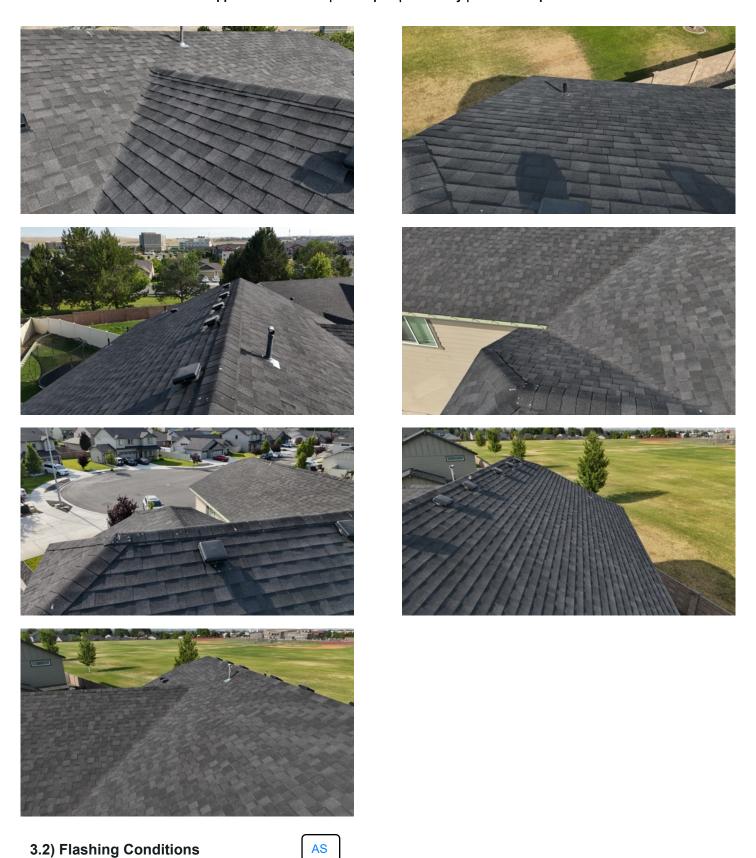
3.1) Roof Covering Condition

There was a wind, damaged shingle observed near the ridge at the front portion of the roof. Recommend further evaluation and repair by a qualified roofing contractor.

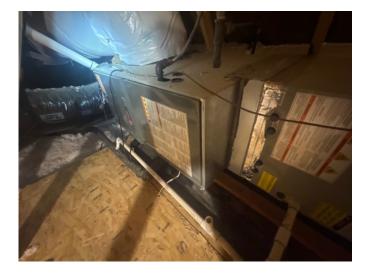
4.1) Unit Conditions

The heating system was operational at time of inspection. This is not an indication of future operation or condition.

There were no service records visible at the HVAC system at the time of inspection. Recommend having the HVAC system serviced by a qualified technician.

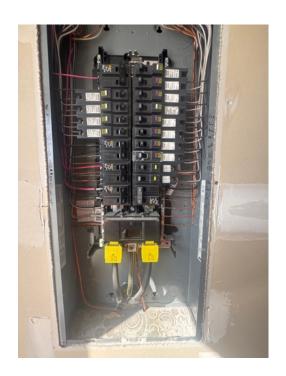
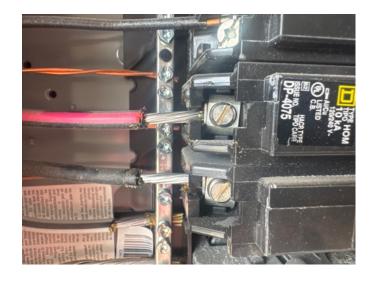
5.3) Electrical Panel Conditions

The Insulation has shrunk at the aluminum circuit conductors that are connected to the bottom left breaker in the electrical panel. This leaves too much bare conductor exposed. Recommend Having a qualified electrician re-insulate the exposed conductors.

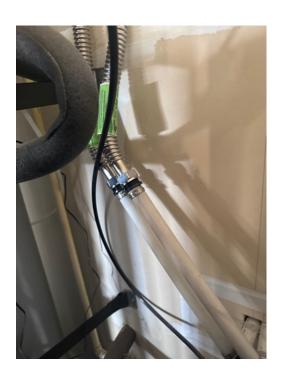
6.2) Supply Line Conditions

Recommend installing insulation to prevent freezing at the exposed plumbing lines that connect to the water softener in the garage.

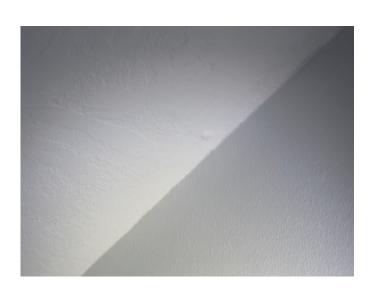
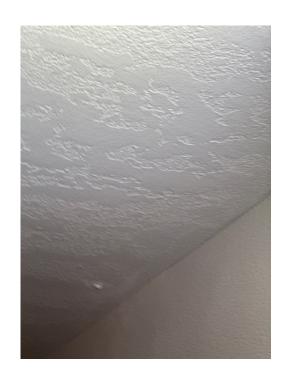
7.2) Ceiling Conditions

There were several popped Drywall screws, observed at the ceilings near the walls in several locations in the home. Recommend repair as needed/desired.

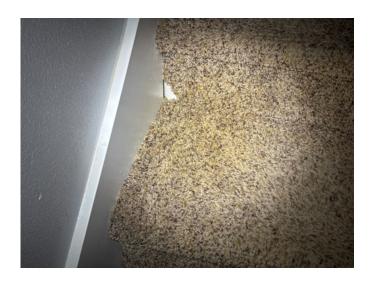
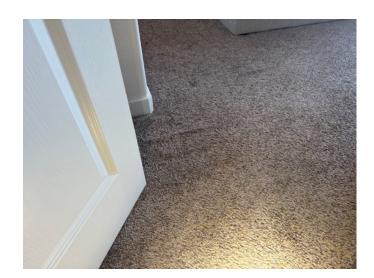
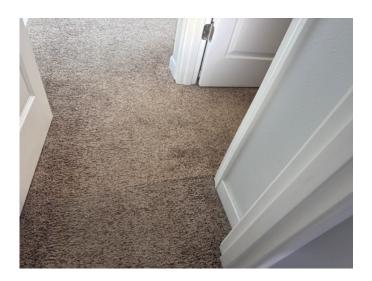
7.3) Floor Conditions

There was a small area of damaged carpet at one of the stair risers. Recommend repair as needed/desired.

The carpet was slightly loose in several areas at the upper level of the home. Recommend stretching carpet.

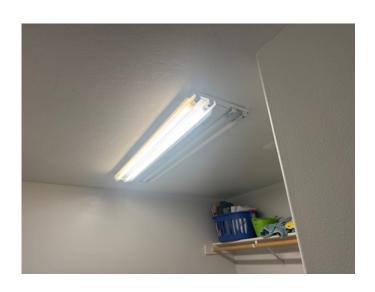
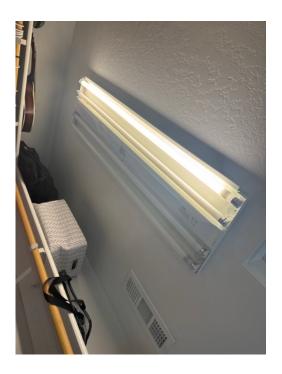
7.7) Lighting Conditions

There were several inoperable lamps at the laundry room, fluorescent light fixture, and the fluorescent light fixture in the master bedroom. The Covers for these fixtures were not installed at the time of inspection. Recommend replacing lamps/repair if needed.

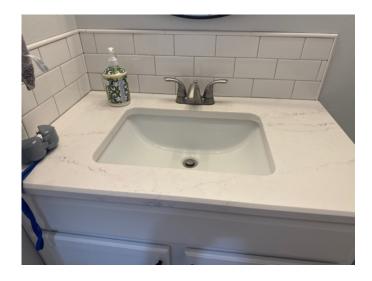
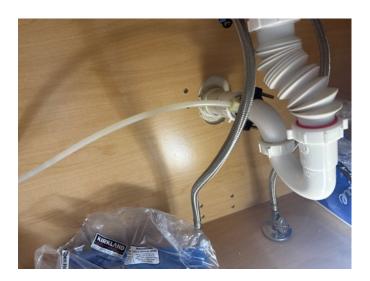
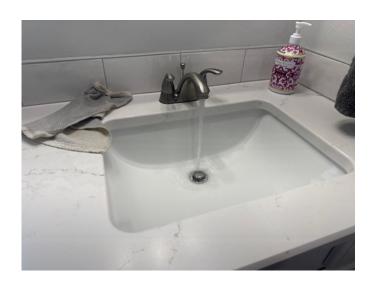
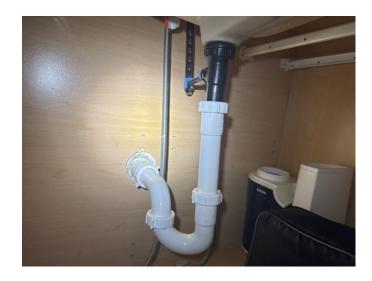
9.5) Sink Conditions

The drain for the water softener in the garage is routed into the sink drain in the powder room.

The drain stop did not operate with the pull handle at the upstairs guest bathroom sink. Recommend adjustment.

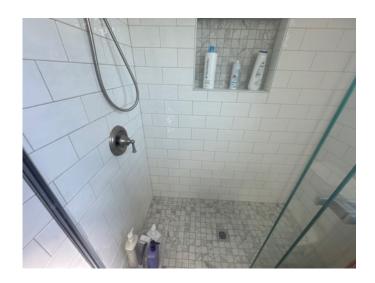
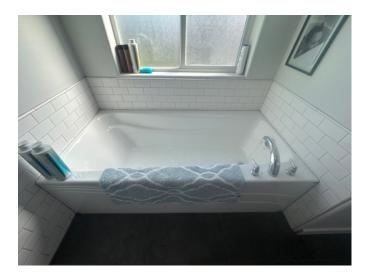
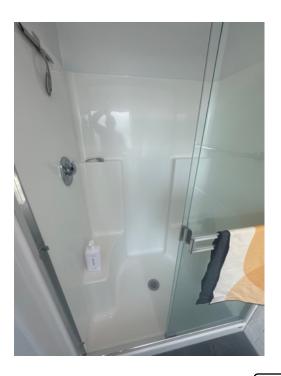
9.6) Shower - Tub Conditions

The faucet was slightly loose at the master bathroom tub. Recommend repair

One panel at the master bathroom shower door did not slide smoothly. Recommend adjustment.

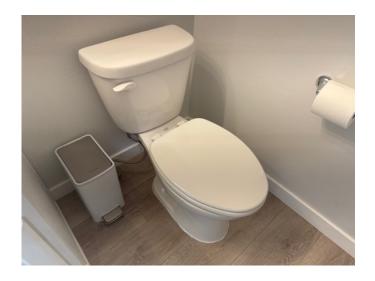
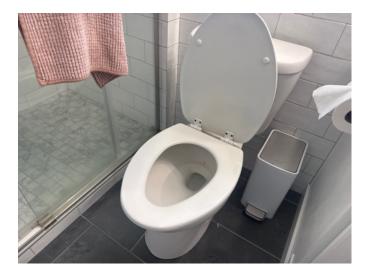
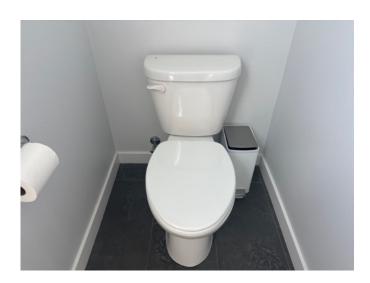
9.7) Toilet Conditions

The master bathroom toilet was not securely fastened to the floor. Recommend repair as this condition could cause a leak at the wax ring seal.

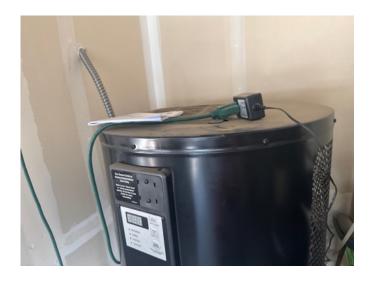
10.6) Electrical Conditions

An extension cord was used to power the water softener in the garage. It would be recommended to install a receptacle near the water softener to eliminate the use of extension cords.

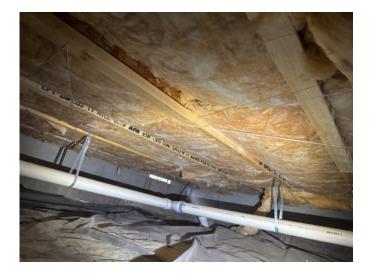
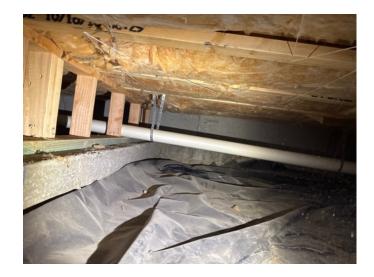
11.1) Foundation Conditions

A crack of approximately 1/8"or less was observed in the foundation wall in the crawlspace below the back door area. The cracking implies that some foundation movement may have occurred. Recommend monitoring for any further movement. Although no obvious evidence suggesting "immediate" concern was observed, this does not however guarantee future conditions. The exact / precise measurement of such conditions is not within the scope of our inspection. Past or future movement may be related to soils and geological issues, which are beyond the scope of our expertise.
