Home Inspection Report

PROPERTY INSPECTED:
32 Chrisval Avenue
Quinte West, ON K8V 5P7

Date of Inspection: 05/23/2023

Inspection No. 141044-904

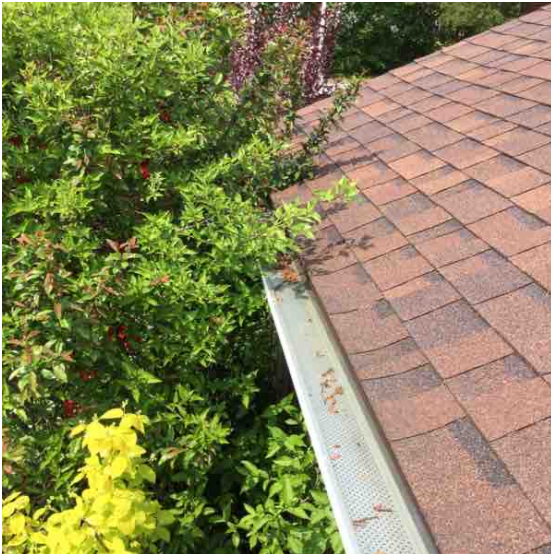
2.2.3 Trim overgrown vegetation from the structure to reduce risk of wear, damages and allow for proper function of eaves trough, monitoring and maintenance and to discourage vermin activity. **(Exterior Left)**

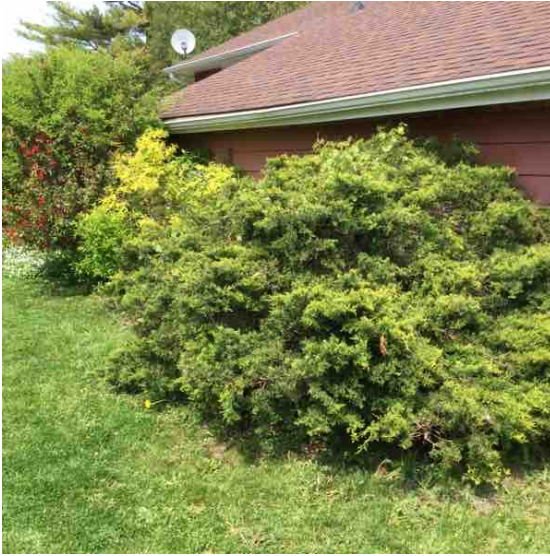
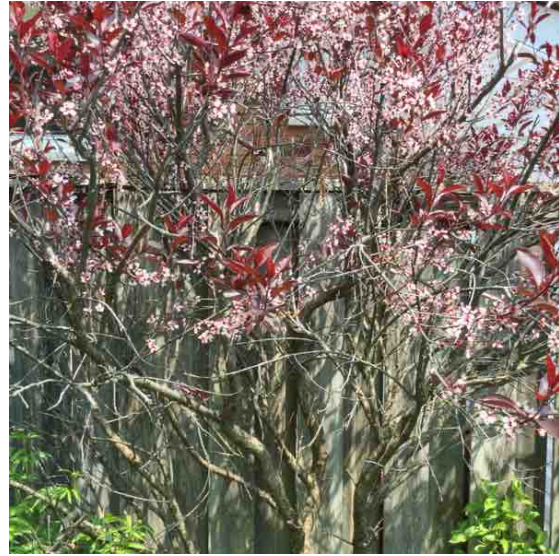
2.2.4 Trim overgrown vegetation from the structure, enclosure to reduce risk of wear, damages and allow for proper function of eaves trough, monitoring and maintenance and to discourage vermin activity. **(Exterior Left)**

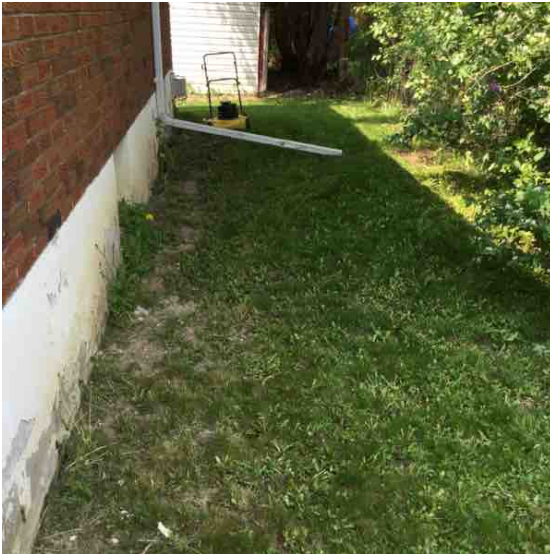
2.2.5 Landscape currently slopes towards structure in this area. Regrade landscaping to slope away from foundation to reduce risk of water entry, related damage to foundation and interior finishes. **(Exterior Right)**

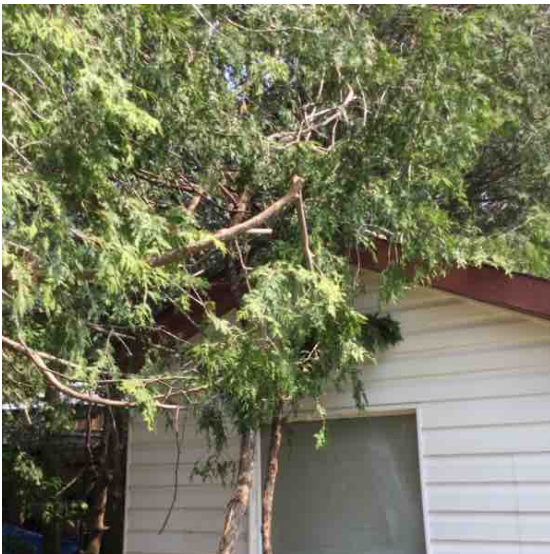
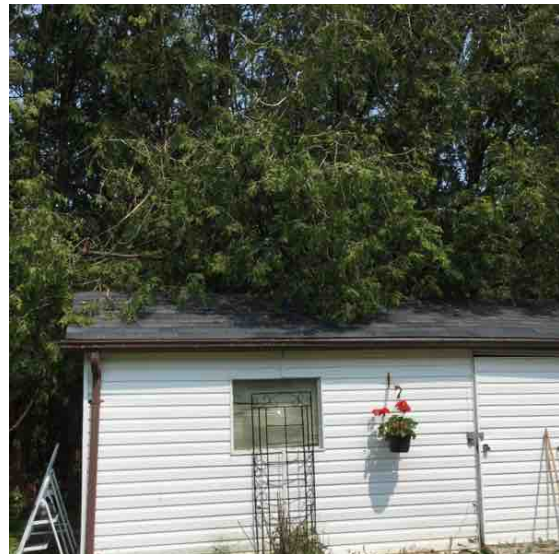
2.2.6 Trim overgrown vegetation from the structure to reduce risk of wear, damages and allow for proper function of eaves trough, monitoring and maintenance and to discourage vermin activity. **(Shed/Outbuilding)**

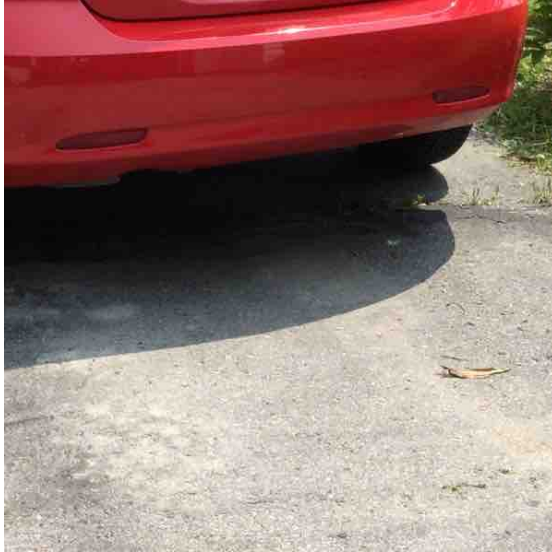
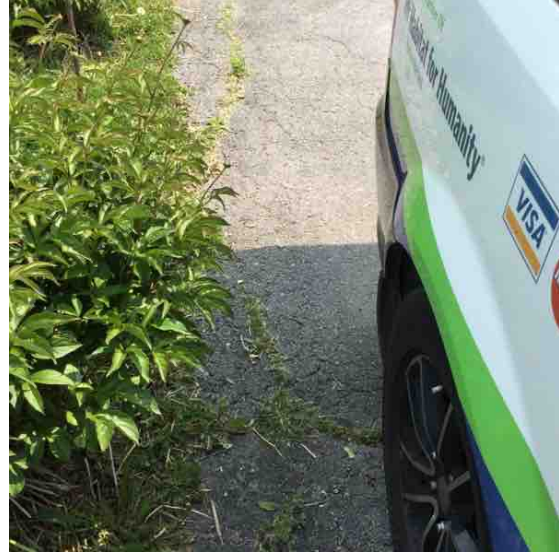
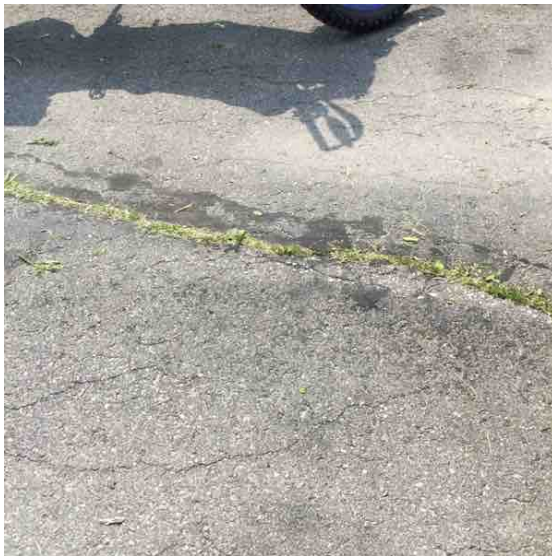
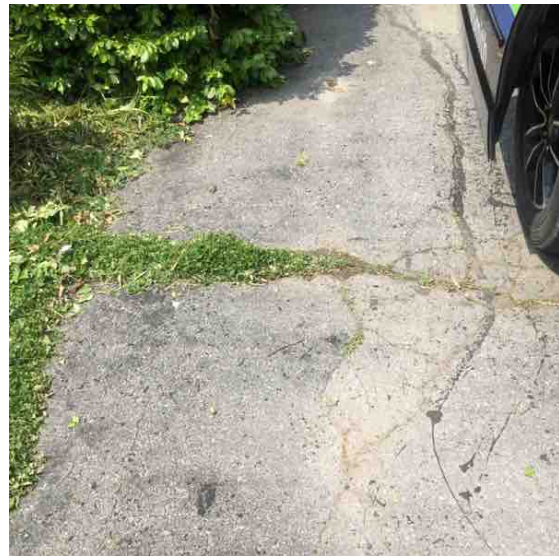
2.4.2 The driveway is damaged. (Multiple significant cracks, separation). Repair, resurface to reduce further deterioration and trip hazards, to extend life.

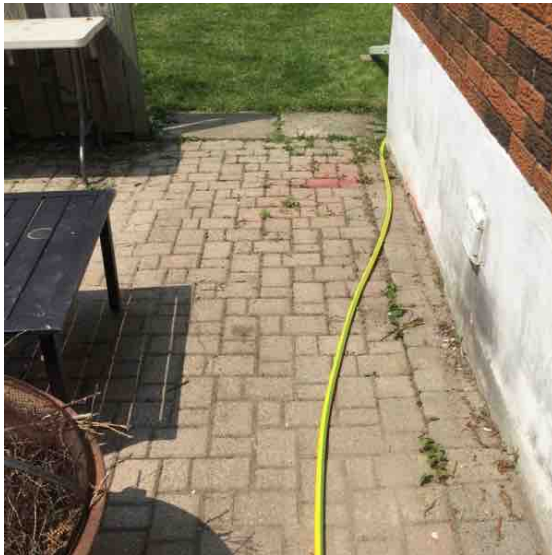
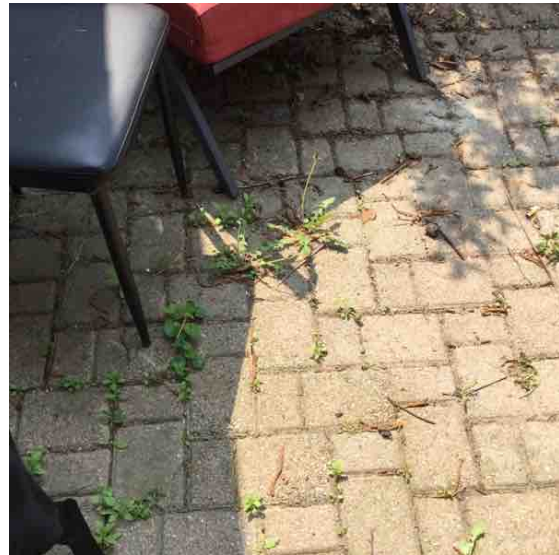
2.5.2 Patio is uneven in areas, recommend to remove the stones, re-level, reset to reduce the risk of puddling, trip hazard. **(Exterior Left)**

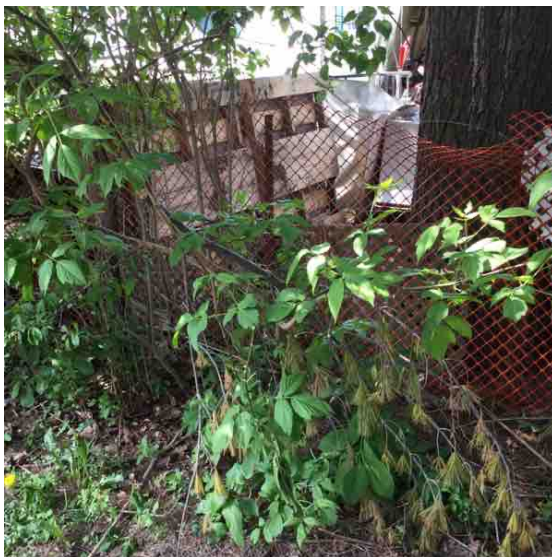
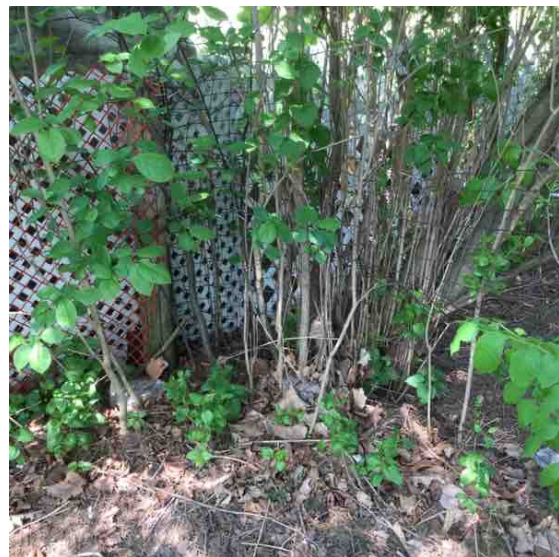
2.6.2 Budget for significant repair, replace the fence, advanced stages of deterioration pose potential risk of failure and safety hazards

2.6.3 Aging and deteriorating fences require significant repairs or replacement. **(Exterior Rear)**

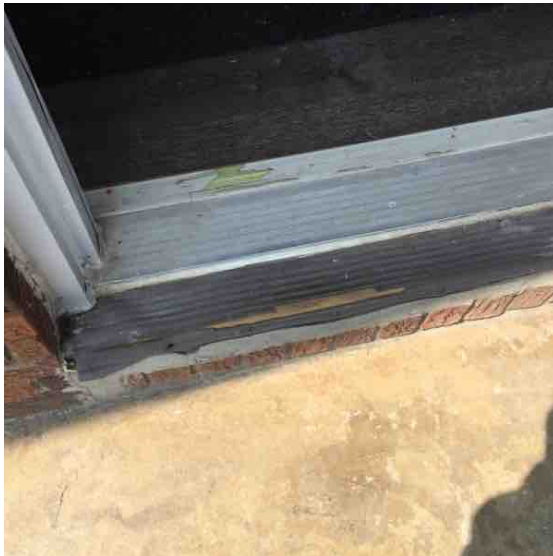
3.8.3 The threshold on the door is damaged. Repair, replace, seal, re-coat to maintain a weather-resistant coating and reduce risk of heat loss, water damage. **(Exterior Front)**

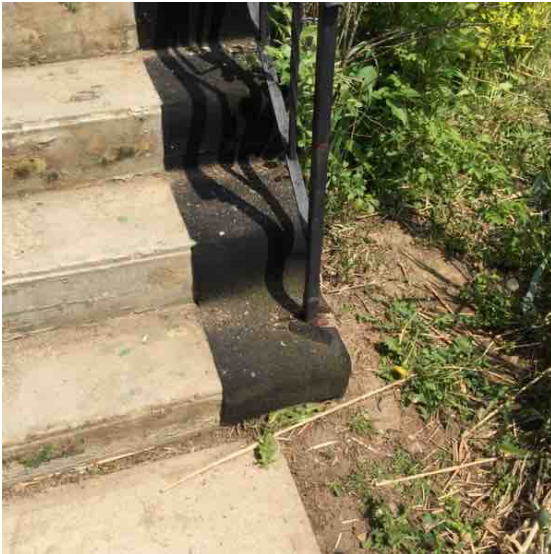
3.9.2 Secure railing as needed for safety. **(Exterior Front)**

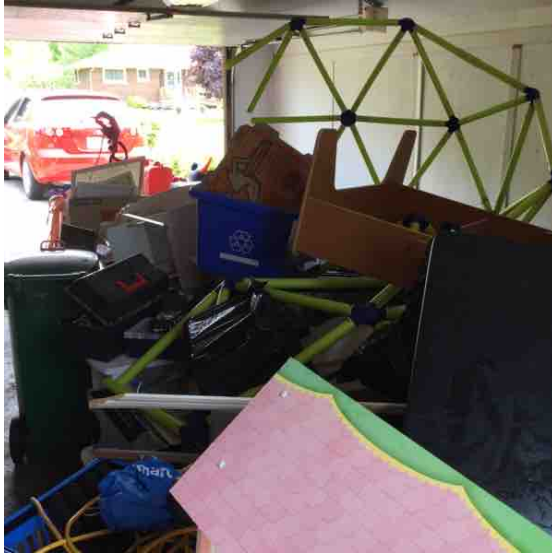
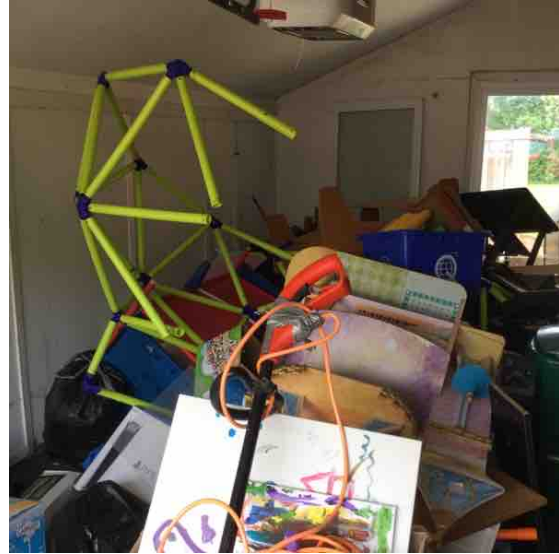
6.2.1 Stored belongings reduce visibility to some aspects of the perimeter walls and ceiling. Strongly recommend to re-inspect these areas when belongings are removed.

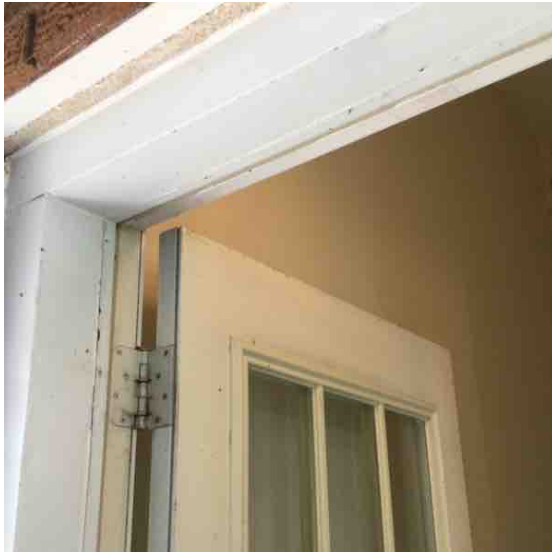
6.4.2 The garage access door does not have an automatic closing mechanism, recommend immediate installation upon possession for fire/gas barrier safety. **(Garage)**

6.4.2 **The garage access door does not have an automatic closing mechanism, recommend immediate installation upon possession for fire/gas barrier safety. (Garage)**

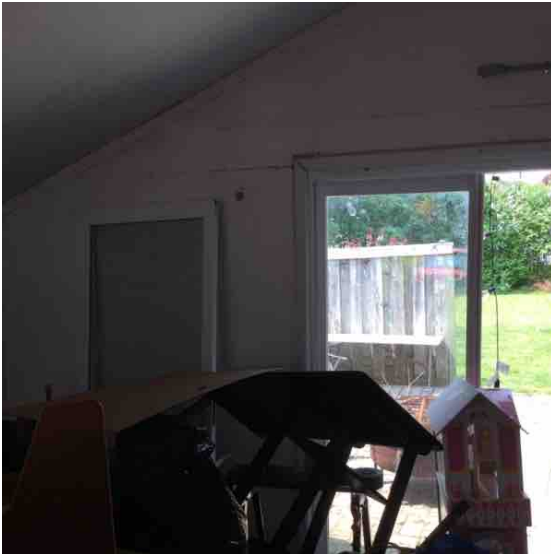
6.5.2 Exterior access door needs to be installed, not tested. No visible damage.

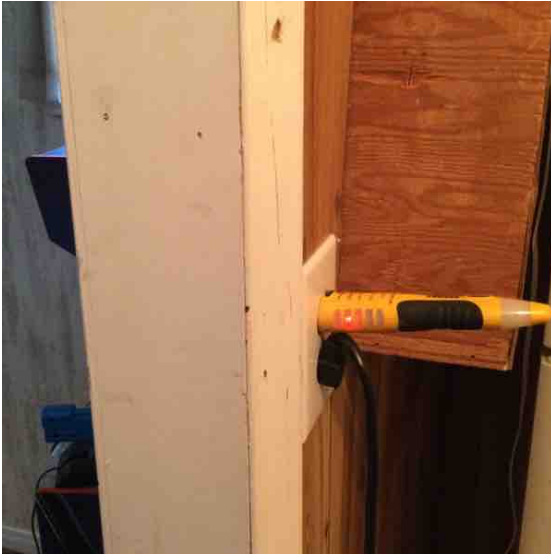
8.9.3 Open ground three-prong receptacle(s) should be corrected by a qualified electrician to reduce the risk of electric shock injuries. **(Basement Storage Room)**

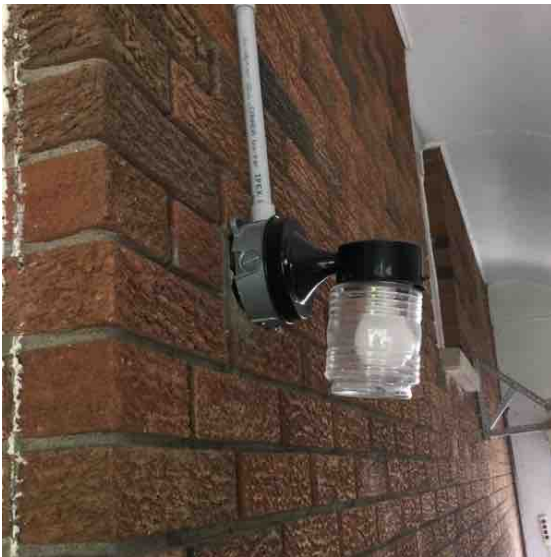
8.10.2 The light(s) is not functional, repair or replace as needed, (replace the bulb as a first step). **(Garage)**

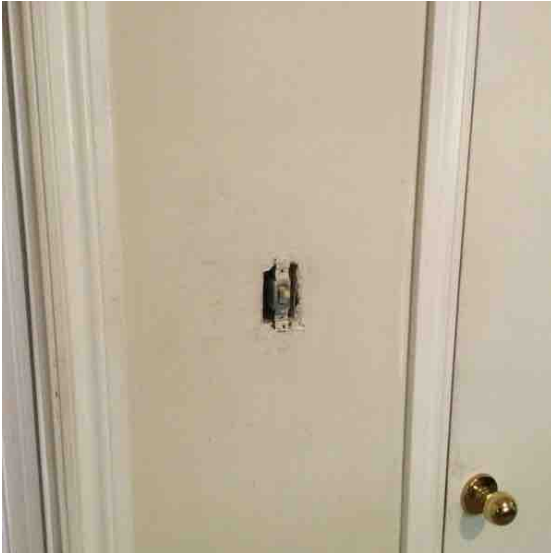
8.10.3 The switch is missing cover plate, install for safety (one example shown, replace all as needed) **(Primary Bedroom)**

8.10.3 **The switch is missing cover plate, install for safety (one example shown, replace all as needed) (Primary Bedroom)**

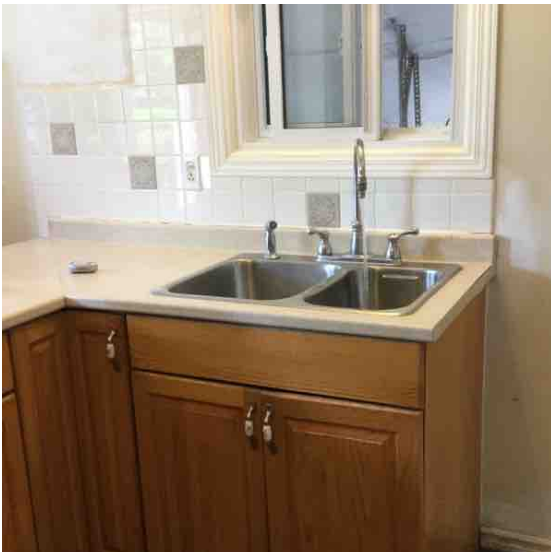
8.12.2 Recommended Update : In any area where there are sinks, tubs, water-use appliances, ensure all receptacles within 1.5 M are GFCI protected. **(Kitchen)**

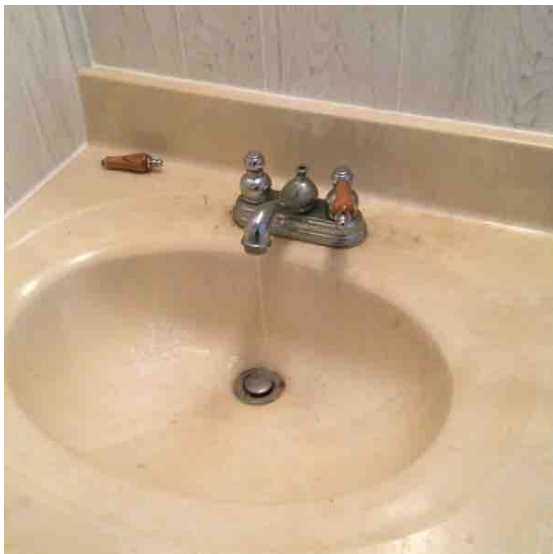
10.8.2 The faucet is damaged. A qualified plumber should further assess and repair as required to regain proper function. **(Basement Half Bathroom)**

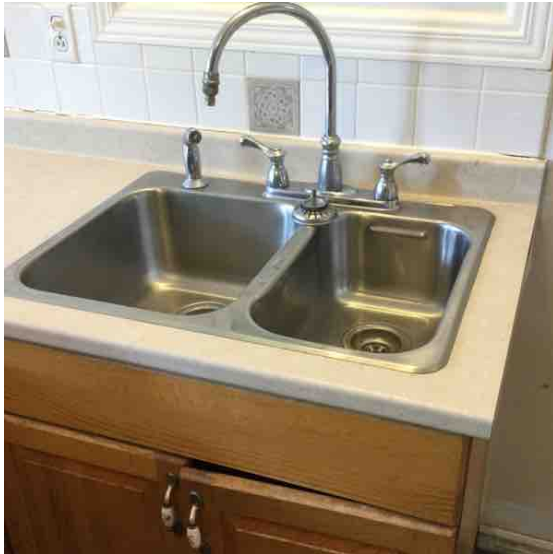
10.9.2 The sink drains very slowly. Repair this for improved functionality. **(Kitchen)**

10.9.2 **The sink drains very slowly. Repair this for improved functionality. (Kitchen)**

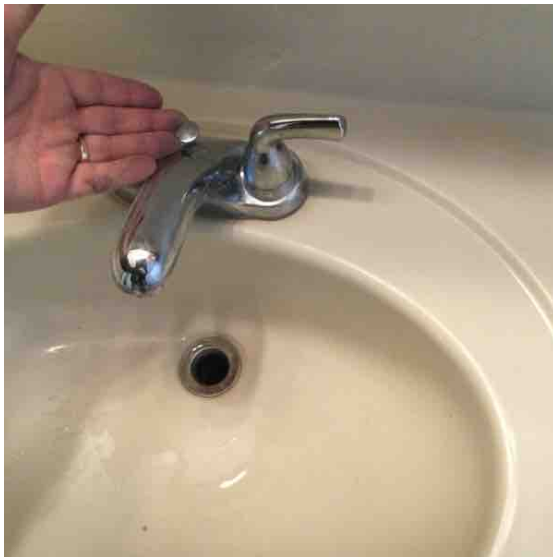
10.9.3 The drain stopper in the sink is disconnected. Repair as required to regain proper function. **(Main Floor Bathroom)**

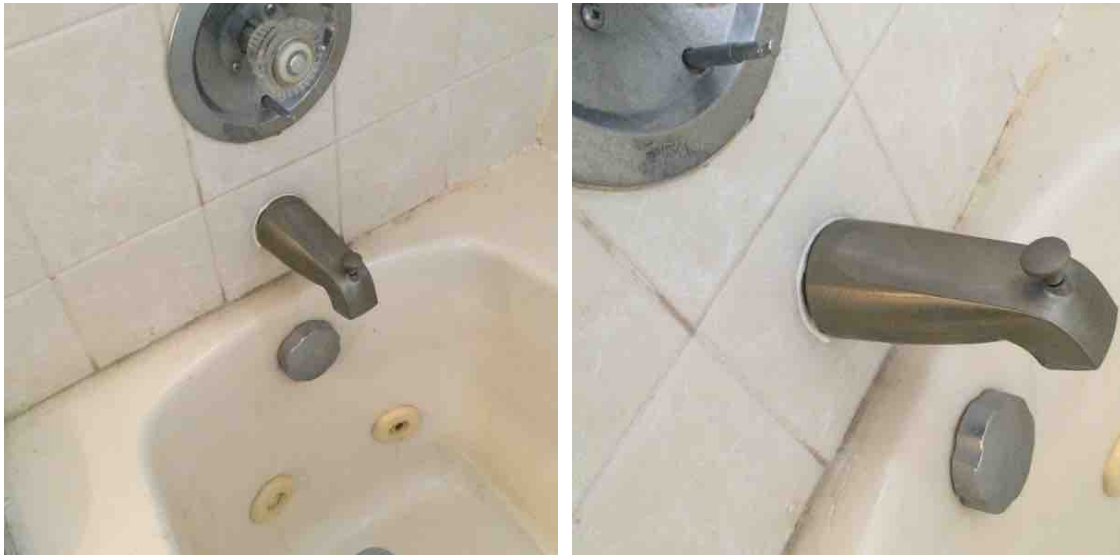
10.11.2 Remove and replace sealant around the tub immediately to reduce the risk of moisture penetration and concealed moisture related damages. Seal spout and trim at that time. **(Main Floor Bathroom)**

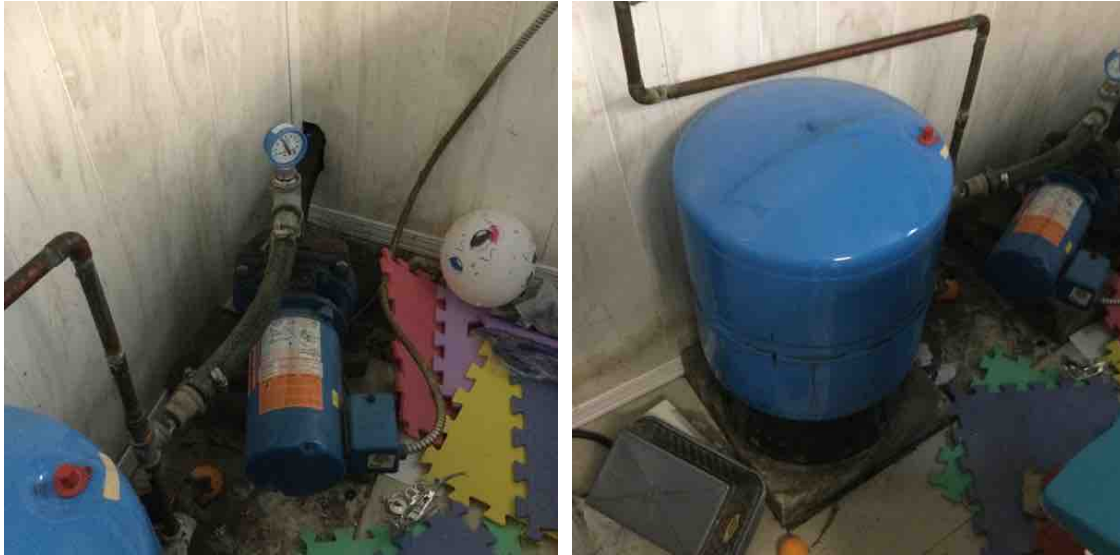
The well water pump is running continuously. A qualified plumber should repair as required to restore proper function. **(Utility/Laundry Room)**

The well water pump is running continuously. A qualified plumber should repair as required to restore proper function. (Utility/Laundry Room)

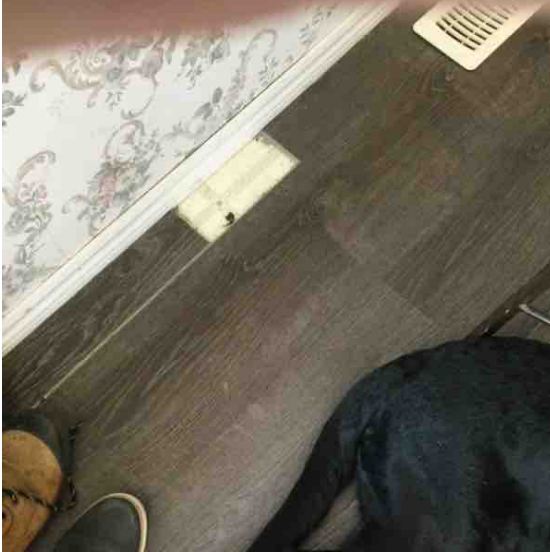
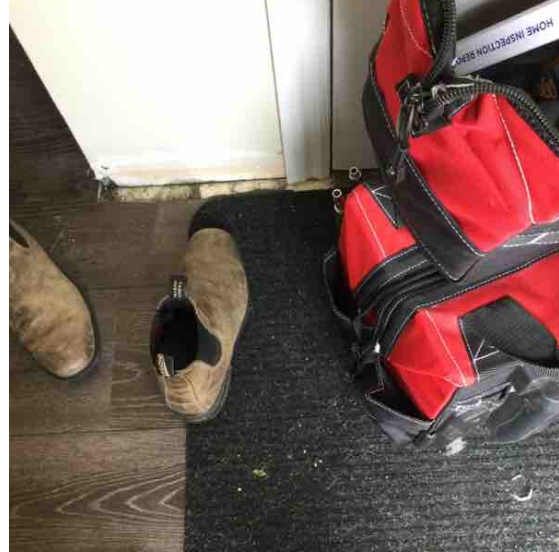
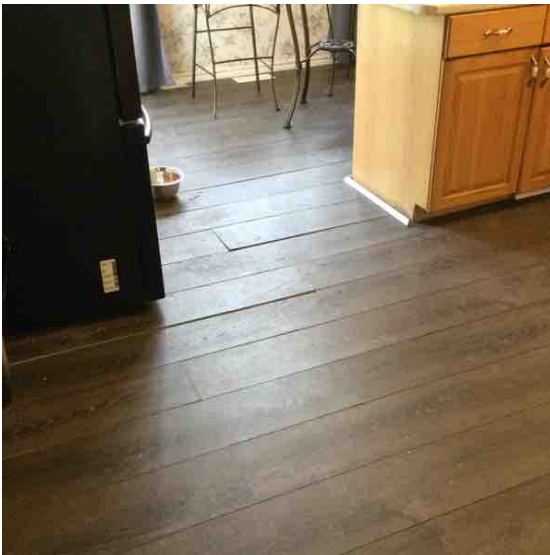
11.2.2 The flooring material is separated, some areas missing millwork, a possible trip hazard. Repair, replace as needed for safety, reduce risk of further deterioration **(Kitchen)**

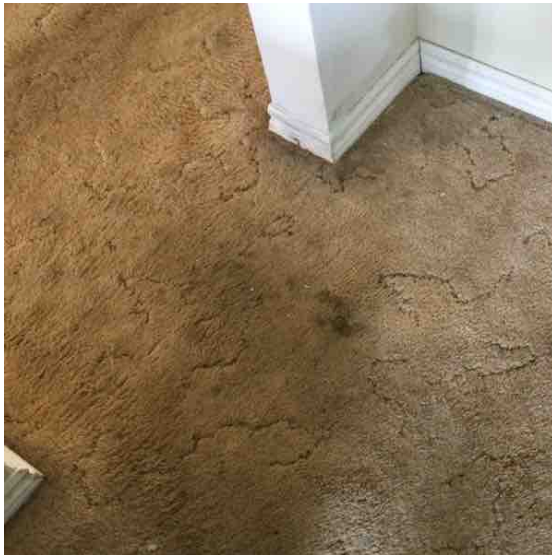
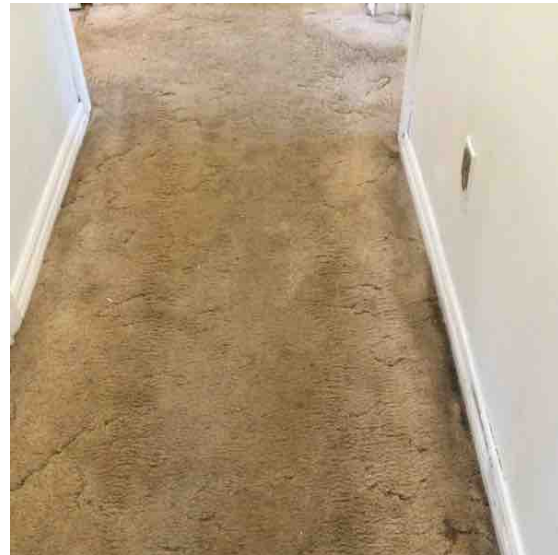
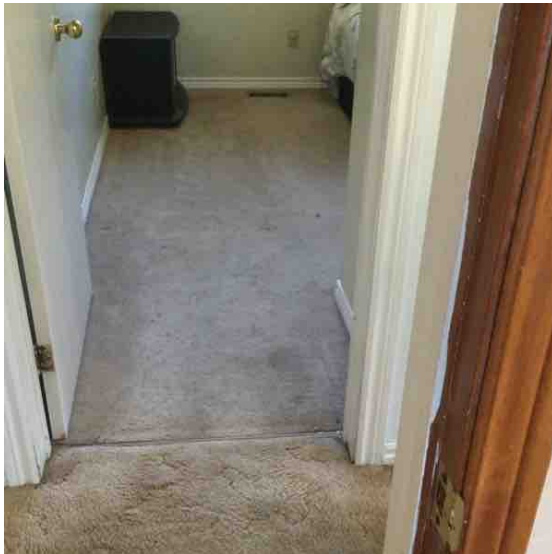
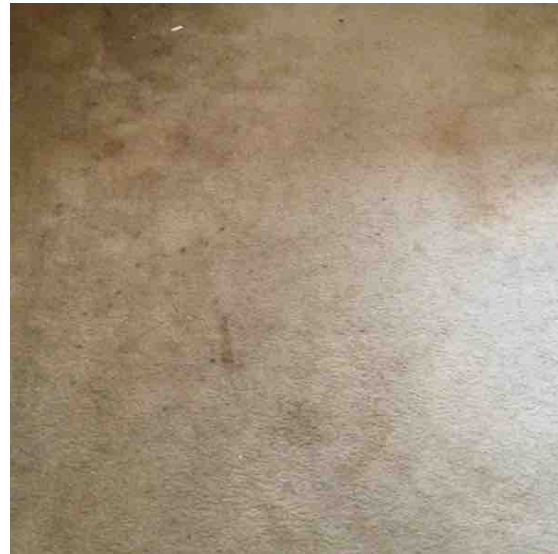
11.2.3 Flooring in areas is worn, soiled, showing its age. This is a cosmetic concern. Repair or replace this as desired.

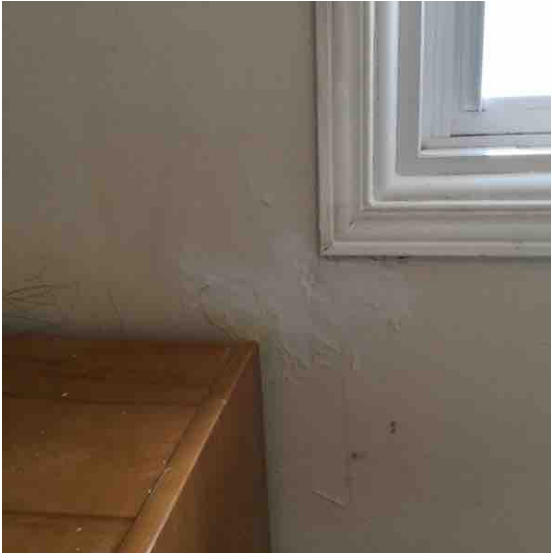
11.3.2 Wall and ceiling finishes are water damaged. Investigate the reasons for the leakage and repair the cosmetic damage. **(Main Floor Rear Corner Bedroom)**

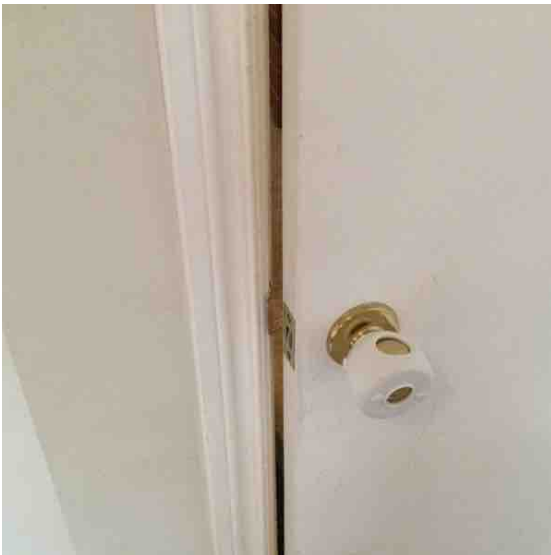
11.5.2 The door does not stay latched. Repair this immediately for improved functionality, fire protection
(Main Floor Rear Corner Bedroom)

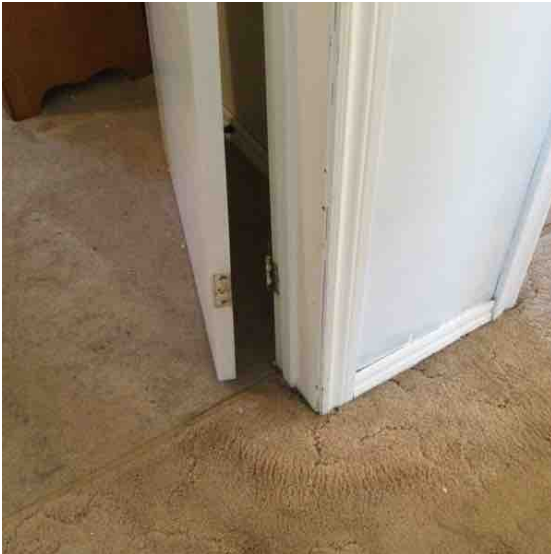
11.5.3 Door hardware is loose or damaged. Repair this for improved functionality.

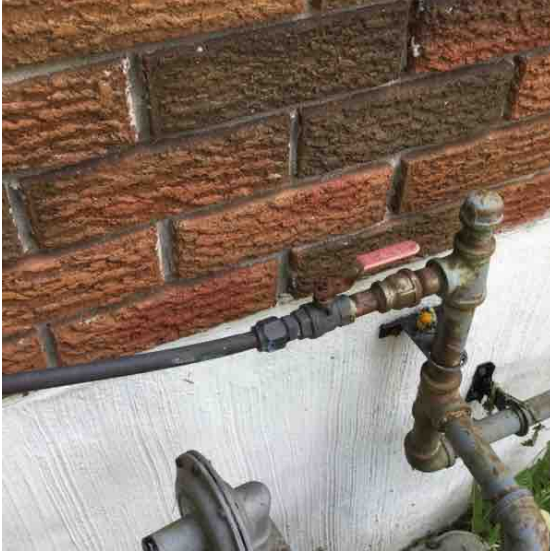
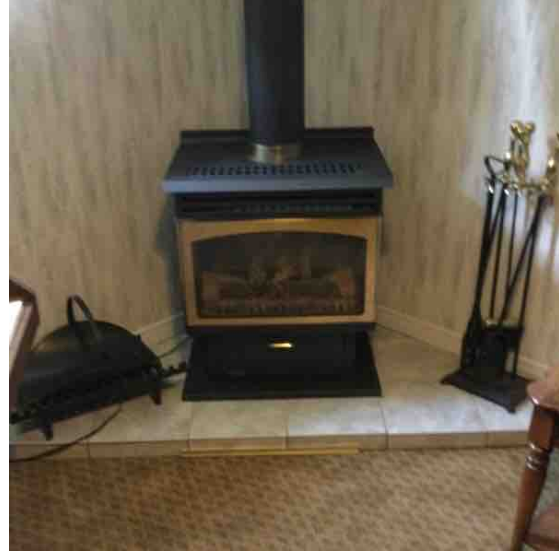
No visible deficiencies with the unit/components, however was not operated / tested as the gas supply was turned off. The functionality / safety of the unit was not determined.

Strongly recommend to have a qualified technician assess and test the unit for full functionality before attempting use. (Exterior Rear)

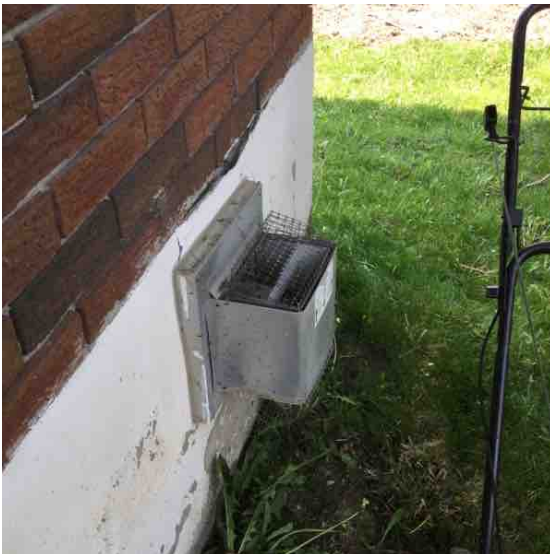
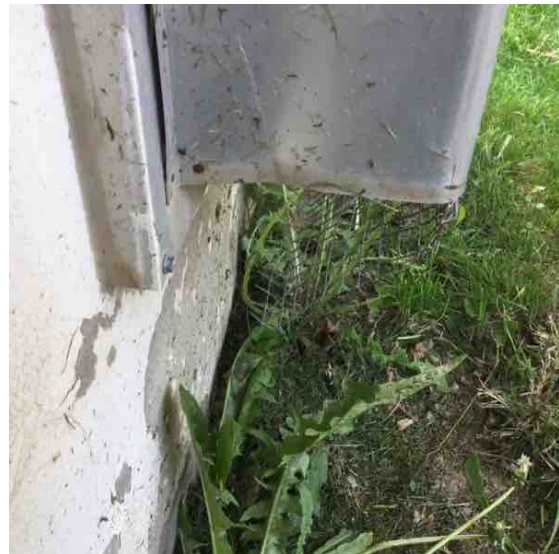
12.3.2 The flue / vent is pest guard is unsecured, repair as needed to reduce risk of infestation **(Exterior Right)**

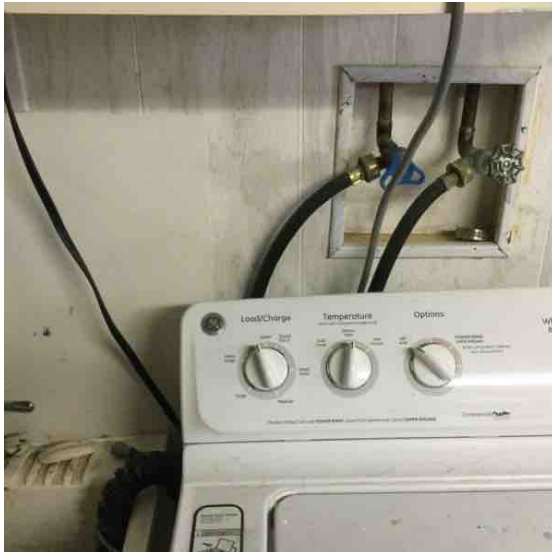
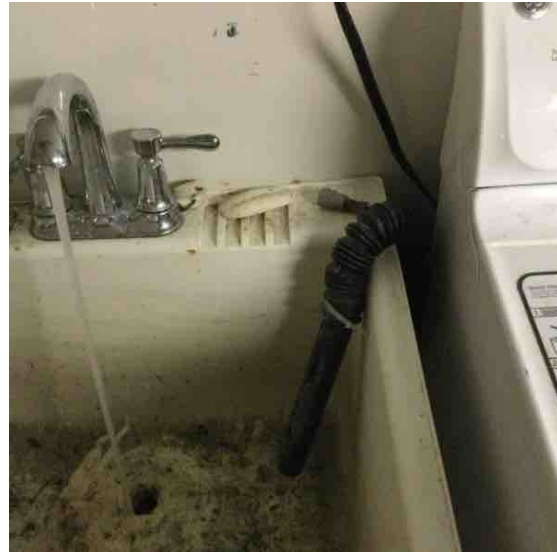
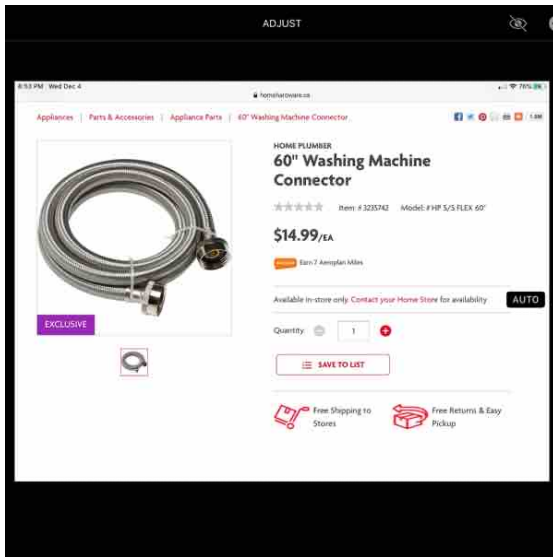
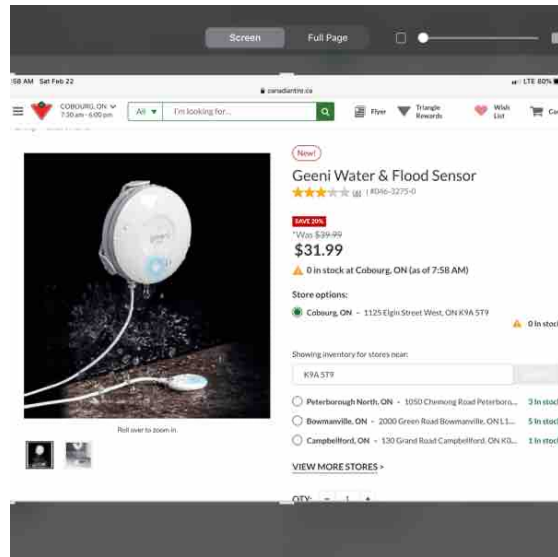
Recommended Update: Gray water for the laundry is draining into the laundry tub, to the sump pump and then to Municipal drainage. Sump pumps are not intended for this use, the phosphates are corrosive and will shorten life of the pump, adding risk to possible flooding in the basement through premature failure. Having soap residue in an open sump well also adds excessive moisture and smell into the basement space. Have a qualified contractor assess and advise on adding an approved, switched laundry pump and standpipe assembly to the laundry tub, creating a separate, sealed system for the laundry drainage. **(Utility/Laundry Room)**

Recommended Update: Gray water for the laundry is draining into the laundry tub, to the sump pump and then to Municipal drainage. Sump pumps are not intended for this use, the phosphates are corrosive and will shorten life of the pump, adding risk to possible flooding in the basement through premature failure. Having soap residue in an open sump well also adds excessive moisture and smell into the basement space. Have a qualified contractor assess and advise on adding an approved, switched laundry pump and standpipe assembly to the laundry tub, creating a separate, sealed system for the laundry drainage. (Utility/Laundry Room)

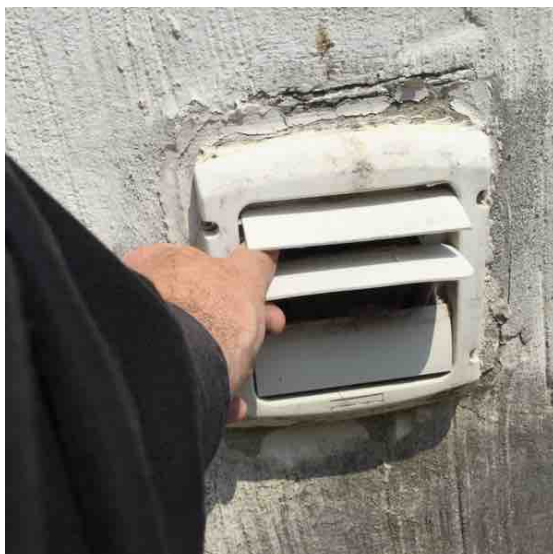
13.8.2 Maintenance Tip: Dryer vent pipes need periodic cleaning due to lint build-up. (clean this immediately) (Exterior Left)
