INSPECTION REPORT

For the Property at:
1180 PULPIT ROAD
PETERBOROUGH, ON K9J 7M7

Prepared for: TEAM VANRAHAN
Inspection Date: Thursday, August 31, 2023
Prepared by: David Sharman

RE: Report No. 4472
1180 Pulpit Road
Peterborough, ON
K9J 7M7

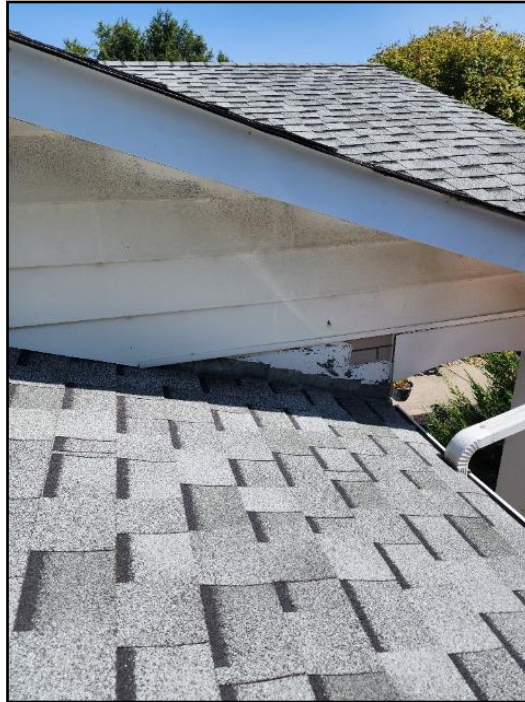
1. Condition: • No step or counter flashings

Implication(s): Chance of water damage to structure, finishes and contents

4. No step or counter flashings

Task: Provide

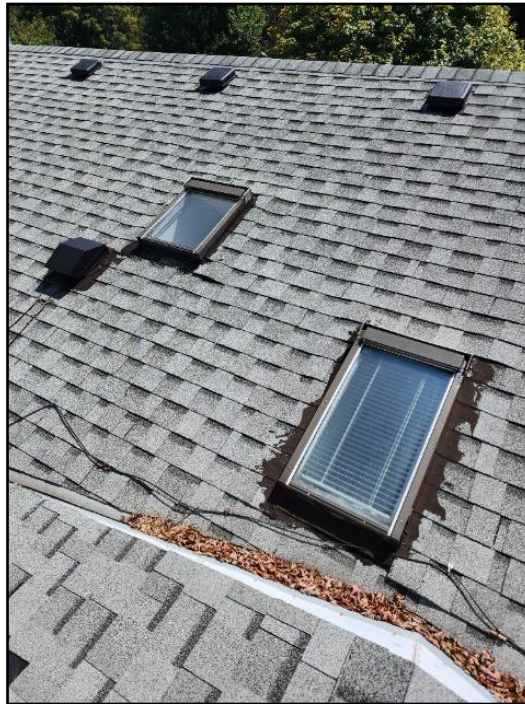
2. Condition: • Damage, patched

Implication(s): Chance of water damage to structure, finishes and contents

5. Damage, patched

Task: Monitor

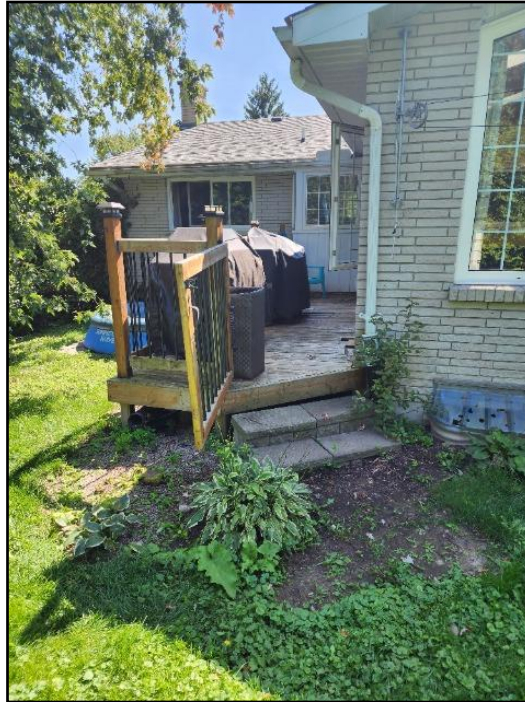
3. Condition: • Movement

6. Movement

Task: Repair

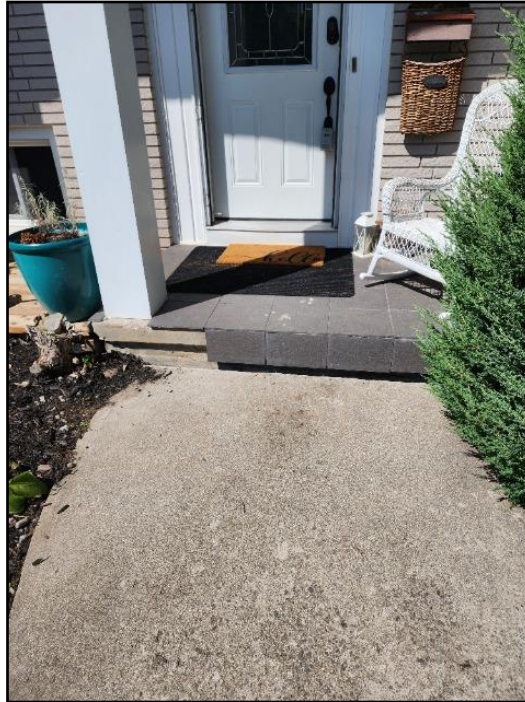
4. Condition: • Stair rise too big or not uniform

Implication(s): Trip or fall hazard

7. Stair rise too big or not uniform

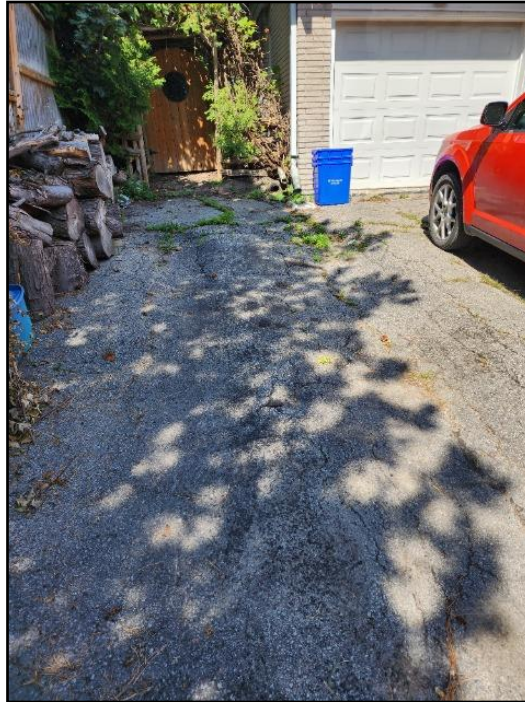
5. Condition: • Cracked or damaged surfaces

Implication(s): Material deterioration

8. Cracked or damaged surfaces

Task: Repair or replace

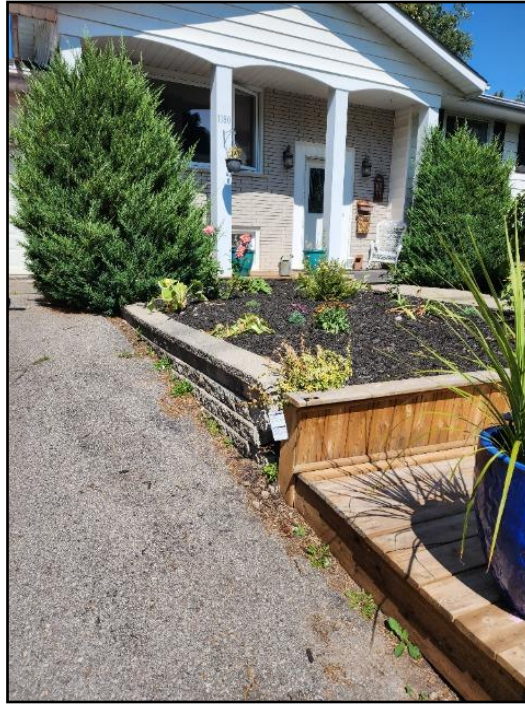
6. Condition: • Settling or shifting

9. *Settling or shifting*

Task: Repair or replace

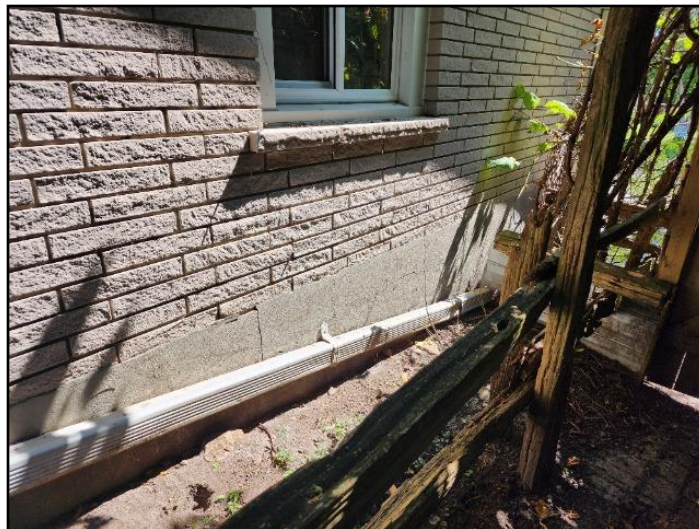
7. Condition: • Typical minor settlement

Implication(s): Potential for frost damage & material deterioration

10. Typical minor settlement

Task: Repair

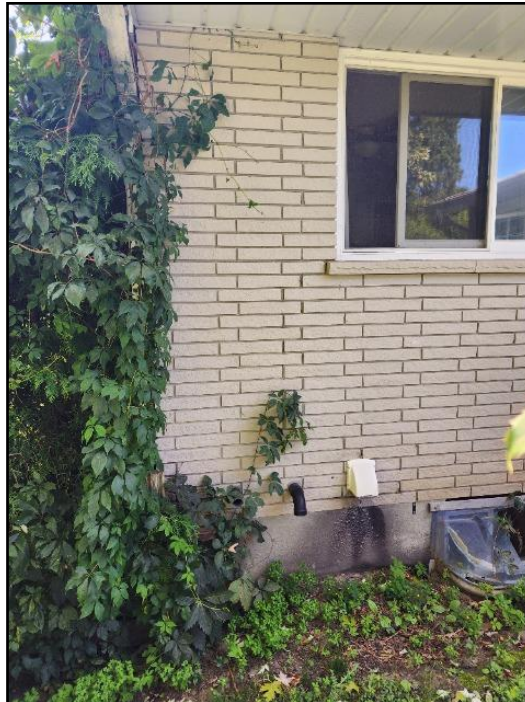
9. Condition: • Typical minor cracks

Implication(s): Chance of frost damage & material deterioration

11. *Typical minor cracks*

Task: Repair

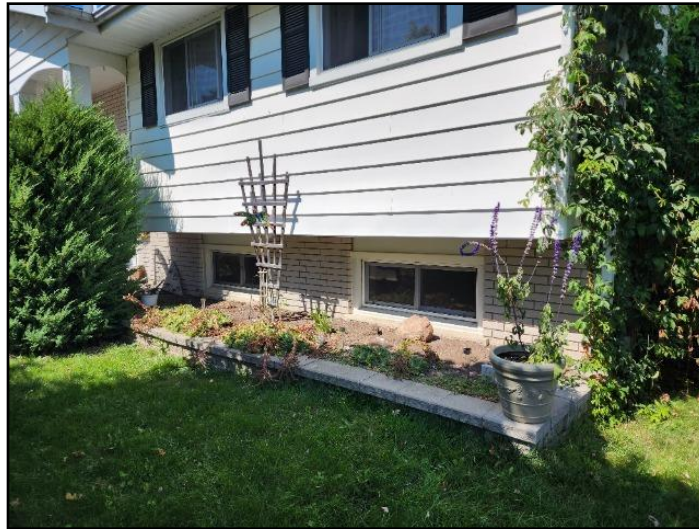
10. Condition: • Masonry or wood too close to grade

Implication(s): Chance of damage to structure

12. Masonry or wood too close to grade

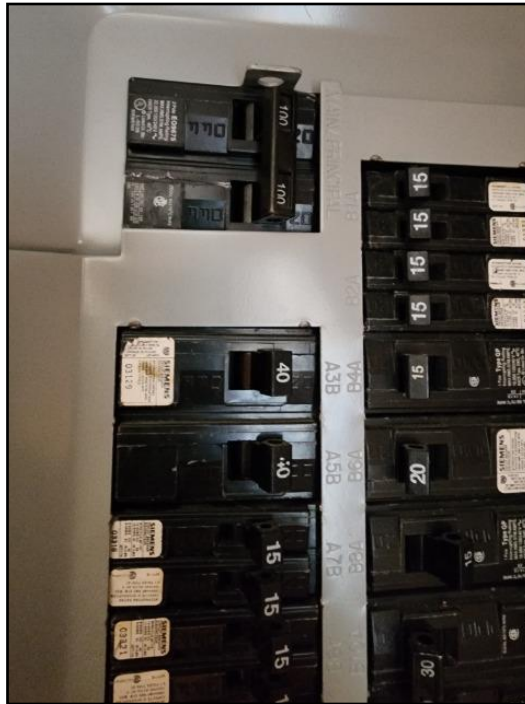
11. Condition: • Breaker bridge missing

16. Breaker bridge missing

Task: Repair or replace

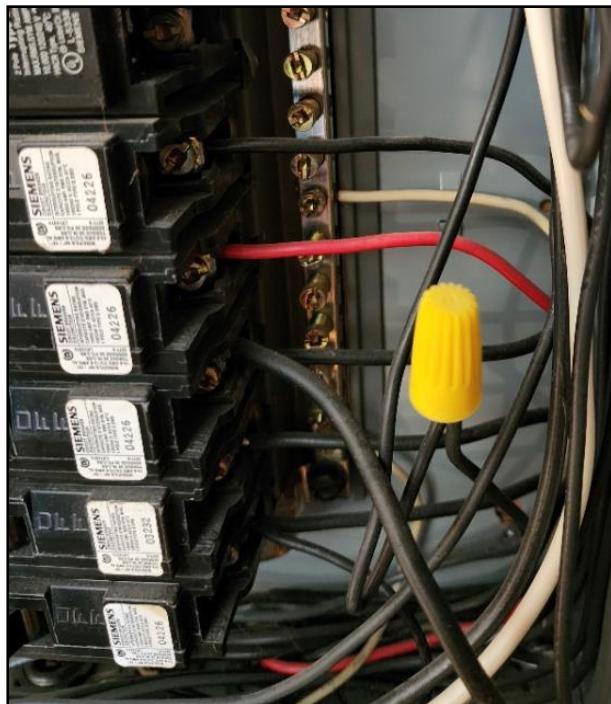
12. Condition: • Double taps

Implication(s): Fire hazard

17. Double taps

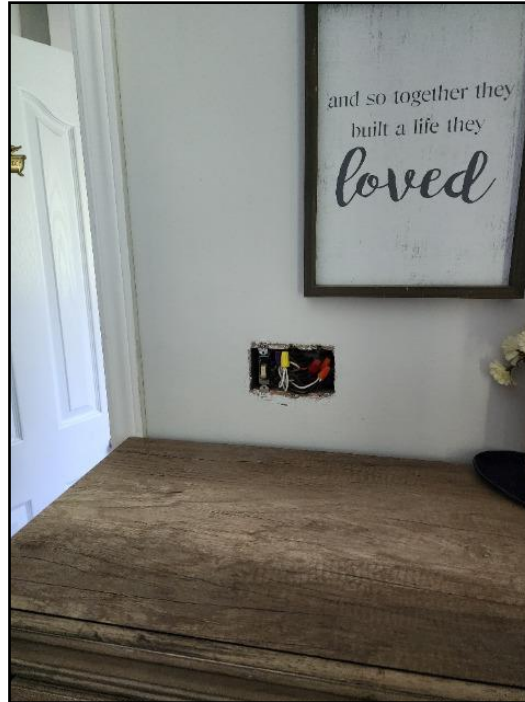
13. Condition: • Cover loose or missing

Implication(s): Fire hazard | Electric shock

18. Cover loose or missing

Task: Replace

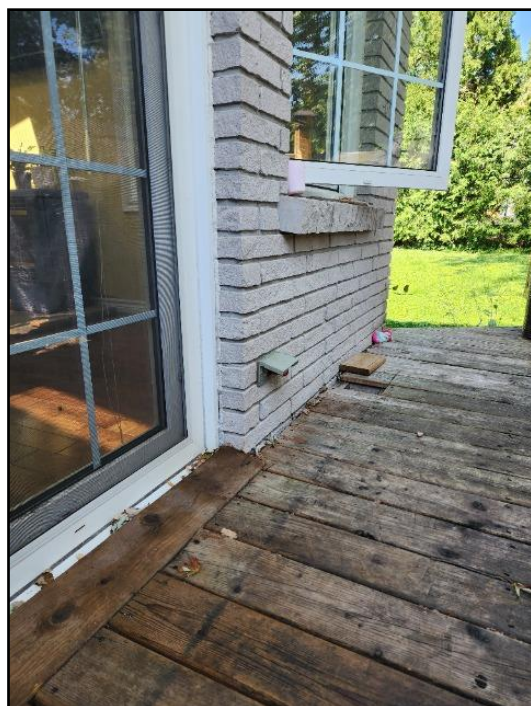
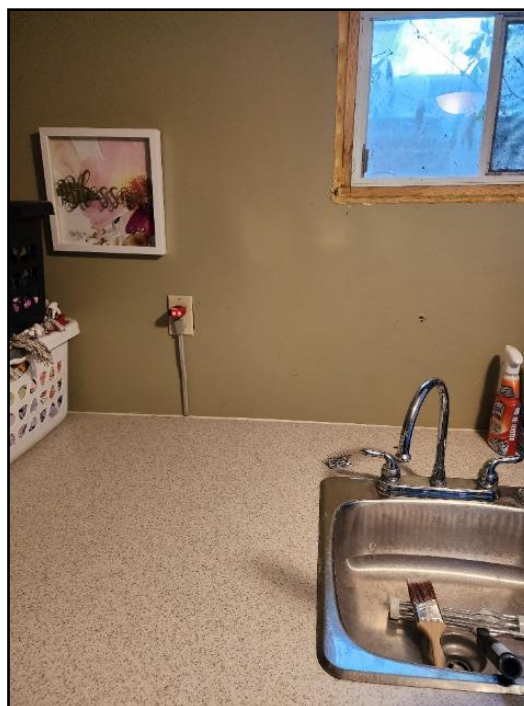
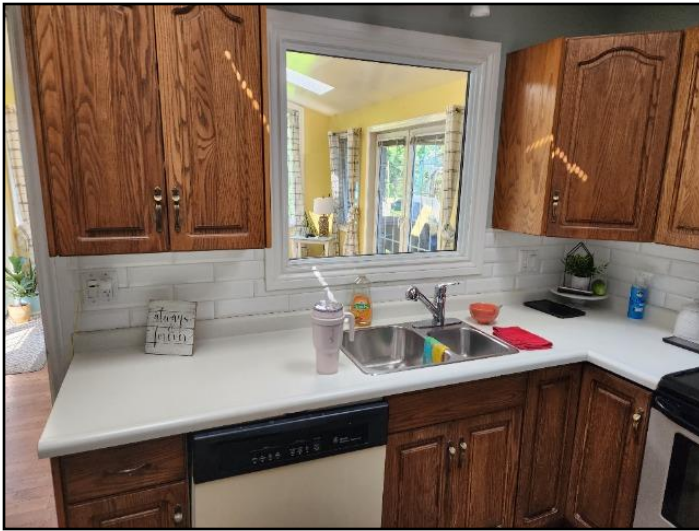
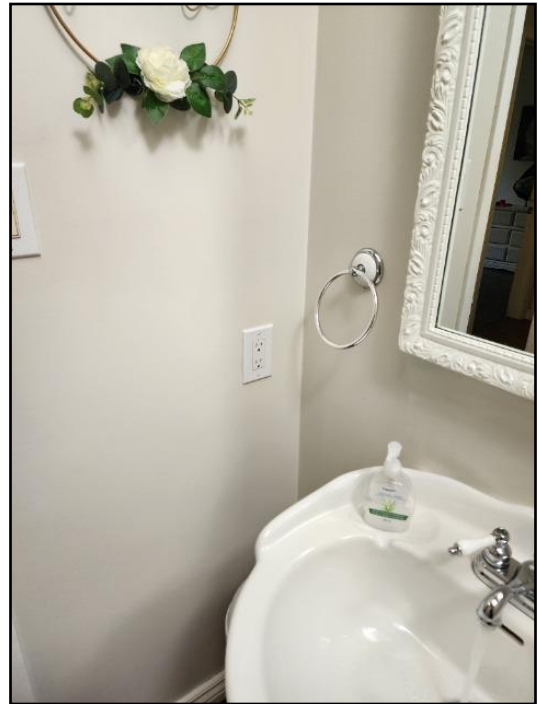
14. Condition: • No GFCI/GFI (Ground Fault Circuit Interrupter)

Although not a deficiency in a home of this age, safety may be improved by upgrading these receptacles.

19. No GFCI/GFI (Ground Fault Circuit...

22. No GFCI/GFI (Ground Fault Circuit...

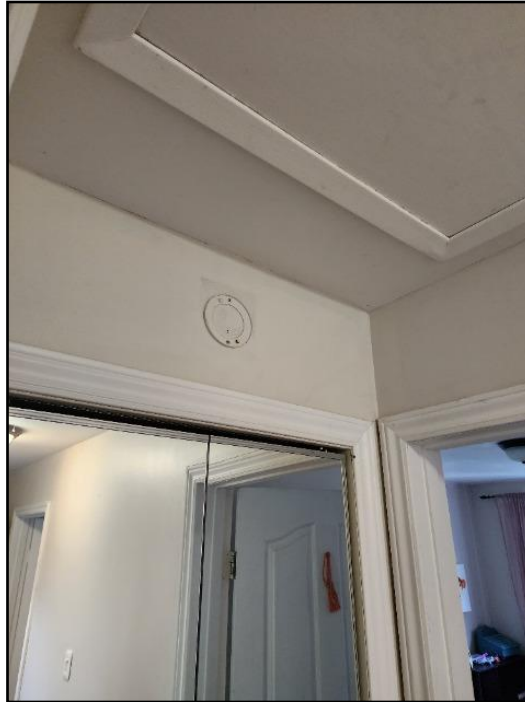
15. Condition: • Missing

23. Missing

Task: Replace

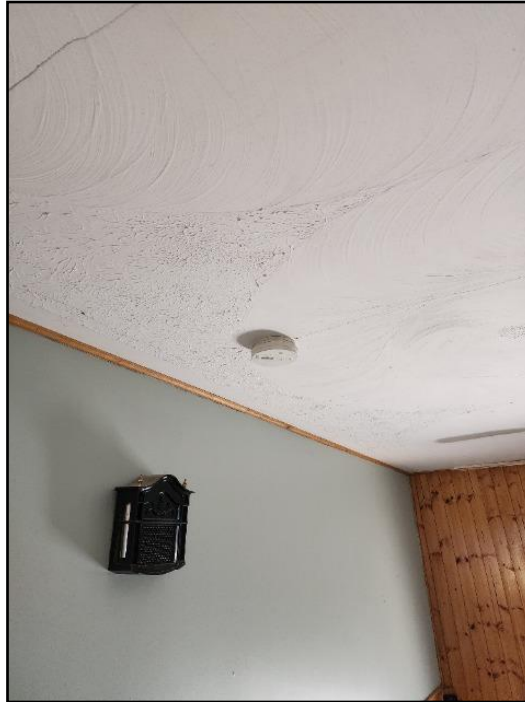
16. Condition: • More than 10 years old

Implication(s): Life safety hazard

24. More than 10 years old

Task: Replace

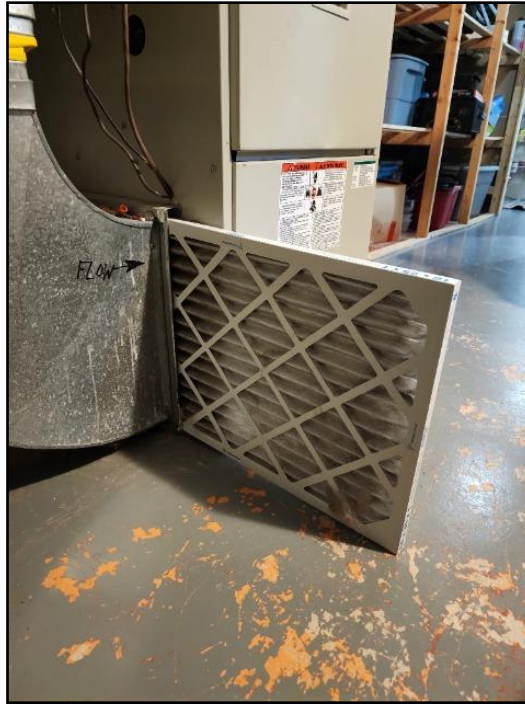
18. Condition: • Replace - regular maintenance

34. Replace - regular maintenance

Task: Replace

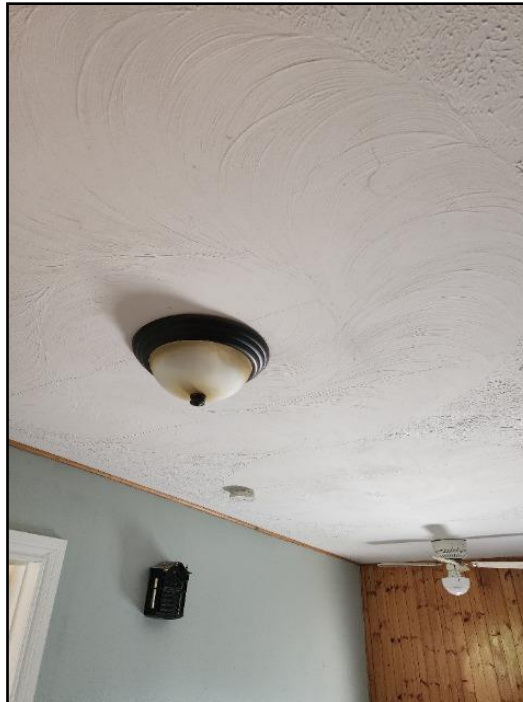
22. Condition: • Cracks

Implication(s): Damage or physical injury due to falling materials

42. Cracks

Task: Repair

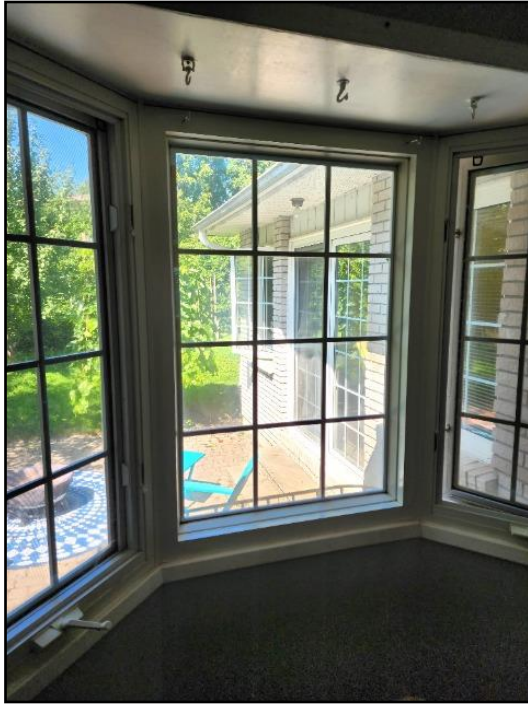
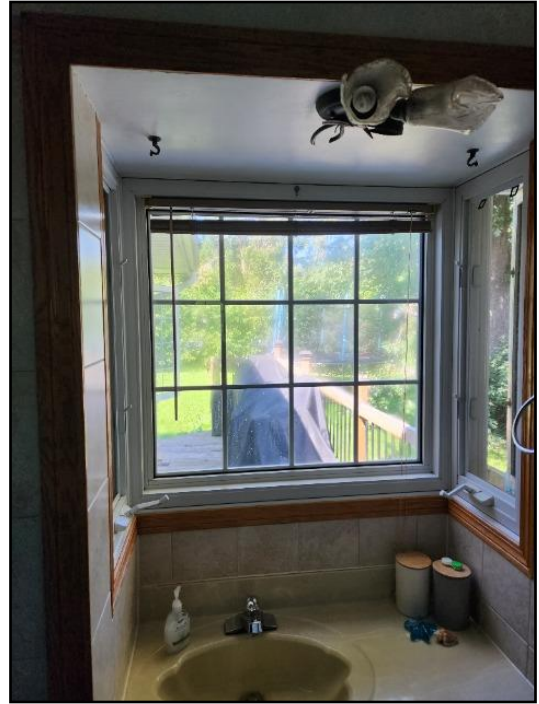
23. Condition: • Lost seal on double glazing

43. Lost seal on double glazing

Task: Repair or replace

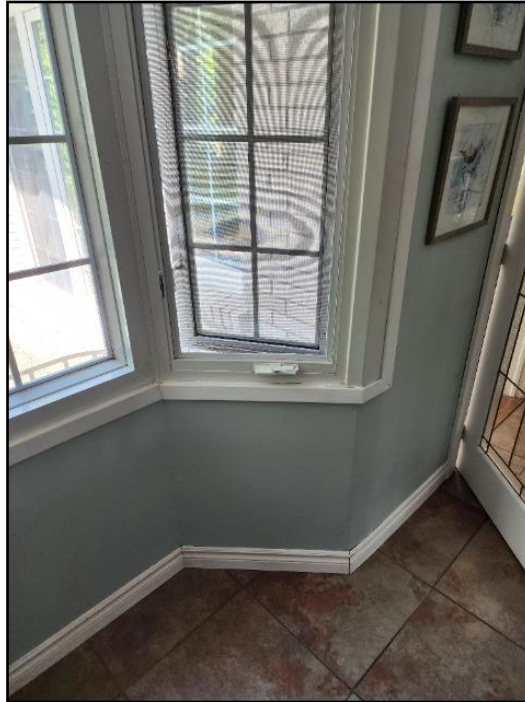
24. Condition: • Missing/damaged

45. Missing/damaged

Task: Repair or replace

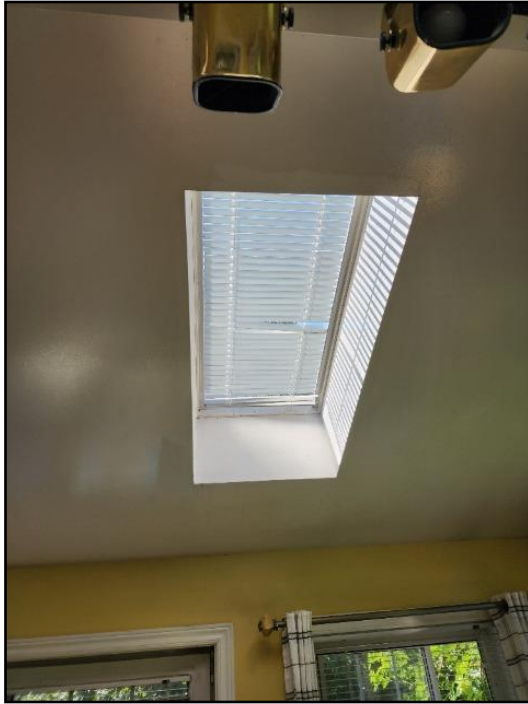
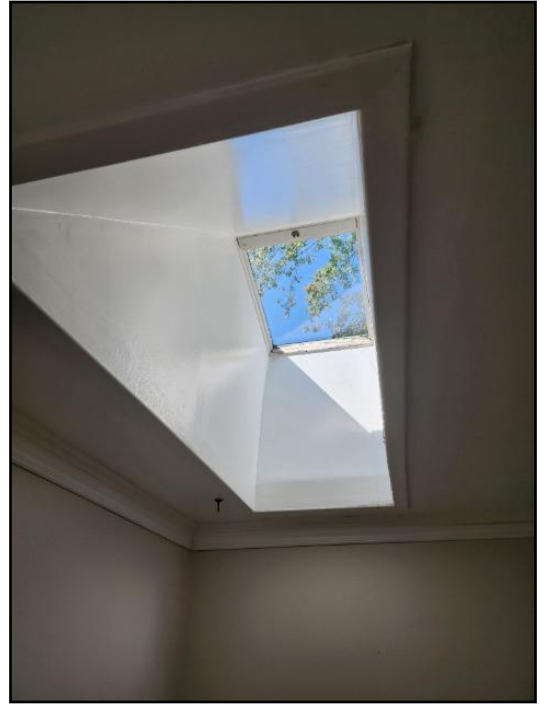
27. Condition: • Water damage

Implication(s): Chance of water damage to structure, finishes and contents

46. Water damage

Task: Repair

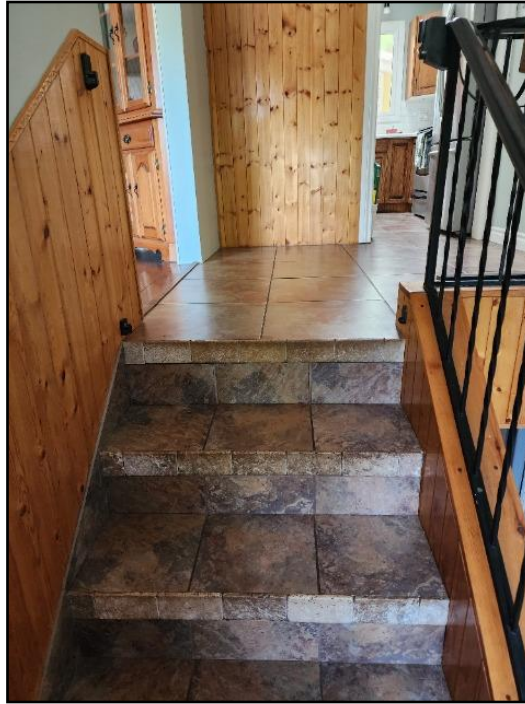
28. Condition: • Rise excessive

Implication(s): Trip or fall hazard

48. Rise excessive

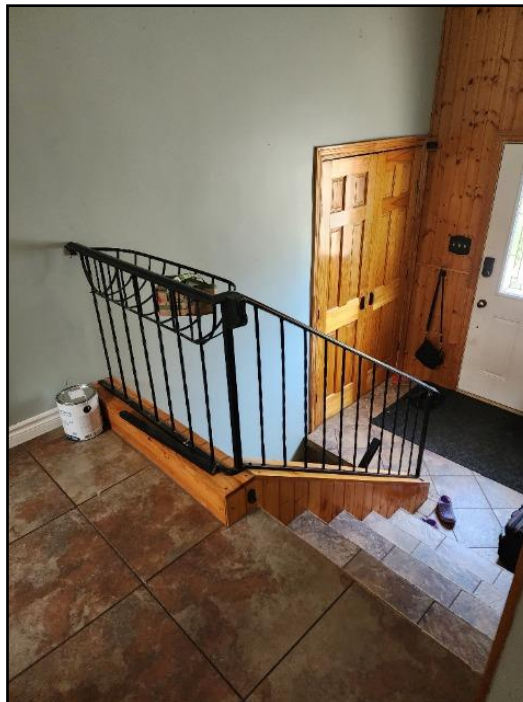
29. Condition: • Too far apart

Implication(s): Fall hazard

49. Too far apart
