# INSPECTION REPORT

For the Property at:  
**620 GOODWIN TERRACE**  
PETERBOROUGH, ON K9J 6X3

RE: Report No. 5117  
620 Goodwin Terrace  
Peterborough, ON  
K9J 6X3

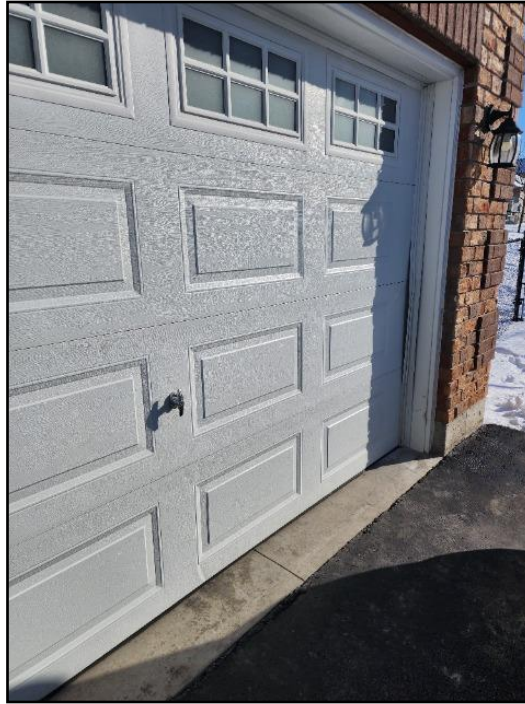
**2. Condition:** • Damage

1. *Damage*

**Task:** Repair

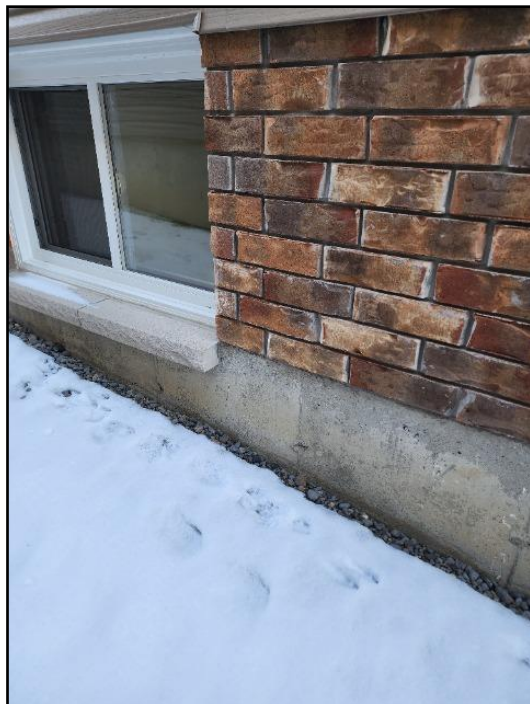
**3. Condition:** • Typical minor cracks  
**Implication(s):** Material deterioration  
**Location:** Various locations  
**Task:** Monitor  
**Time:** Ongoing

2. Typical minor cracks

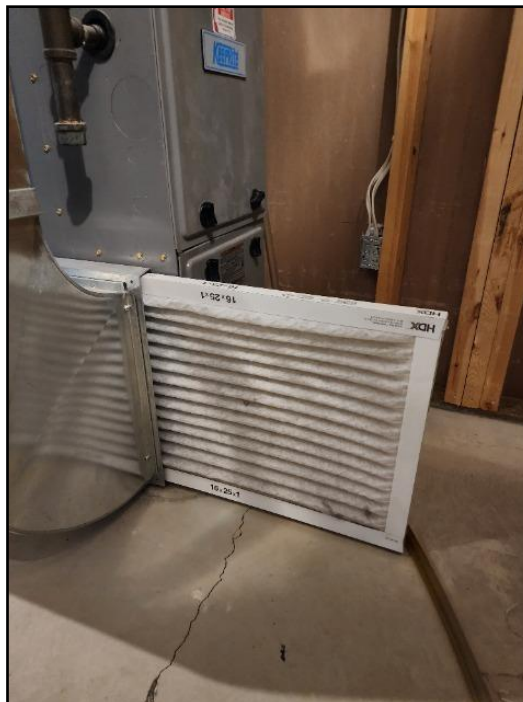
**6. Condition:** • Replace - regular maintenance

**Implication(s):** Increased heating & maintenance costs, Reduced comfort

13. Replace - regular maintenance

**Task:** Replace - regular maintenance

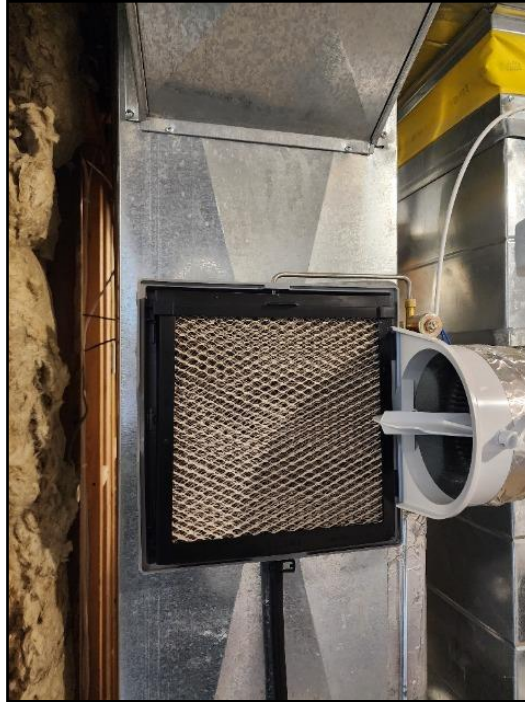
**7. Condition:** • Clean pad/mesh - regular maintenance

**Implication(s):** Equipment not operating properly

14. Clean pad/mesh - regular maintenance

**Task:** Clean - regular maintenance

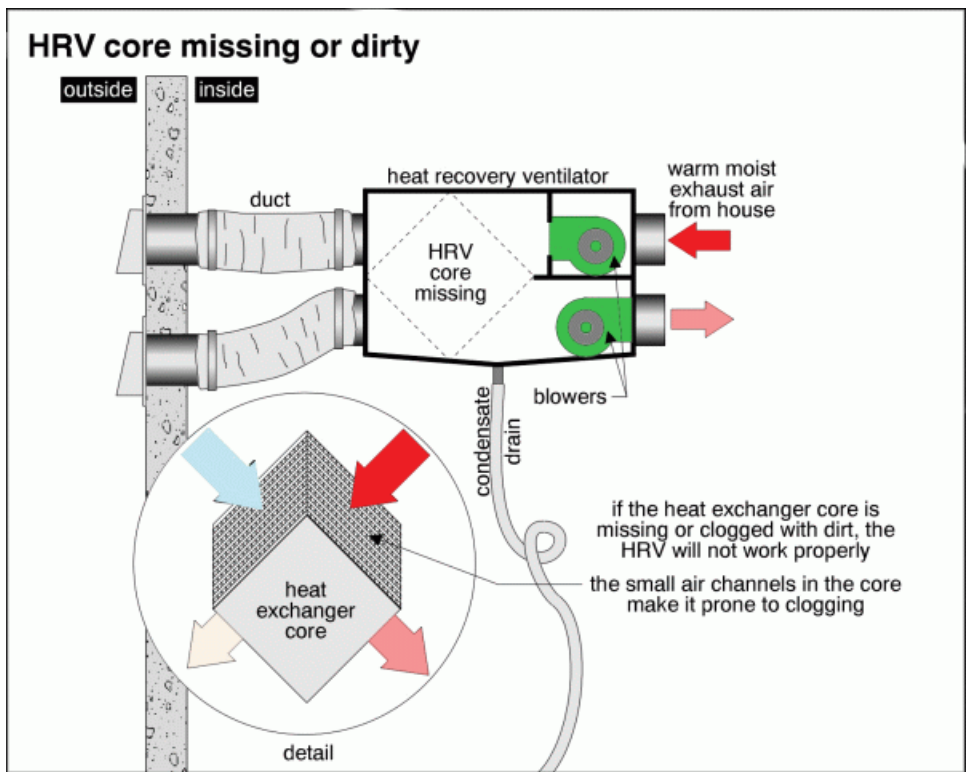
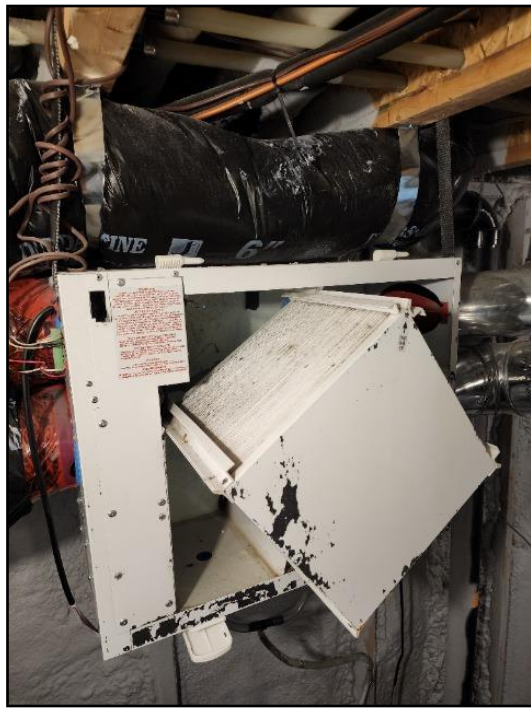
**8. Condition:** • Clean core - regular maintenance

**Implication(s):** Reduced operability & comfort

15. Clean core - regular maintenance

**Task:** Clean - regular maintenance

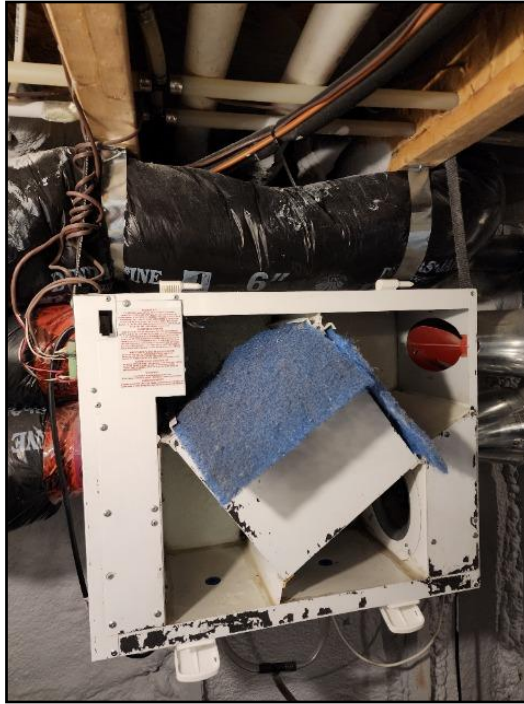
9. Condition: • Clean filters - regular maintenance

**Implication(s):** Reduced operability & comfort

16. Clean filters - regular maintenance

**Task:** Clean - regular maintenance
