SELLER'S DISCLOSURE NOTICE

CONCERNING THE PROPERTY AT **7108 Eagles Ridge Court, Argyle, Texas 76226**

LIMITED SITE INVESTIGATION

Enslin Residence
7108 Eagles Ridge Ct.
Argyle, Texas 76226
PSE Project Number: 22-0414-N1

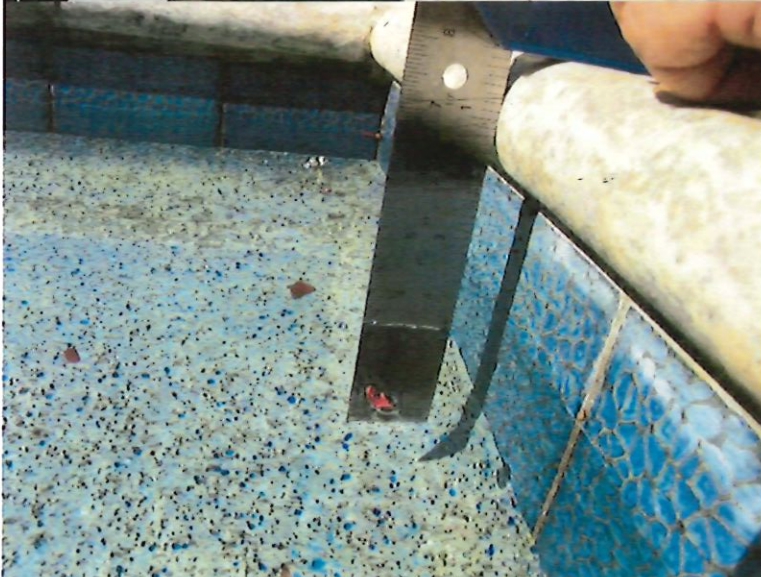
6. Water level at southwest corner of pool measures 4.5" below top of coping.

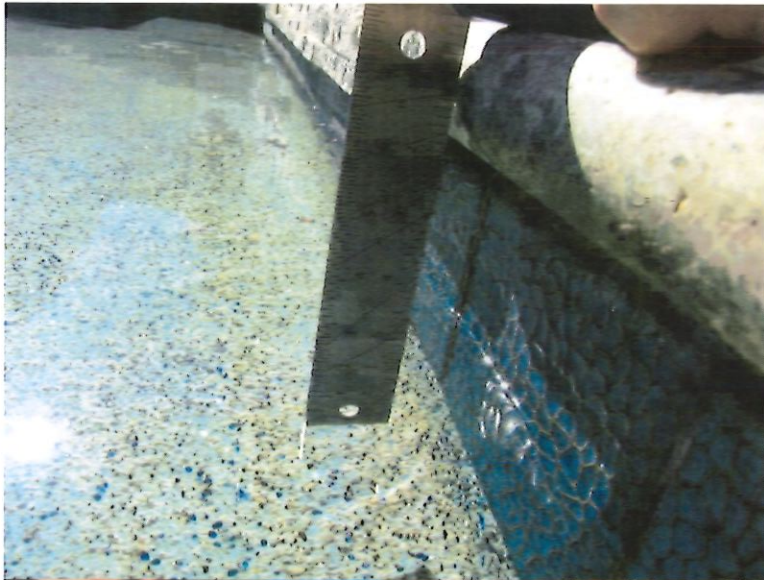
7. Water level at west side of fireplace measures 5-1/16" below top of coping.

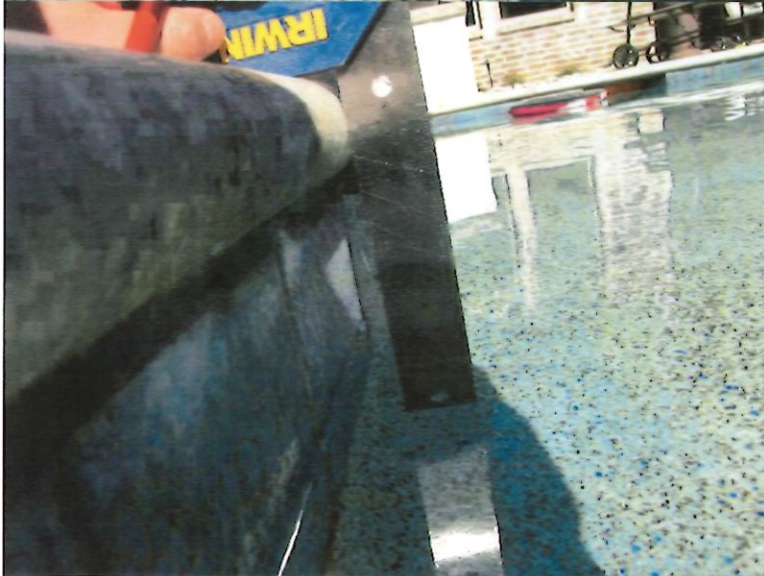
8. Water level at east side of fireplace measures 5-3/4" below top of coping.

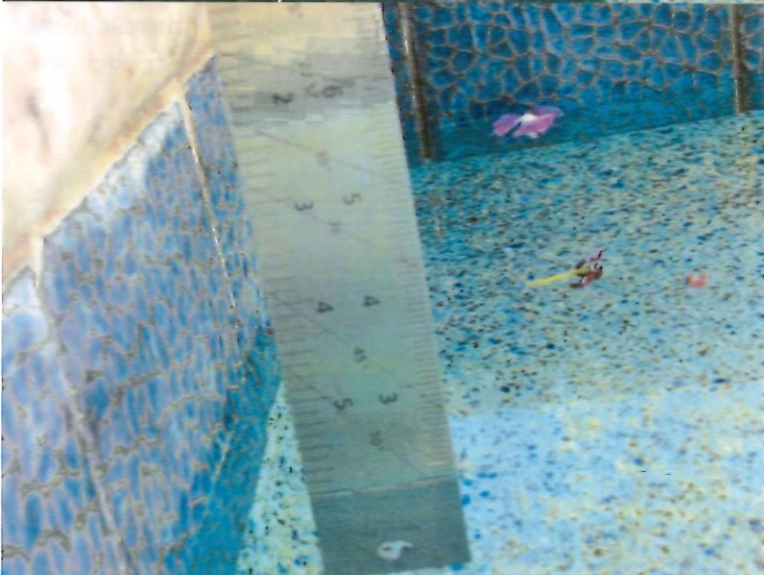
9. Water level at southeast corner measures 6" below top of coping.

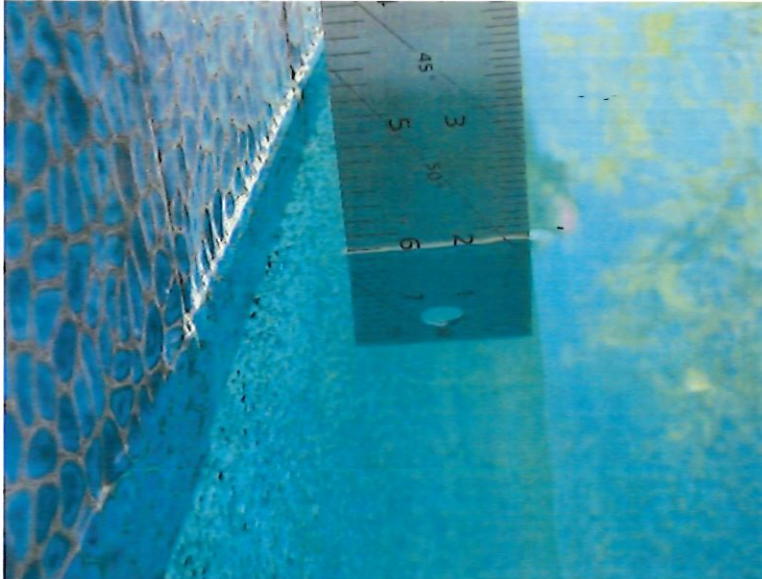
10. Water level at quarter point from south perimeter, east side, measures 6-1/8" below top of coping.

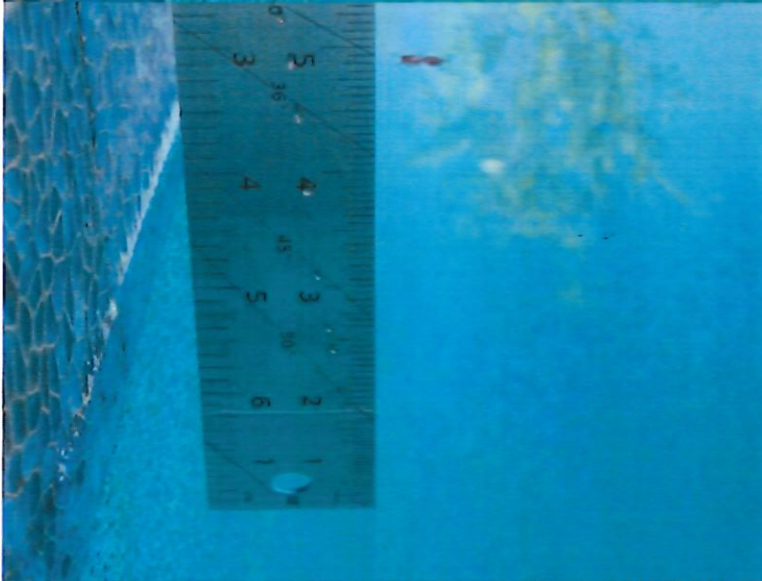
11. Water level at midpoint along east elevation measures 6-1/4" below top of coping.

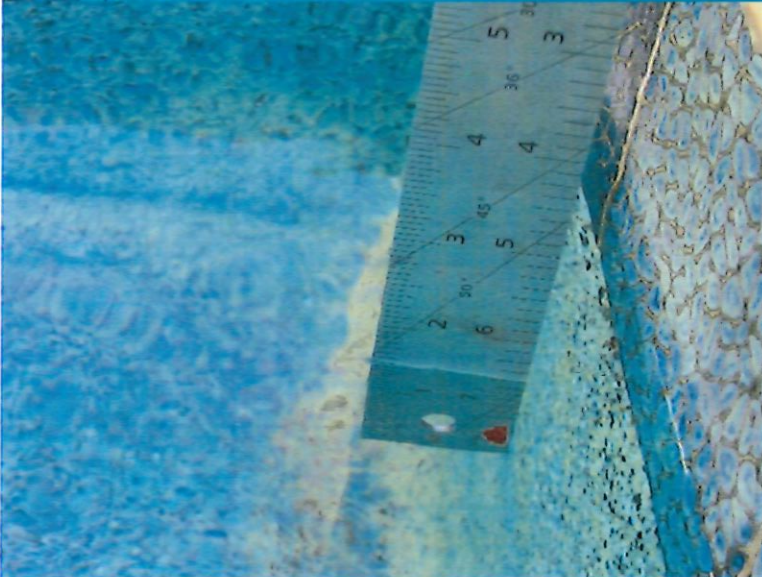
12. Water level at northeast corner measures 6-1/2" below top of coping.

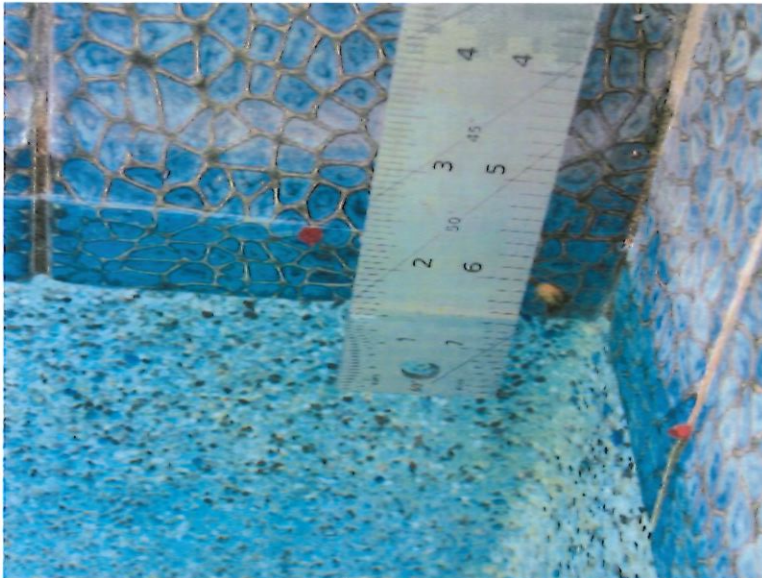
13. Water level at pool at east side of spa at northeast corner measures 6-1/2" below top of coping.

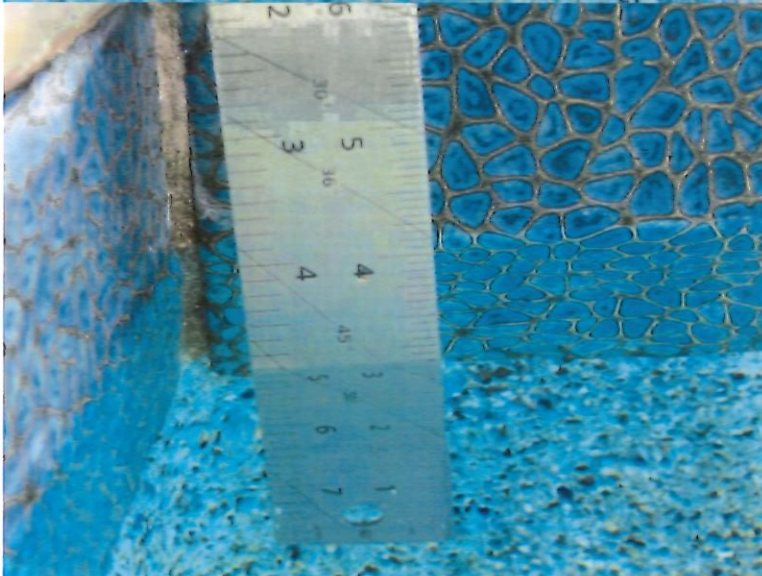
14. Water level at southeast corner of spa measures 4-7/8" below top of coping.

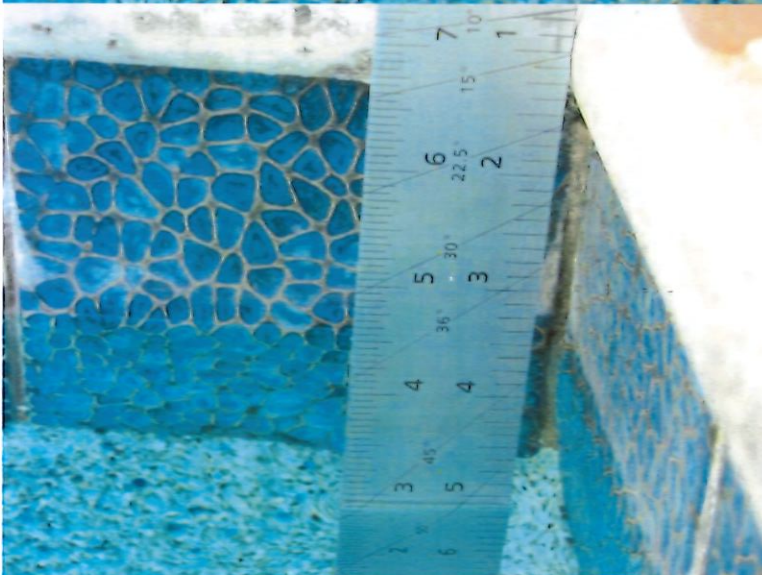
15. Water level at northeast corner of spa measures 5" below top of coping.

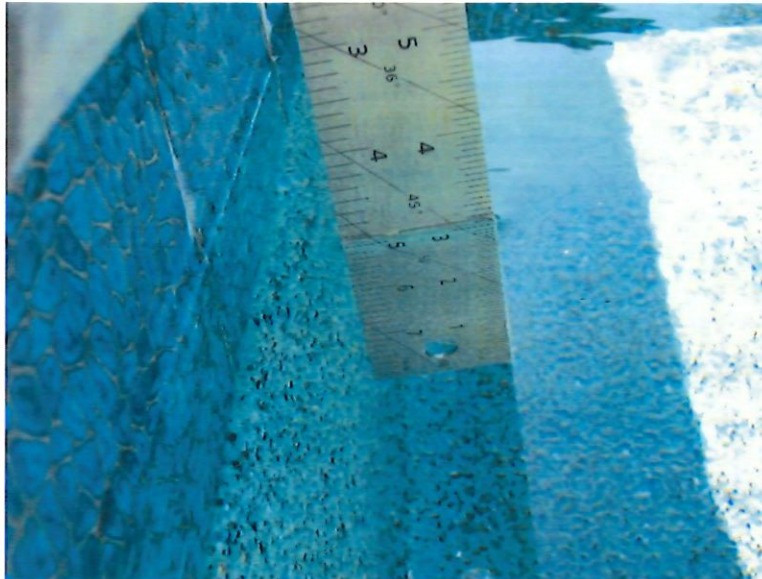
16. Water level at midpoint along northern perimeter of spa measures 4-7/8" below top of coping.

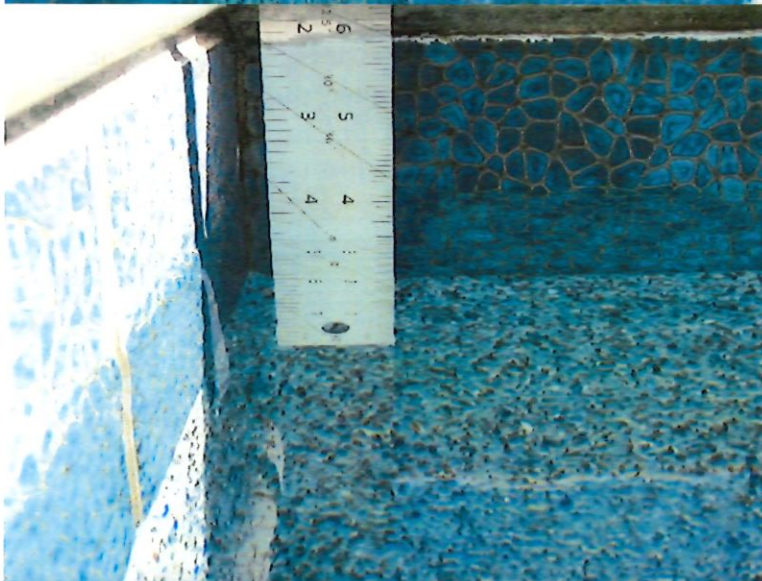
17. Water level at northwest corner of spa measures 4-5/8" below top of coping.

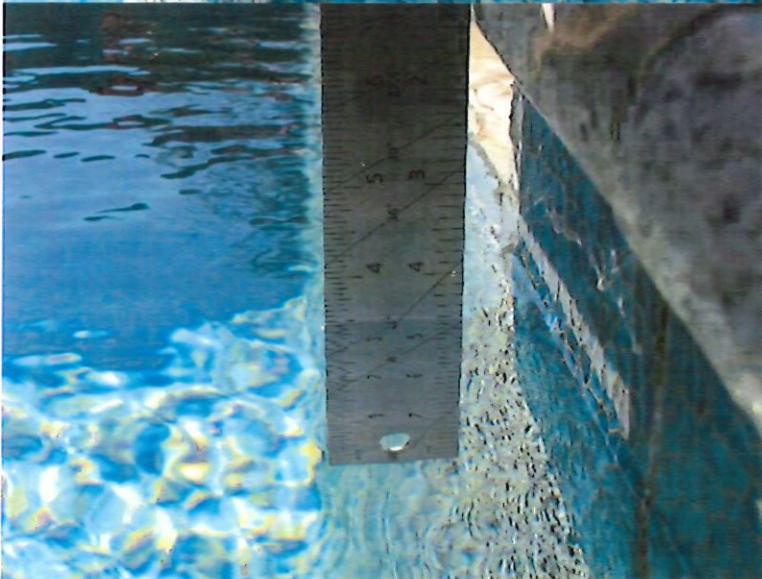
18. Water level at southwest corner of spa measures 4-1/2" below top of coping.

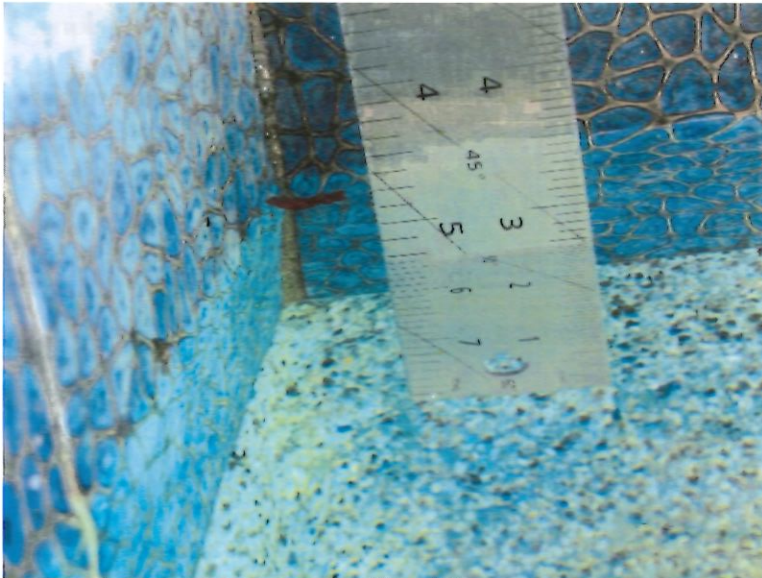
19. Water level at west side of spa at pool measures 5-1/4" below top of coping.

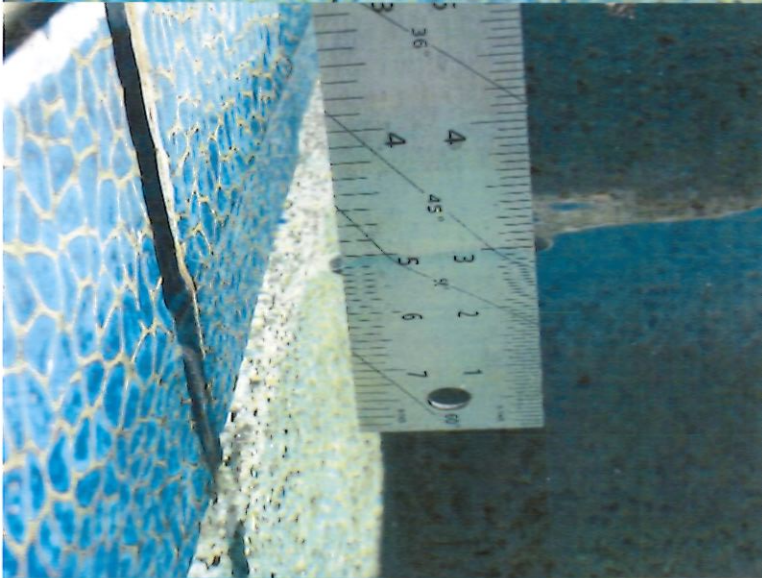
20. Water level at northwest corner measures 5" below top of coping.

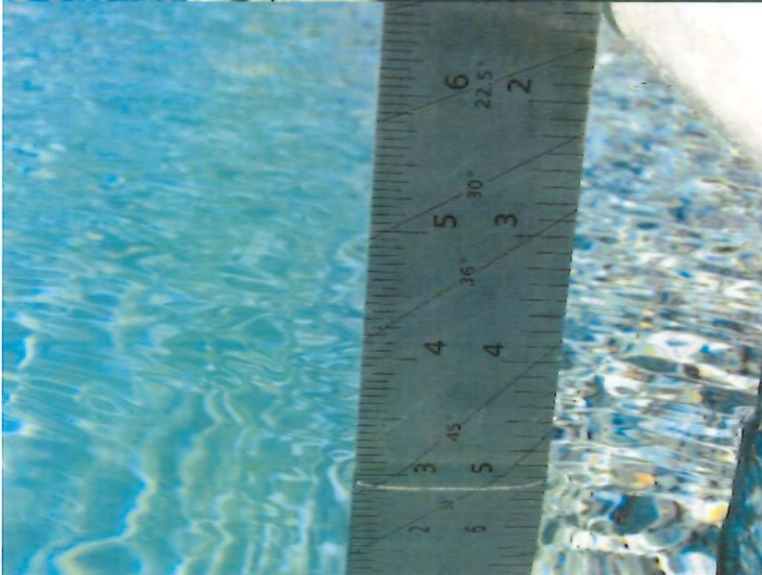
21. Water level at northeast corner of tanning ledge measures 4-7/8" below top of coping.

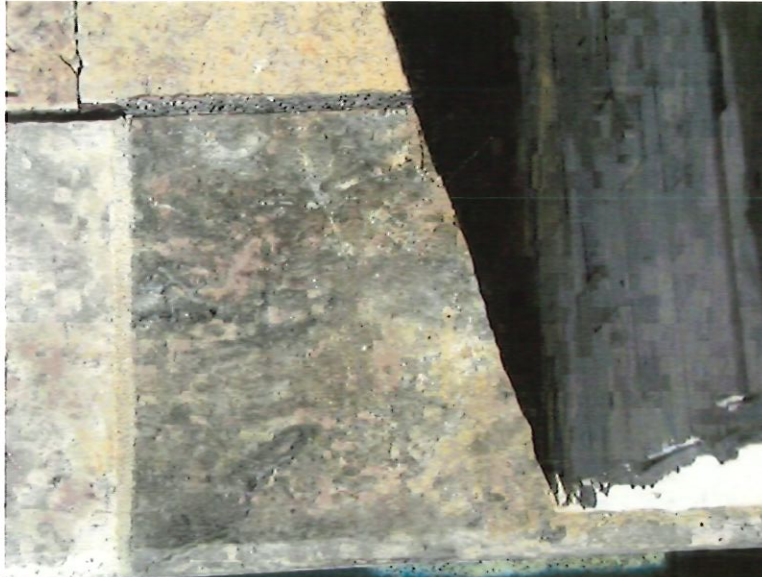
28. Cracked coping tile at same location from prior photograph.

4. PSE is of the opinion that an expansion/movement joint should be installed between the coping and the deck pavers along the west perimeter of the pool. The pavers should be cut back, and the joint filled with backer rod and a flexible sealant. In addition, PSE recommends cosmetic repairs to the coping and pool tile along the west perimeter of the pool.

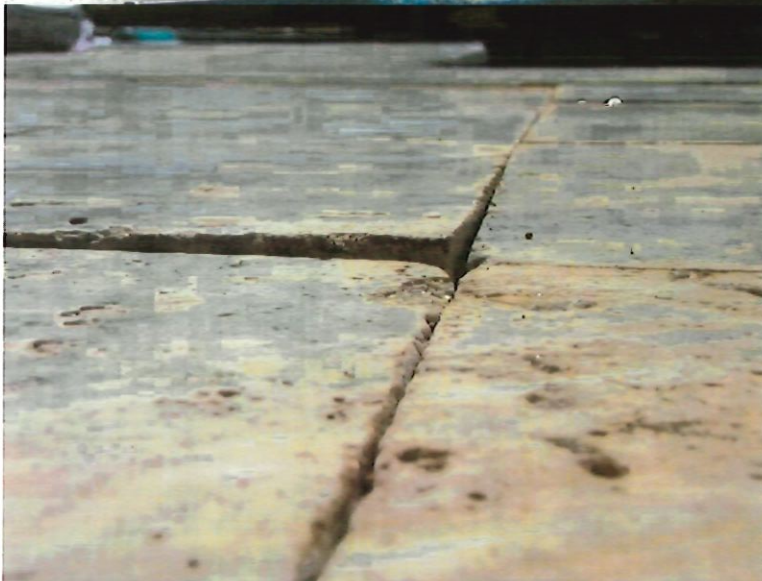
3. PSE is of the opinion that the soil-related differential movement of the pool is causally related to distress observed in the paver pool deck located adjacent to the west perimeter of the pool.

29. Diselevation at paver along west side of tanning area.

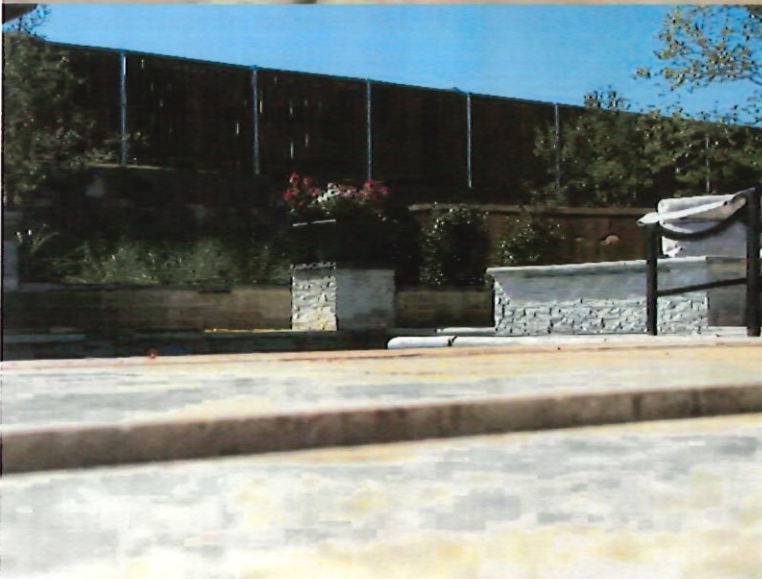
30. Diselevation at paver along west side of tanning area.

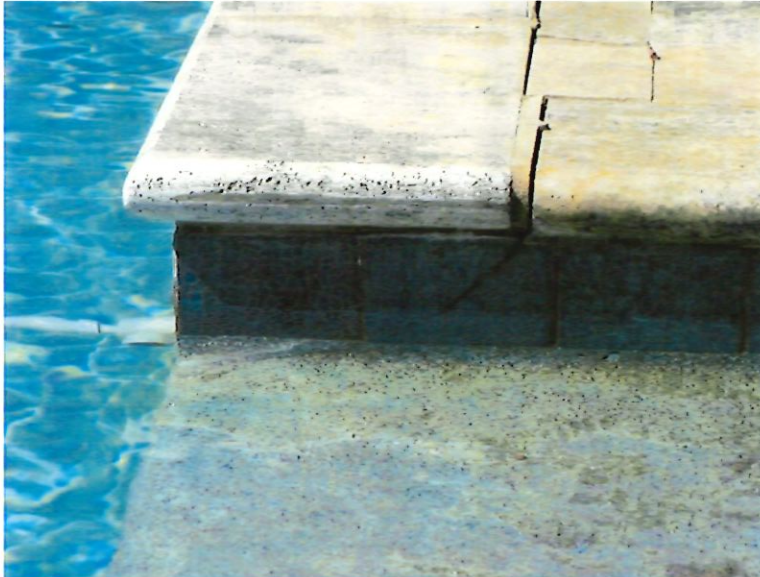
34. Cracked mortar and tile at southeast corner of tanning area.

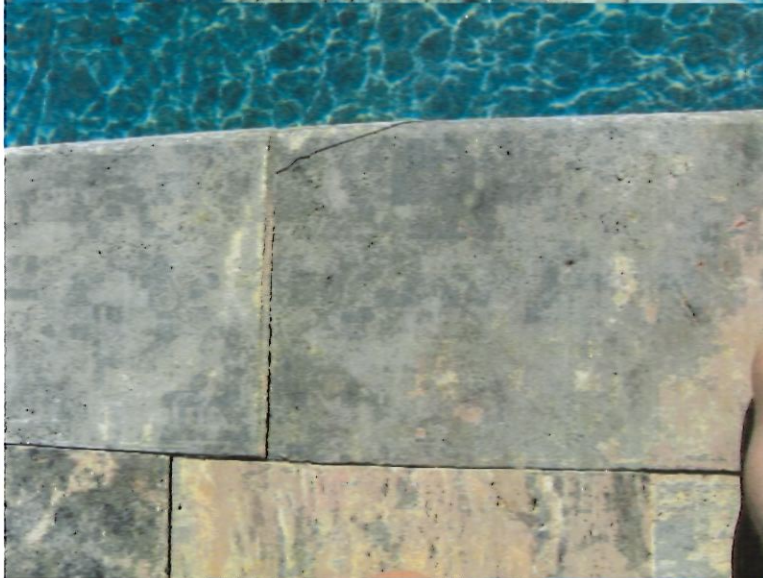
- Cracked coping along the west perimeter (refer to Photographs 28, 38, and 39 in Appendix 1).

38. Cracked coping ledge at southwest corner of pool.

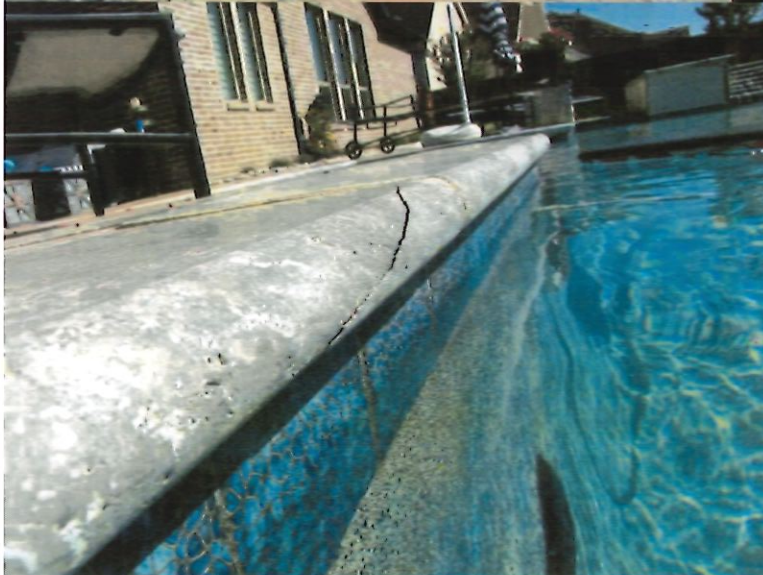
39. Cracked coping ledge at southwest corner of pool.

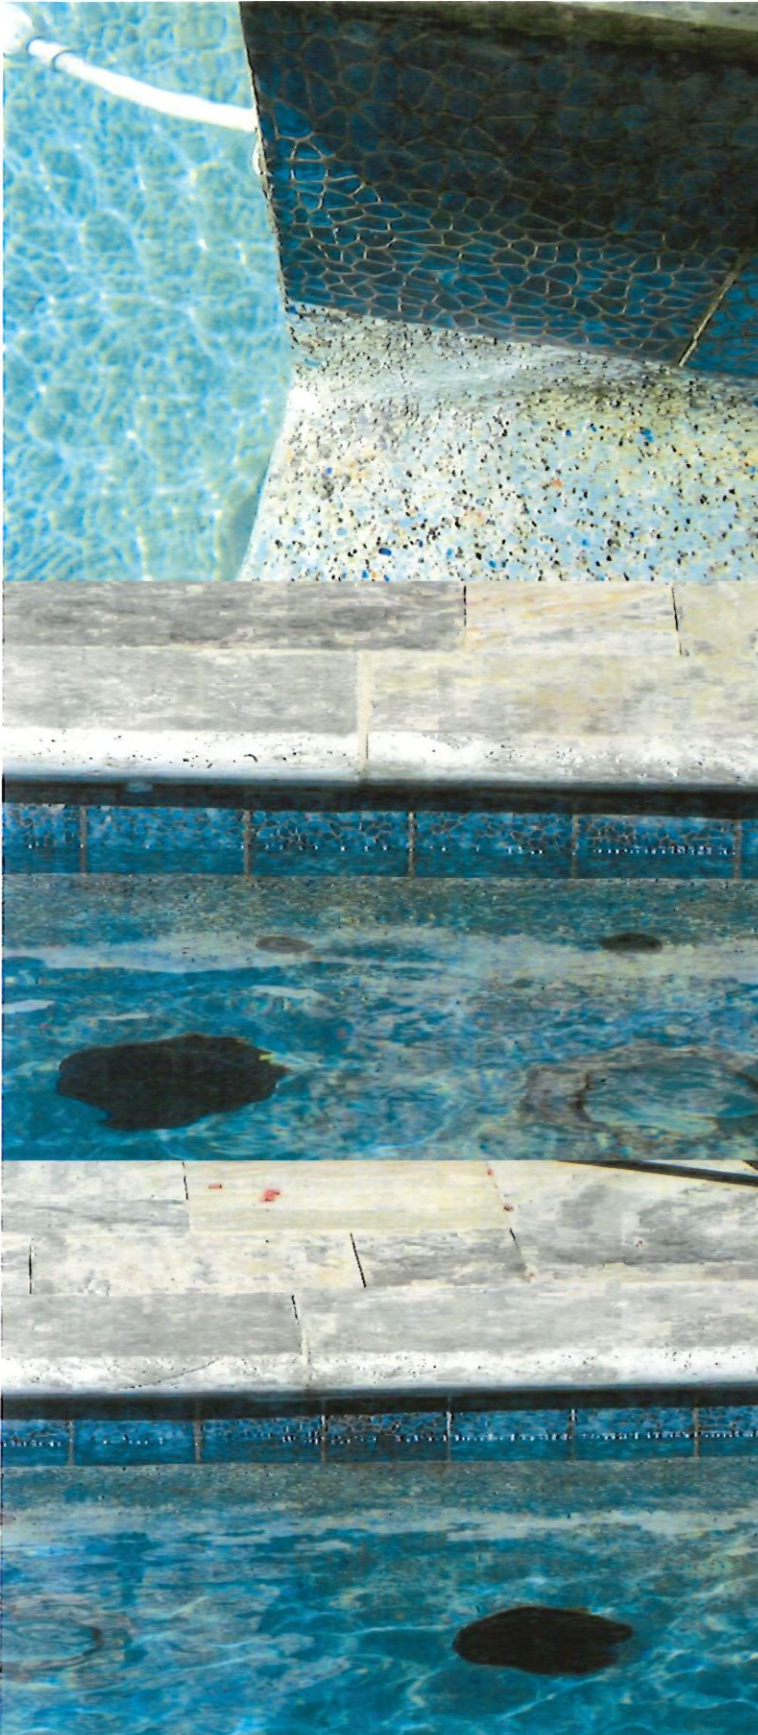
40. Crack in pool shell at southeast corner of tanning area.

7. In order to repair the distress in the pool shell/tile/coping, it is recommended to remove the pool finished (coping, tile, plaster) at the locations where there are cracks in the shell (west perimeter near tanning ledge) in order to allow access to the pool shell to repair the cracks at this location. To repair cracks that exhibit an out-of-plane offset across the crack, it is anticipated the the pool shell above the location of the crack will need to be removed and re-constructed. It is recommended that any new portions of the pool shell be properly connected to the existing pool shell with steel reinforcement, doweled and epoxied, into the existing pool shell.

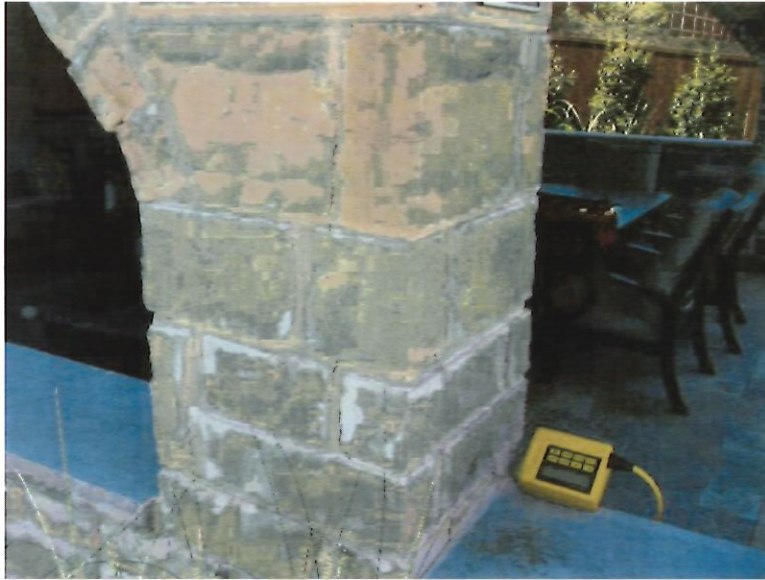
52. Mortar separation at northwest column of gazebo.

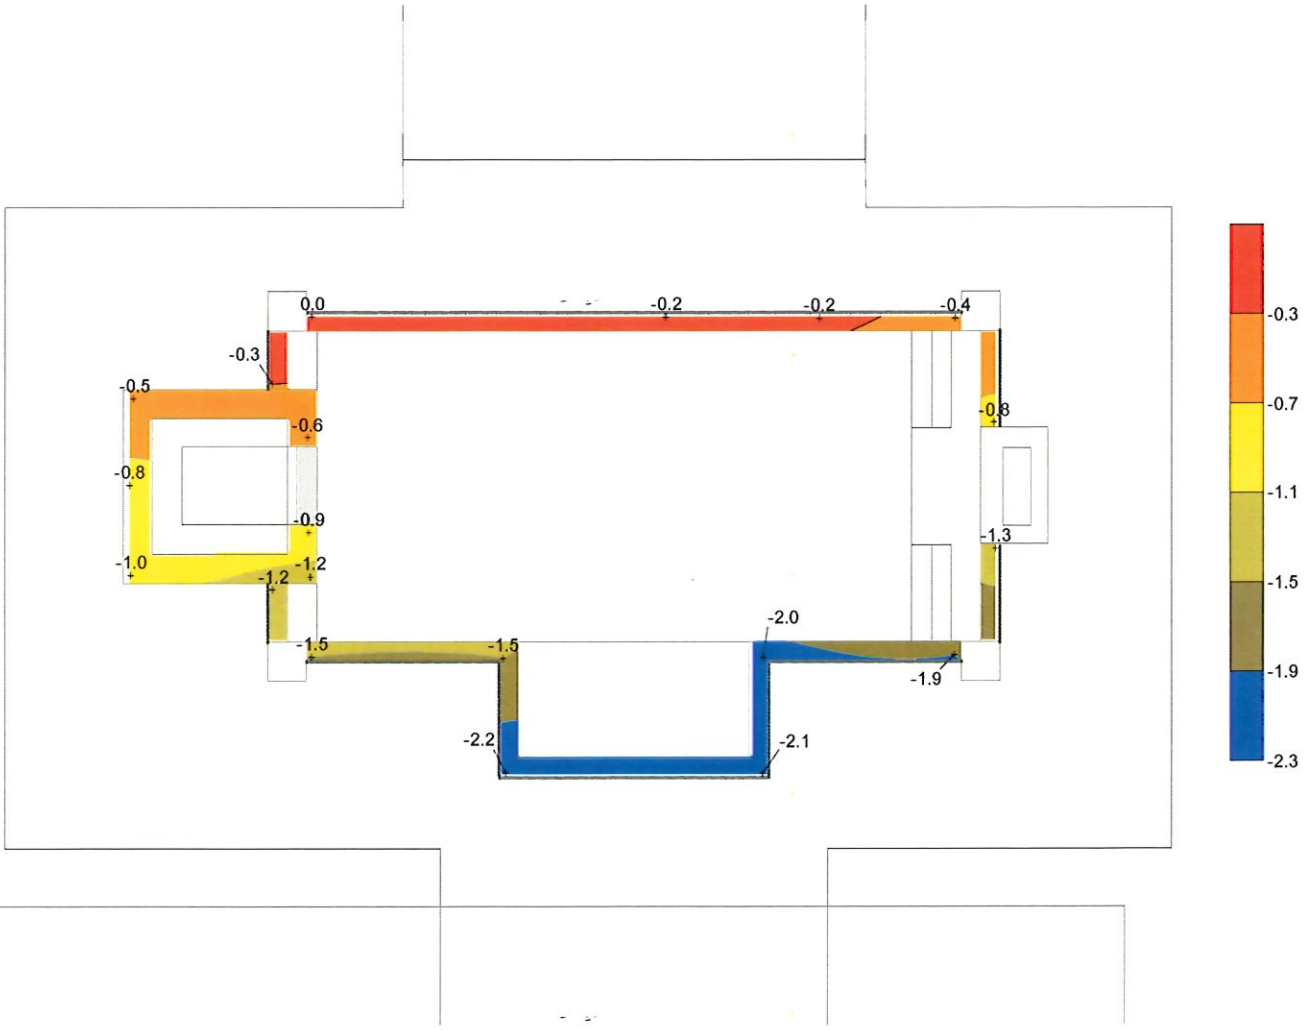
PROJECT NUMBER: 22-0414-N1 SHEET S-1

1. PSE is of the opinion that the pool at the referenced address has likely experienced upward differential movement (i.e. heave) along the eastern portion of the pool structure due to moisture-induced expansion of the supporting soils such that the pool has tilted/rotated toward the house.
