# Inspection Report

5135 Parker St  
Omaha NE 68104

**AmeriSpec Inspection Services**

<b>Date:</b> 5/8/2025	<b>Time:</b> 08:00:00 AM	<b>Report ID:</b> 42560
<b>Property:</b> 5135 Parker St Omaha NE 68104	<b>Customer:</b> Chris Holbeck	<b>Real Estate Professional:</b>

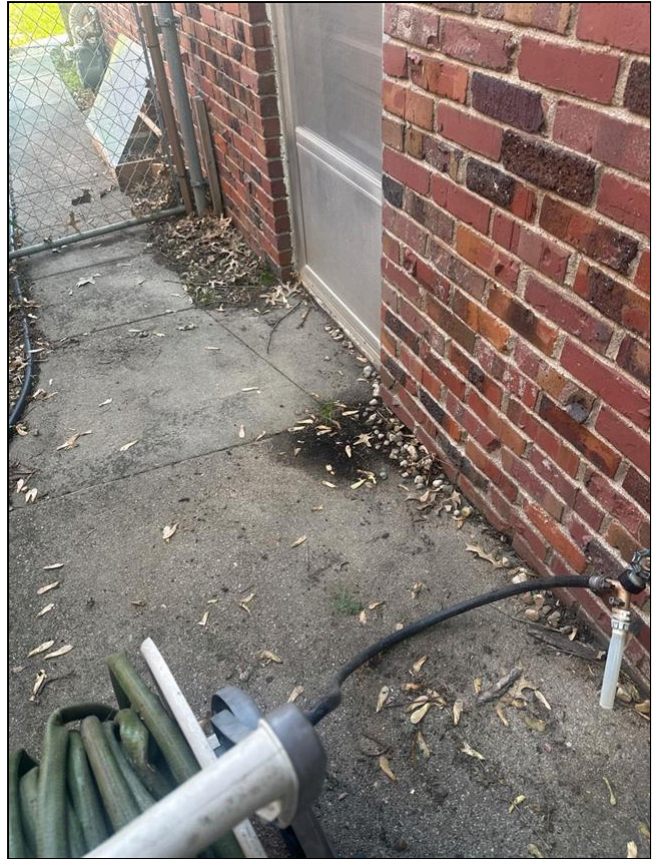
Settlement noticed at the concrete walkways. Recommend repairs needed to prevent further damage and possible pooling near the foundation and possible trip hazards.

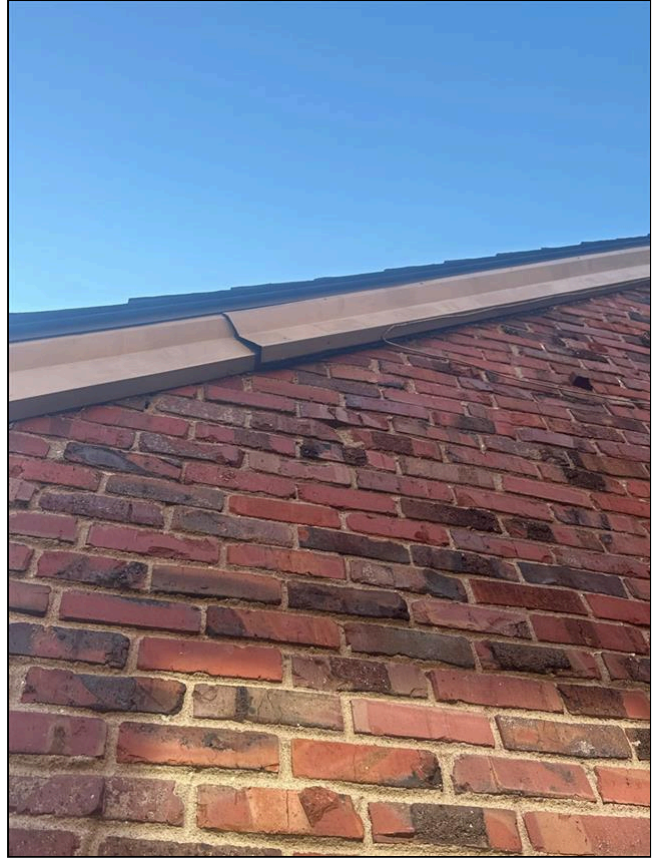
(1) Loose fascia noticed. We suggest repairs/adjustments as needed.

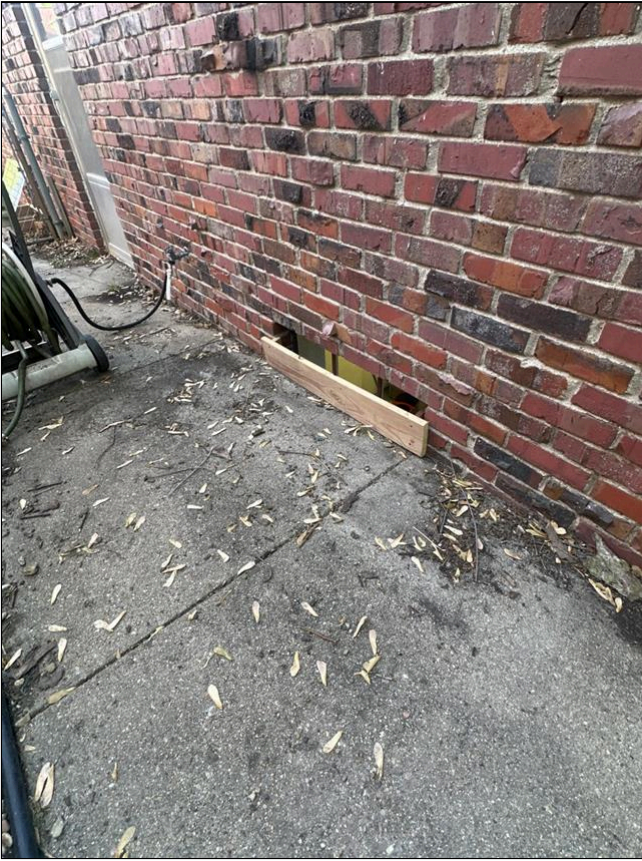
Concrete walkway is above window level. We recommend monitoring/repairs needed to prevent possible moisture intrusion.

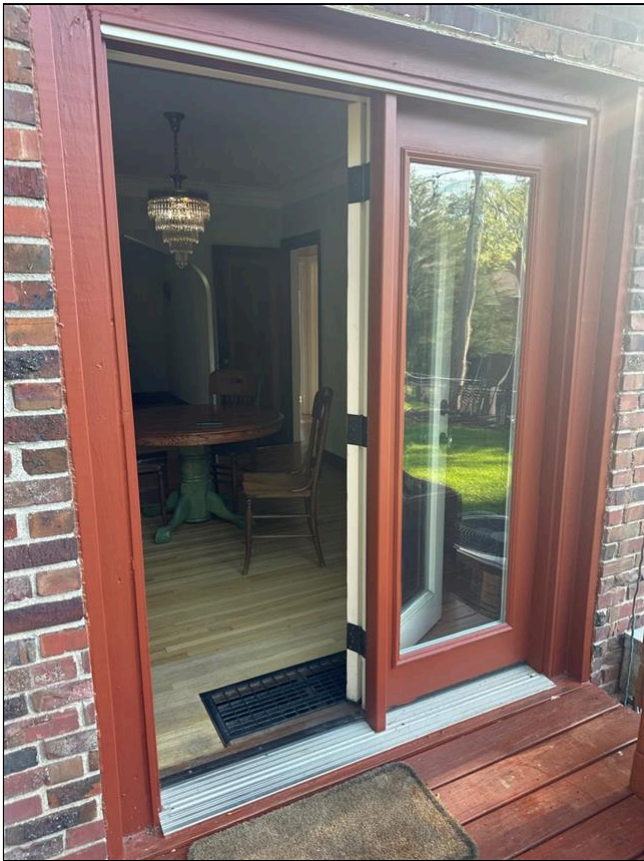
Slider screen door is not present. We recommend installing a slider screen door as needed to prevent possible pest intrusion.

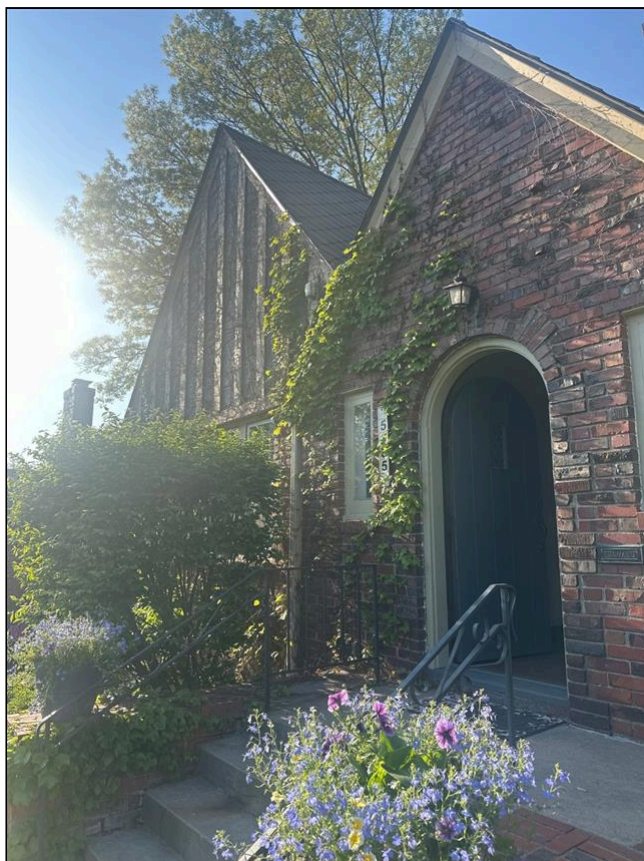
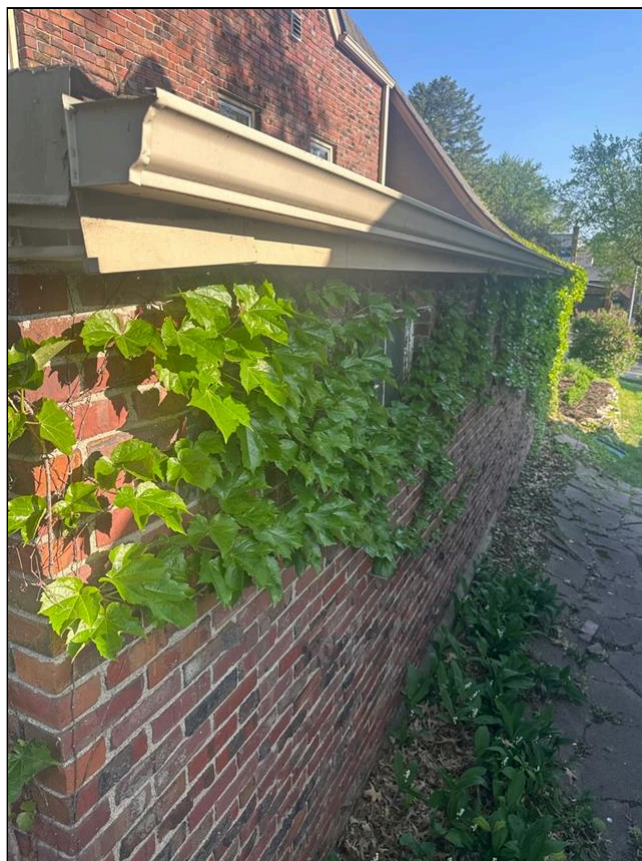
Vegetation is growing near and on the home. We suggest removal and trimming vegetation away from the home. This is typically a maintenance item.

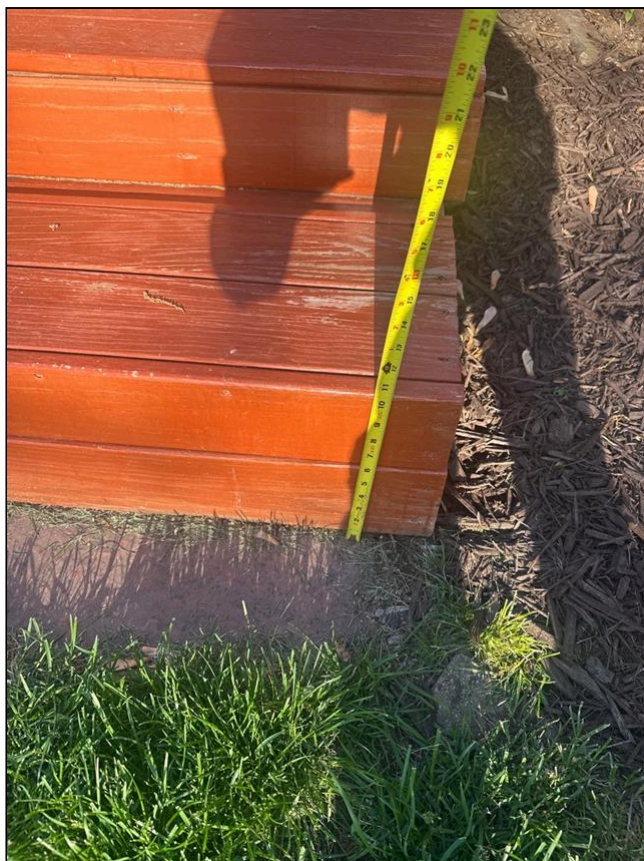
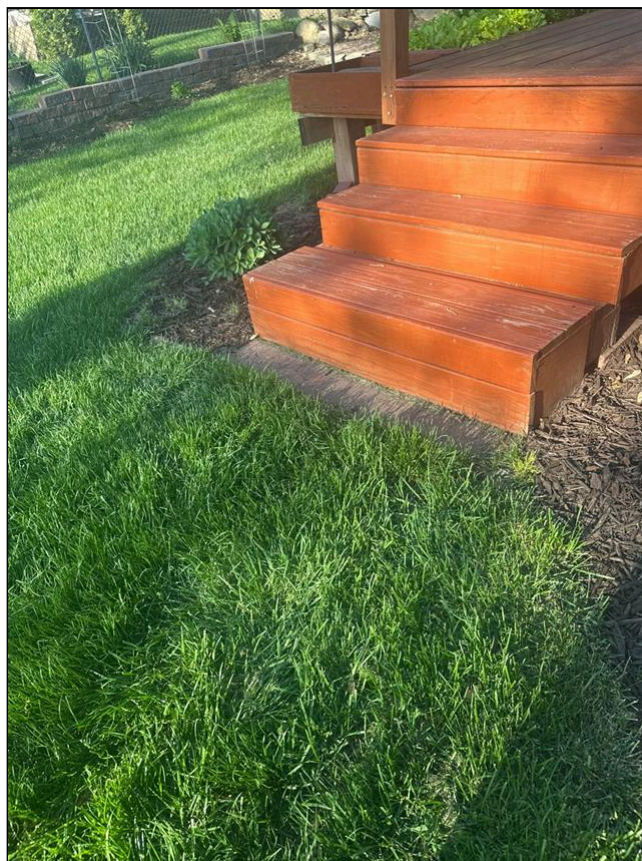
(2) Steep step noticed at the rear of the home. We recommend repairs as needed to prevent possible trip hazards.

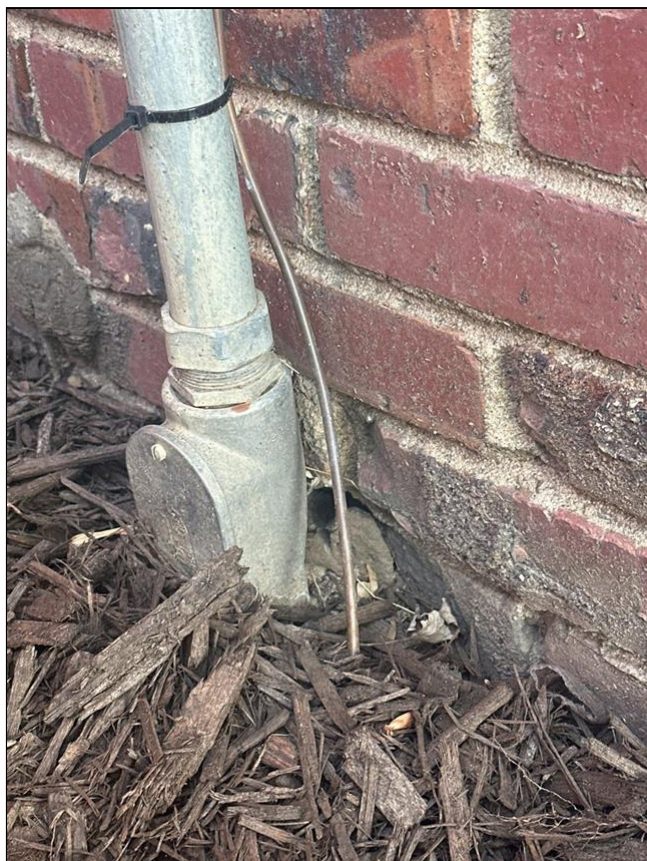
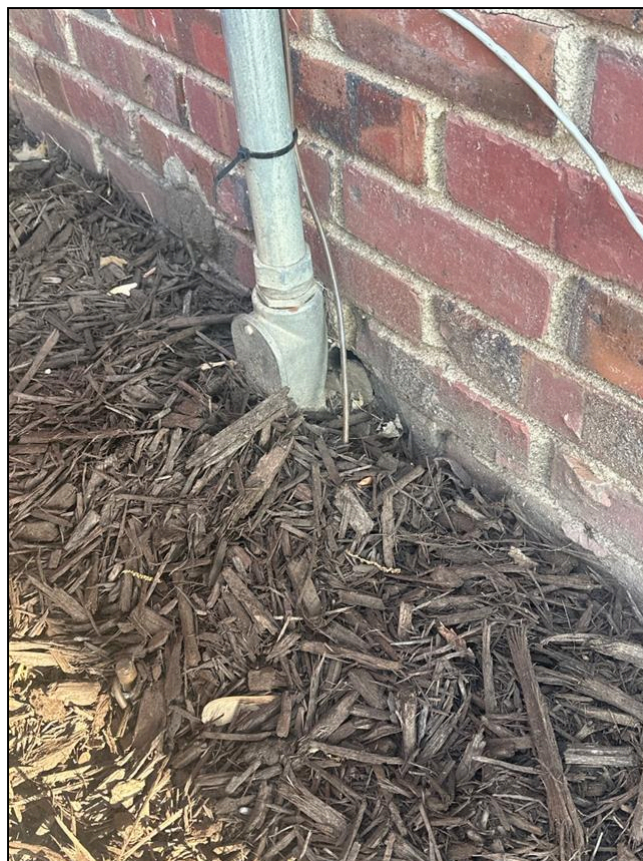
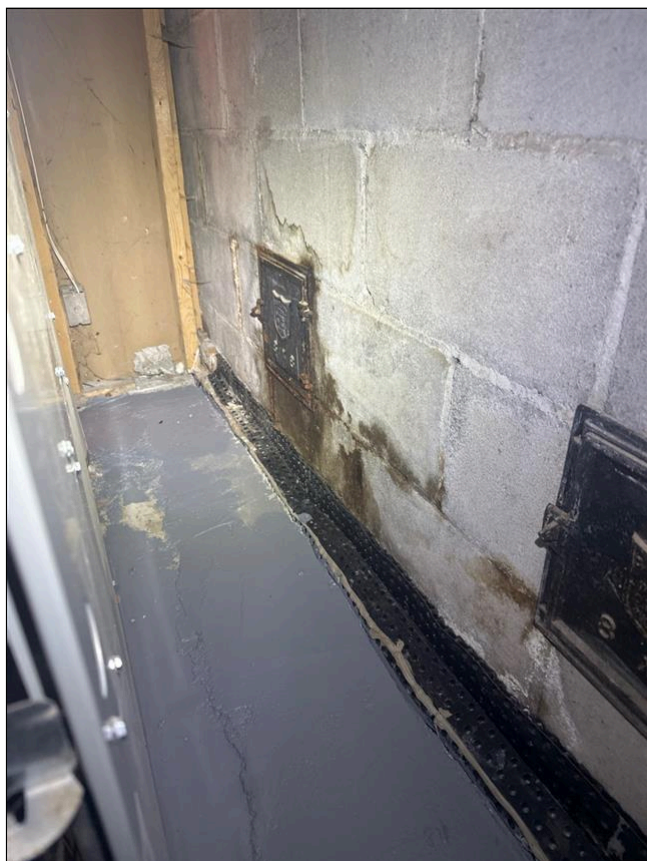
(1) Gaps noticed at the lower foundation, staining noticed near the coal shoot. We recommend further review/repairs needed by a qualified contractor.

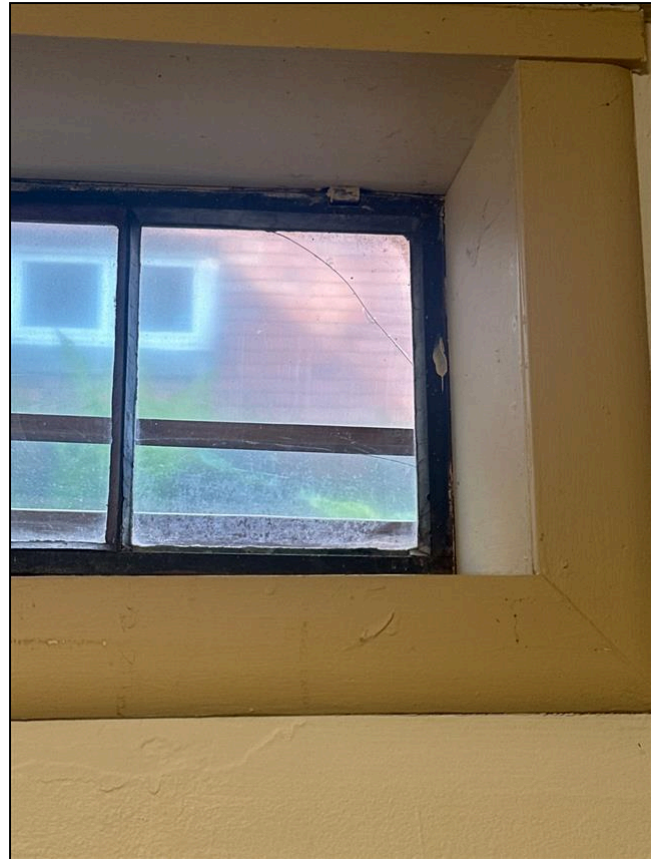
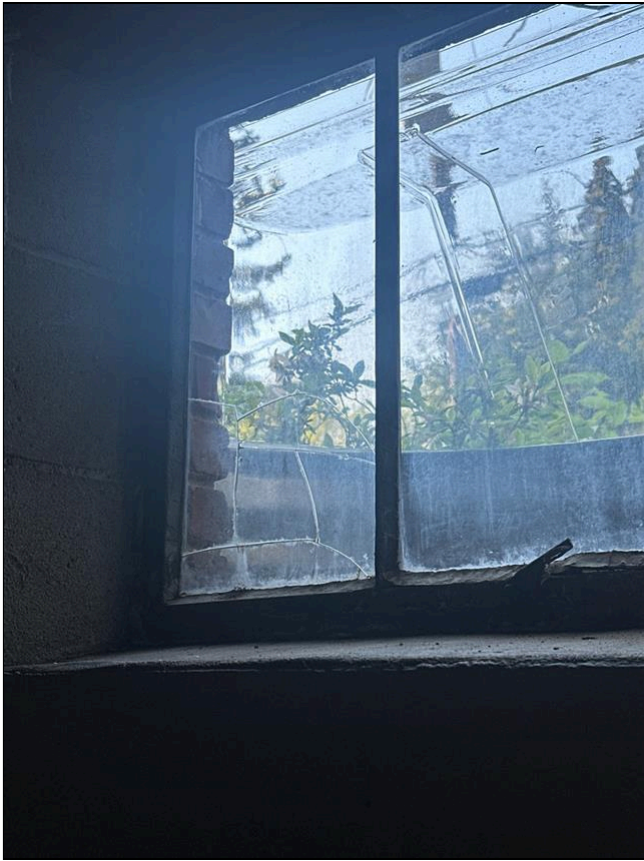
Multiple cracked basement windows found. We recommend repairs/replacements needed to prevent further damage.

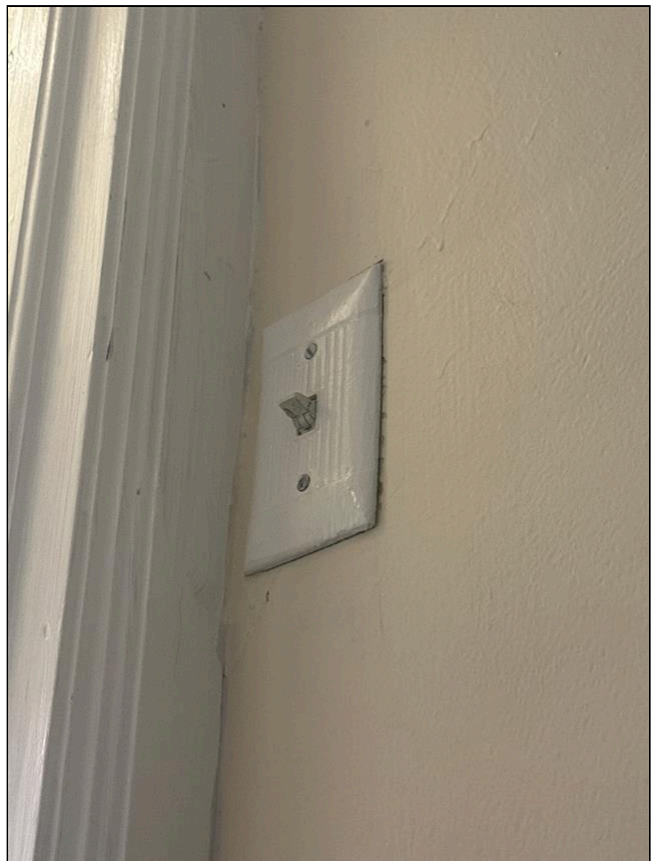
(1) Upstairs light switch was inoperable. We recommend repairs needed by a qualified electrician.

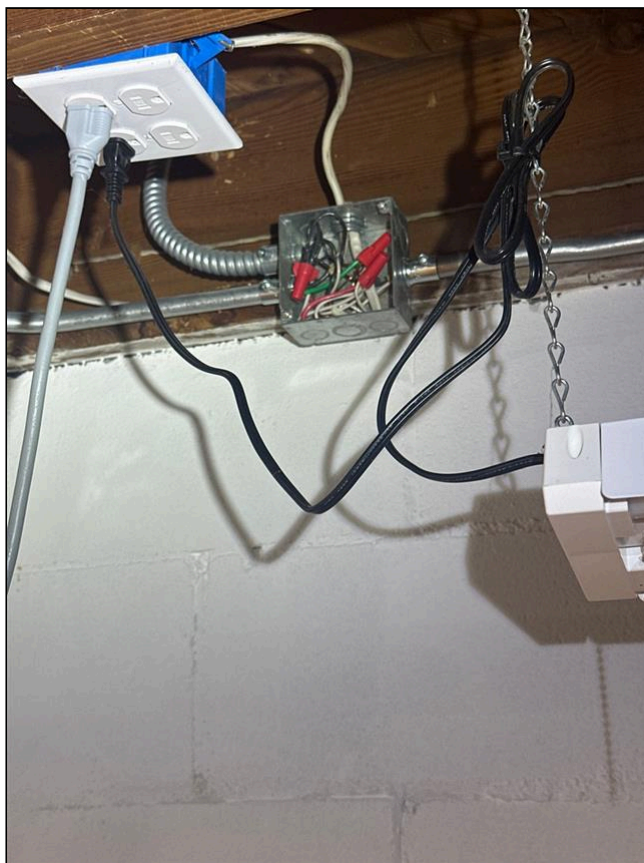
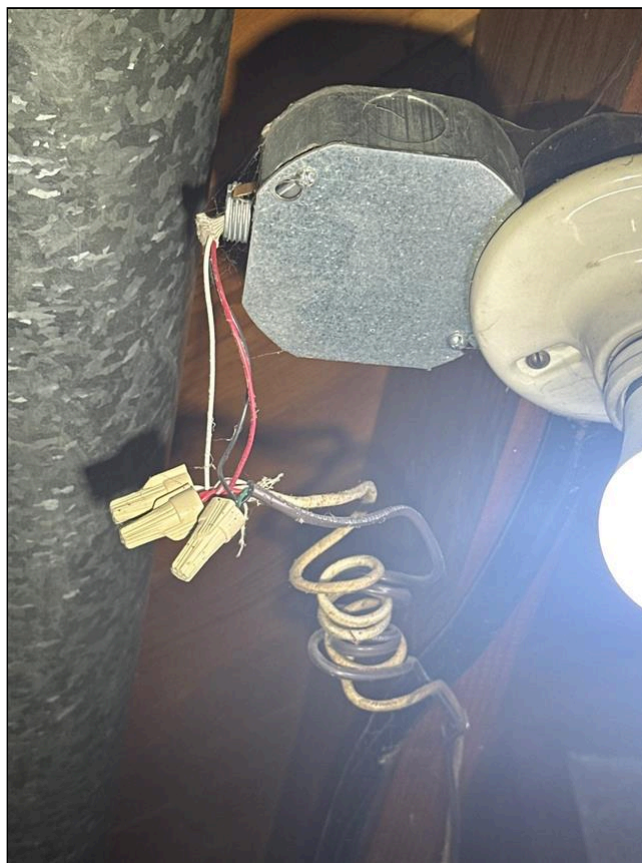
(2) Open splices were observed in the basement. This is a "Safety Concern". Whenever an electric wire is cut and reconnected, the "splice" should be encased in a covered "junction box" to prevent shocks and separation of the splice. Client is advised to consult with a licensed electrician prior to closing for repairs/ replacement as needed to ensure safety.

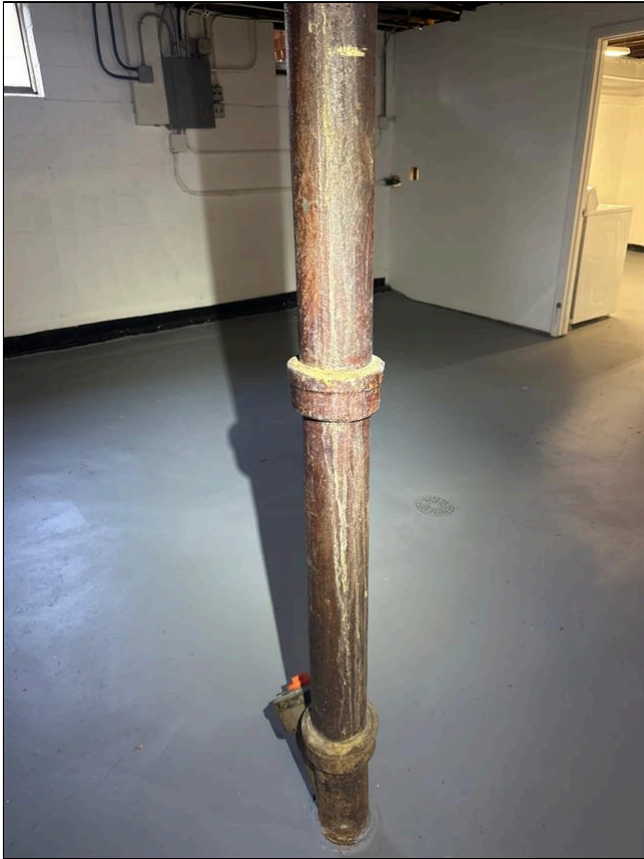
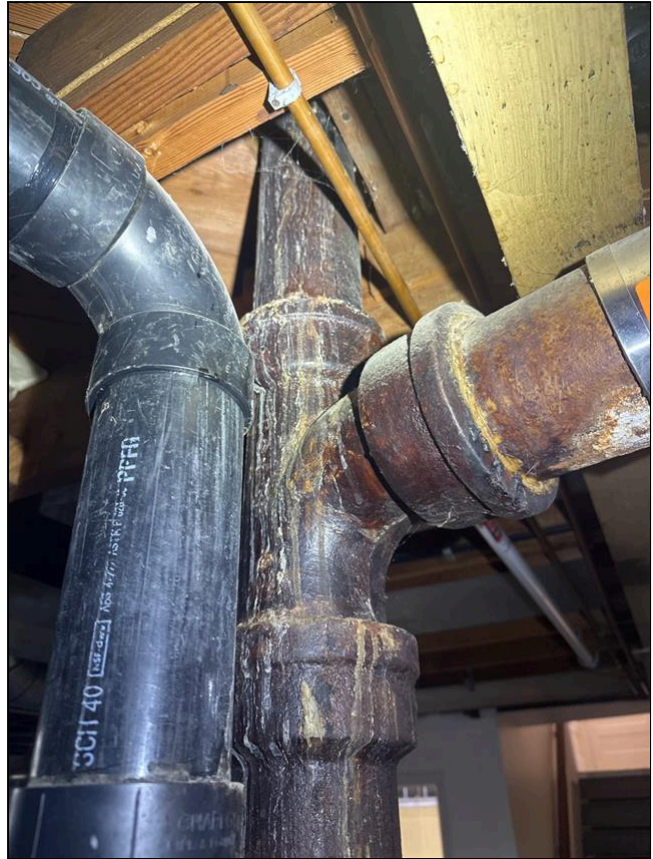
Water stains noticed at the main drain stack, no active leaks found at time of inspection. We suggest monitoring/repairs if needed.

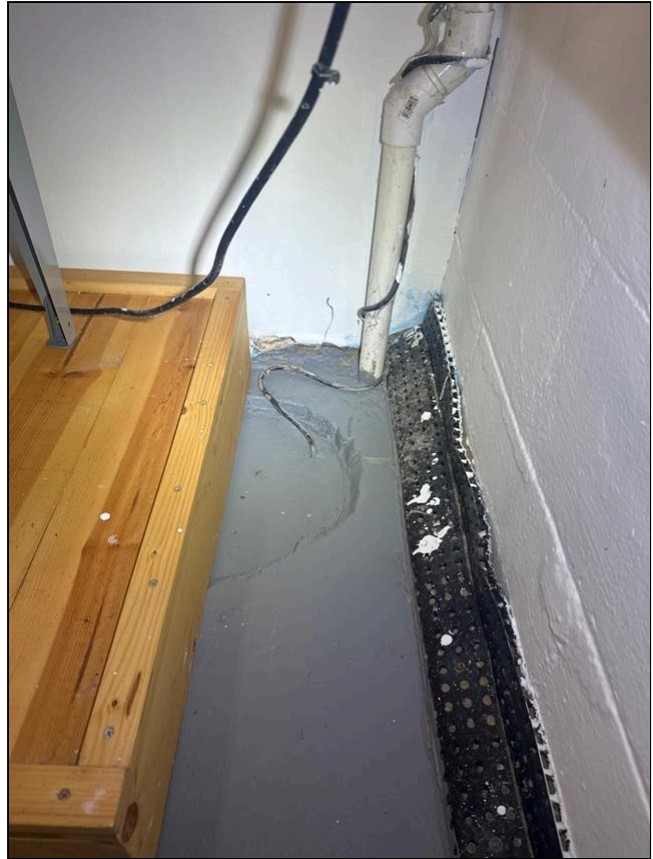
Extension hose is missing at the sump pump, plumbing, unable to verify conditions of the sump pump. Pit has been sealed. We suggest further review for proper operation.

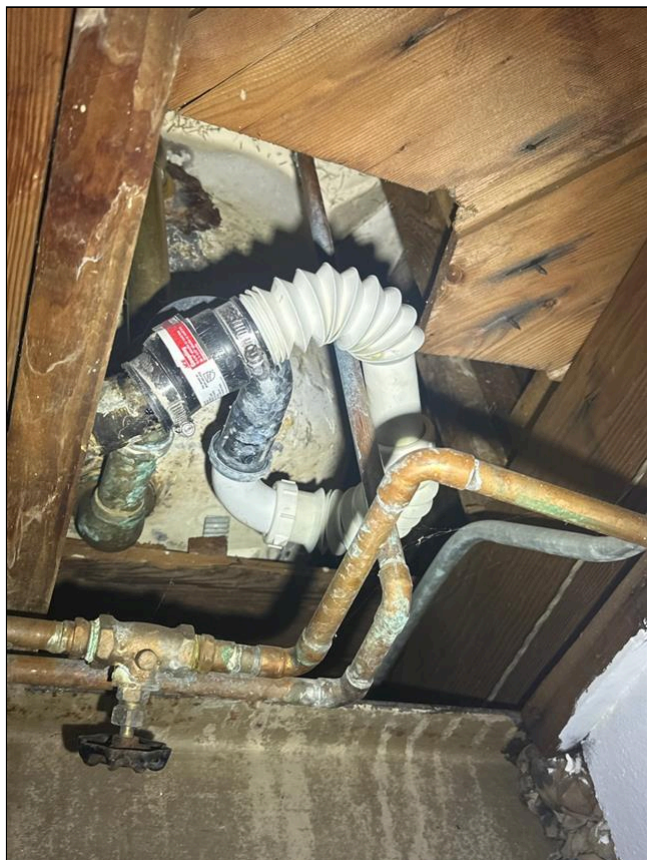
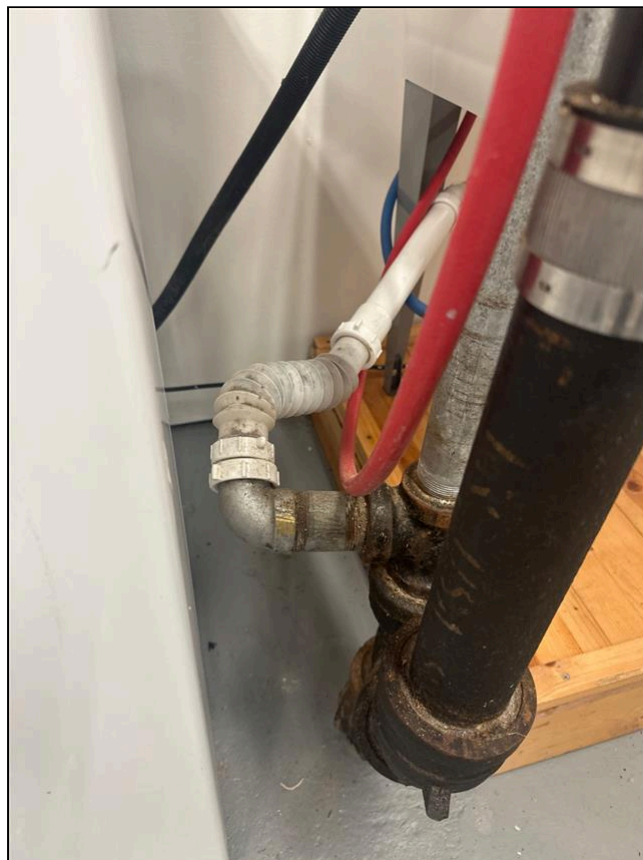
Flex drains found, flex drains are known for clogging. We recommended monitoring/repairs as needed.

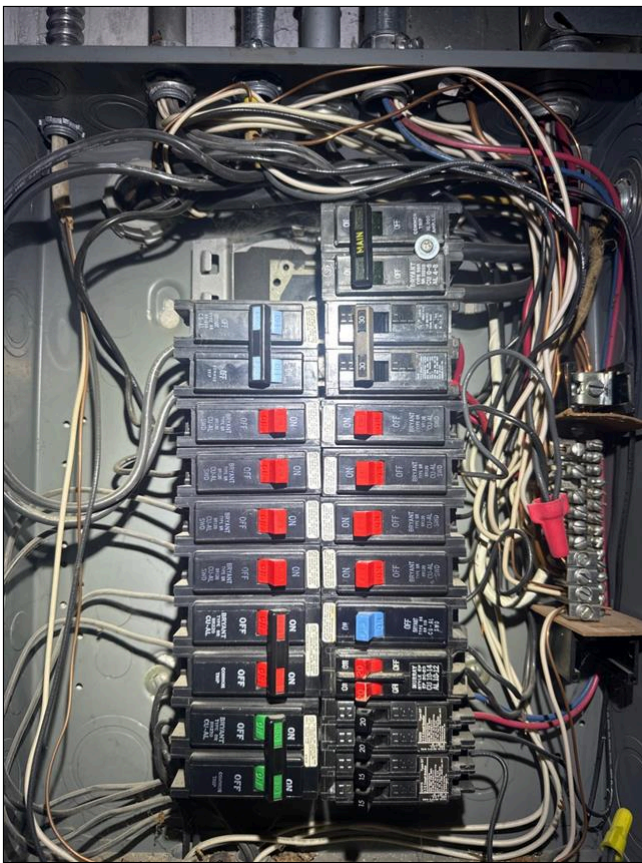
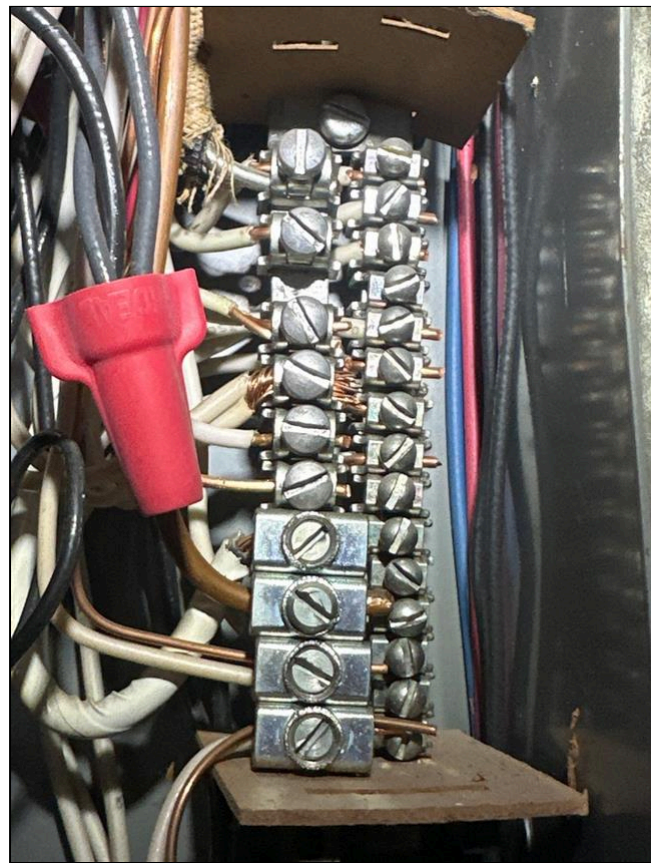
Doubled up neutrals and grounds were observed in the main panel. The connection of a neutral and equipment-grounding conductor creates a significant problem. One of the objectives of a correct arrangement of bonding jumpers, neutrals and equipment grounds is to allow circuit isolation while keeping the equipment grounding conductor still connected to the grounding electrode. A licensed electrician is needed to review the panel and make all corrections necessary for safe and proper operation of the system.

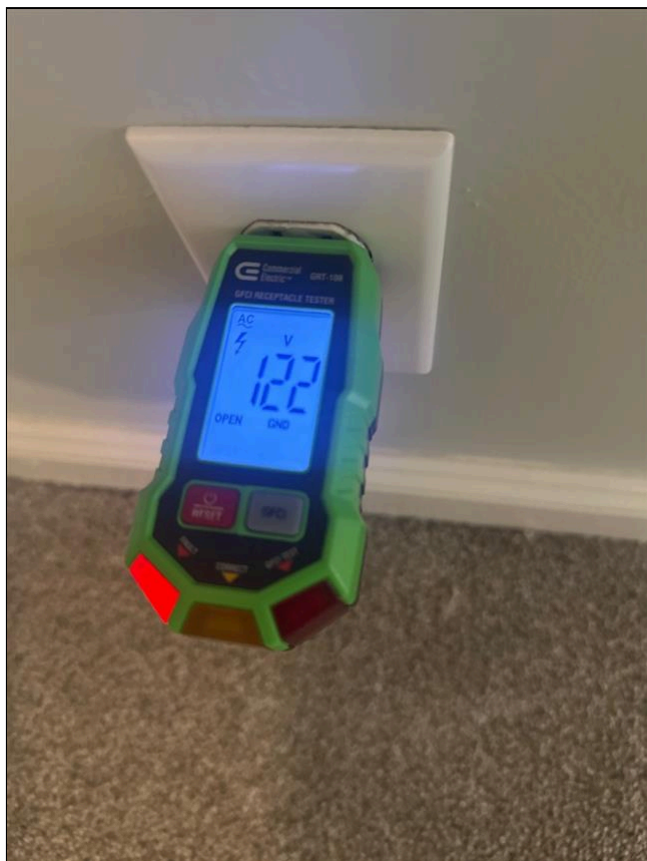
Multiple ungrounded outlets found throughout the home. This may not have been required when the home was built, however, we suggest installing grounding wire or adding GFCI outlets, enhanced safety.

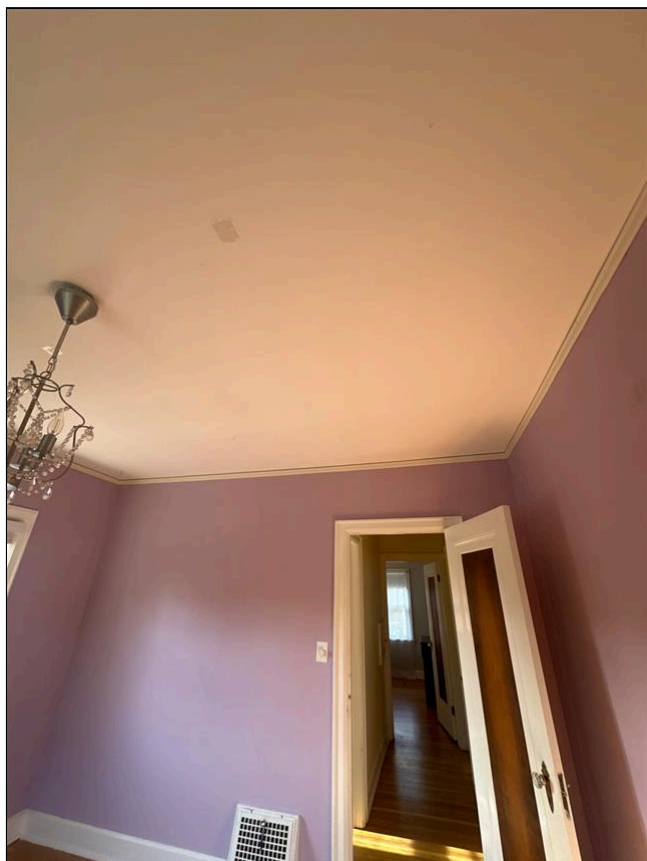
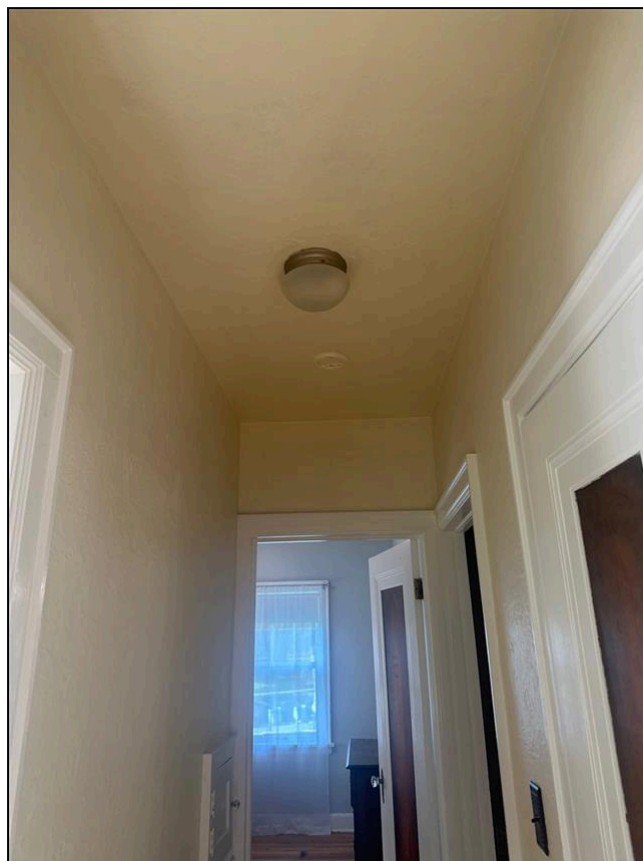
The smoke alarms should be added tested upon moving in to home, smoke alarms should be installed to any rooms that will be bedrooms. We recommend installing monoxide detectors where needed and periodically testing alarms for enhanced safety.

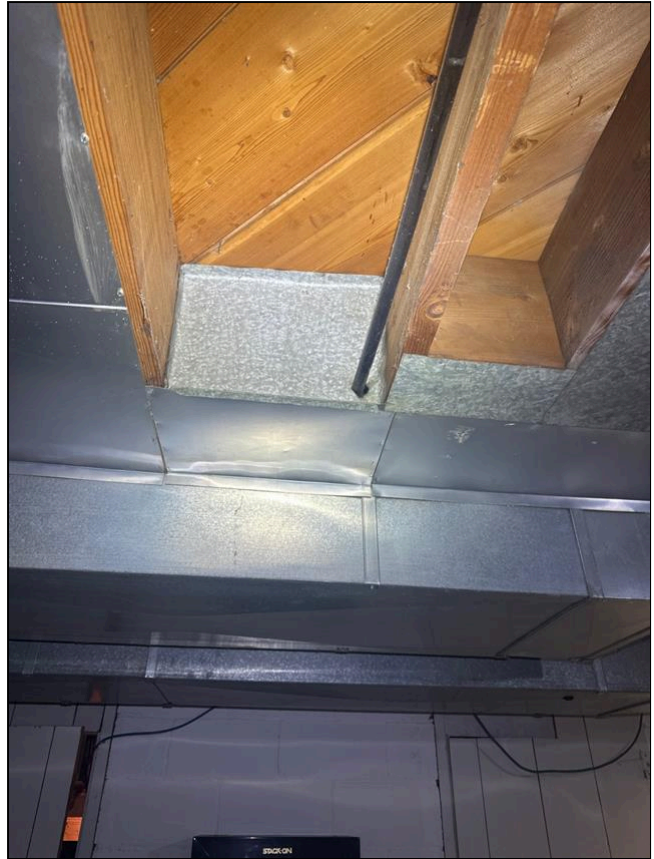
(1) Electrical has been inserted through ductwork. This is not allowed. We recommend further review/repairs needed by a qualified contractor.

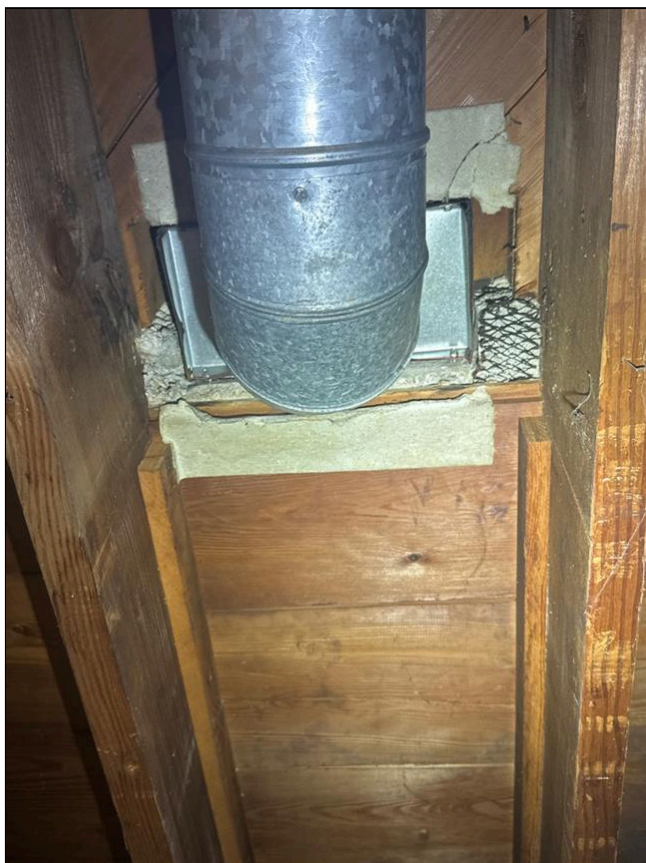
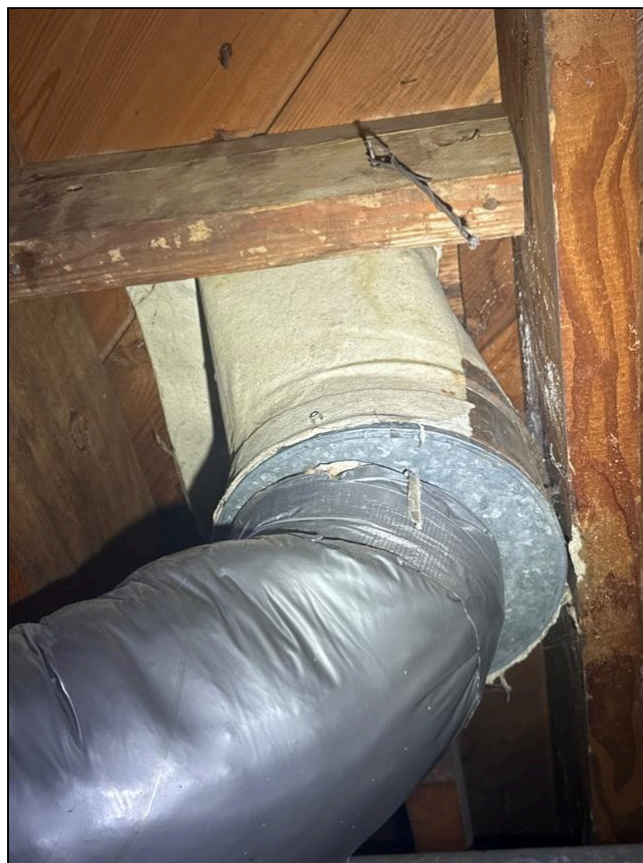
(2) Possible asbestos materials observed. The materials appeared to be intact at the time of inspection. Asbestos materials are considered safe by the EPA if they are not disturbed, torn, ripped, or damaged. No torn, ripped, or damaged materials were observed. If client has any concerns regarding asbestos materials, an asbestos testing lab should be consulted for further review to ensure safety.

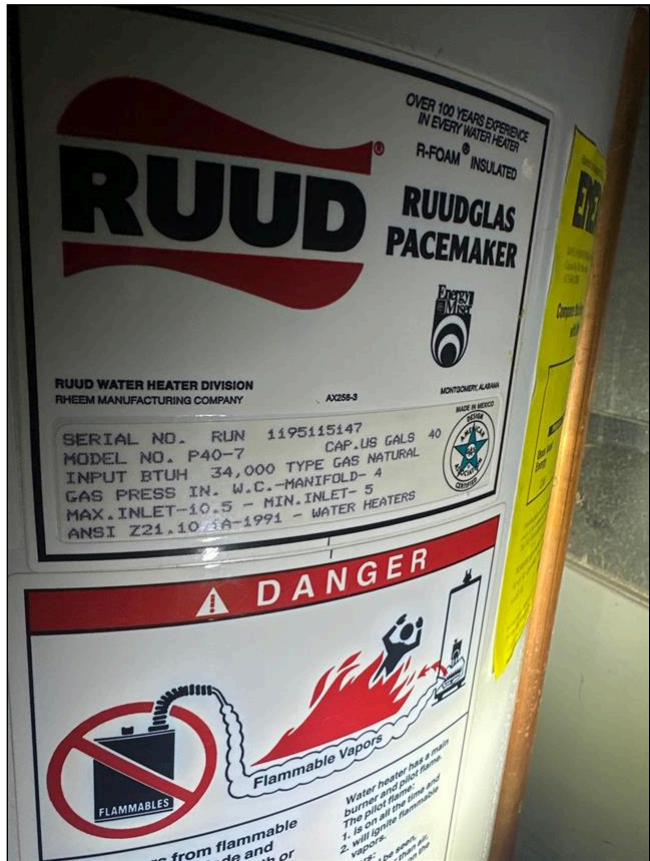
Low water temperature noticed at time of inspection. Units typically last 5-10 years. We suggest replacing when needed.

The water temperature at time of inspection was 90 degrees, which is not within the normal operating range of 120 to 130 degrees. Recommend checking with sellers as to the settings. Many homeowners lower the temperature for a variety of reasons. This could also indicate an issue with the water heaters performance if the water heater is set at the normal temperature. A licensed plumbing contractor should review and make any corrections needed if the thermostat has not been set low intentionally.

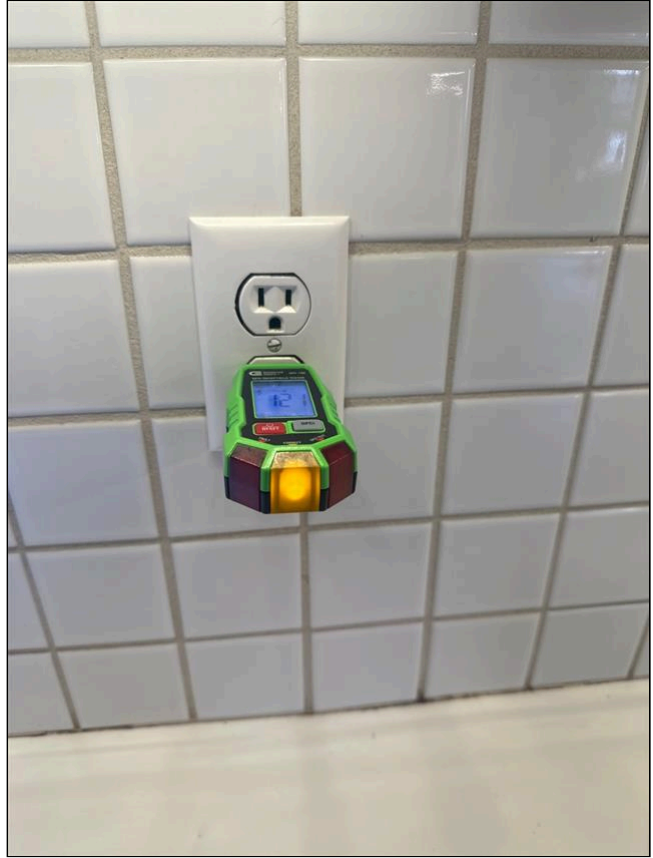
Kitchen outlets 6 feet within the water source are not GFCI protected, ground fall circuit interrupters may not have been required when this home was built. We recommend installing GFCI outlets as needed for enhanced safety. This is typically a buyer improvement.

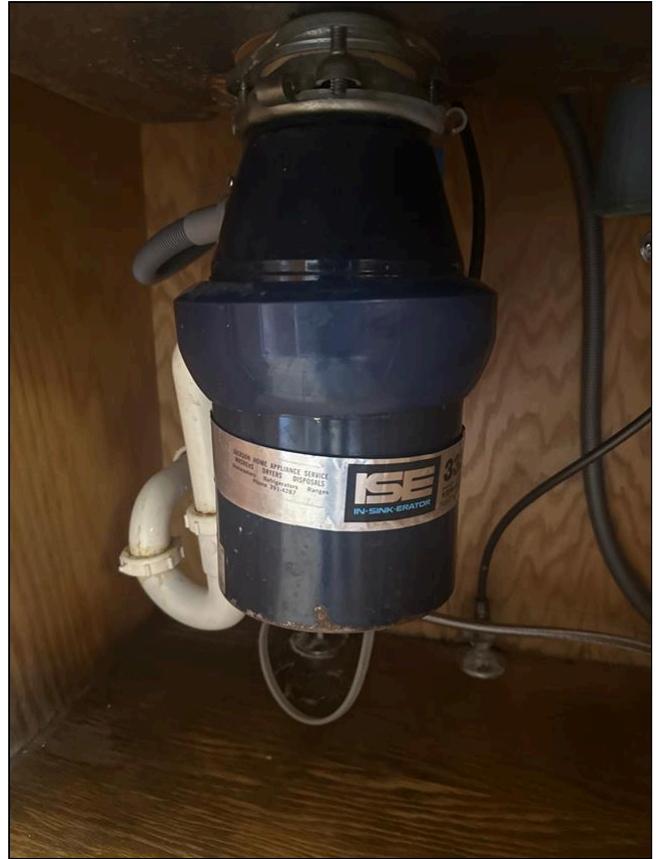
Obstruction noticed at the kitchen disposal. We recommend repairs/cleaning as needed to prevent possible damage and proper function.

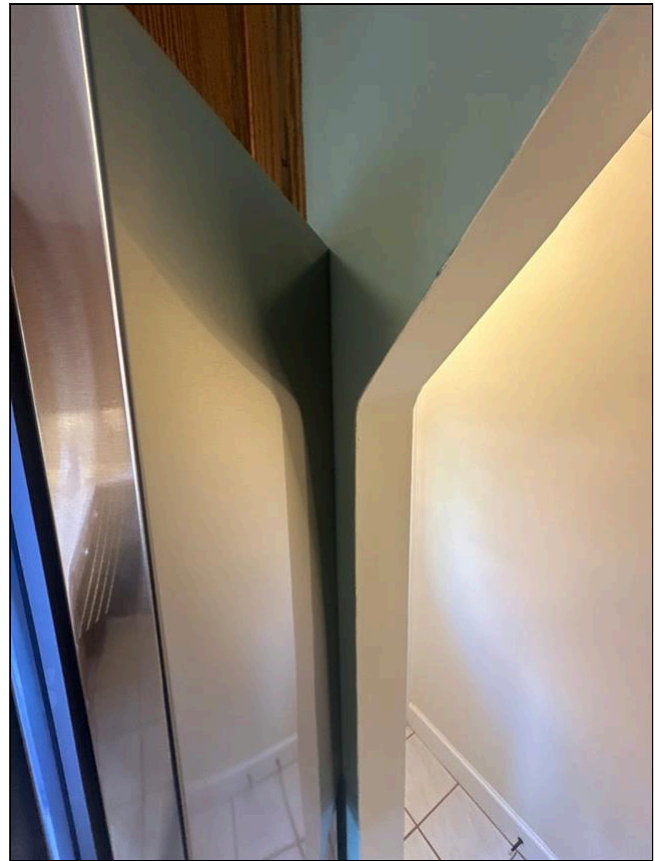
Refrigerator door cannot fully open due to wall. We suggest repairs/adjustments as needed.

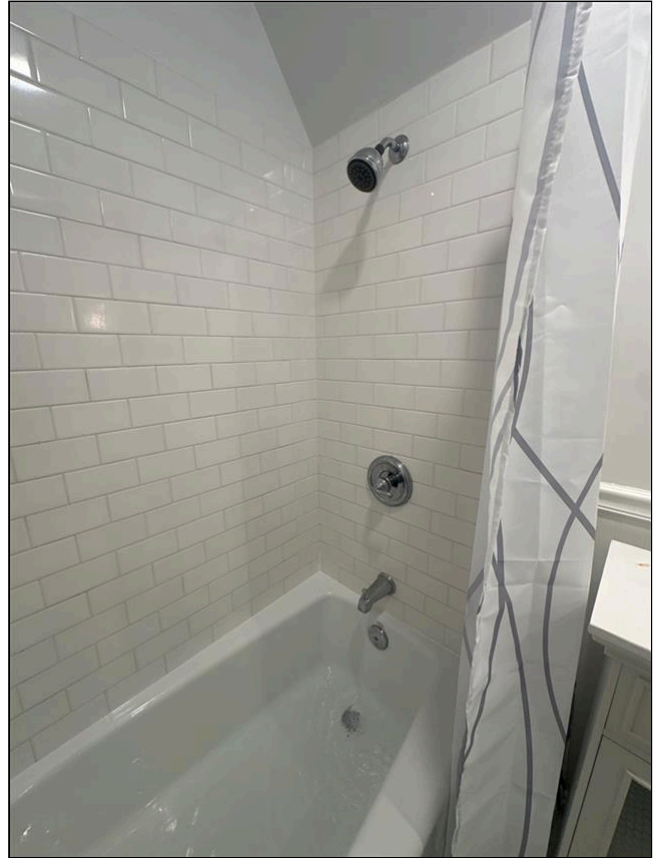
(1) Upstairs bathroom, diverter valve does not function properly, no water comes out of the showerhead. We recommend further review/repairs needed by a qualified contractor.

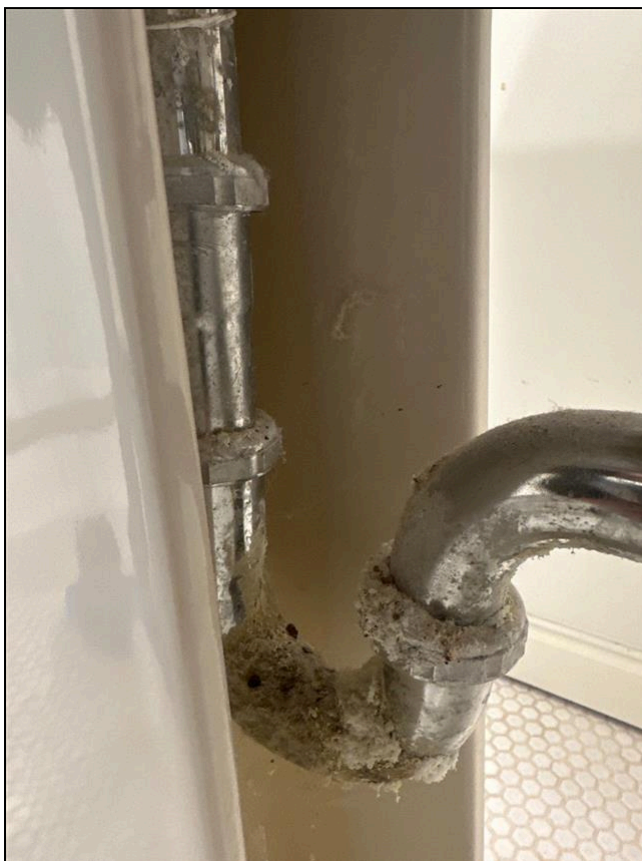
(1) Excessive corrosion noticed at the upstairs bathroom sink drain, no leak found at time of inspection. We recommend monitoring/repairs as needed.

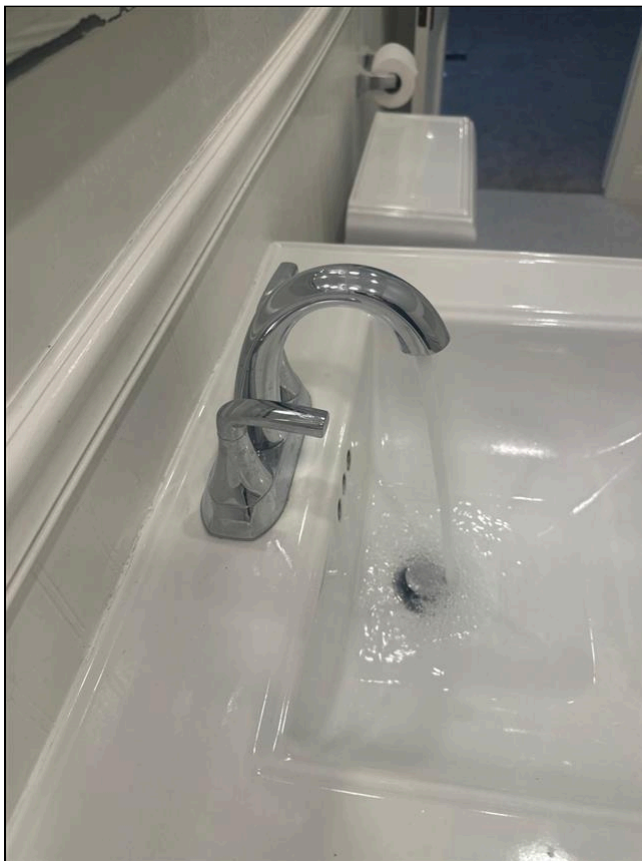
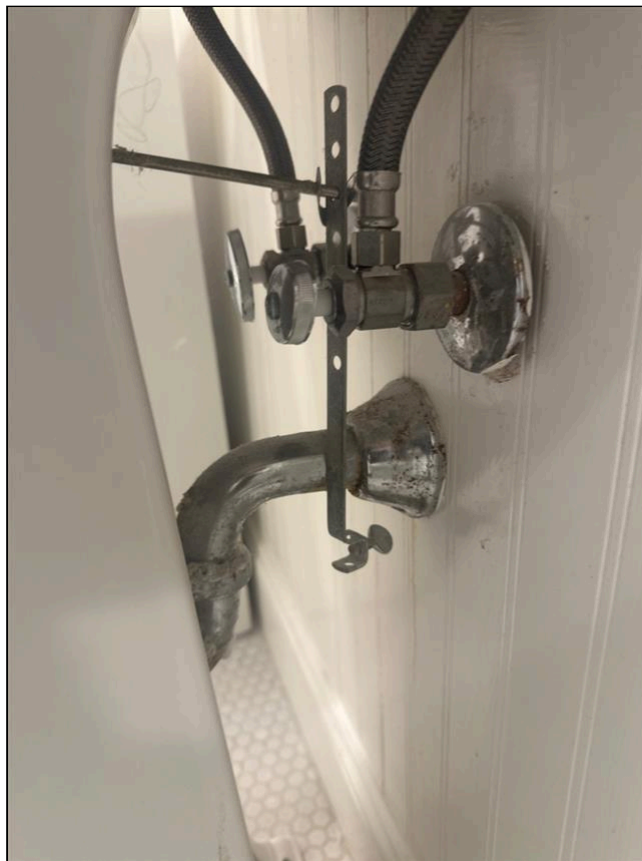
(2) No drain stopper release lever found. We suggest installing drain stopper release lever as needed.

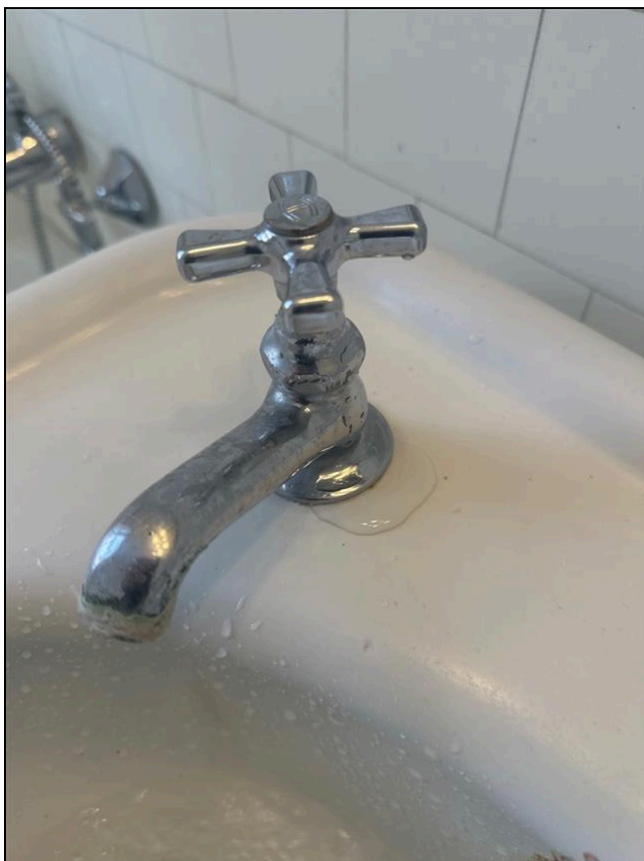
(3) Main bathroom sink handles leak when open. We suggest repairs/replacement as needed to prevent further damage.

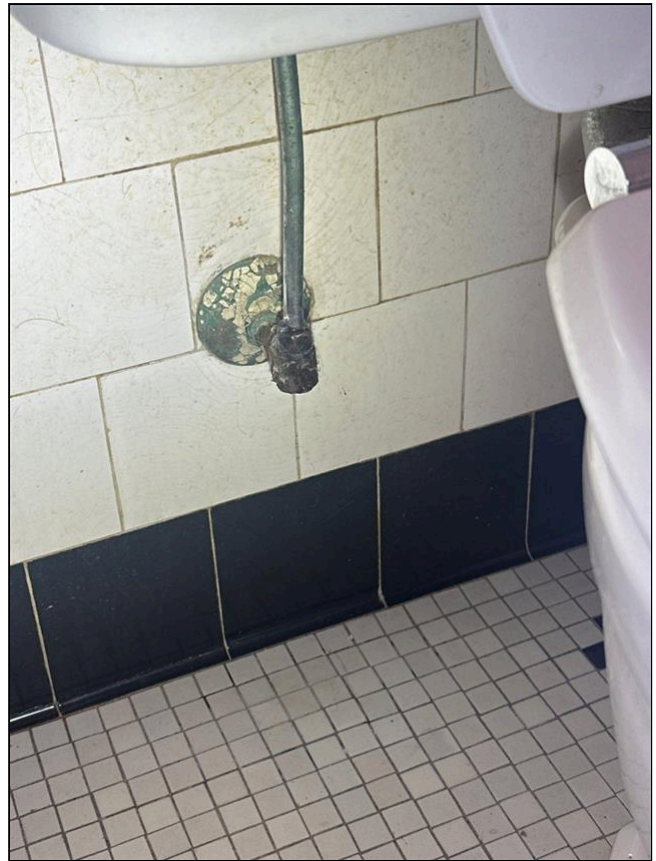
(1) Leak and/or deterioration observed at the toilet water supply line in the hall bathroom. Recommend review by Licensed/Qualified plumber for repair or replacement as necessary.
